4 i omi mopec				
Insured/Applicant Name: Billings Home Inspe	ections	Application	n / Policy #:		
Address Inspected: 2753 Vista Parkway , West Palm Beach, FL 33411					
Actual Year Built: 1956	ı	Date Inspected: 01/2	20/2019		
Minimum Photo Requirements  ☑ Dwelling: Each side ☑ Roof: Each slope ☑ Plumbing: Water heater, under cabinet plumbing/drains, exposed valves ☑ Main electrical service panel with interior door label ☑ Electrical box with panel off ☑ All hazards or deficiencies noted in this report  A Florida-licensed inspector must complete, sign and date this form.					
Be advised that Underwriting will rely on the information in this sample form, or a similar form, that is obtained from the Florida licensed professional of your choice. This information only is used to determine insurability and is not a warranty or assurance of the suitability, fitness or longevity of any of the systems inspected.

# **Photos, Additional Comments or Observations**

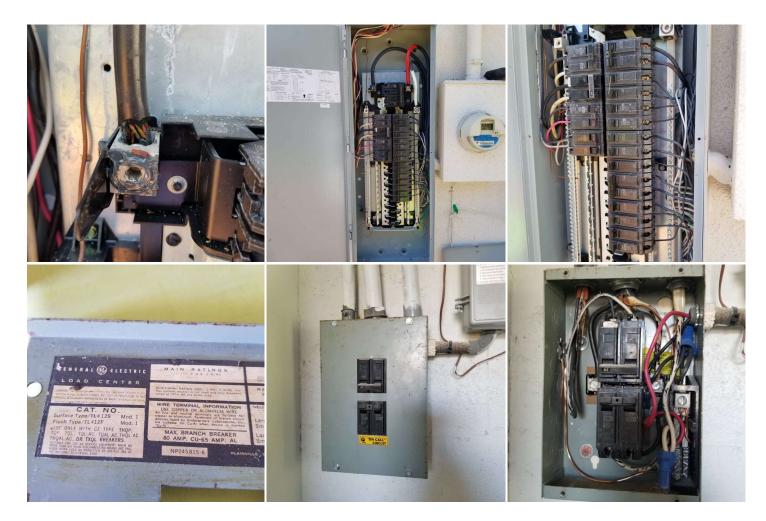
#### Hazards

Pointed screws sub-panel

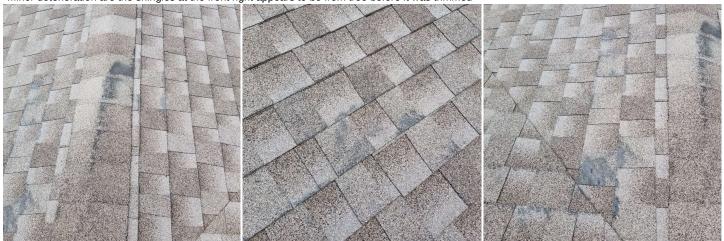
Visible signs of damage / deterioration

Minor deterioration are the shingles at the front right appears to be from tree before it was trimmed
