ELEVATE HOME INSPECTION

123 Curl Dr
Columbus, OH 43221

James DeGraw
NOVEMBER 8, 2021

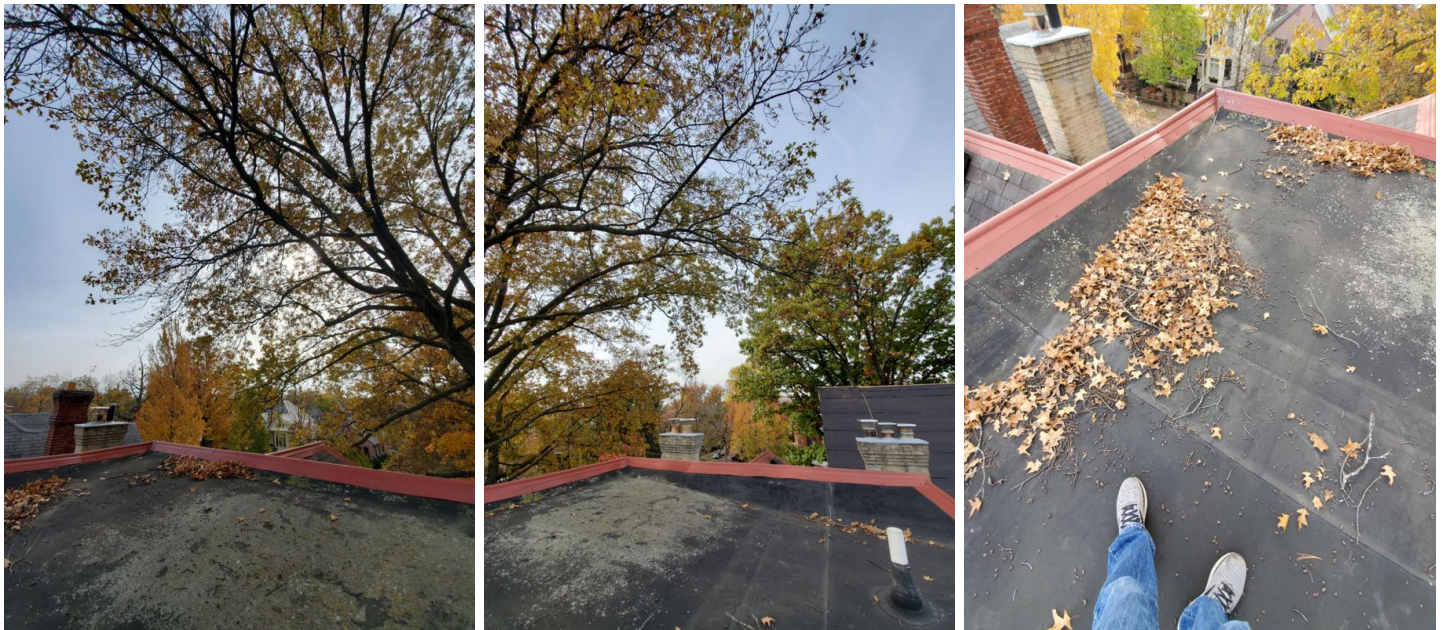
TREE TOO CLOSE

We observed that a tree/branch was overhanging the roof and may be in contact with it. This can damage the roofing system and allow pest entry into the house.

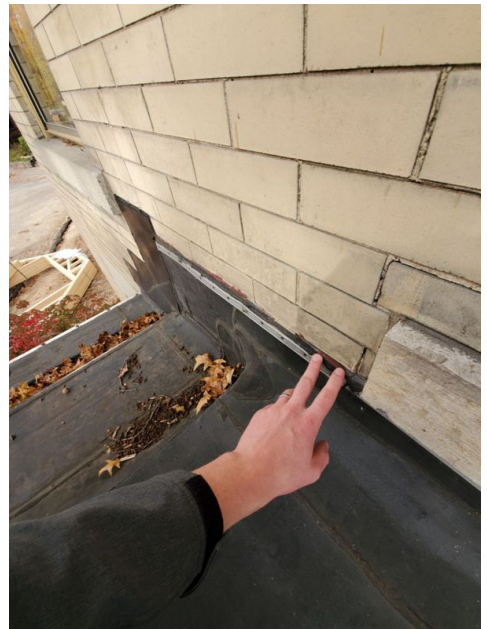
Front Porch

SEALANT NEEDED

We observed exposed fasteners and/or loose seams on the roof-covering materials. Fasteners & seams should be sealed because they are potential water entry points.

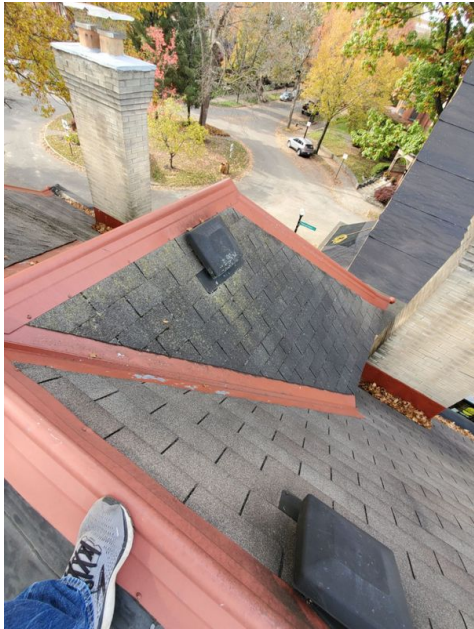
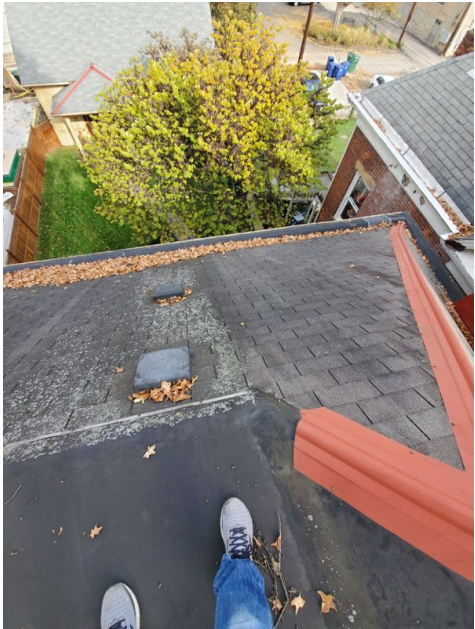
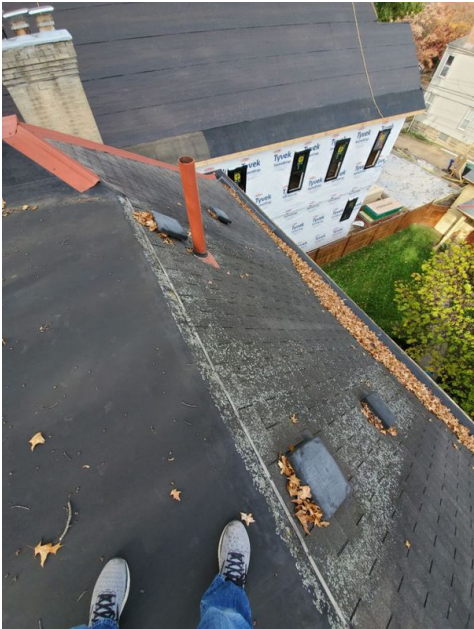
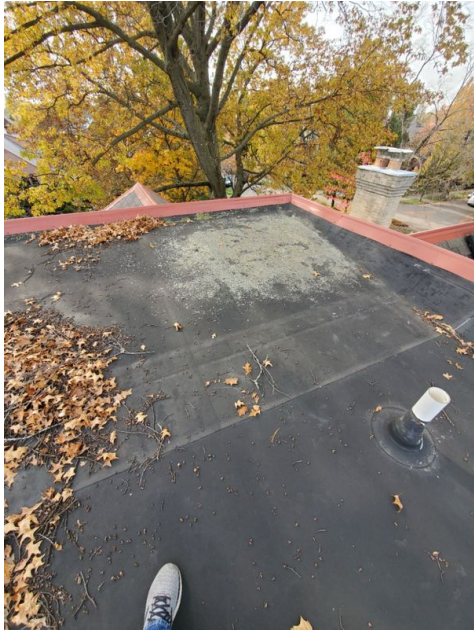
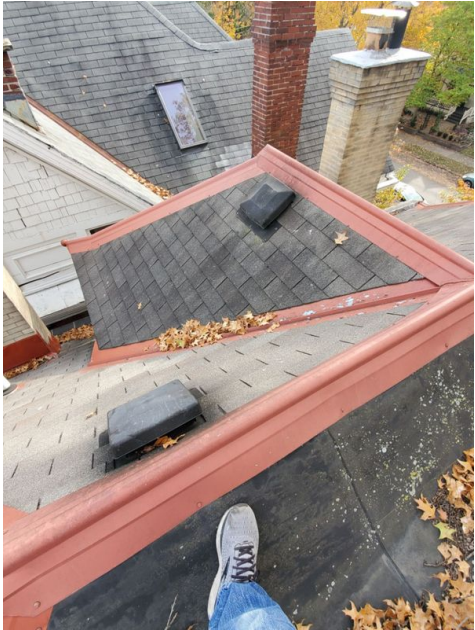
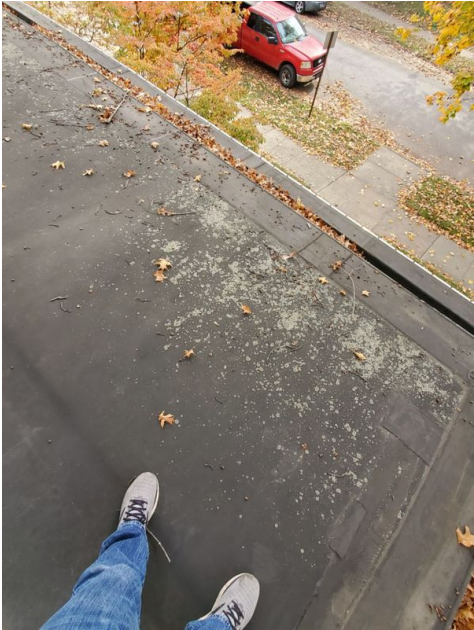
We observed staining and discoloration on the roof-covering materials. This condition seemed to be caused from a moss or algae-like plant growth. When environmental conditions are right, the problem can spread quickly across a roof. This condition may shorten the lifespan of your roof-covering materials. Algae bonds itself tightly to the shingle, which can make it difficult to remove without damaging the roof. [Here is a helpful article](#) on common roof stains and ideas on how to deal with them.

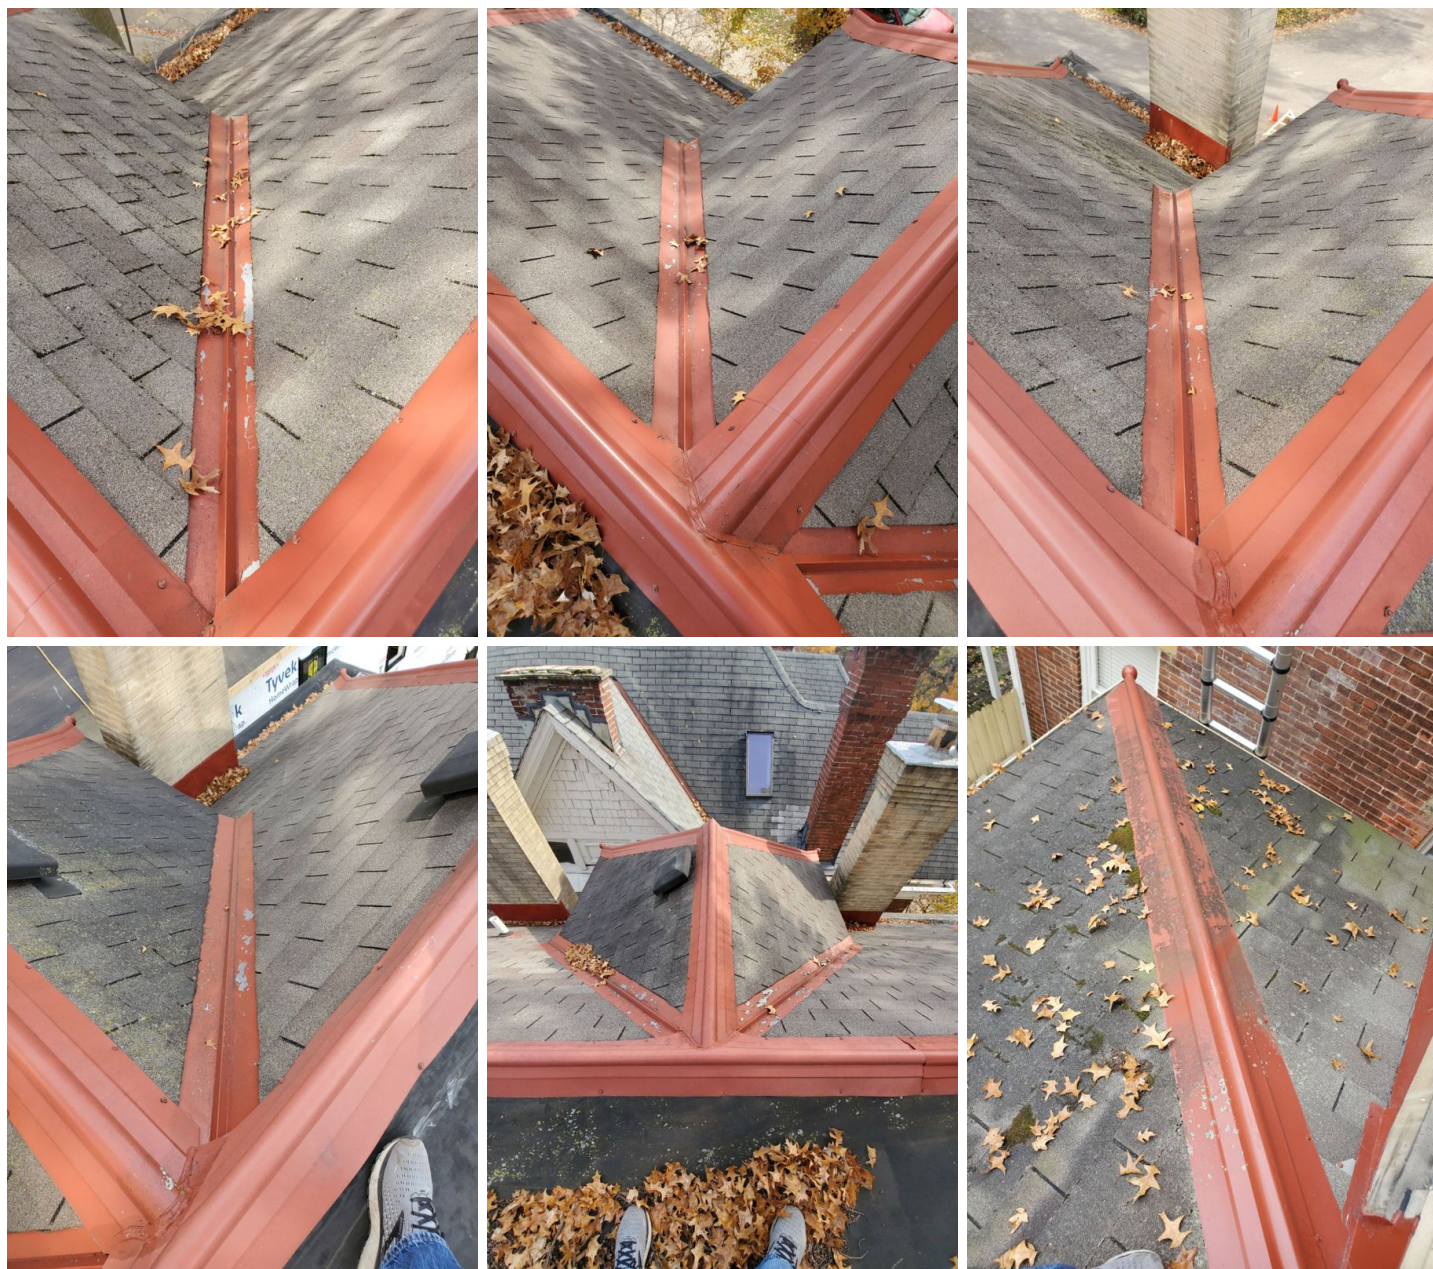
Back Porch

MINOR CORROSION

We observed roof flashing with mild corrosion. This flashing should be repaired/repainted to prevent severe corrosion and the area should be monitored.

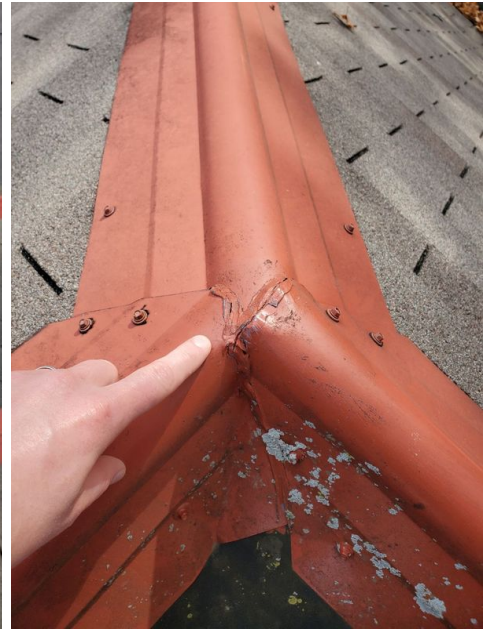
Back Porch

We observed flashing with exposed fasteners and/or seams. These should be sealed to prevent water intrusion.

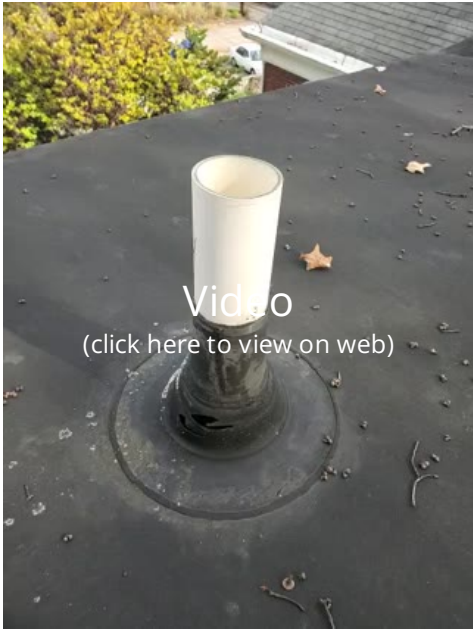
FLASHING DAMAGED

We observed that the rubber membrane flashing boot around the vent pipe was cracked and damaged, making this area prone to water penetration.

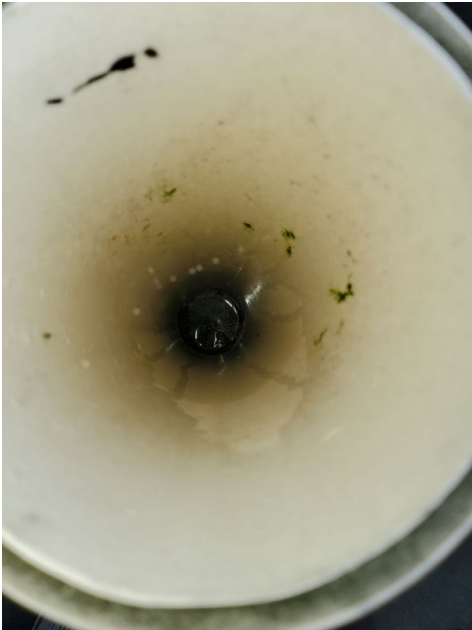
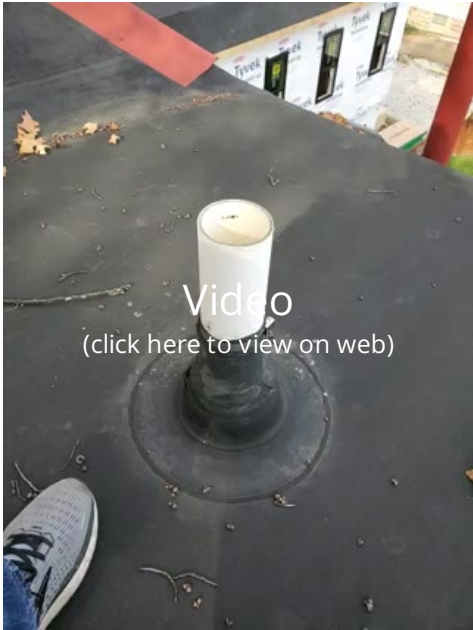
PIPE APPEARED CLOGGED

We observed a plumbing vent pipe with standing water visible inside. This may indicate a clog, which may impact the performance of the house's drain system.

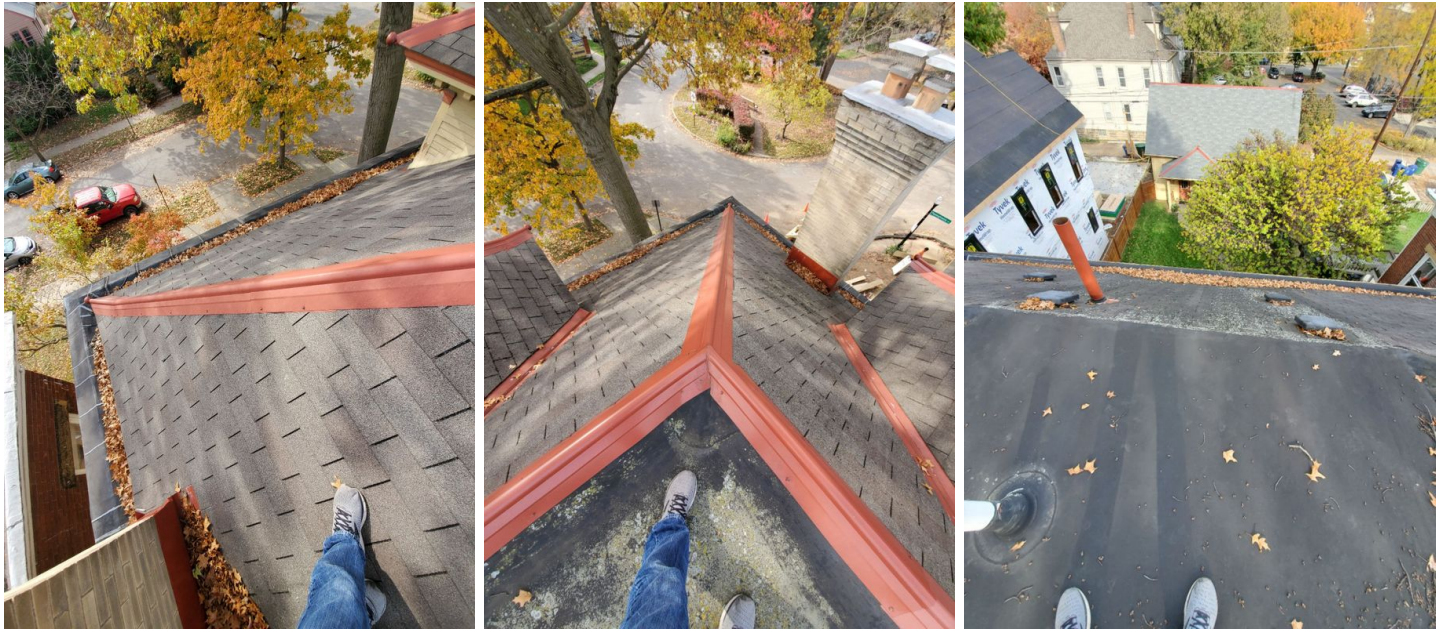
DEBRIS IN GUTTERS

We observed debris in the gutter. We recommend regular cleaning & maintenance.

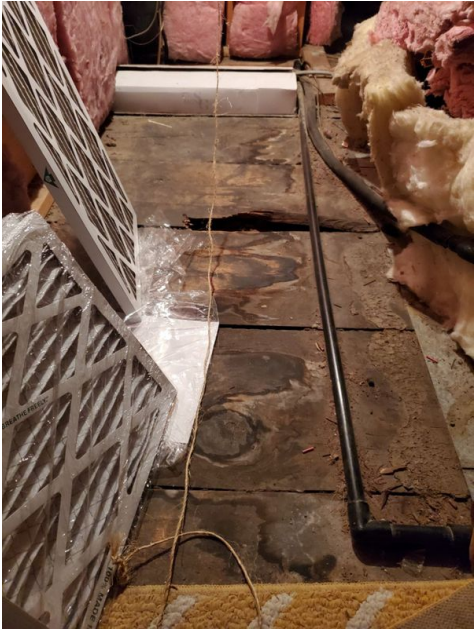
We observed indications that sometime in the past there was likely water penetration into the attic. At the time of the inspection, an active leak in this area was not observed, but we recommend you ask the seller about this area and monitor this area closely to ensure that any water issue has been fully corrected.

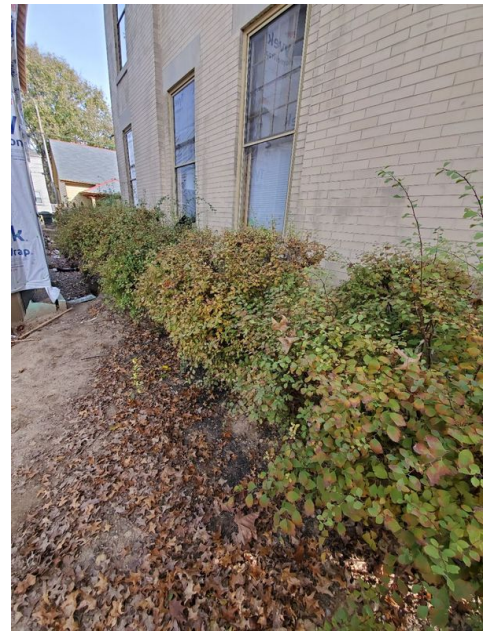
VEGETATION RESTRICTION

At the time of the inspection, dense vegetation near the house restricted our ability to closely inspect some areas of the foundation. Defects may be hidden from view by the dense vegetation and this was an inspection restriction.

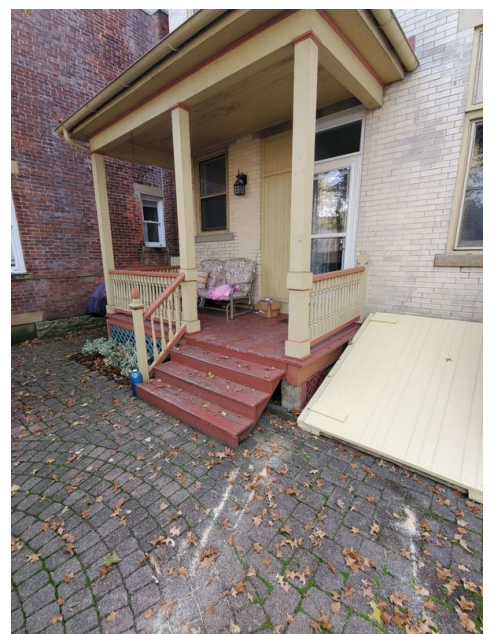
DECK/PATIO BLOCKED VISIBILITY

The attached deck/patio blocked visibility to potential defects that were not visible at the time of the inspection. This was an inspection restriction.

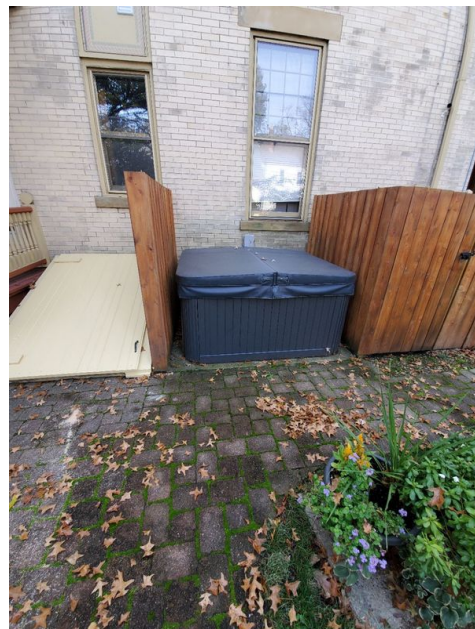
SPA/HOT TUB BLOCKED VISIBILITY

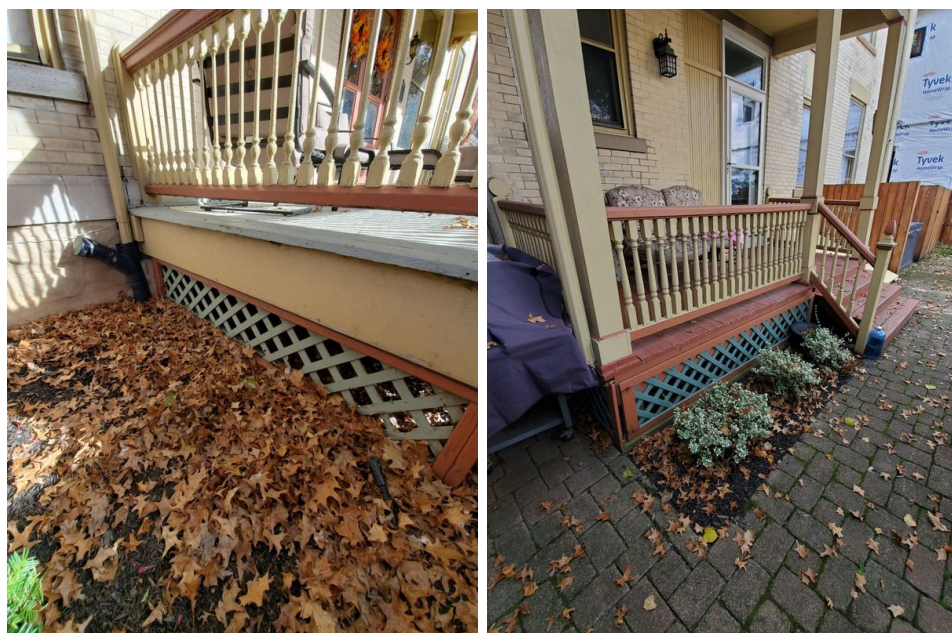
LOW DECK

We weren't able to access underneath the deck to inspect the structure and condition. This was an inspection restriction.

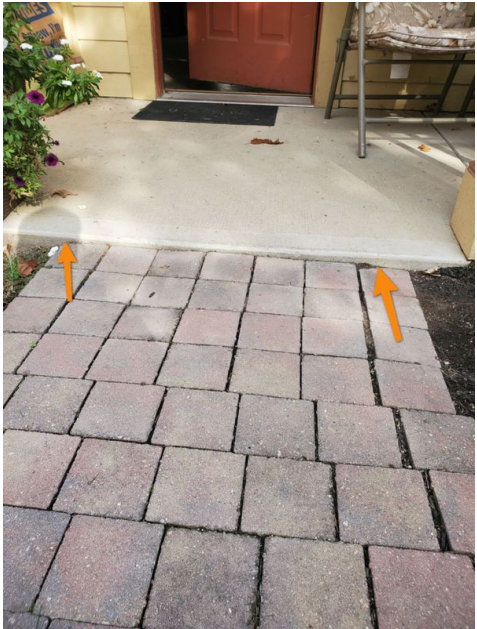
Back Yard

TRIP HAZARD

We observed a trip hazard, which we consider for cracks on walking surfaces with vertical displacement 1 inch or more. This is a safety concern.

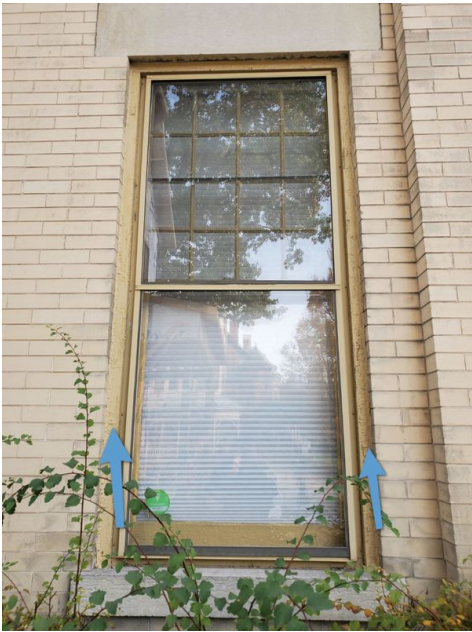
Left Side

PAINT IN POOR CONDITION

We observed paint in poor condition. This should be corrected to avoid further damage to wall-covering/trim materials.

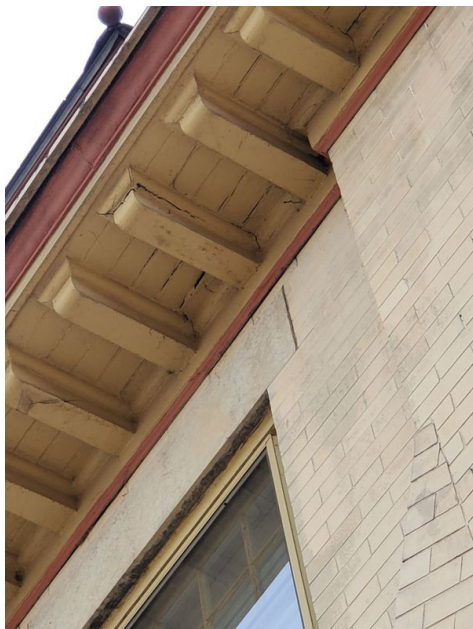
Left Side

DAMAGE AREA

We observed that one or more areas of the eaves was damaged.

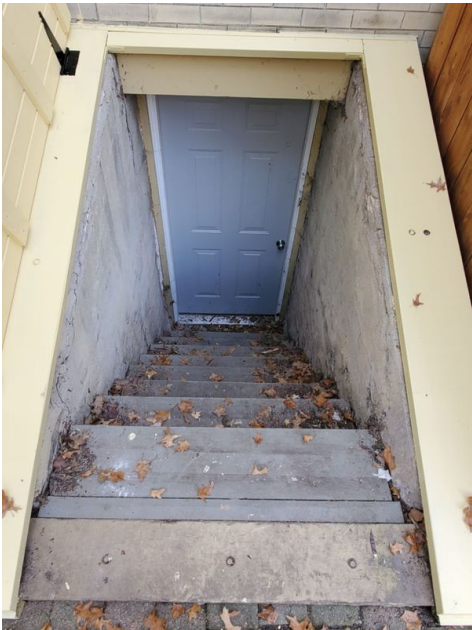
Back

HANDRAIL MISSING

We observed a missing handrail at exterior steps. Steps with 4 or more risers require a handrail. This is a safety concern.

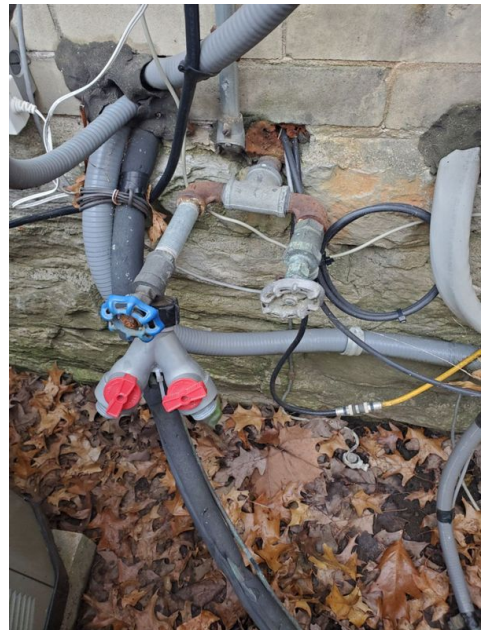
Back

SPIGOT APPEARED AGED

We observed that the spigot/hose bib appeared aged and may be near the end of its service life. As such, it may not perform reliably. We recommend budgeting for replacement. [Check out this helpful guide for estimating the service life of home systems.](#)

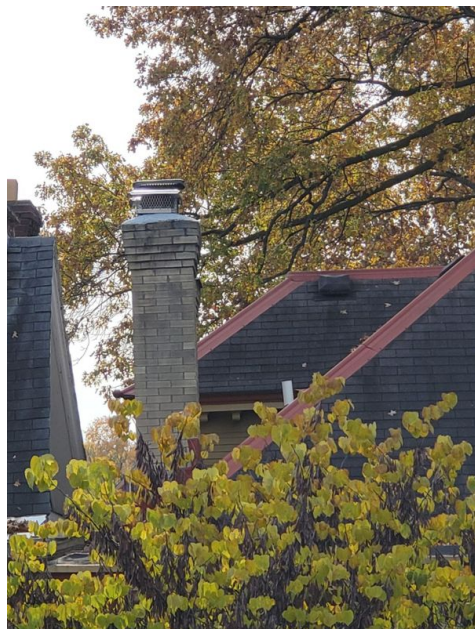
STRUCTURAL CONCERN

We observed a structural concern at the chimney system that may pose a future hazard to the house's structure or its occupants. This should be further evaluated and corrected by a qualified professional and/or structural engineer.

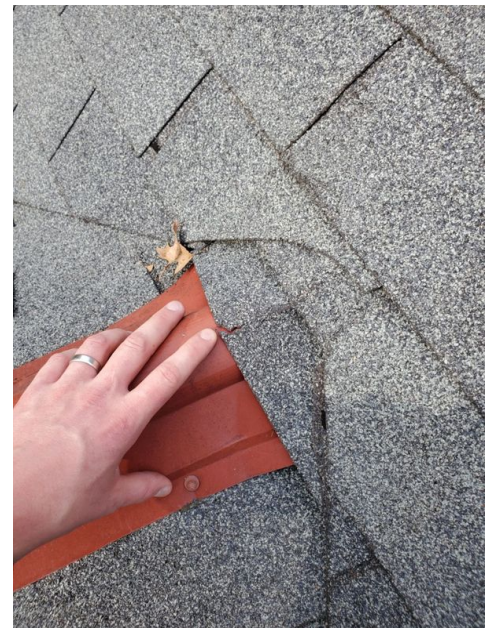
DAMAGE AREA

We observed areas of cracked/splitting and damaged roof-covering materials that may be prone to leaking.

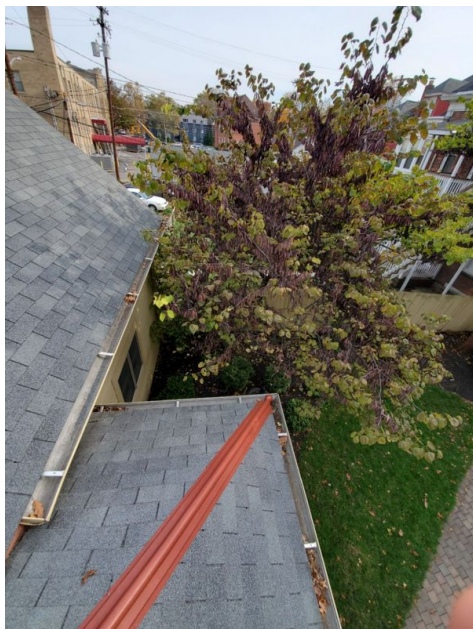
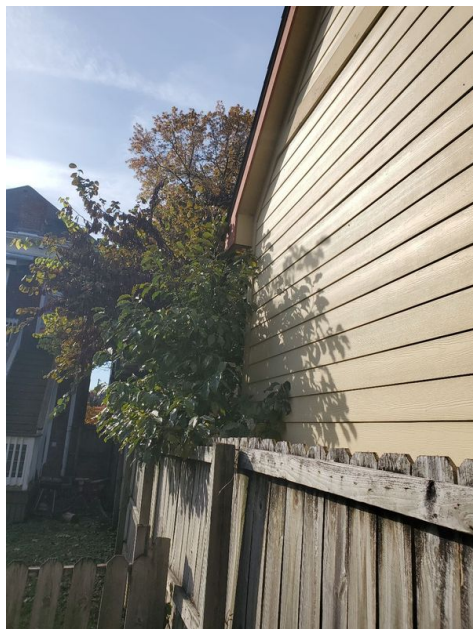
TREE TOO CLOSE

We observed that a tree/branch was overhanging the roof and may be in contact with it. This can damage the roofing system and allow pest entry into the garage.

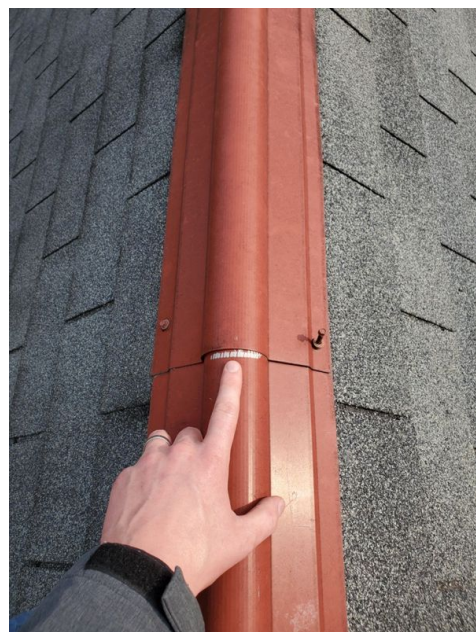
SEALANT NEEDED

We observed flashing with exposed fasteners. These should be sealed to prevent water intrusion.

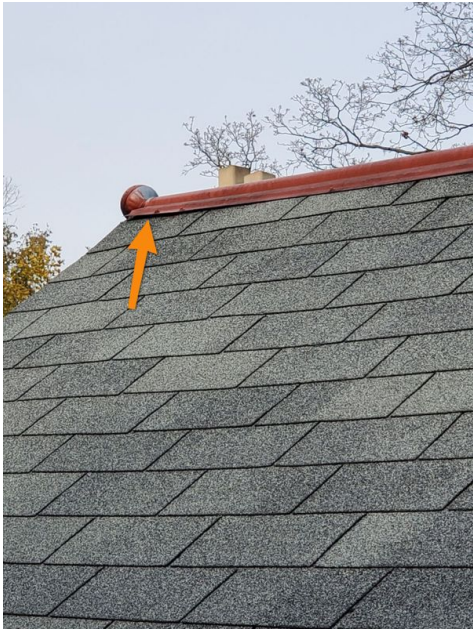
LOOSE FLASHING

We observed loose flashing, which can cause roof leaks. All flashing should be water-tight and designed to divert water away from undesired areas.

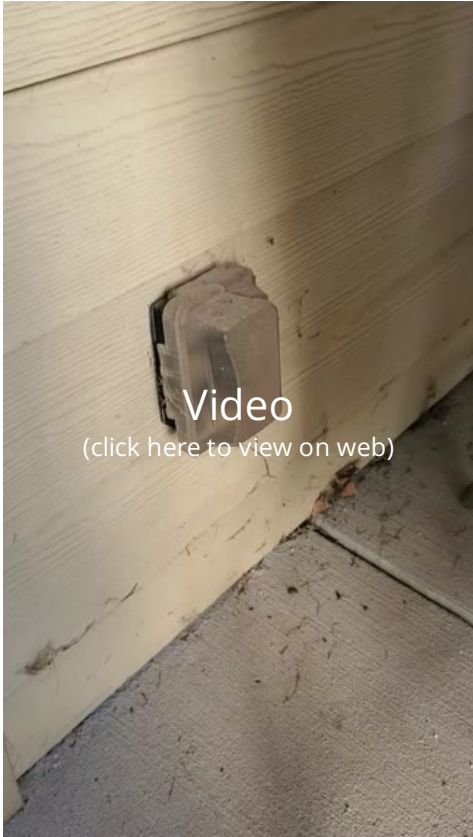
LOOSE RECEPTACLE

We observed one or more receptacles that wasn't properly secured.

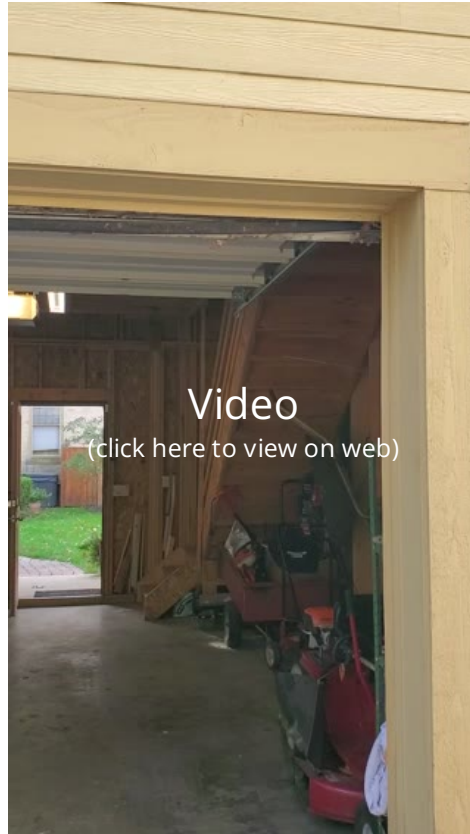
DAMAGE AREA

We observed damage to the garage vehicle door. At the time of the inspection it did not affect the operation of the door.

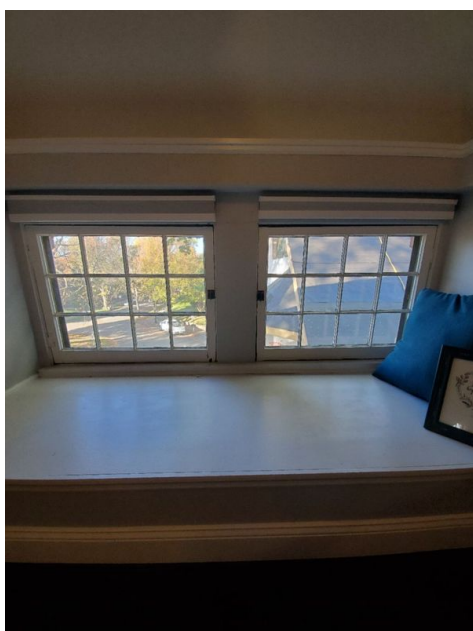
Master Bedroom

AGED WOOD-FRAME WINDOWS

We observed wood-frame windows with advanced age throughout the home. They may not perform as efficiently or as easily as a modern vinyl window.

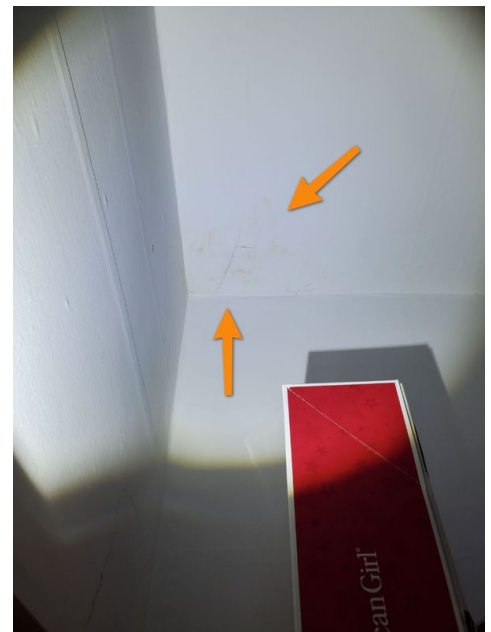
2nd Floor Bedroom Closet

MOISTURE DAMAGE

We observed stains on interior finished surfaces at the time of the inspection that appeared to be the result of moisture intrusion. The source of moisture may have been corrected, but we can't say for sure.

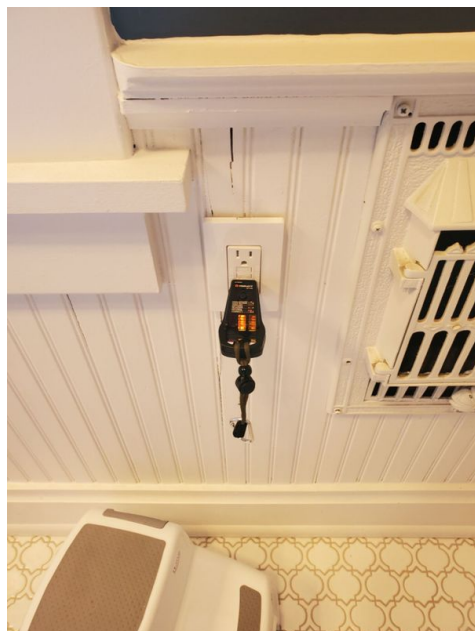
2nd Floor Bathroom

We observed a receptacle that when tested showed as having an open/missing ground at the time of the inspection. In older homes, sometimes old 2-slot ungrounded electrical outlets are replaced with newer 3-prong outlets for ease-of-use with modern plugs. This is incorrect unless the electrical wire was upgraded to current standards as well. This should be further evaluated and corrected by a qualified professional.

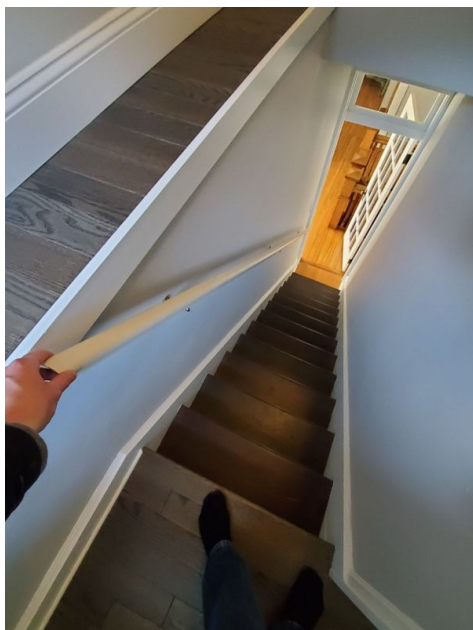
Master Bedroom

We observed a loose handrail. This is a safety concern.

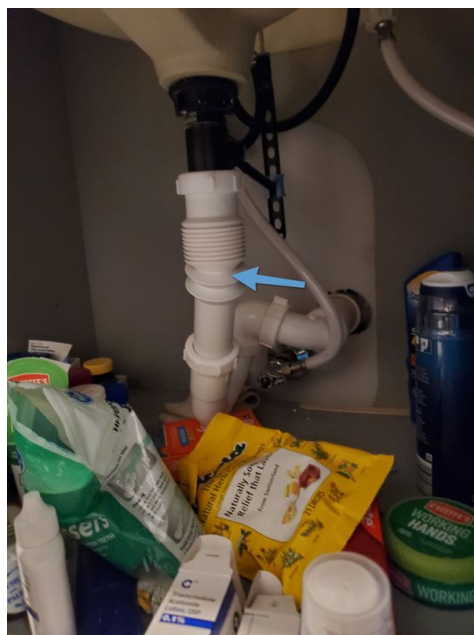
Master Bathroom

We observed improper installation of components at the bathroom plumbing system that may make it more likely to leak and/or fail to perform as intended. We recommend monitoring this area closely and correcting the issue.

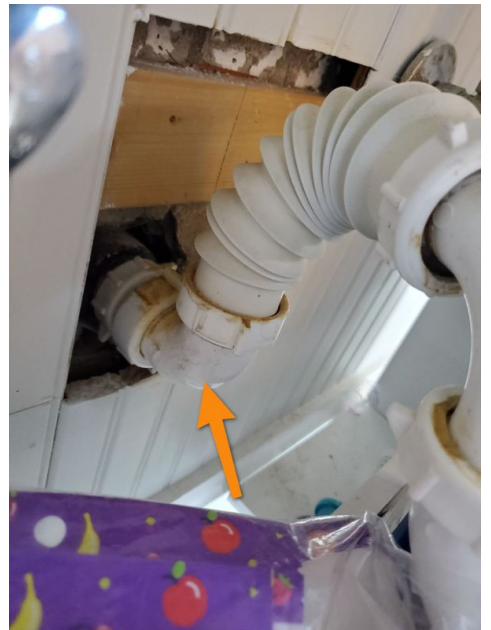
2nd Floor Bathroom

We observed a plumbing pipe that is meant only for the venting system used as part of the drain system. As such,, it may not perform as expected.

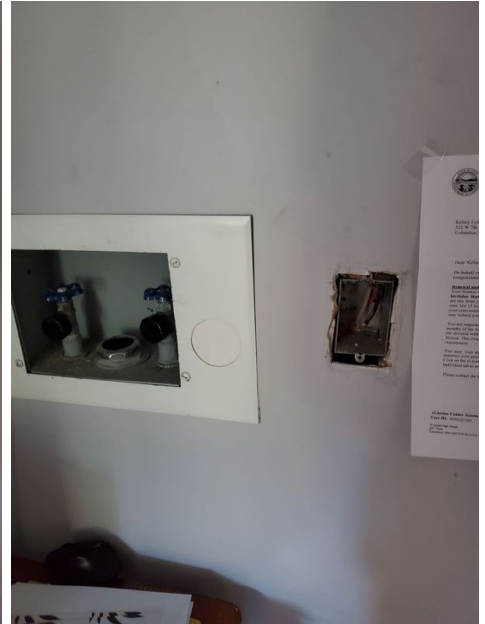
We observed an unused laundry area. The plumbing and electrical was turned off to this area at the time of inspection.

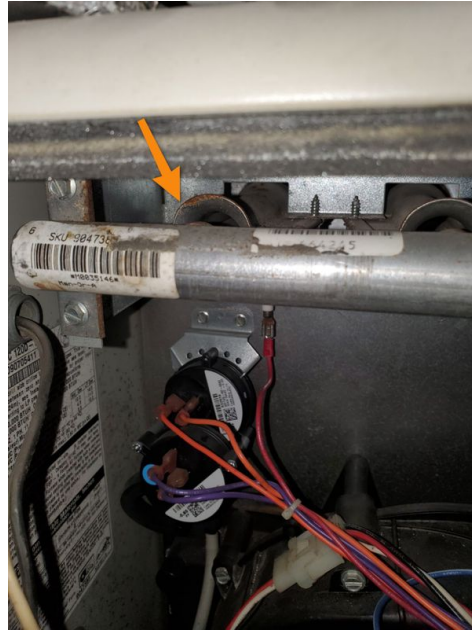
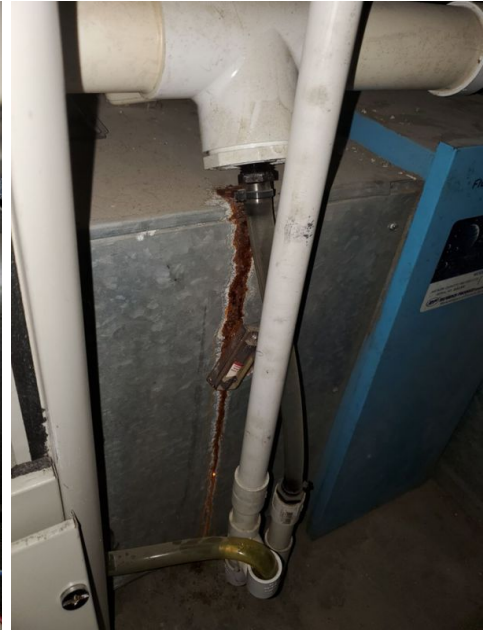
We observed areas of corrosion and rust at the heating system that may indicate its approaching the end of its service life. We recommend it is further evaluated by a qualified professional.

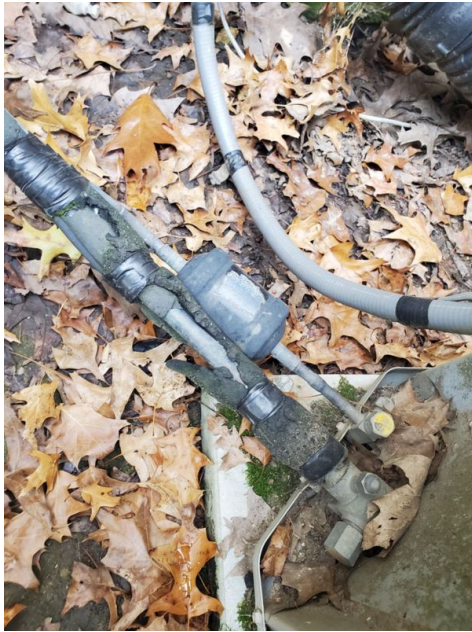
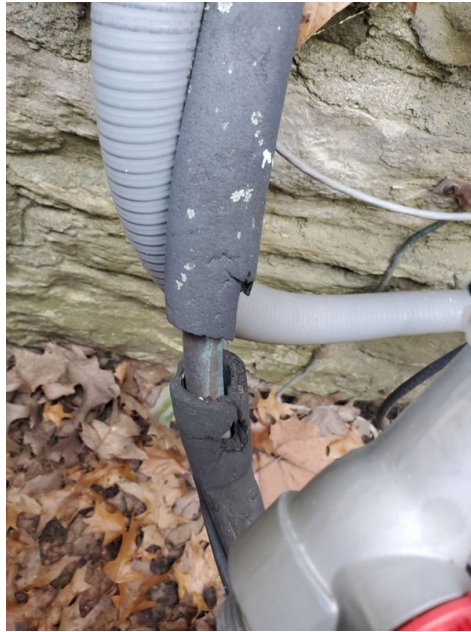
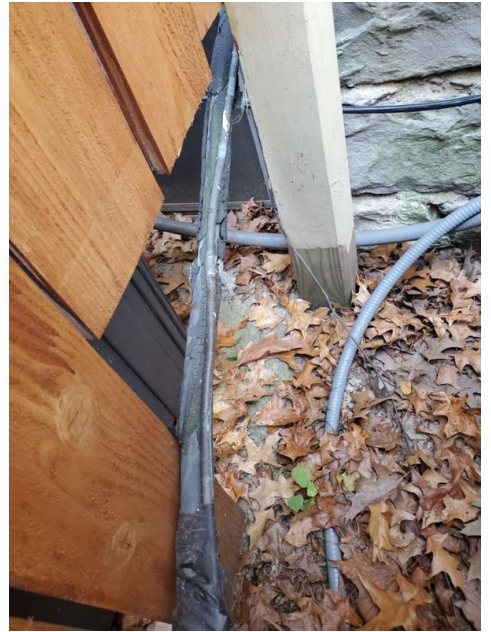
We observed missing or damaged foam insulation at the cooling system's refrigerant line, which can cause energy loss and excessive condensation.

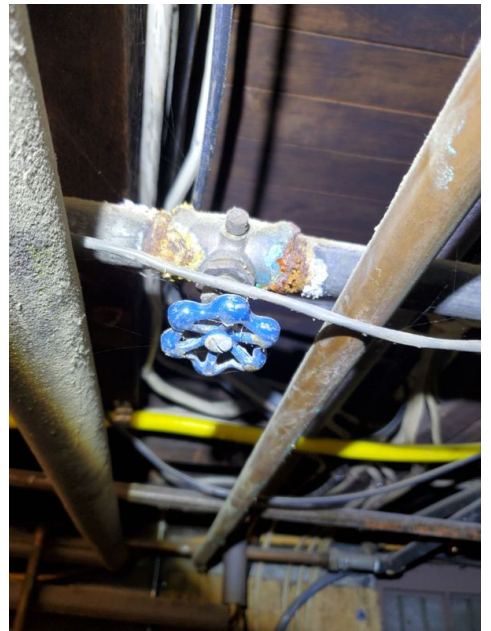
We observed more-than-expected corrosion at pipe fittings in one or more areas. Continued corrosion can cause leaks, but no active leaks were observed. We recommend this is further evaluated by a qualified professional.

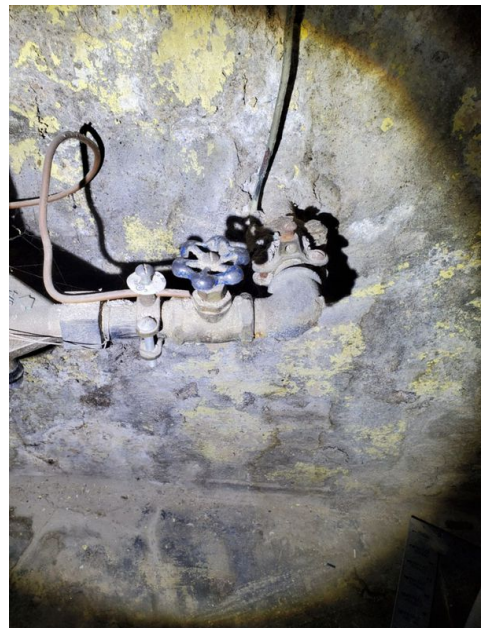
We observed advanced age of the house's main water shutoff valve. It is likely that this valve would have issues fully turning off the water supply in an emergency. We recommend it is replaced with a newer valve by a qualified professional.

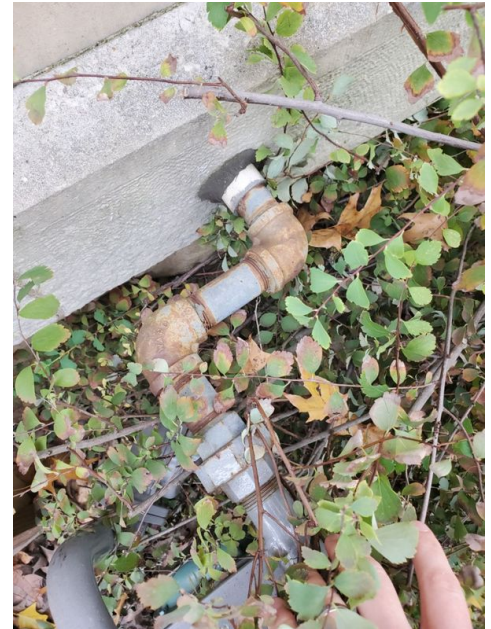
Outdoor gas components should be painted to protect the gas pipes from corrosion. Corrosion can lead to gas leaks.

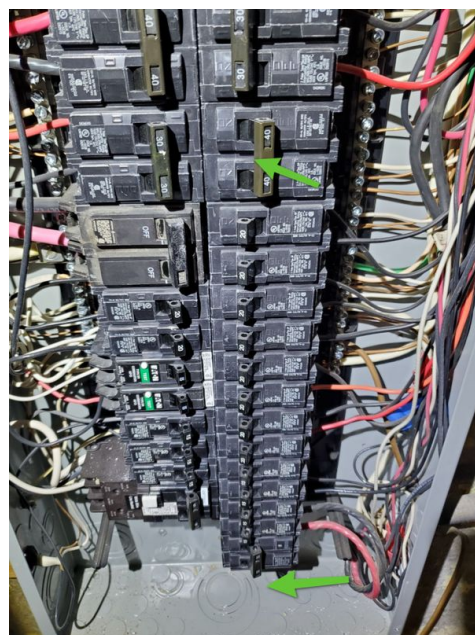
We observed that one or more breakers was turned off prior to inspecting the electrical panel. We recommend asking the seller what this breaker is for and why it is off.

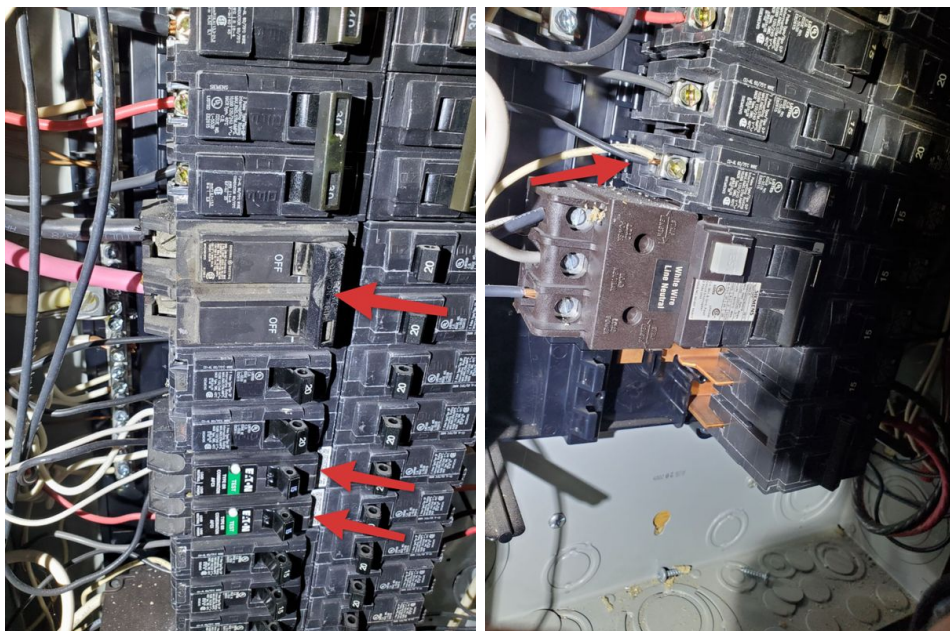
We observed that one or more circuit breakers was incorrectly wired or installed. A type/brand of breaker was used that does not match the type/brand of the panel. This may indicate that work was not performed by a licensed electrician. This is a safety concern should be corrected by a qualified professional.

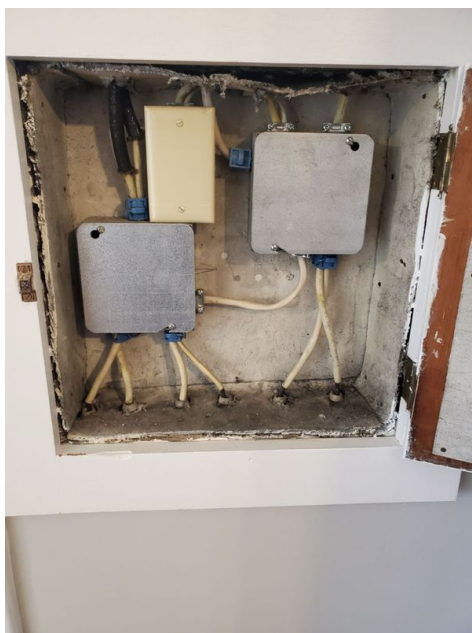
2nd Floor Hallway

ACTIVE KNOB & TUBE WIRING

We observed live knob & tube wiring in the home. Based on the age of this type of electrical, we considered it a hazard and replacement is recommended. Knob & tube wiring is not grounded, is susceptible to damage and deterioration, and certain types may contain asbestos in the wire insulation.

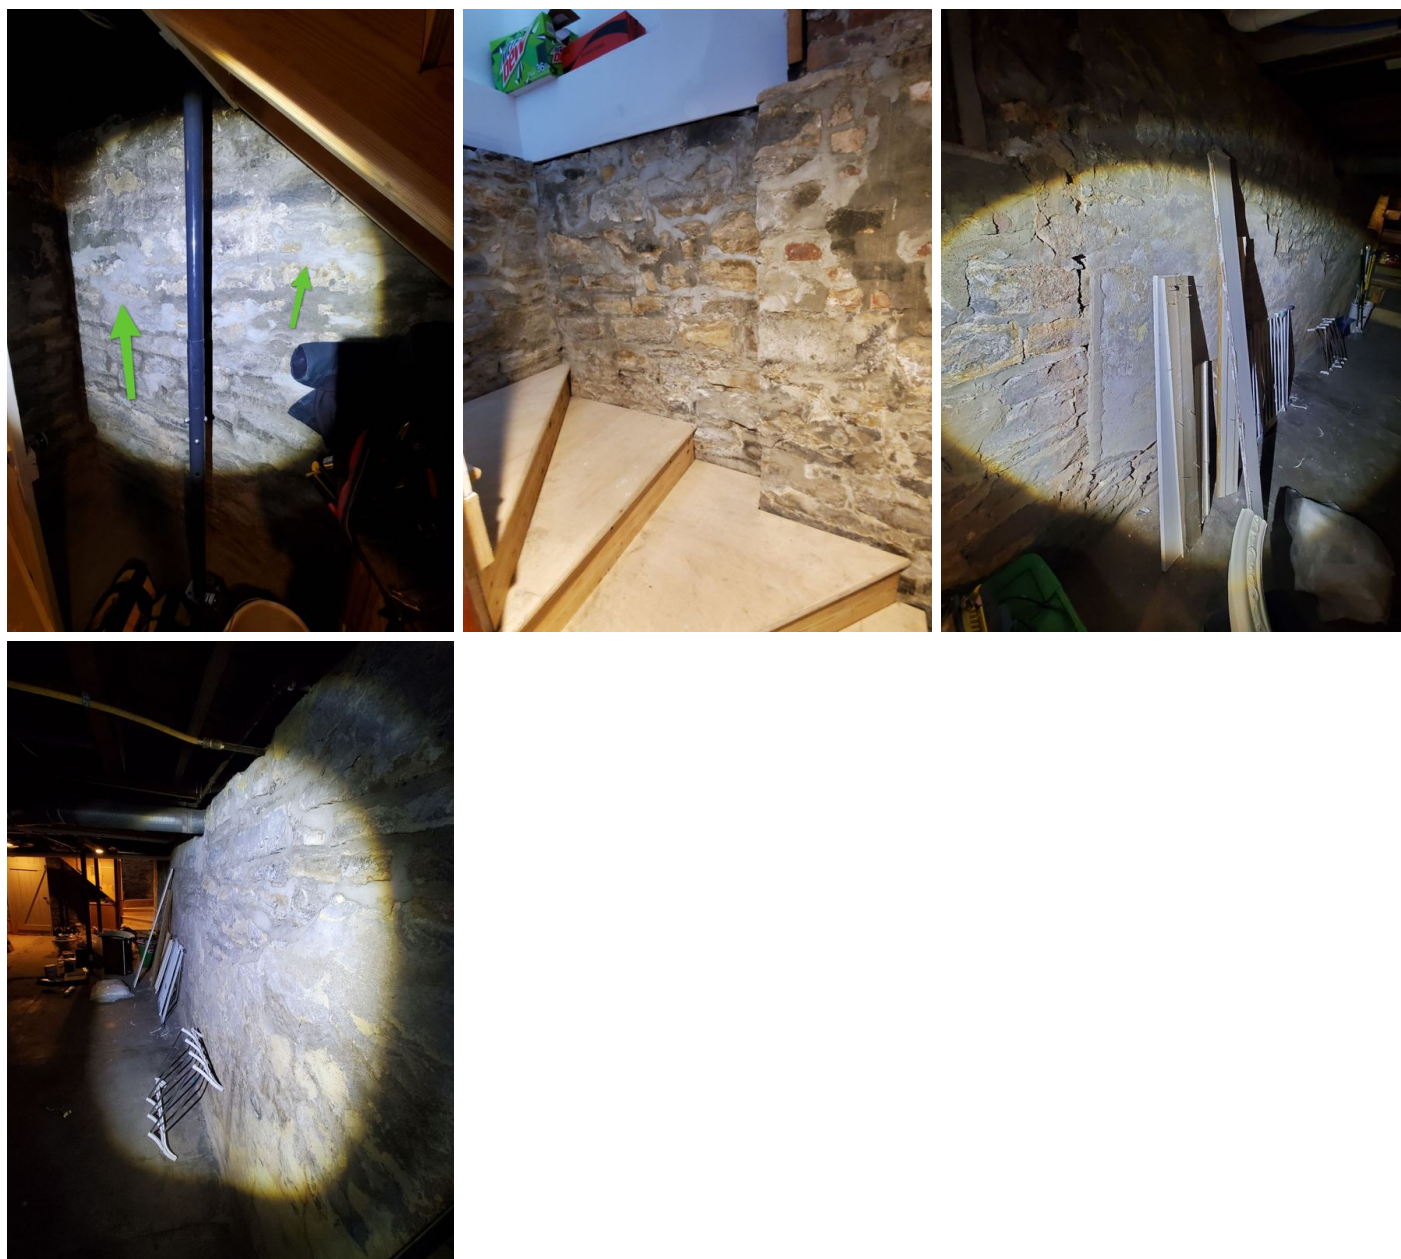
We observed in area where foundation repair was made. We recommend you ask the seller for more information about this repair.

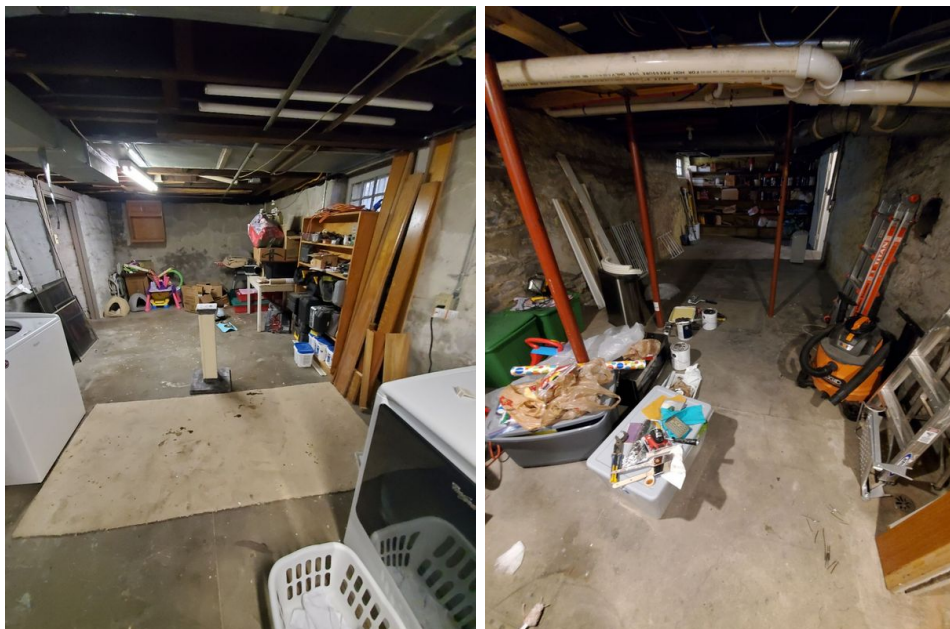
Personal items limited our visual inspection and this was an inspection restriction.
