ELEVATE HOME INSPECTION

123 Curl Dr
Columbus, OH 43221

James DeGraw
NOVEMBER 8, 2021

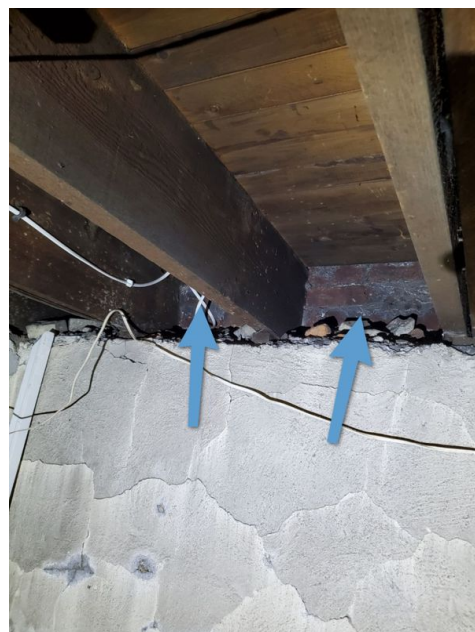
We observed the general absence of insulation in the basement. We highly recommend insulation in the rim joists, as this is a major heat loss area.

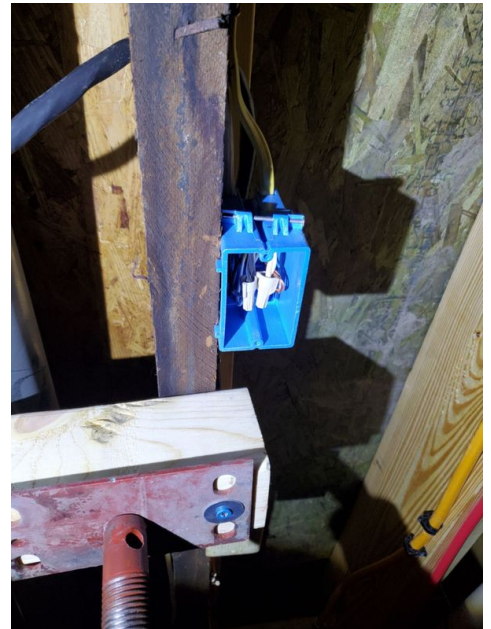
We observed that a receptacle box has a damaged or missing cover plate. This is a safety concern.

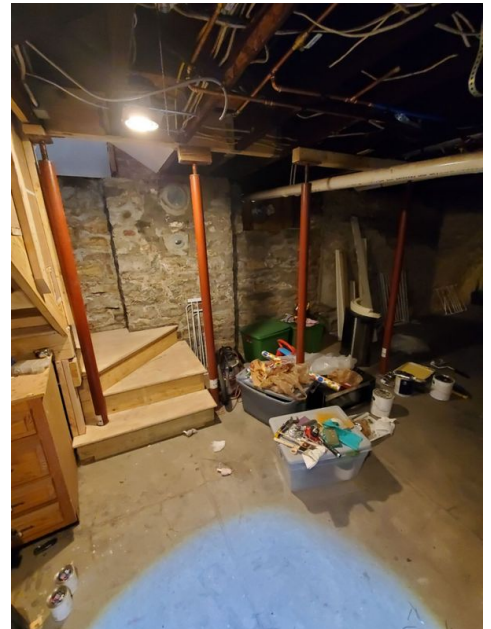
We observed previous structural/foundation repairs that were likely due to foundation and settling issues. We recommend you monitor these areas for new cracking or movement and ask the seller about the history and reasons for these repairs.

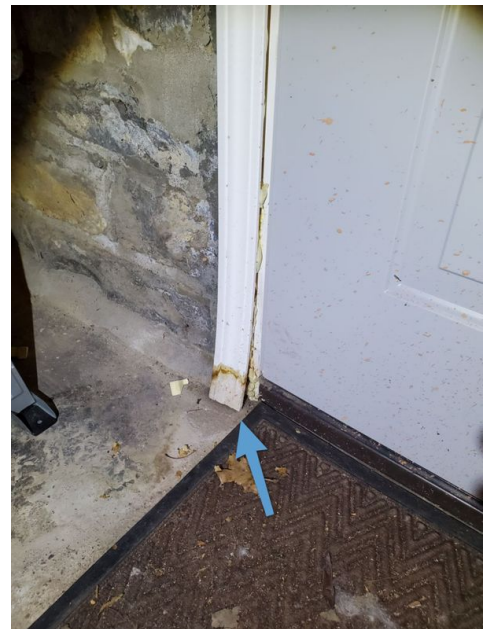
We observed an area with indications of past water issues. No water or dampness was observed in this area.

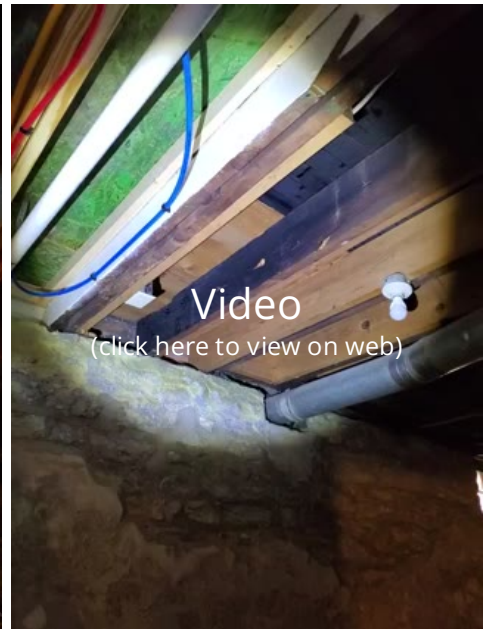
EVIDENCE OF FIRE DAMAGE

We observed indications that there may have been a fire in the house at some point. We recommend this is further evaluated by a qualified professional and/or structural engineer to determine that proper repairs were made.
