SCOTT HOME INSPECTION, LLC

## HOME INSPECTION REPORT

879 4th St  
Berthoud CO 80513

OCTOBER 30, 2018

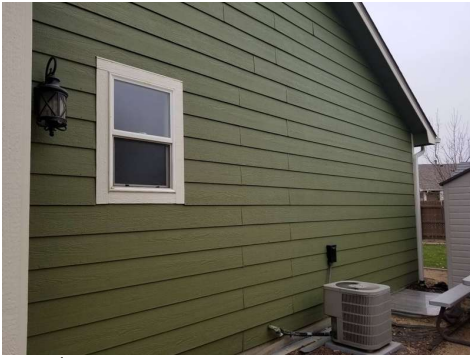
North

**NAIL/END CUT FAILURE**

The siding is failing at nail heads and end cuts in several areas. Water absorption is present and damage and deterioration are observed. It is recommended that a siding professional investigate and repair or replace the damaged siding as necessary.

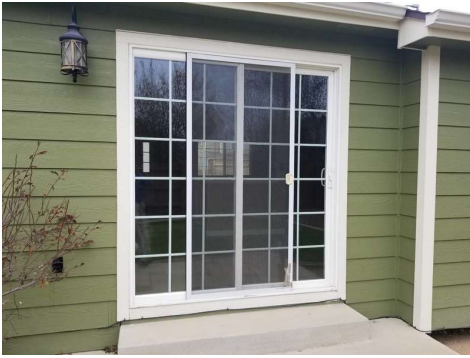
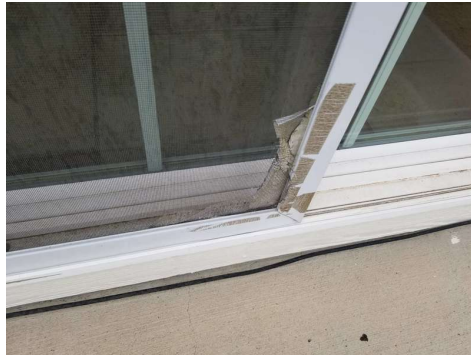
The screen door is damaged and torn. A screen door repair or replacement is needed.

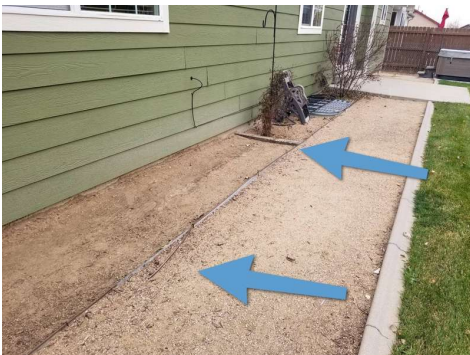
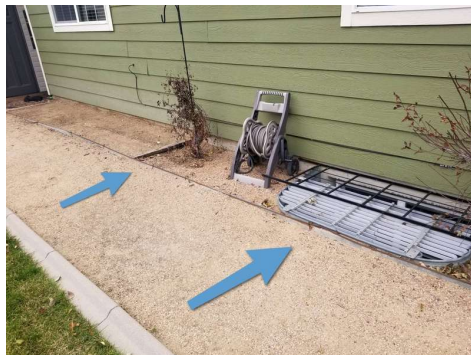
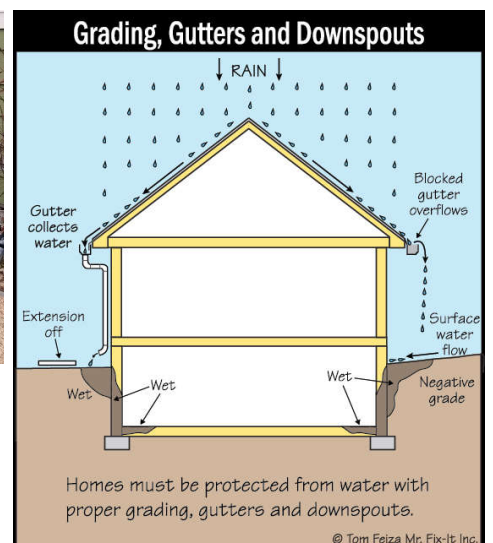
B158C  
Grading

There is a flat or negative slope to the landscaping, which can cause or contribute to water intrusion or deterioration. No structural or moisture concerns are currently noted, but to prevent long-term concerns, the landscaping and slope need to be corrected. A landscaping professional or qualified person should repair this item.

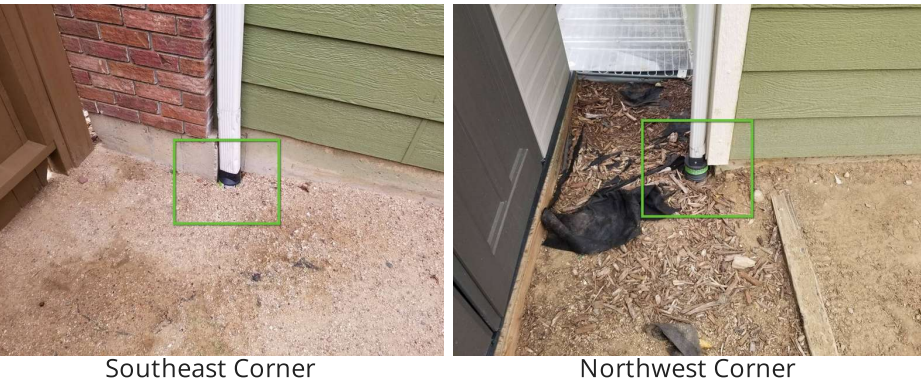
#### GUTTERS AND DOWNSPOUTS: Buried gutter drain lines

The below ground drain lines for downspouts do not appear to drain above grade, and it is unable to determined if drains will function properly. As a maintenance item, you should monitor these areas, and periodically clean out these lines with a drain-snake, to keep drainage flowing away from the foundation of the home.

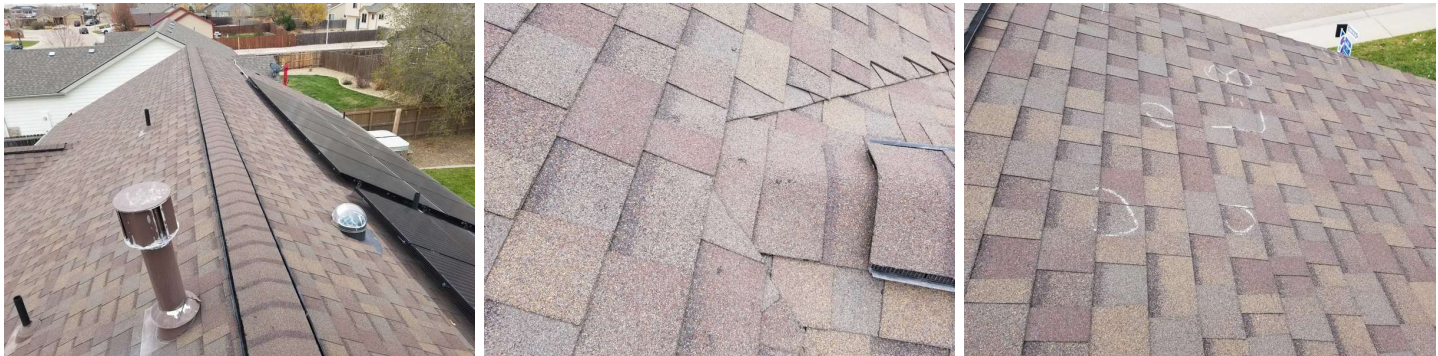
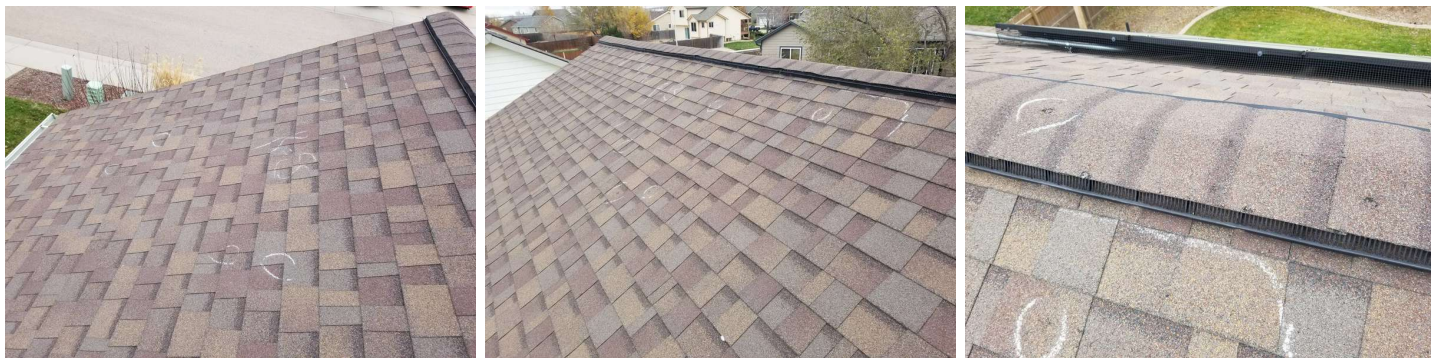
4.1.1 ROOF COVERINGS

HAIL DAMAGE

The roof was walked and fully inspected. There is evidence of apparent hail damage and granule loss throughout; this can greatly reduce the life expectancy of the roof. It is recommended that a roofing professional further evaluate to obtain estimates on replacement at this time.

Contact a qualified roofing professional.

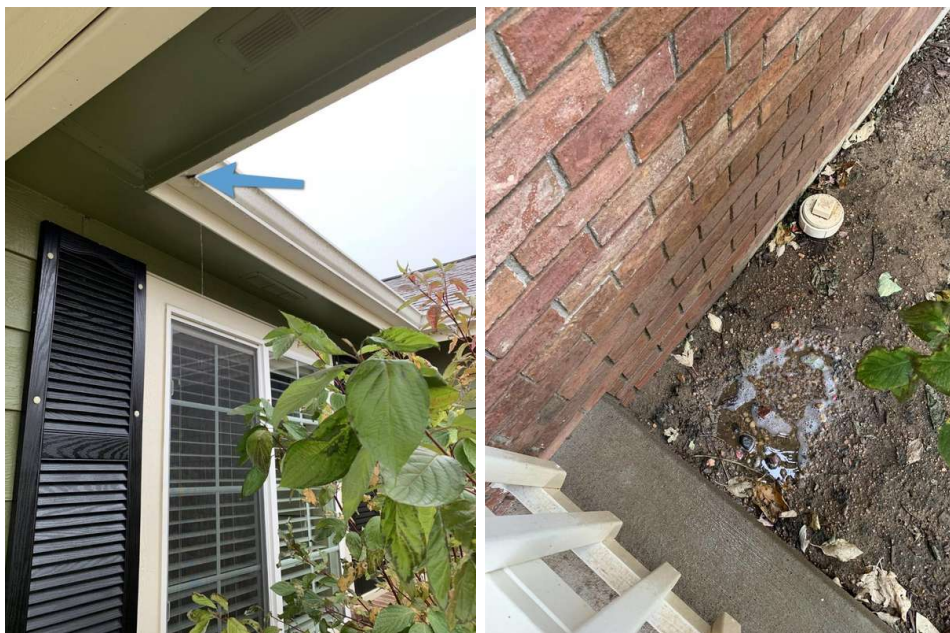
##### **SEAM LEAK**

The gutter appears to leak at the seam. Cleaning of the gutter is needed and application of gutter sealant or epoxy to seal the seam.

Contact a handyman or DIY project

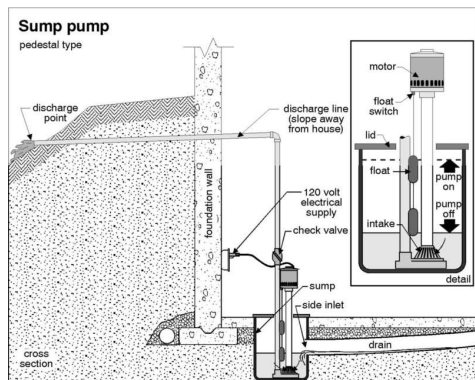
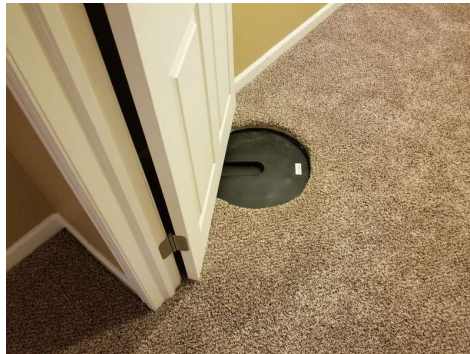
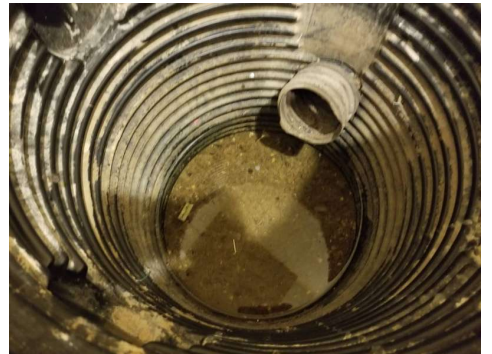
A sump pit is present in the home. However, there is no sump pump installed. There is water in the sump pit at or near the level of the input perimeter drain. It is recommended that a sump pump be installed, to drain the pit regularly and to help prevent possible moisture intrusion or flooding in the basement. A plumber should install a sump pump system at this time.

Contact a qualified plumbing contractor.

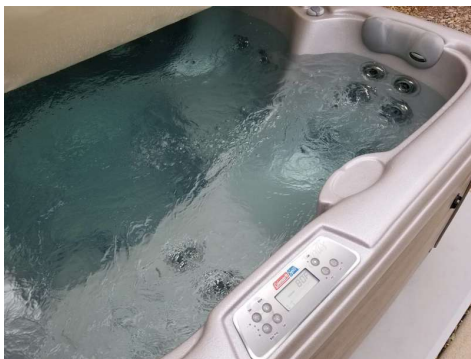
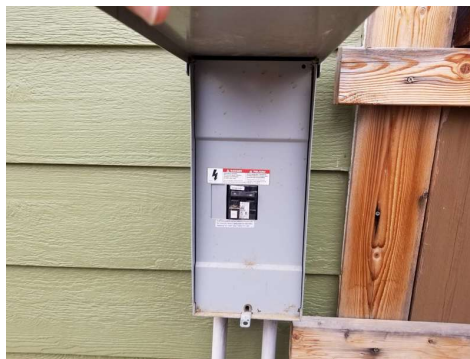
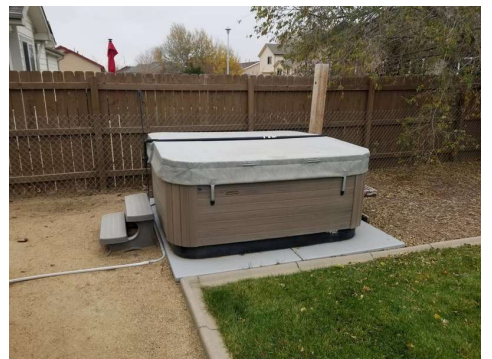
#### 5.12.1 HOT TUB

### LIMITED FUNCTIONAL TEST

A basic functional test of the hot tub was done to check operation and to check for leaks, and to inspect the electrical service for any concerns. The system appears to be in working condition. This is a very limited visual inspection. A hot tub specialist should evaluate further, if concerns are noted.

Contact a qualified professional.

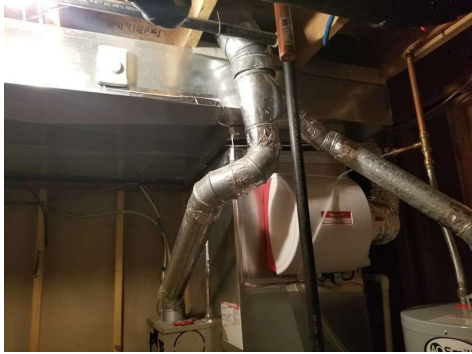
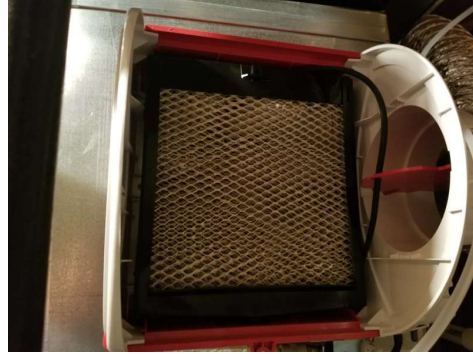
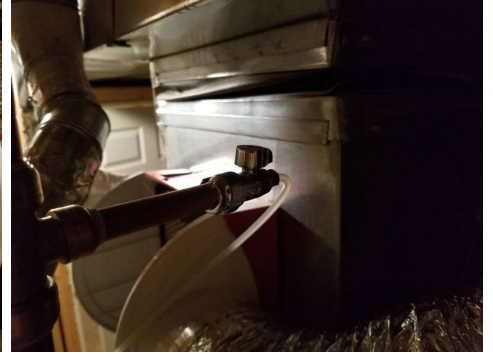
## 7.6.1 HUMIDIFIER EQUIPMENT

**HUMIDIFIER PAD REPLACE**

Contact a handyman or DIY project

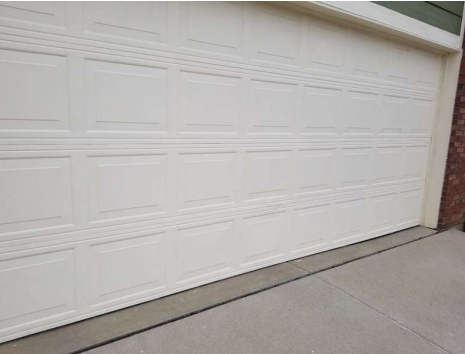
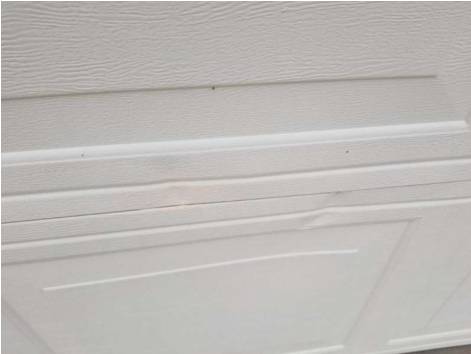
Cosmetic denting was present at the garage overhead door. This did not appear to affect operation, and is noted as information, and can be repaired by a garage door professional as desired.

Recommendation  
Contact a qualified garage door contractor.

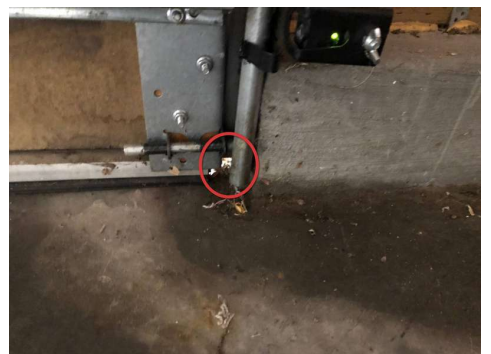
## GARAGE DOOR GAPS

The garage overhead door does not close evenly or uniformly, and there are gaps where pest entry can occur. Pests such as mice commonly enter homes through poorly sealed garage doors. The door will need adjustment or weather stripping replaced to properly seal and to prevent pest entry. A garage door professional should repair this item.

Gap at bottom right of garage door
