HOME INSPECTION

119 Wahane Ln
Bastrop TX 78602

PROPERTY INSPECTION REPORT

Concerning: 119 Wahane Ln, Bastrop TX 78602

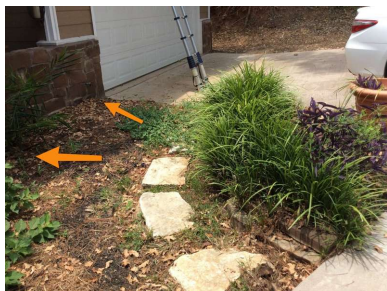
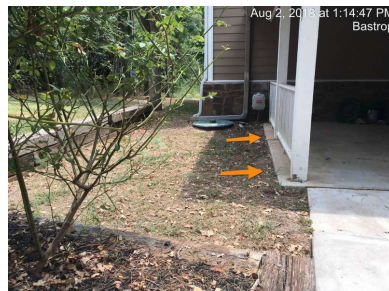
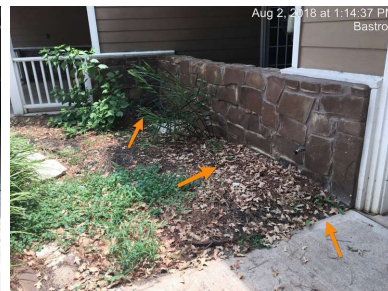
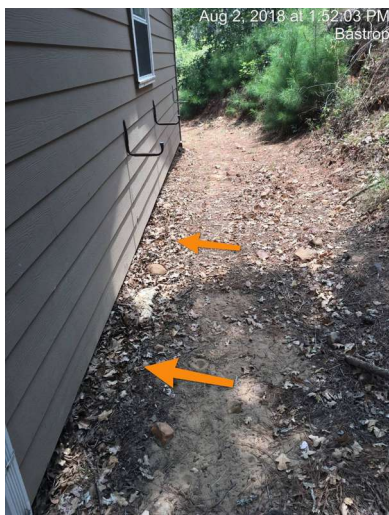
1: Negative Grade

Deficient: Front and right side of home has negative grade towards the home. Industry standards call for a minimum of 6" inch slope away from the foundation in the first 10 feet. Recommend having a landscaping specialist provide further evaluation and establish guidelines for achieving positive drainage in these areas.

Recommendation: Contact a qualified landscaping contractor

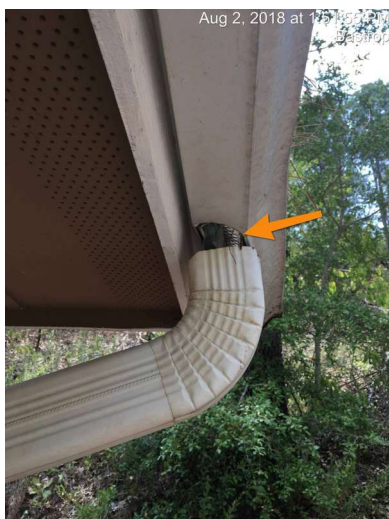
2: Gutter Downspout Disconnected

Deficient: Down spout disconnected at bottom of gutter to the right of garage. Have a gutter specialist perform needed repairs.

Recommendation: Contact a qualified gutter contractor

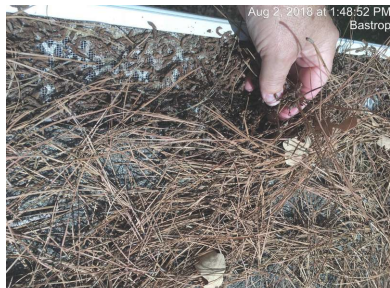
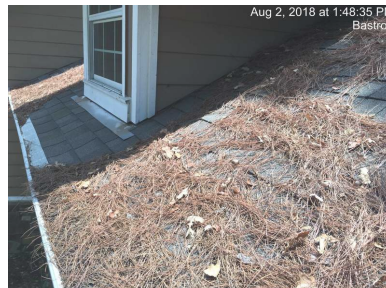
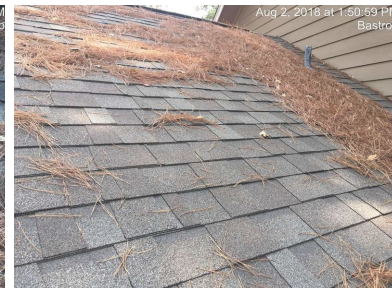
1: Excessive Debris

Deficient: Roof covering has excessive amount of debris such as pine needles collecting on the surface. Gutters are being clogged and this can cause rain water to back wash onto fascia and into soffit cavities causing rot and deterioration in these locations. Recommend regular cleaning to prevent water damage from occurring.

Recommendation: Contact a handyman or DIY project

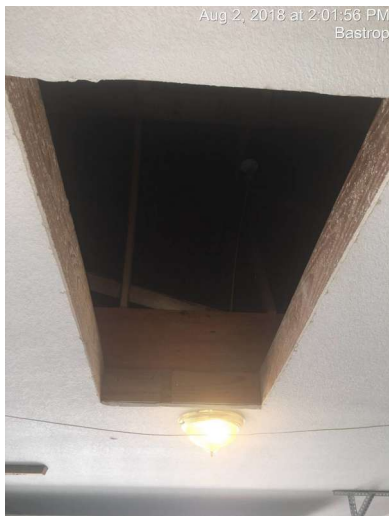
1: Un-Insulated Attic Cover

Deficient: Drywall cover for attic opening in master bedroom closet is not insulated and is allowing conditioned air to escape into attic space resulting in higher utility bills. Recommend replacing drywall cover with insulated materials available at the local building supply.

Recommendation: Contact a handyman or DIY project

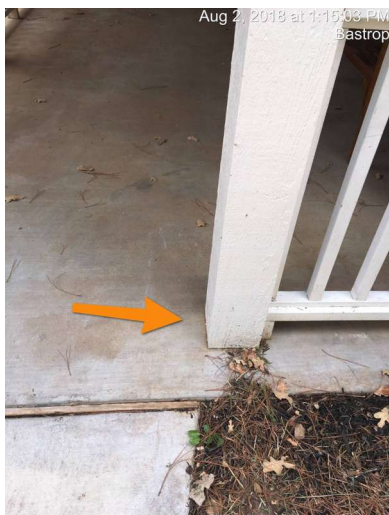
1: Support Post Bases:

Deficient: Support post on front porch should have metal post bases installed to prevent deterioration and rot from occurring from wood to concrete contact. Recommend having a carpentry specialist perform needed repairs.

Recommendation: Contact a qualified carpenter.

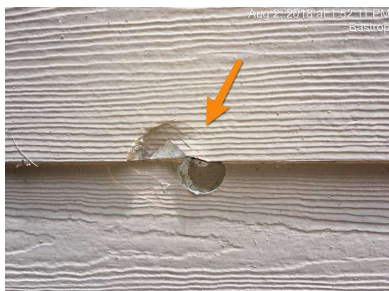
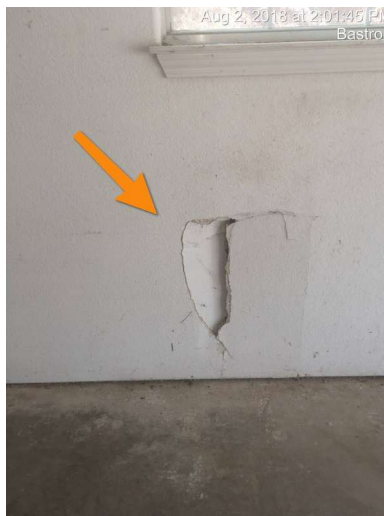
2: Wall Damages

Deficient: Exterior siding has one minor area with damage on the right side of the garage, and the interior wall of the garage has some sheet rock damage. Have a handyman provide needed repairs.

Recommendation: Contact a qualified handyman.

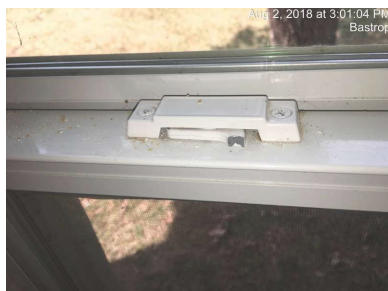
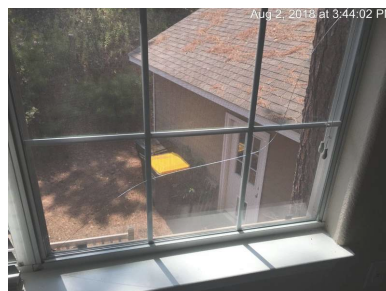
Deficient: The following issues were discovered with windows:

Latches are broken on downstairs front bedroom window.

Upstairs master bedroom window has a broken glass.

Have a window & glass specialist perform needed repairs.

Recommendation: Contact a qualified window repair/installation contractor.

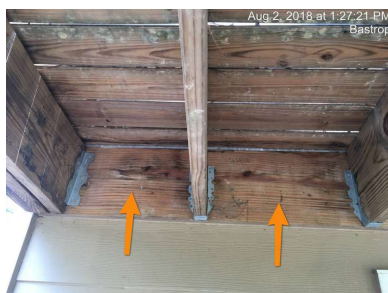
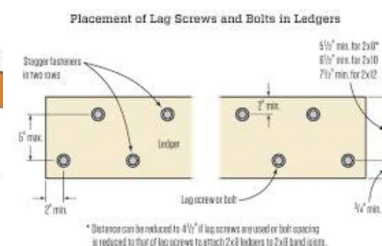
Deficient: Ledger board supporting back balcony deck is required to have specific fasteners installed in a specific pattern. (see attached diagram) Recommend adding wood supports under the outside band joist to add additional stability.

Recommendation: Contact a qualified carpenter.

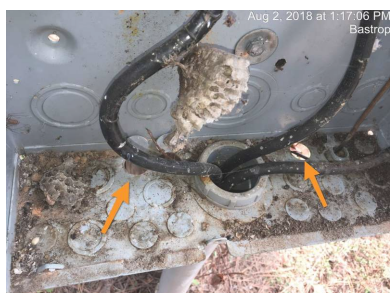
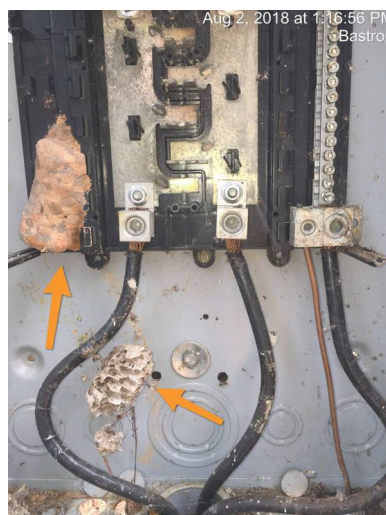
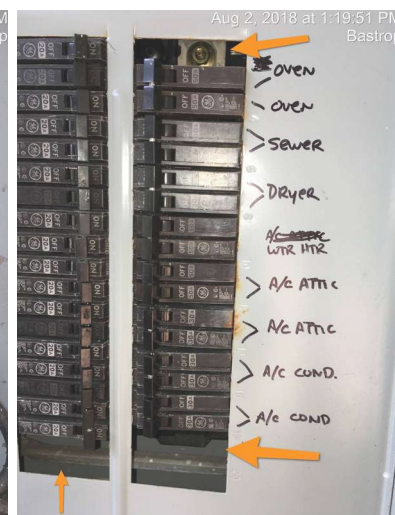
1: Service Panel Issues:

Deficient: The following deficiencies were discovered with the service panels:

Panel located right below meter with the main disconnect is not sealed. There are openings in the bottom of the panel allowing insects such as wasp to build nest inside the panel. This can very easily cause a short and can be very dangerous. Recommend having an electrical specialist perform needed repairs.

Sub-panel located on exterior of wall does not have the required space in front of the panel to allow for a safe environment when working on the panel. Industry standards call for a minimum of 36" inches in front of the panel with 30" inches free space on either side of the panel. Recommend cutting tree that is obstructing this space back to allow for proper access.

Sub-panel has knock-out covers missing on panel cover to protect live wiring on the inside of the panel. Have an electrical specialist perform needed repairs.

Recommendation: Contact a qualified electrical contractor.

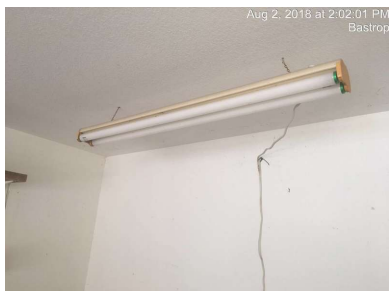
Deficient: All exposed light bulbs are required to have a shatterproof globe as protection. Have a handyman provide needed repairs.

Recommendation: Contact a qualified handyman.

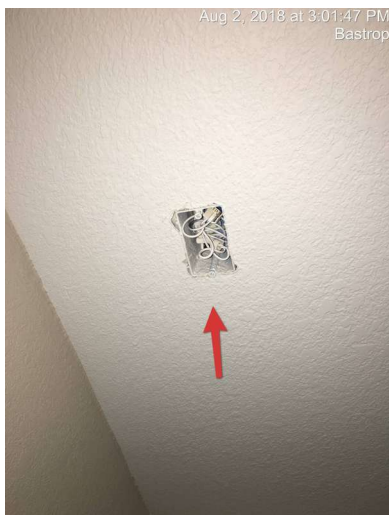
2: Missing Smoke Detectors

Deficient: Two bedrooms have missing smoke detectors, hallway outside of bedrooms does not have a smoke detector as required. Have an electrician install all new combination smoke /carbon monoxide detectors as now required.

Recommendation: Contact a qualified electrical contractor.

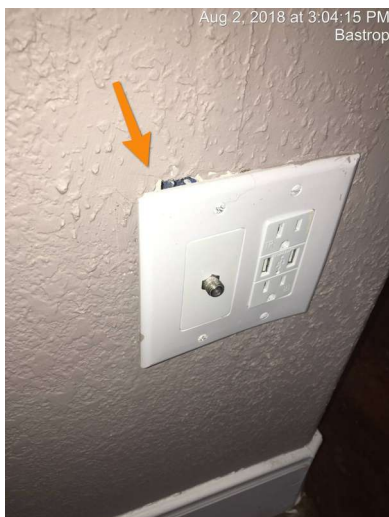
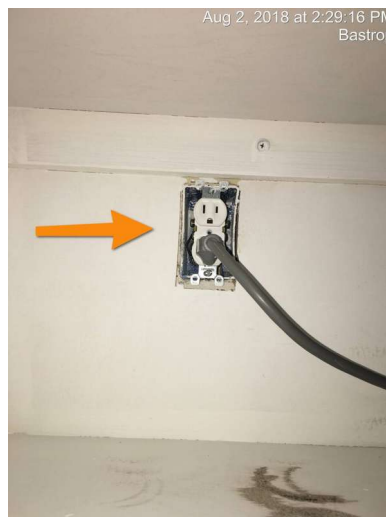
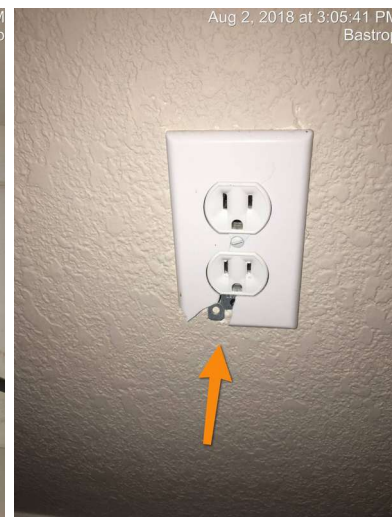
3: Receptacle Issues:

Deficient: The following receptacle issues were discovered:

Receptacle cover damaged in upstairs bedroom.

Receptacle cover missing in cabinet above microwave.

Recommendation: Contact a qualified electrical contractor.

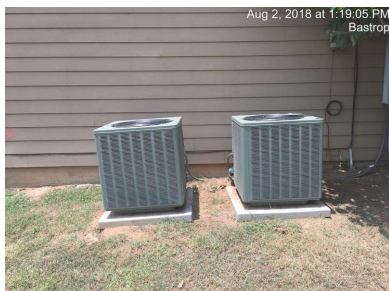
1: Unit Not Level

Deficient: Concrete pad supporting one of the outdoor condensing units is not level . This can cause accelerated deterioration of components. Recommend licensed HVAC contractor level the unit.

Recommendation: Contact a qualified HVAC professional.

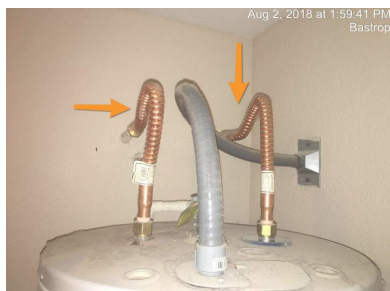
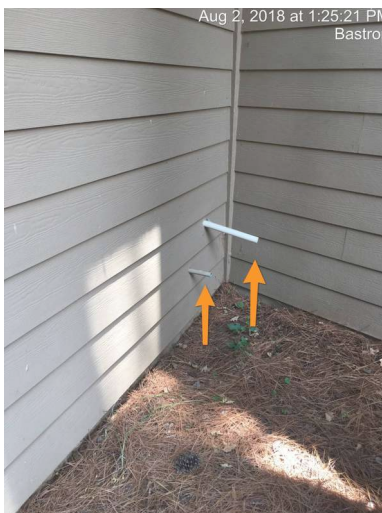
Deficient: Cold water supply line for the water heater does not have a cut-off valve at the entrance to the tank as required. Cold water line into water heater should have a cut-off valve to allow water supply to be turned off for service or in an emergency event.

Deficient: Drain line terminations should have a 90 degree turn-down installed that terminated approx. six inches above grade.

Note: It is also recommended that hot water line be insulated.

Have a plumbing specialist perform needed repairs.

Recommendation: Contact a qualified plumbing contractor.

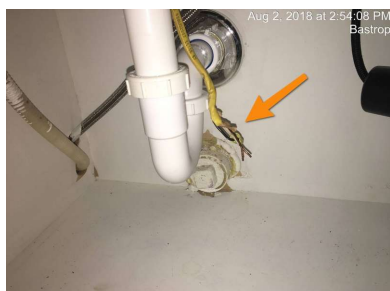
Deficient: Disposer is in place with power supply hooked up to it . Have an electrical specialist perform needed repairs.

Recommendation: Contact a qualified electrical contractor.

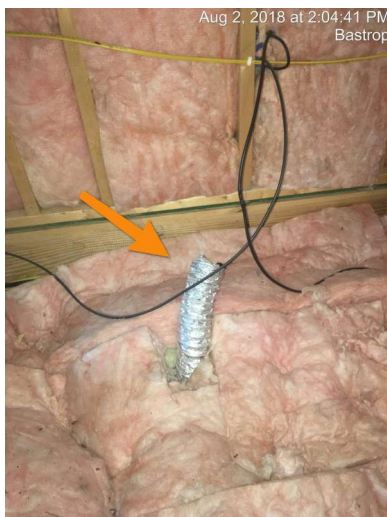
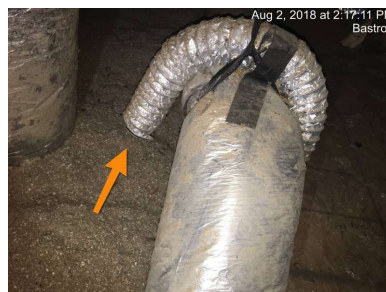
1: Improper Venting

Deficient: Improper venting practices were noted. All bathroom exhaust fans are terminated into attic space and are required to vented to the exterior of the home. Have a plumbing specialist provide needed repairs.

Recommendation: Contact a qualified plumbing contractor.

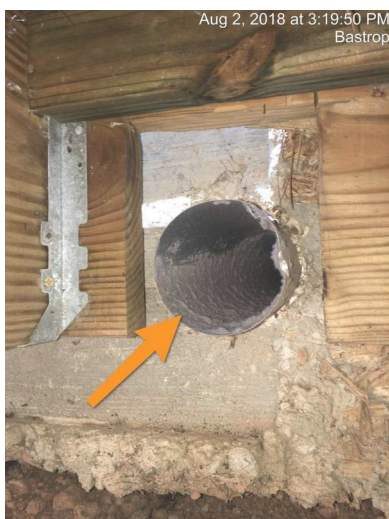
Deficient: **Dryer vent exhaust pipe is clogged with lint and will need to be cleaned by a professional.** Annual cleaning is recommended to prevent build-up of lint.

Recommendation: Contact a qualified professional.
