HOME INSPECTION REPORT

1930 S Sheridan Ave
Tacoma WA 98405

John Lund
JUNE 21, 2019

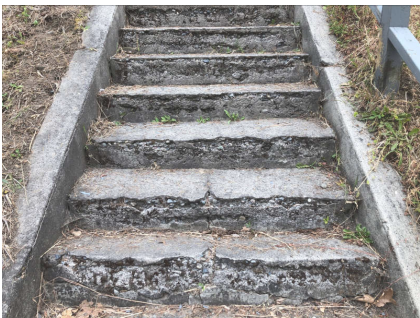
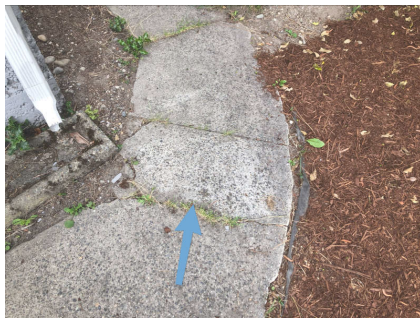
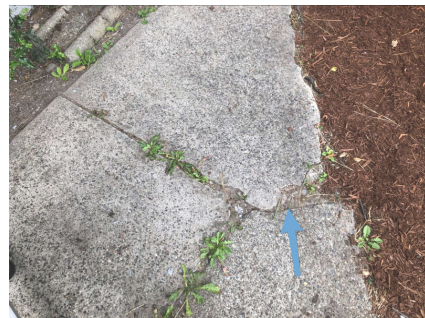
**Low Priority****CRACKS IN WALKWAYS****FRONT**

There are a few cracks in the walkways around the residence that are mostly cosmetic. We suggest you view these yourself and repair as necessary.

Contact a qualified professional.

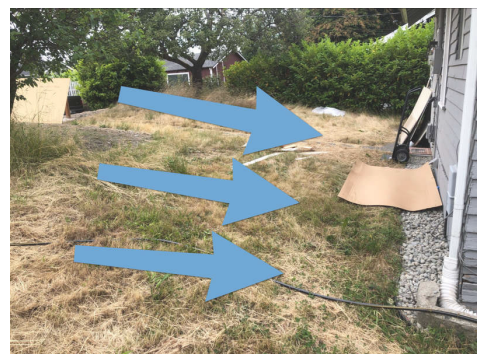
3.4.1 Grading & Drainage

Grading and drainage is either negative or neutral adjacent to the residence, and moisture intrusion will remain a possibility. The soil or the hard surfaces should slope away from the residence to a distance of at least six feet, to keep moisture away from the footings. We can elaborate on this issue, but you should seek a second opinion from a geologist or grading and drainage contractor.

Recommend monitoring.

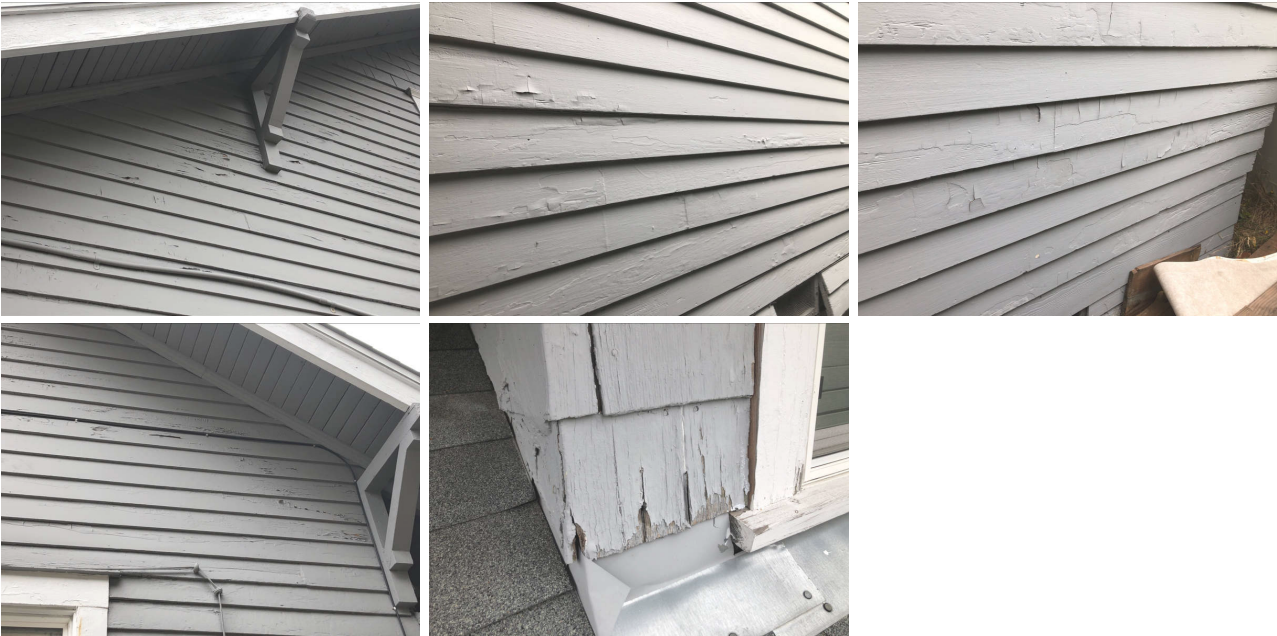
3.5.1 Exterior Siding Notes

WEATHERED SIDING

The exterior siding is weathered. Maintenance and minor repairs are recommended.

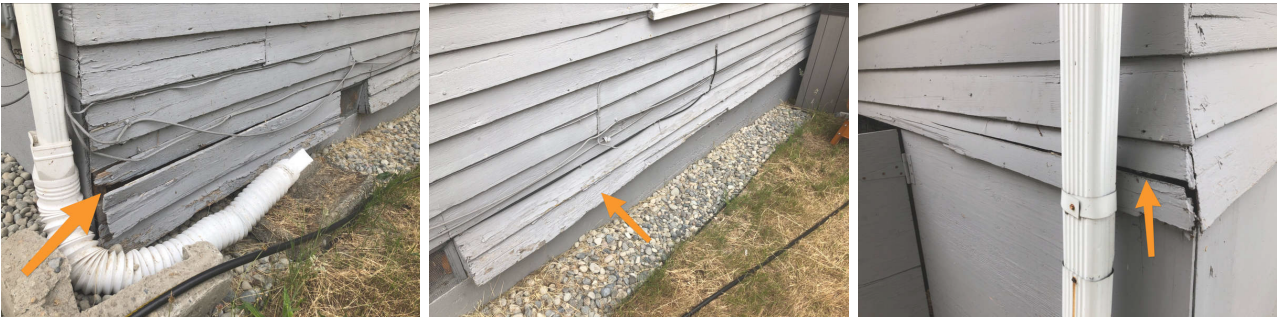
3.5.2 Exterior Siding Notes

DAMAGED SIDING

Observed areas of damaged siding around the residence that should be repaired to help prevent moisture intrusion issues. These damaged areas can allow moisture to penetrate the walls if not properly repaired.

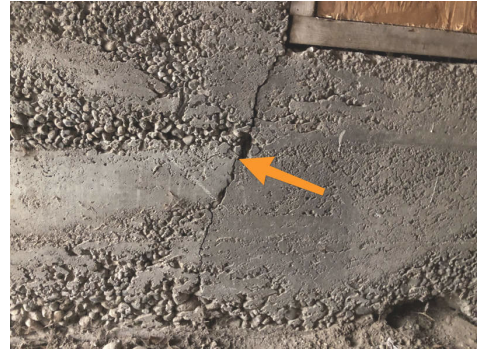
3.6.1 Foundation as Viewed from the Exterior

CRACKS MODERATE

Moderate sized cracks were observed on the Exterior foundation. This suggests unstable or settling soils. Recommend a soil or structural engineer should be consulted for corrective repairs. This may include sealing the pieces back together with a concrete or similar patch. Sealing is to deny possible moisture entry. a structural engineer evaluate and provide a report on course of action and remedy.

Contact a qualified professional.

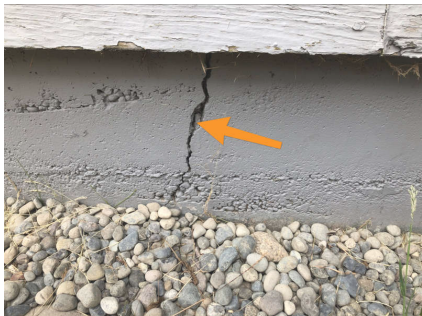
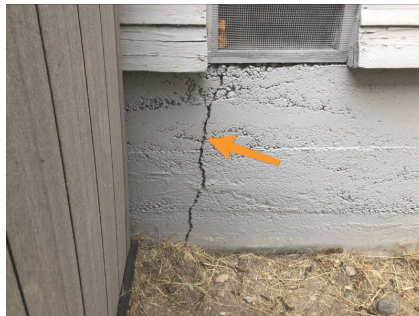
3.6.2 Foundation as Viewed from the Exterior

CRACKS-MAJOR

Severe cracking noted at the foundation. This is typically consistent with soil movement and could lead to serious damage to structural components, foundation and/or slabs. Recommend a structural engineer evaluate and provide a report on course of action and remedy.

Contact a qualified structural engineer.

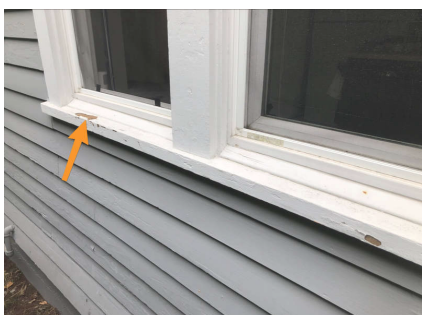
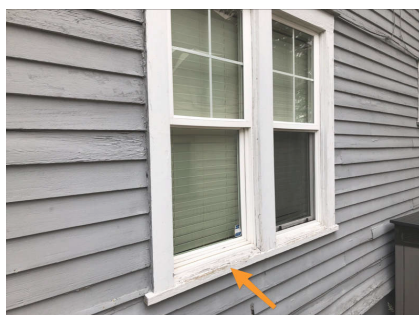
3.7.1 Fascia, Trim & Eaves

SECTIONS OF FASCIA OR WOOD TRIM ARE WEATHERED

Sections of the fascia board or wood trim around the residence are slightly weathered, and should be serviced as necessary to prevent further deterioration. Service such as scraping, repainting and sealing.

Contact a qualified handyman.

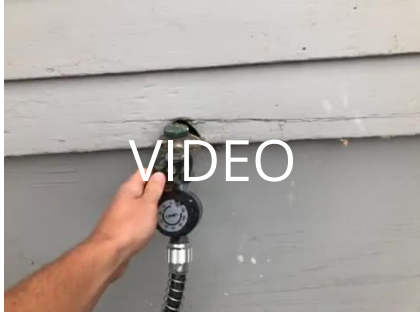
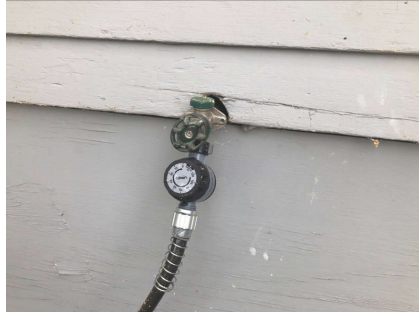
3.8.1 Exterior Plumbing

NOT SECURED TO WALL

The hose bib is not secured to the wall. This could potentially damage the Plumbing. Recommend securing.

Contact a qualified professional.

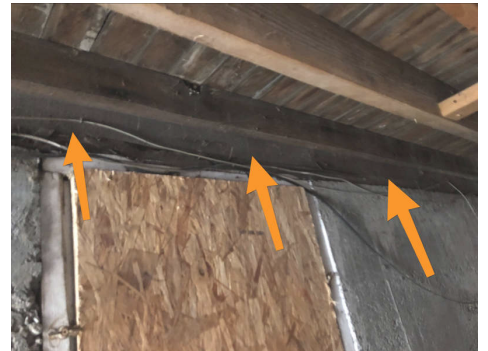
3.14.1 Deck

LAG SCREWS MISSING

The connection of the deck to the house is lacking lag screws which was not required in construction for the year of the home. We recommend that additional lag bolts be installed to adequately secure the deck to the house.

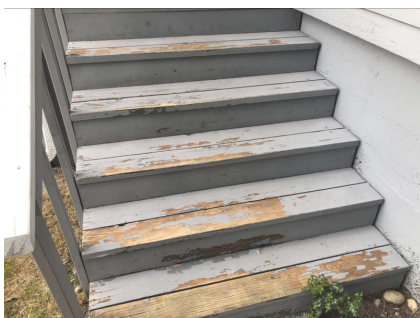
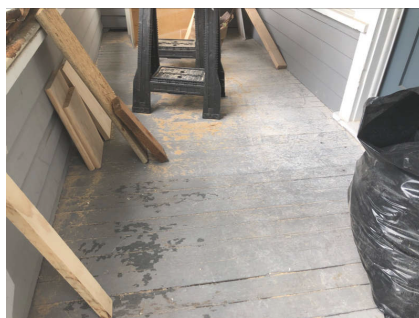
3.14.2 Deck

WEATHERED

Portions of the deck were weathered and in need of minor repairs and maintenance.

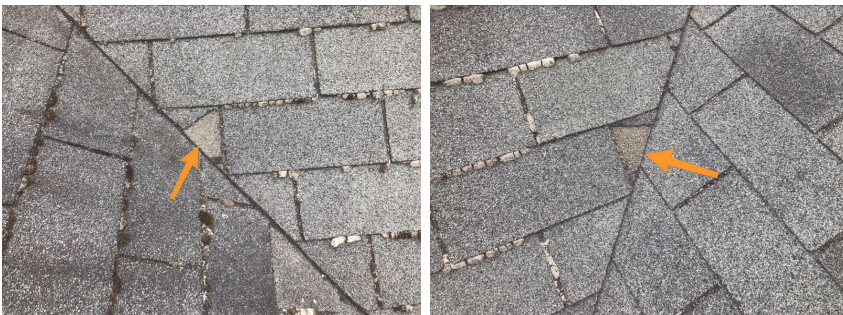
MISSING SHINGLES

The roof has a one or more missing shingles that should be replaced by a roofing contractor. This will help prevent the possibility of moisture getting past the roof covering, wearing the protective barrier beneath, and into the attic or residence. We recommend having a roofer inspect the rest of the roof as well.

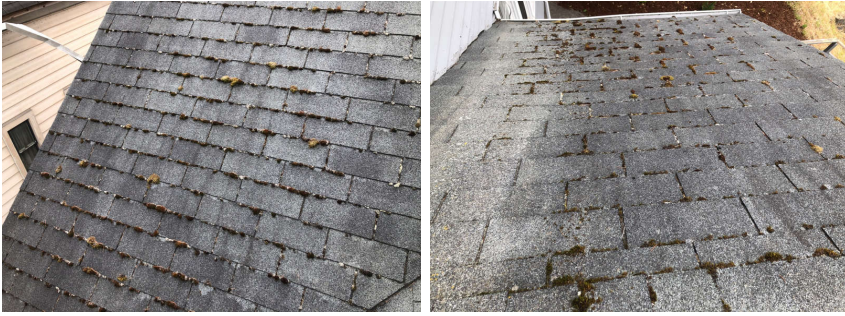
4.3.1 General Observations

Parts of the roof needs to be cleaned of moss and/or debris. This can restrict drainage and lead to moisture intrusion and moisture damage if not corrected.

Contact a qualified professional.

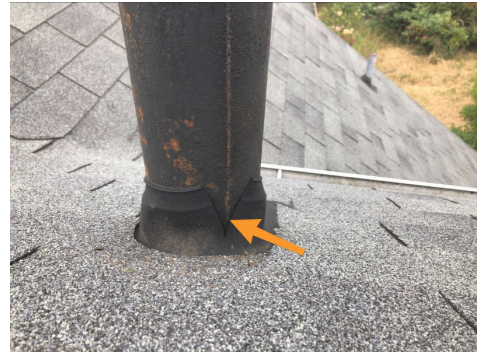
4.4.1 Vents & Flashings

RUBBER BOOTS DETERIORATED

The rubber boots around Plumbing vents for cracked or deteriorated. We recommend replacement.

Contact a qualified professional.

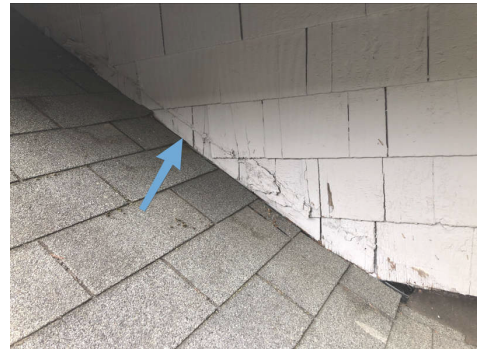
4.4.2 Vents & Flashings

SIDEWALL CONTACT

The siding or trim material is in contact with or very close to the roof surface. This may lead to water damaged siding. Recommend proper installation by leaving a 1-1.5' roof/siding gap and use of sidewall flashing.

Contact a qualified roofing professional.

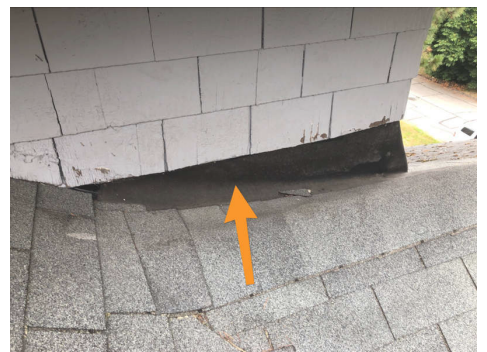
4.4.3 Vents & Flashings

SIDEWALL FLASHING MISSING

The sidewall flashing was missing. We recommend installing to prevent leaking.

Contact a qualified professional.

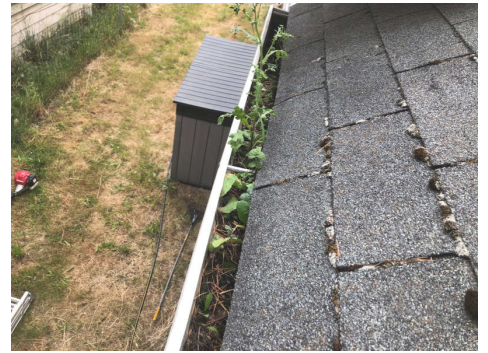
4.5.1 Gutters & Drainage

GUTTERS NEED TO BE CLEANED OF DEBRIS

Contact a qualified roofing professional.

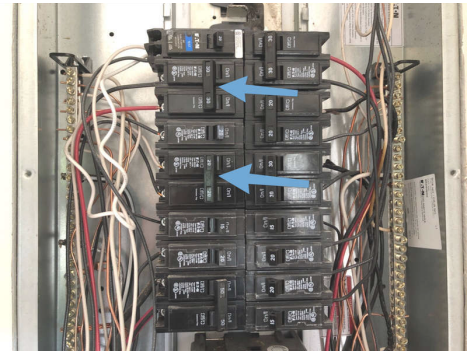
One or more circuit breakers were in the off position. Washington State law prohibits us from turning on these Breakers. Recommended testing all circuits and connected appliances once these Breakers are turned on.

Contact a qualified professional.

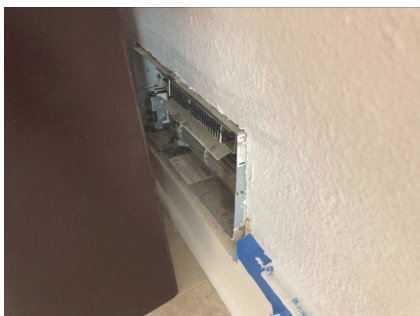
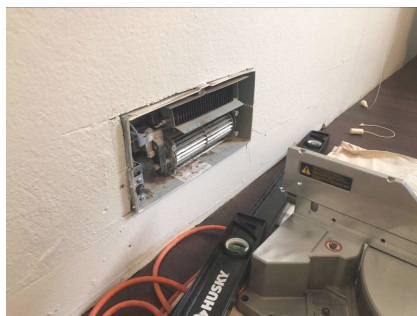
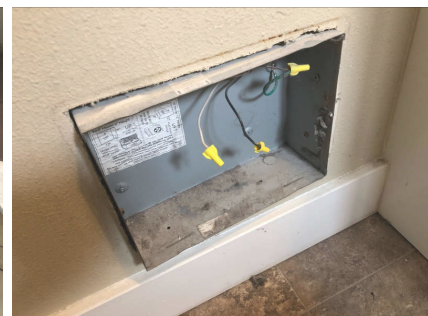
6.1.2 Electric Heating Notes

HEATER MISSING/COVER MISSING

There were some electric wall heaters missing. Recommend installing.

Contact a qualified professional.

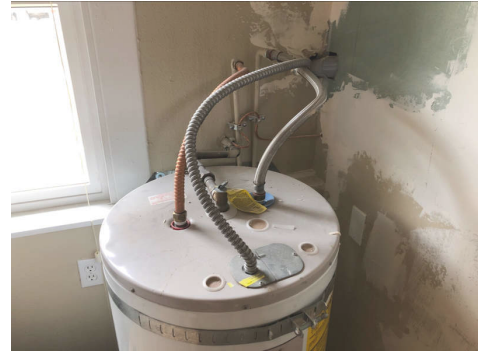
A thermal expansion tank was not installed. We recommend installation

Contact a qualified professional.

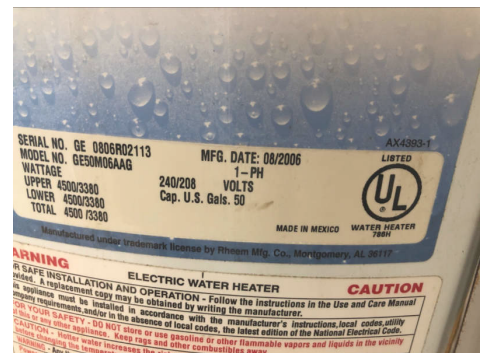
7.1.2 Water Heating System

NEARING EXPECTED LIFE

The water heater is nearing the end of its average expected life of 15 years. Replacement may be needed in the near future.

Contact a qualified plumbing contractor.

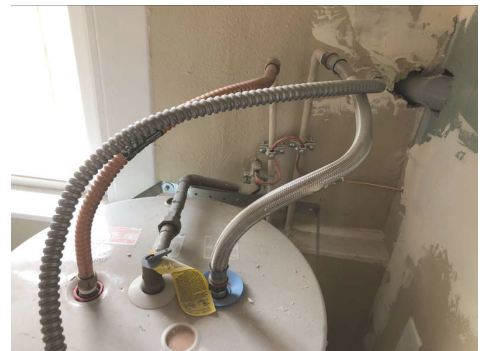
7.1.3 Water Heating System

NO WATER SHUT-OFF VALVE

Contact a qualified plumbing contractor.

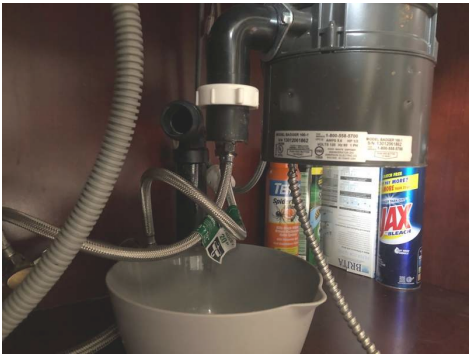
KITCHEN SINK BEING REPAIRED

The kitchen sink was not tested due to repairs and plumbing missing. Recommend testing.

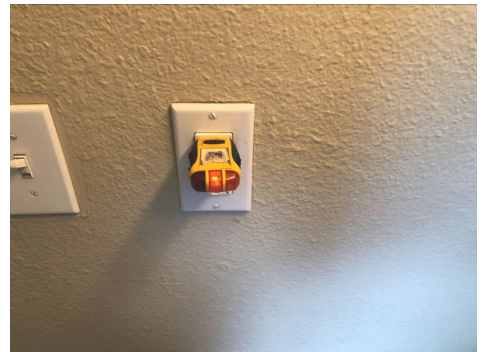
The GFCI outlet was not a wired properly but did have power, it didn't trip when tested. Recommend repair or replacement of the outlet.

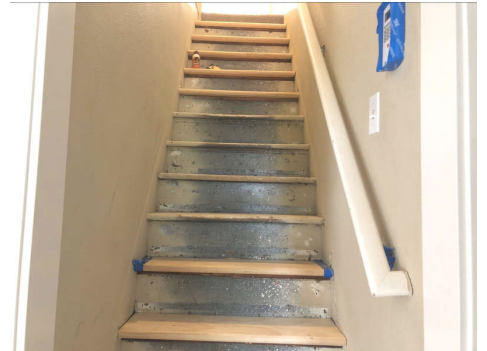
12.9.1 Floor Treads & Risers

STAIRS NON-CONFORMING

The stairs were non conforming to today's standards. Stair Heights or depths did not meet the standard. We recommend evaluation and repairs as needed.

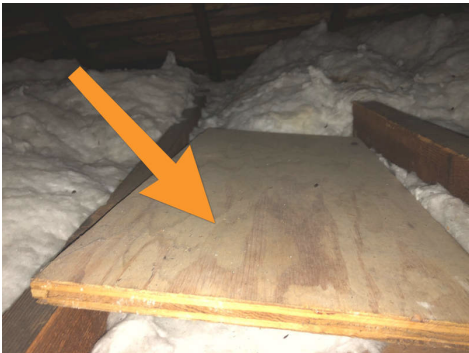
HATCH MISSING INSULATION

The attic access hatch was missing insulation. We recommend installing.

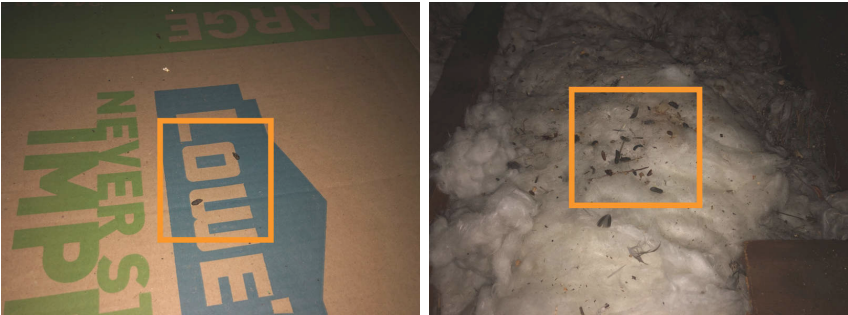
13.6.1 Common Observations

RODENT ACTIVITY

The attic has evidence of rodent activity. We recommend ceiling access points in eliminating any active rodent activity
