DOCK/PIER AND BULKHEAD INSPECTION

5586 Leeward Ln
Tilghman Island MD 21671

MARCH 18, 2021

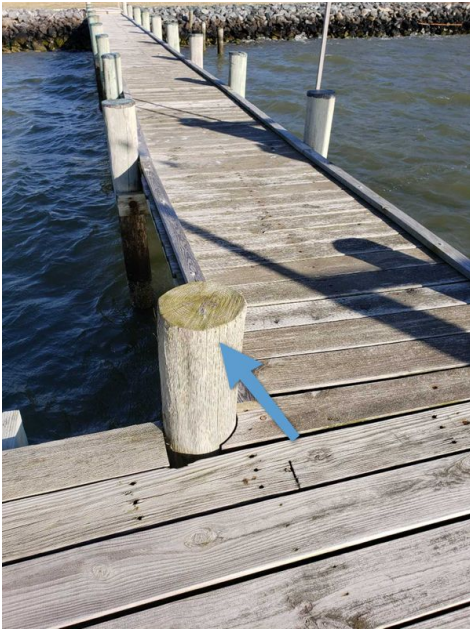
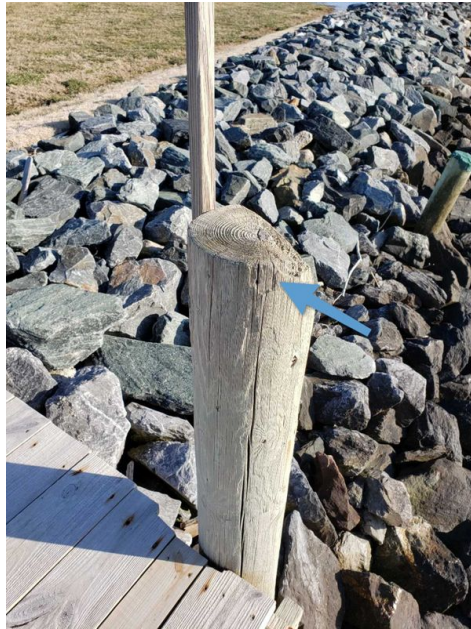
2.2.1 Condition of Piles (Where Visible)

PILING POST CAPS WERE MISSING

VARIOUS LOCATIONS

The post cap on the piling in this location was missing.
Post caps serve to protect pilings from water intrusion.
Recommend replacing missing post caps.

Contact a qualified professional.

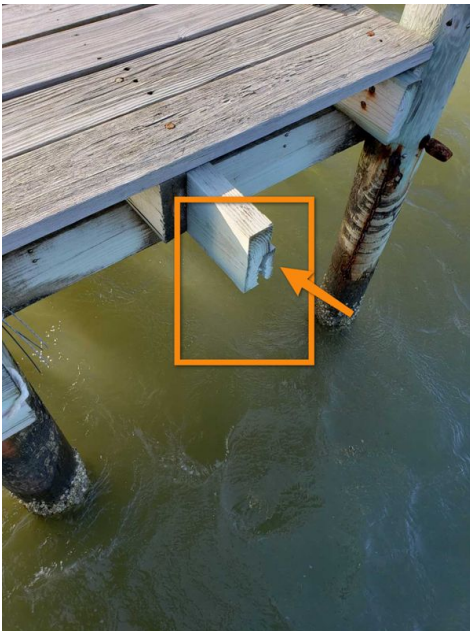
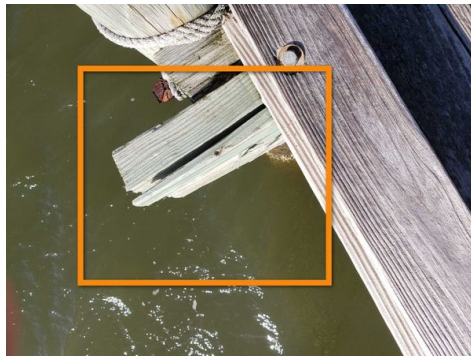
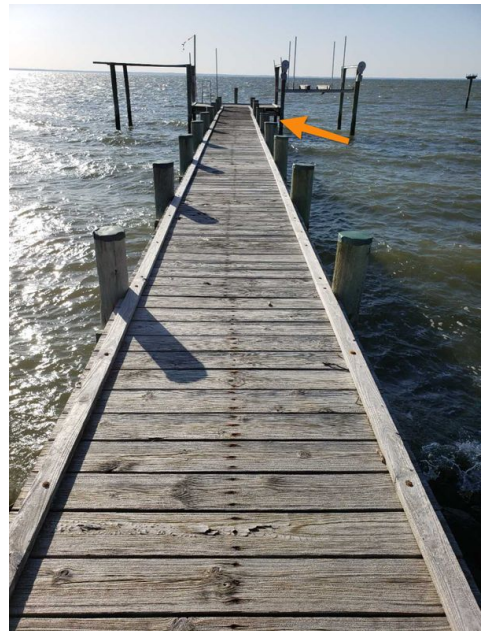
2.3.1 Framed Structure

DETERIORATION AT STRUCTURAL SUPPORT

AT END OF DOCK RIGHT SIDE

Deterioration at a structural support was observed.

This may compromise the structural integrity of the dock.

Recommend a qualified dock installer evaluate and repair.

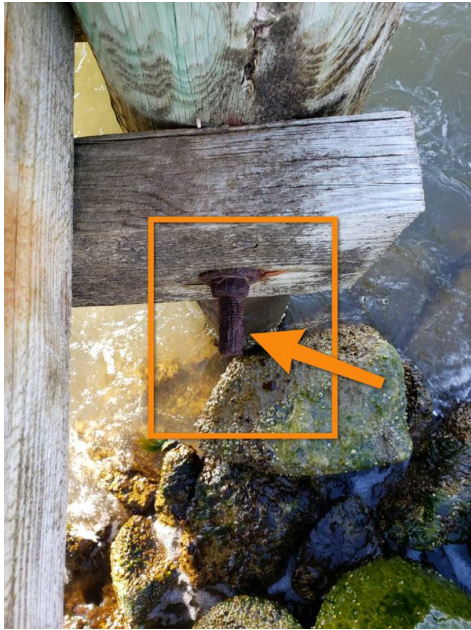
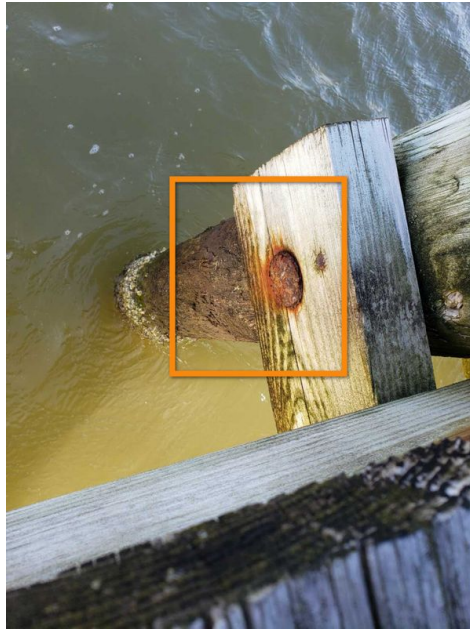
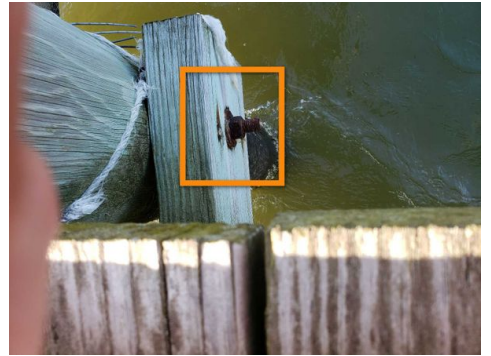
2.3.2 Framed Structure

DETERIORATION AT STRUCTURAL FASTENERS/HARDWARE

THROUGHOUT

The fasteners that attach the deck frame to the pilings were deteriorated and or showing signs of wear. Recommend replacing theses fasteners.

Contact a qualified professional.

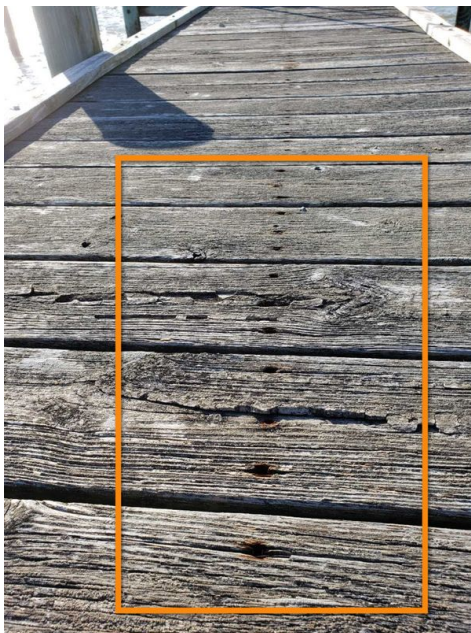
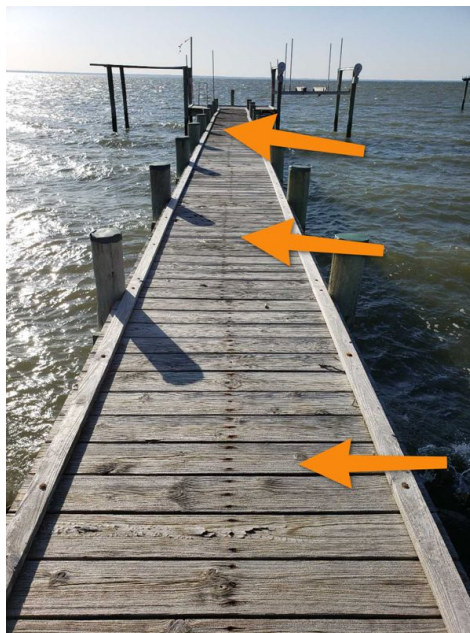
2.4.1 Decking/Condition

EXCESSIVE WEAR

THROUGHOUT

Excessive wear was observed at the deck surface. Recommend replacing the deck surface material.

Contact a qualified professional.

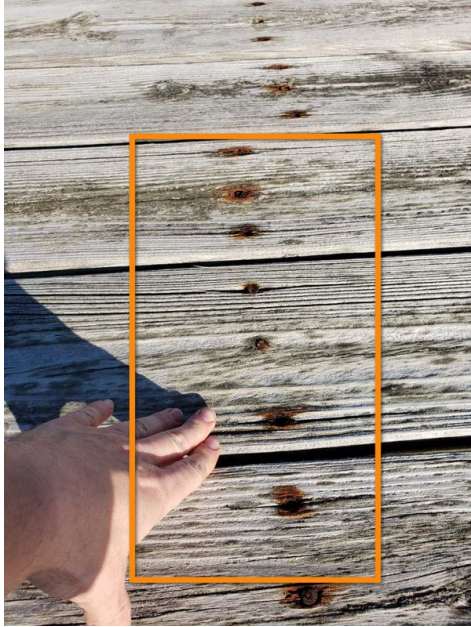
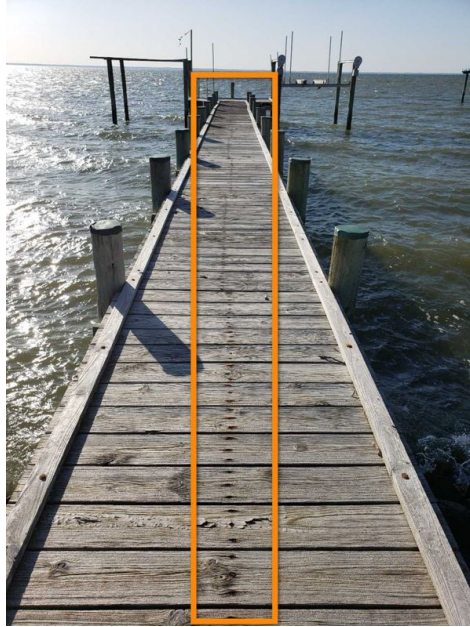
2.4.2 Decking/Condition

LOOSE DECK BOARDS

THROUGHOUT

A deck board was loose or was not properly supported.

Recommend properly securing this deck board.

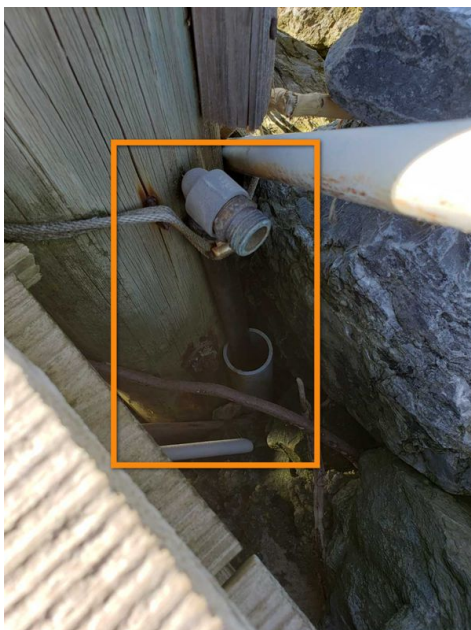
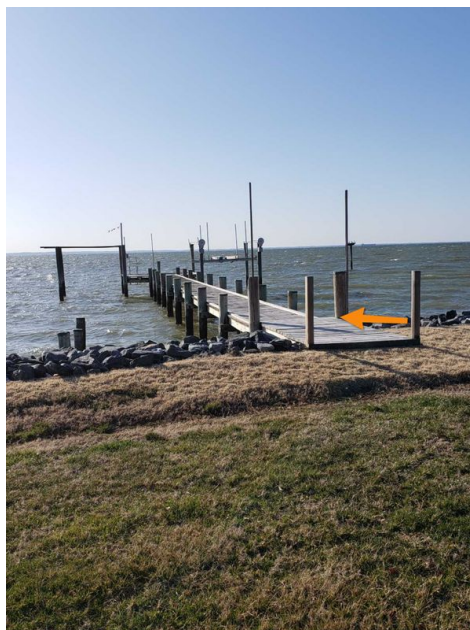
2.5.1 Plumbing

THE PLUMBING TO THE DOCK WAS DISCONNECTED

The plumbing to the dock was disconnected.

Recommend reconnecting the plumbing to a water source.

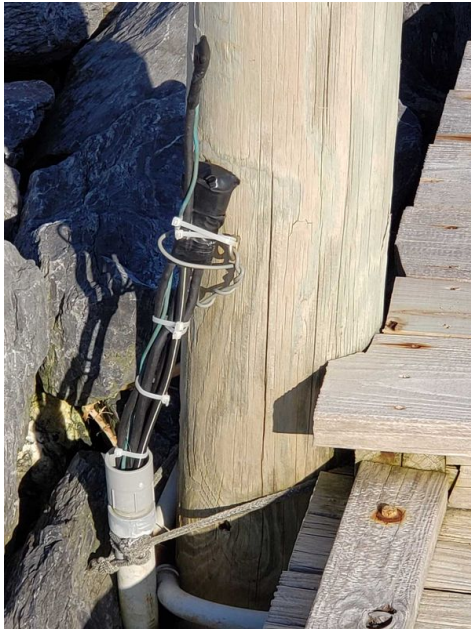
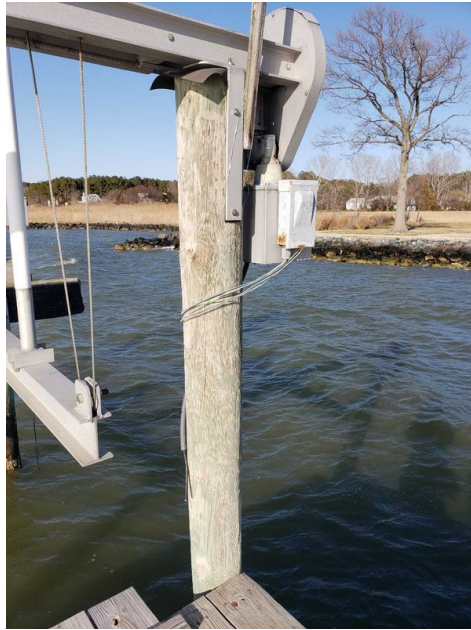
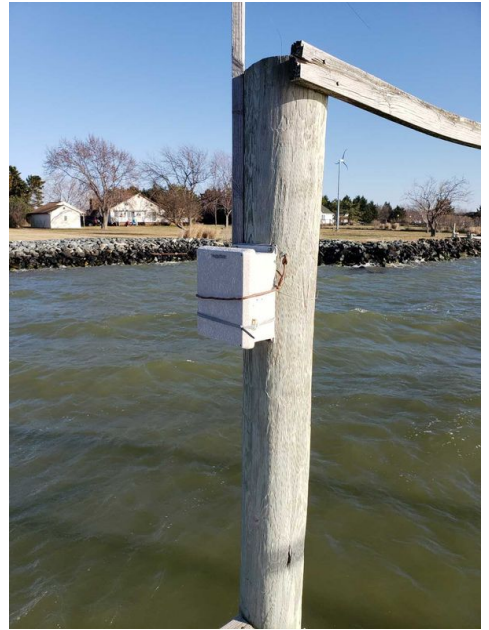
2.6.1 Electrical

THE ELECTRICITY TO THE DOCK WAS DISCONNECTED

The electricity to the dock was disconnected.

Recommend reconnecting the electricity to the dock.

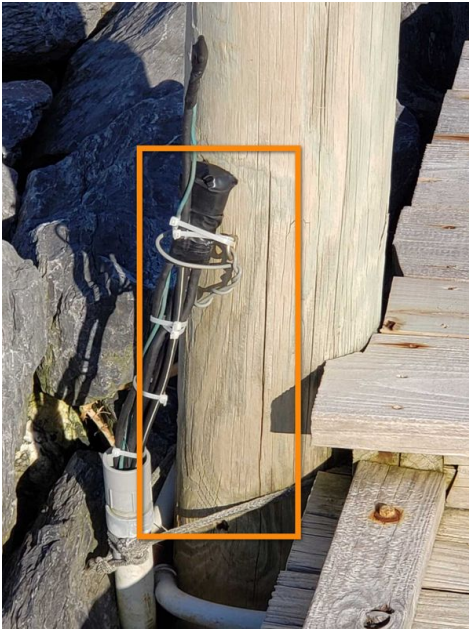
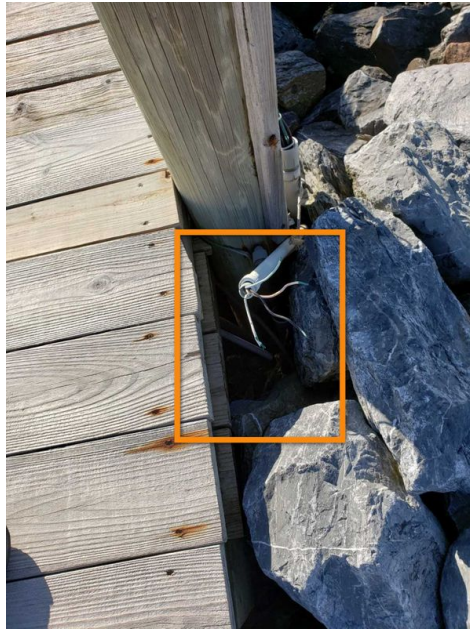
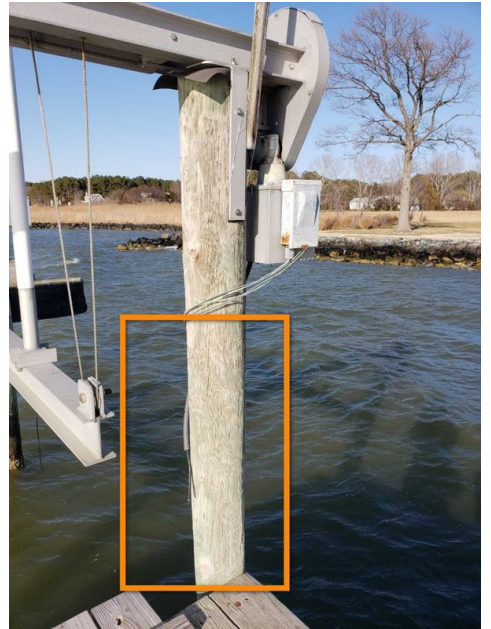
2.6.2 Electrical

IMPROPER WIRING TERMINATION

Wiring was exposed and was not properly terminated.

All electrical wiring should terminate in an approved junction box.

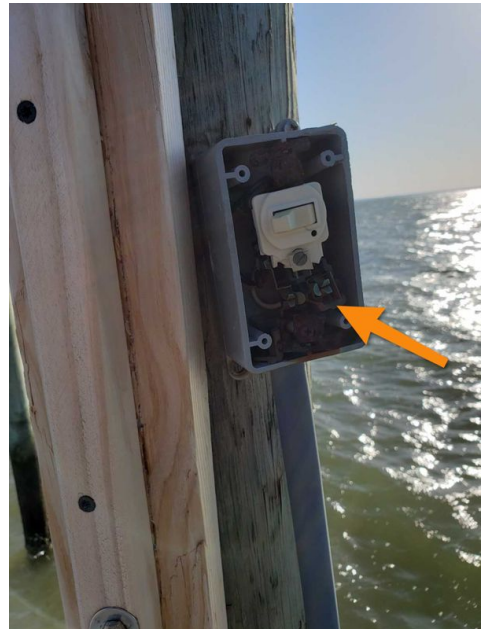
2.6.3 Electrical

DAMAGED ELECTRICAL COMPONENT

An electrical component was damaged.

Recommend a qualified contractor evaluate and repair.

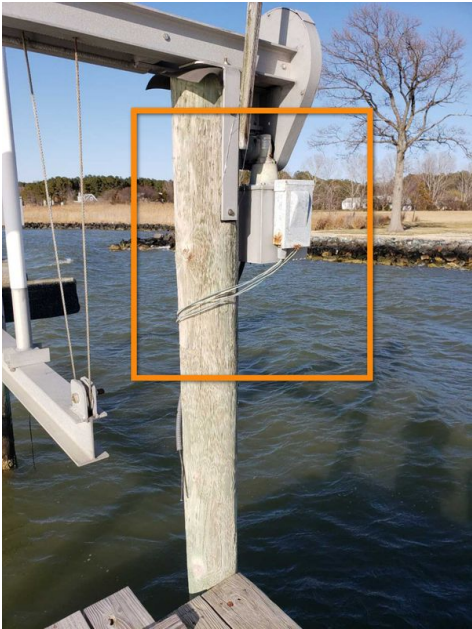
2.7.1 Boat Lifts

THE BOAT LIFT WAS NOT OPERATIONAL

The boat lift was not operational at time of inspection.

Recommend a qualified contractor evaluate and repair.

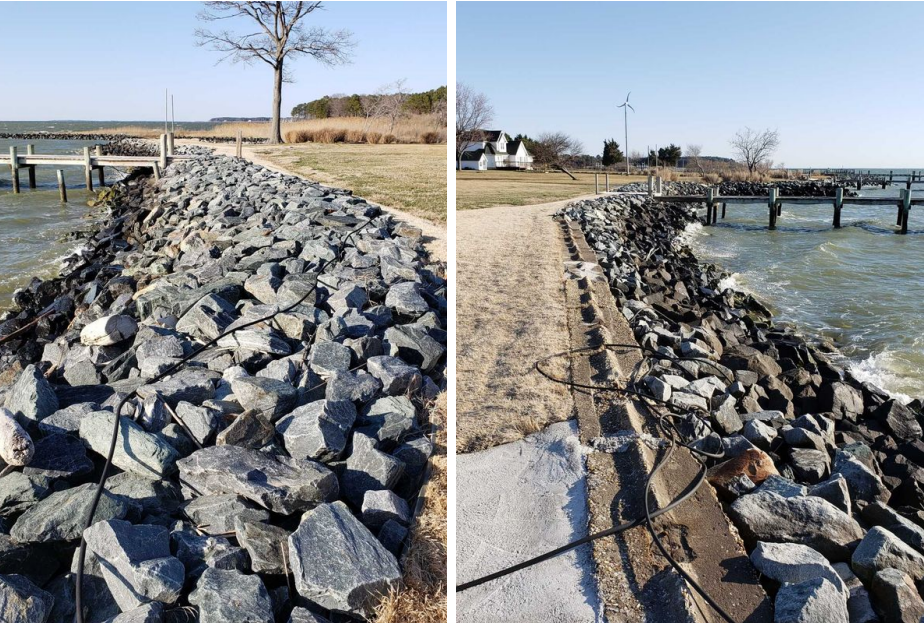
Overall Condition: Acceptable

The overall structural condition of the visible components of the bulkhead was found to be acceptable at time of inspection.
