# PROPERTY INSPECTION REPORT

Concerning: 123 Lucky Loop, Round Rock, Texas 78665

By: Josh Molleur - License # 23872

11/19/2019 8:30 am

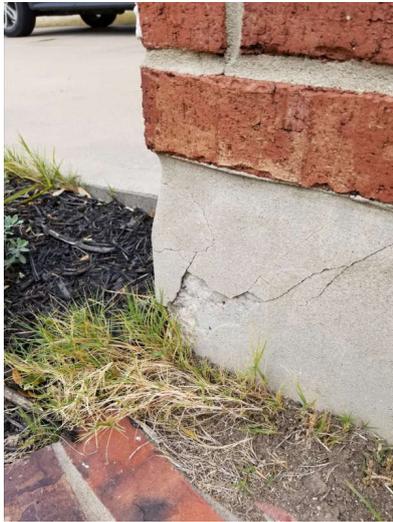
Southwest Corner

One or more of the corners of the foundation had cracking and/or damage commonly called as corner pops or spalling. This is a common condition and is do to thermal expansion and contraction of the masonry wall that rests on the slab. This condition does not adversely affect the foundations performance, however it is recommended having corner pops repaired to prevent moisture intrusion, insect penetration and to prevent damage to the masonry siding that rests above the corner of the foundation.

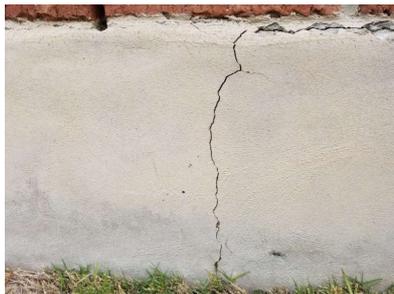
South Side

Cracks were observed in the cosmetic skim coat covering the concrete perimeter beam of the foundation. Cracks in the cosmetic skim coat should be repaired as this allows moisture penetration, can create conducive conditions for wood destroying insects and allow further deterioration of the cosmetic skim coat. This should be closely monitored and repaired as needed.

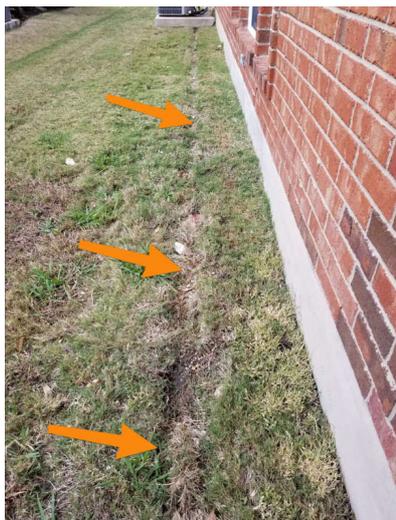
South Side

A drip line was observed to be developing along the house. A drip line is the result of erosion from storm water running off the roof. Drip lines may result in negative drainage or related issues. Any area where the ground or grade does not slope away from the structure is to be considered an area of improper drainage. The ideal slope is 6 inches per 10 feet. It is recommended to monitor the drip line and if negative grade begins occurring, contact a qualified landscaper or qualified contractor to regrade so water flows away from home.

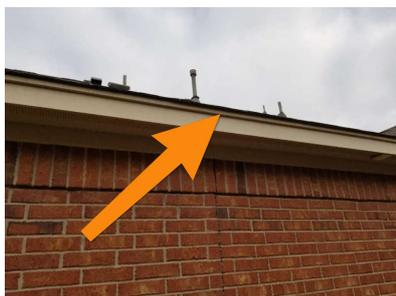
Drip edge flashing was missing at one or more location. Drip edge is a metal flashing that helps to alleviate water from running behind the fascia and other building material.

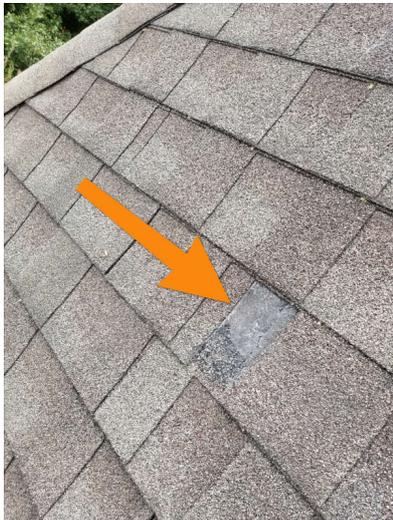
Northeast Side

Composition shingles were observed missing at one or more location. This can cause damage to the roof decking material and can also allow access for water to penetrate. It is recommended that a qualified roofing specialist further evaluate and repair or replace as needed.

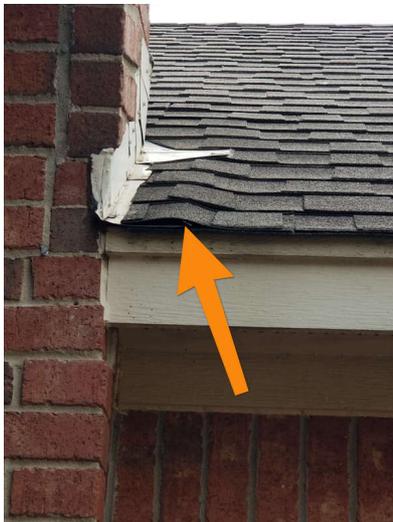
Front Entryway

Sections of the roof flashing were observed to be lifting, damaged or improperly installed. Lifting, damaged or improperly installed flashing may allow for water to penetrate in these areas. It is recommended that a qualified roofing specialist further evaluate and repair or replace as needed.

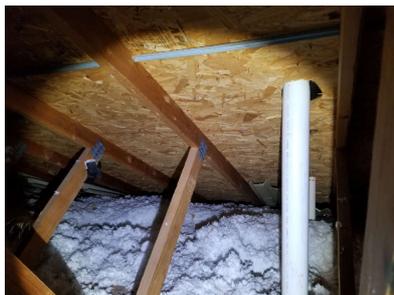
Northeast Corner

Missing baffles were observed at one or more location in the attic. Baffles are used to help prevent insulation or other materials from blocking the soffit vents. Blocked soffit vents restrict the attic ventilation.

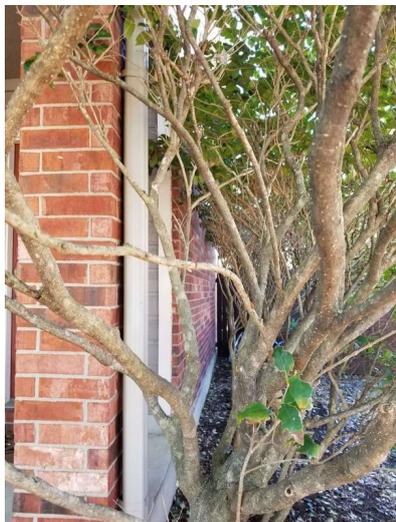
Foliage limits the inspectors visual observation of the exterior surfaces. Heavy foliage at exterior surfaces can damage exterior veneer, create conditions for wood destroying insects and trap moisture. It is recommended at have all foliage trimmed away from the exterior surface a minimum of 18 inches.

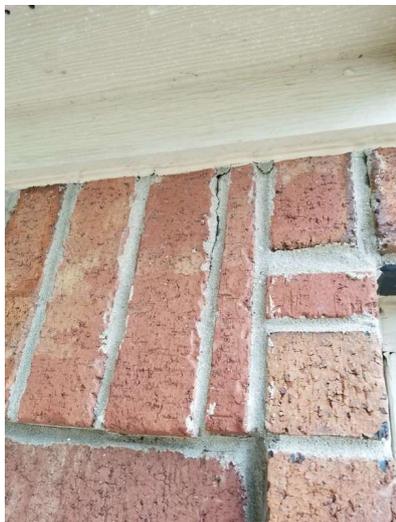
Top Left Garage Door

Minor cracks were observed in the exterior brick/stone veneer walls. Cracks in exterior brick/stone veneer can be indications that some movement or settlement has occurred. It is recommended that cracks in exterior walls be repaired and closely monitored. If concerns about the current or future foundation performance exist, it is also recommended to have a licensed structural engineer further evaluate prior to closing.

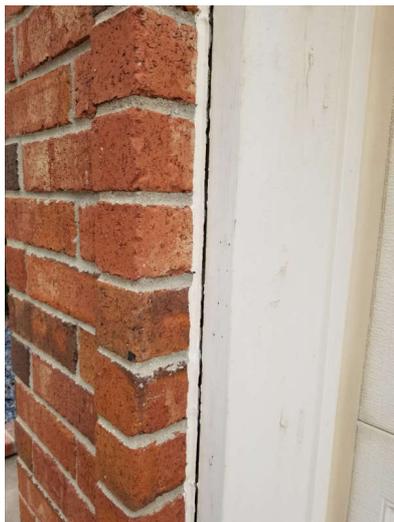
Garage Trim

Exterior sealants/caulking was deteriorated and/or missing in one or more location. Sealants/caulking help to reduce moisture penetration and insect intrusion.

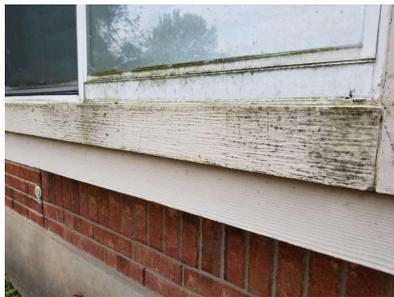
North Side

Fungal growth was observed on the exterior veneer of the structure and should be removed.

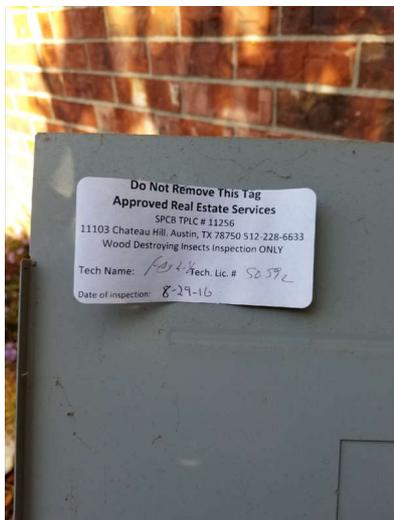
Indications of a previous wood destroying insect (WDI) treatment were observed. It is recommended that the buyer learn more about the treatment prior to closing.

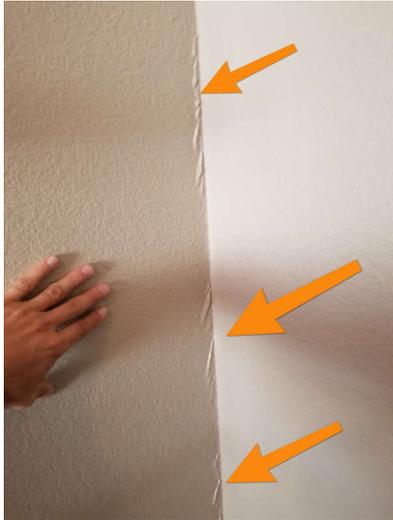
The drywall tape was coming loose and/or twisting in one or more location. This can be an indication of poor installation, expansion and contraction of building materials or that there is and/or was some degree of movement or settling occurring in the structure. It is recommended to monitor these areas and if the condition worsens, contact a licensed structural engineer to further evaluate or if concerns arise.

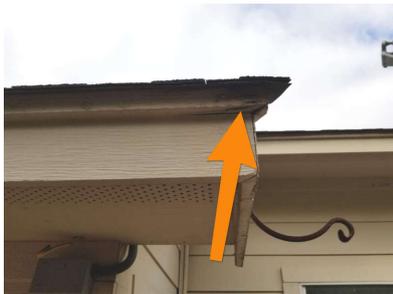
East Trim

The exterior wood trim was deteriorated and/or damaged in one or more location. Deteriorated or damaged exterior wall veneer should be repaired to prevent further damage, reduce moisture penetration and reduce insect intrusion.

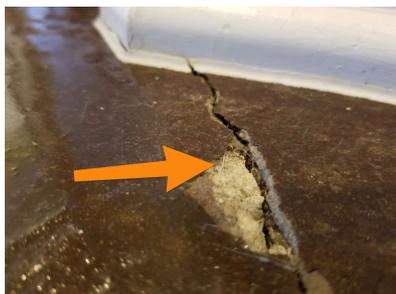
Main Hallway

Small cracks in the concrete floor were observed in one or more location. Small cracks (shrinkage cracks) in concrete are typically normal due to the nature of concrete, however it is recommended that cracks in the concrete floor be closely monitored and if there are concerns about the current or future foundation, it is also recommended that there be a further evaluation by a licensed structural engineer prior to closing.

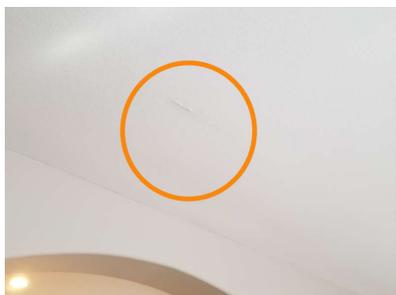
Living Room

The leak was checked with a moisture meter at the time of the inspection and the area was found to be dry.

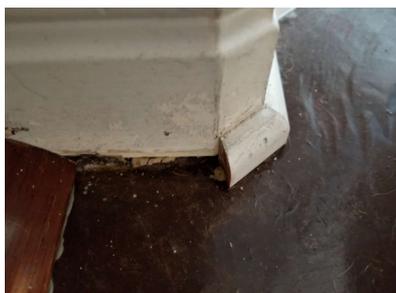
Formal Dining Room

Trim was found to be missing and/or damaged in one or more location.

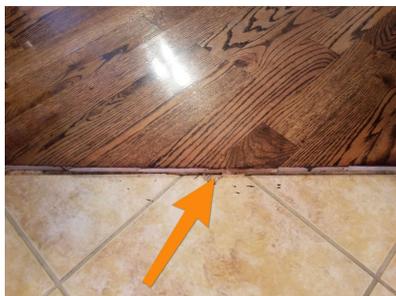
Master Bathroom

The transition piece at one or more location was found to be missing and/or damaged.

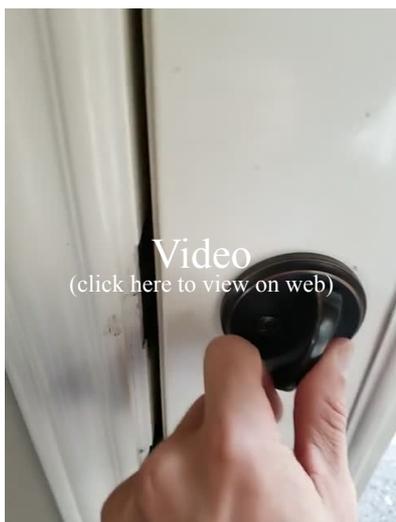
The deadbolt lock throw-out bolt(s) for the backdoor was found to not fully throw and extend into the door jamb all the way. Adjustments should be made to the deadbolt locking mechanism or door jamb to ensure that the dead bolt(s) can fully extend.

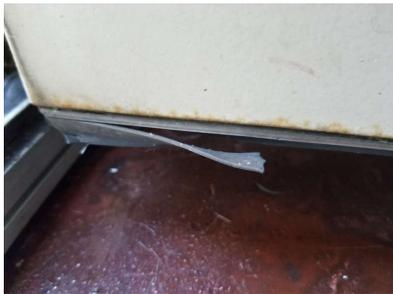
Back Door

The door sweep was damaged and/or missing at the back door. Damaged or missing door sweeps may reduce energy efficiency and allow water penetration.

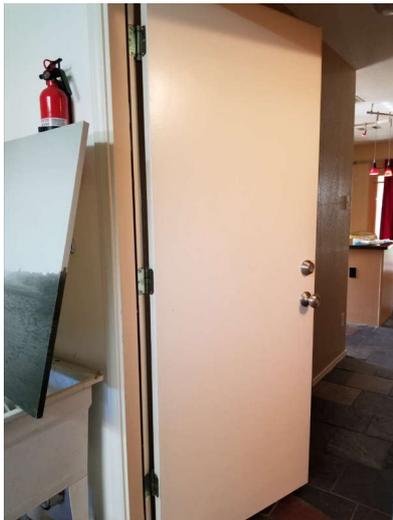
Door to Garage

The self close hinge for the door at the garage was missing or not functioning. The garage door that provides access to the conditioned dwelling must be fire-rated, have weatherstripping and have a self-close mechanism for safety purposes. This is considered to be a SAFETY HAZARD.

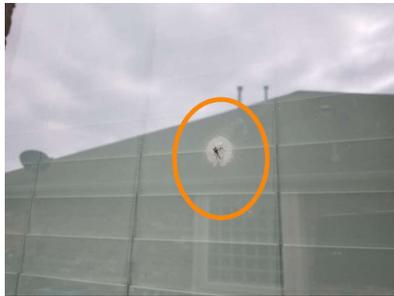
Southwest Window

One or more window pane was observed to be cracked and/or broken. It is recommended that a qualified window specialist or qualified contractor further evaluate and repair or replace as needed.

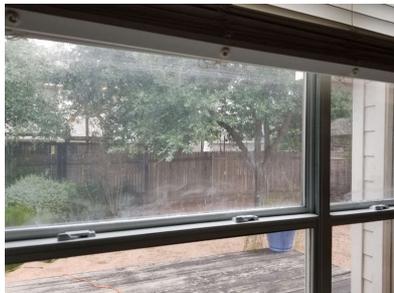
One or more of the windows appear to have lost its thermal seal between the two glass panes. When a thermal seal is lost, condensation will typically develop between the panes of glass which can cause discoloration or fogging. Discoloration or fogging may appear and disappear as humidity and temperature change during the seasons. It is recommended that a qualified window specialist or qualified contractor further evaluate and repair or replace as needed.

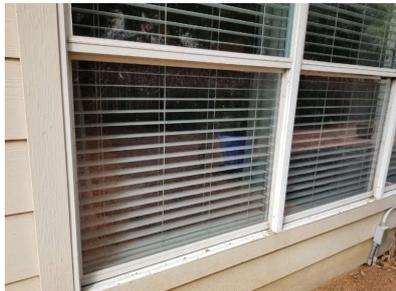
Window screens were observed missing at one or more of the windows. Window screens help prevent insect penetration and can also prevent minor impact damage to the window.

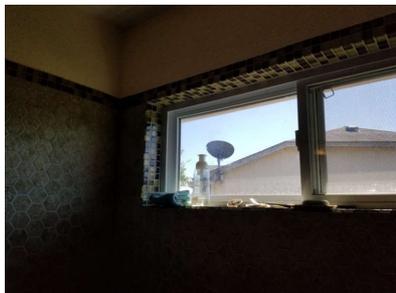
Full Bathroom

One or more window was found installed in the bathroom shower enclosure. Windows in a bathroom enclosure can be susceptible to water penetration. It is recommended to monitor these areas and repair as needed.

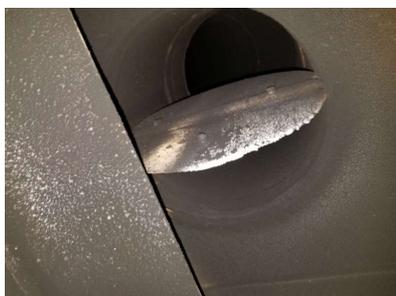
A missing or damaged blocking mechanism was observed at the fireplace damper. A damper blocking mechanism (such as a clamp) assists in preventing the damper from completely closing and leaking harmful gasses, fumes or smoke into the interior of the structure. This is considered to be a SAFETY HAZARD and should be repaired.

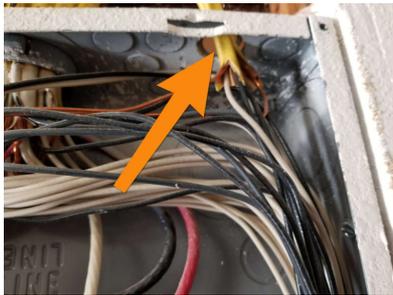
Subpanel

The wires entering the electrical panel box were not properly protected from the sharp edges within the panel. Where wires enter an electrical panel box, bushings should be installed to help protect wires from sharp edges. It is recommended that a qualified, licensed electrician further evaluate and repair or replace as needed.

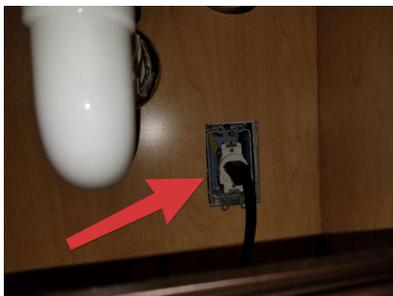
Kitchen Sink

Missing or damaged faceplate was observed below the kitchen sink. Faceplates that are missing are considered to be a SAFETY HAZARD and should be repaired.

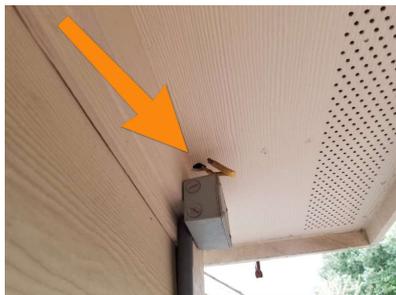
South Eave

Unprotected or exposed exterior wiring was observed that is not located in a protective conduit.

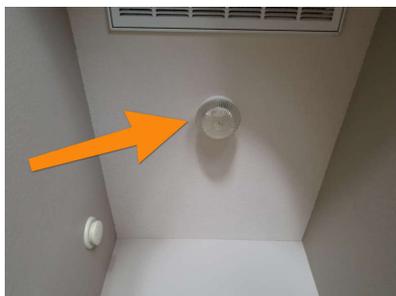
Hallway Near Master

Lights were observed to not be operating in one or more location. This condition may need a bulb replacement, fixture repair or a fixture replacement.

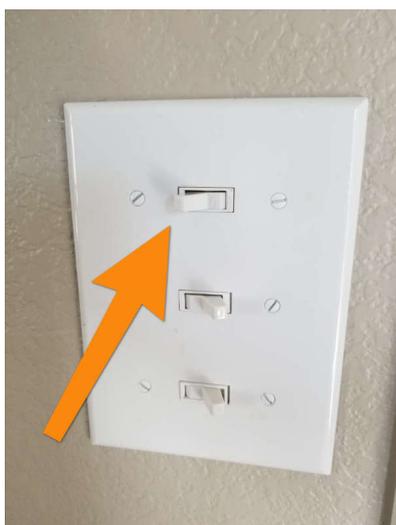
Near Back Door

One or more light switch was found to be non-functioning and the inspector was not able to determine the function of light switch.

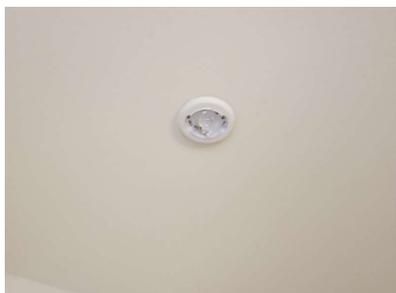
Master Bedroom

One or more smoke alarm was missing. Under current building standards, there should be a smoke alarm located in every bedroom, immediately outside of every bedroom, in the living areas and on each habitable level of the home. This considered to be a SAFETY HAZARD.

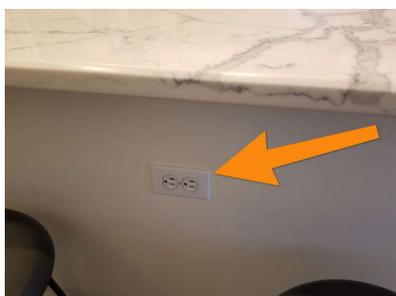
Kitchen Island

One or more receptacle in the kitchen was observed to not be ground fault circuit interrupter (GFCI) protected. Under current building standards, all kitchen electrical receptacles should be GFCI protected.

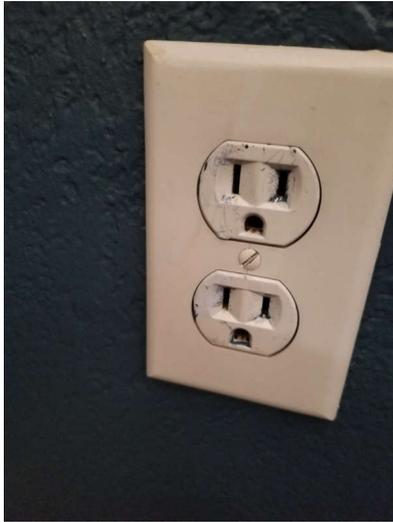
Front Bedroom

One or more electrical receptacle was observed to be painted. Painted electrical receptacles are considered damaged and should be replaced by a qualified, licensed electrician.

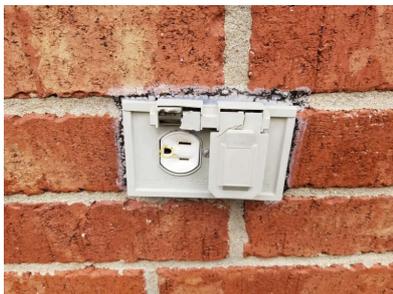
North Side

One or more outdoor electrical receptacle cover was observed to be damaged. Missing or damaged electrical receptacles covers should be repaired by a qualified, licensed electrician.

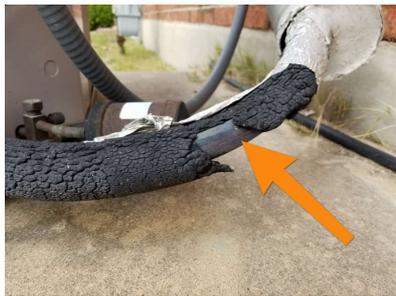
Outside Condensing Unit

Damaged, deteriorated and/or missing insulation on the refrigerant line was observed. Properly insulating the refrigerant line can improve performance, help to prevent moisture from building on the exterior of the line and help reduce the chances of leaking condensate. The refrigerant line should be repaired as needed.

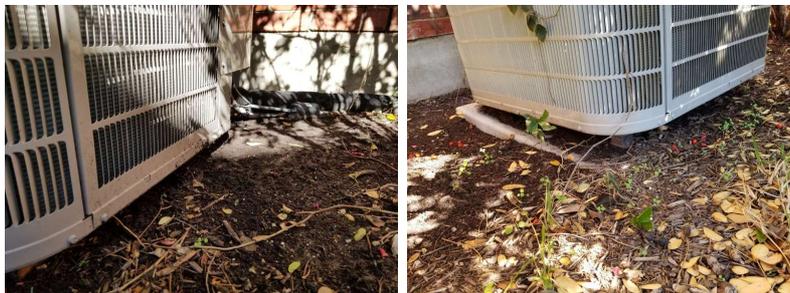
The AC condensing unit was not installed 3 inches above the grade. The improper height of the AC condensing pad may allow moisture to penetrate the equipment, reduce equipments serviceable life and may affect the condensing units performance. It is recommended to improve the grading around the AC condensing unit pad.

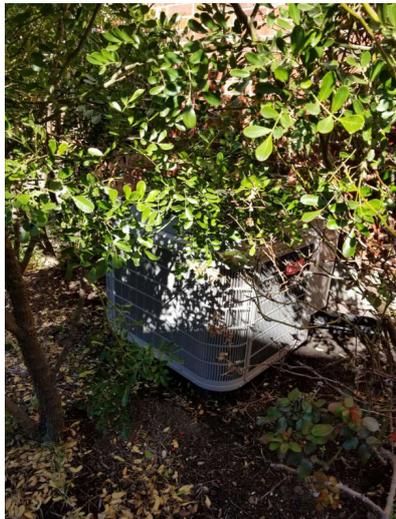
The outside condensing unit was found to not have adequate clearance. Condensing units should have enough clearance from exterior walls and foliage to allow for proper air flow around the unit.

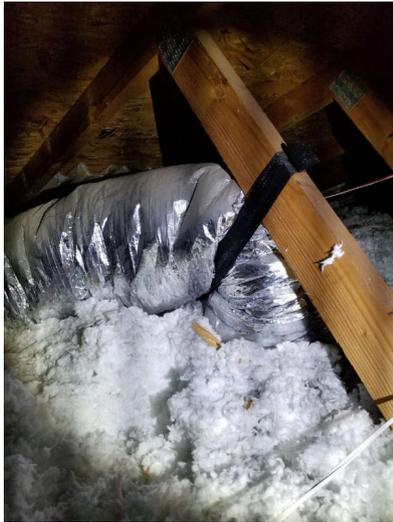
Right of Walkway

Observed ducts that were improperly routed due to sharp and abrupt bending. Under current building standards, the radius at the centerline of the bend should be no less than the diameter of the duct. Sharp and abrupt bending can restrict the airflow and affect the airflow balance in certain areas of the house.

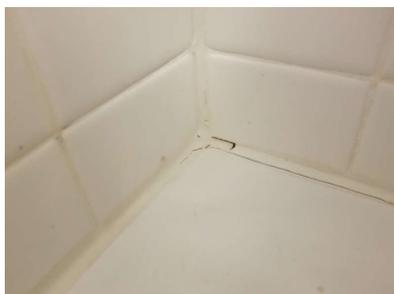
Front Bathroom

Missing or damaged caulking was found in the front shower/tub enclosure. These areas should be repaired to prevent water penetration.

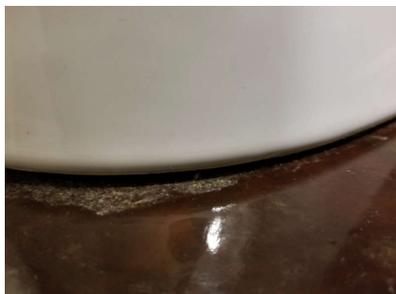
Half Bathroom

The toilet in the half bathroom was found to have missing or damaged caulking at the base of the toilet. The base of the toilet should be sealed to the floor to help prevent bacteria and sewer gasses from the toilet drain entering the house.

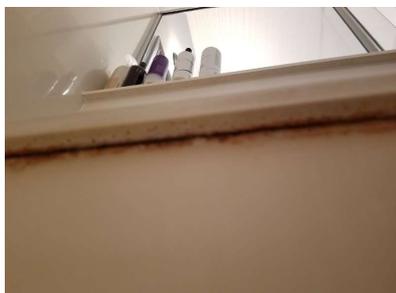
Master Bathroom

Cracked, deteriorated and/or missing caulking and/or grout was observed under the sitting ledge in the master shower. Cracked, deteriorated and/or missing caulk or grout should be repaired or replaced to prevent water penetration.

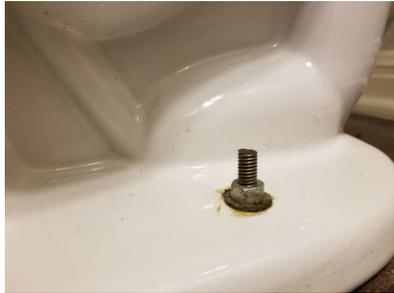
Half Bathroom

The toilet anchor bolts protruding from the base of the toilet were not properly covered. The bolts should be covered to help prevent rust and deterioration from occurring.

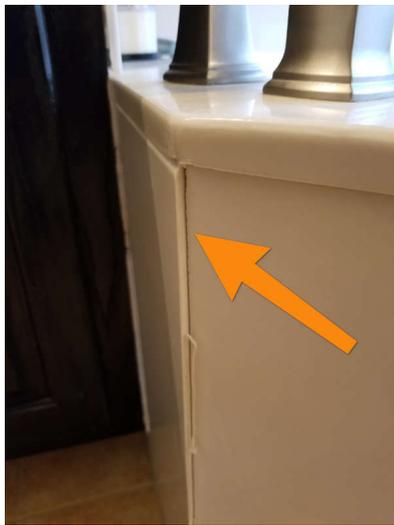
Master Bathroom

The bathtub in the master bathroom was observed to be damaged.

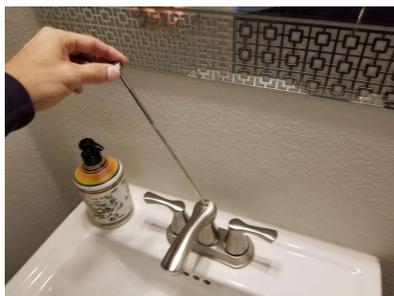
The stopper in the half bathroom sink was found to not be connected.

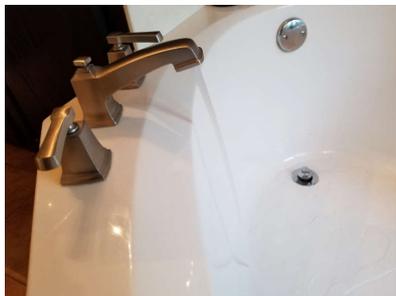
Master Bathroom

Slow flow was observed for the master tub.

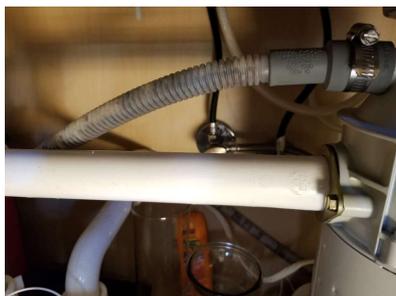
A high loop or air gap was observed to be missing for the dishwashers drain line. High loops or air gaps help in separating waste water from the supply water and also helps to prevent the flow of drain water from coming back into the dishwasher.

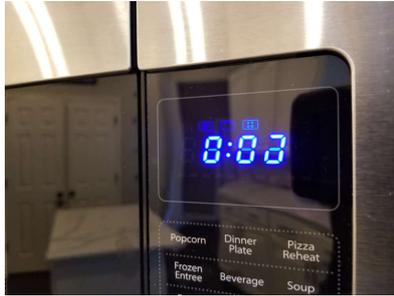
The digital display was found to be damaged and/or not displaying correctly.
