DDP RECON REPORT COPY

Sample Recon Report - 691 San Marcos St
Giddings, TX 78942

APRIL 29, 2021

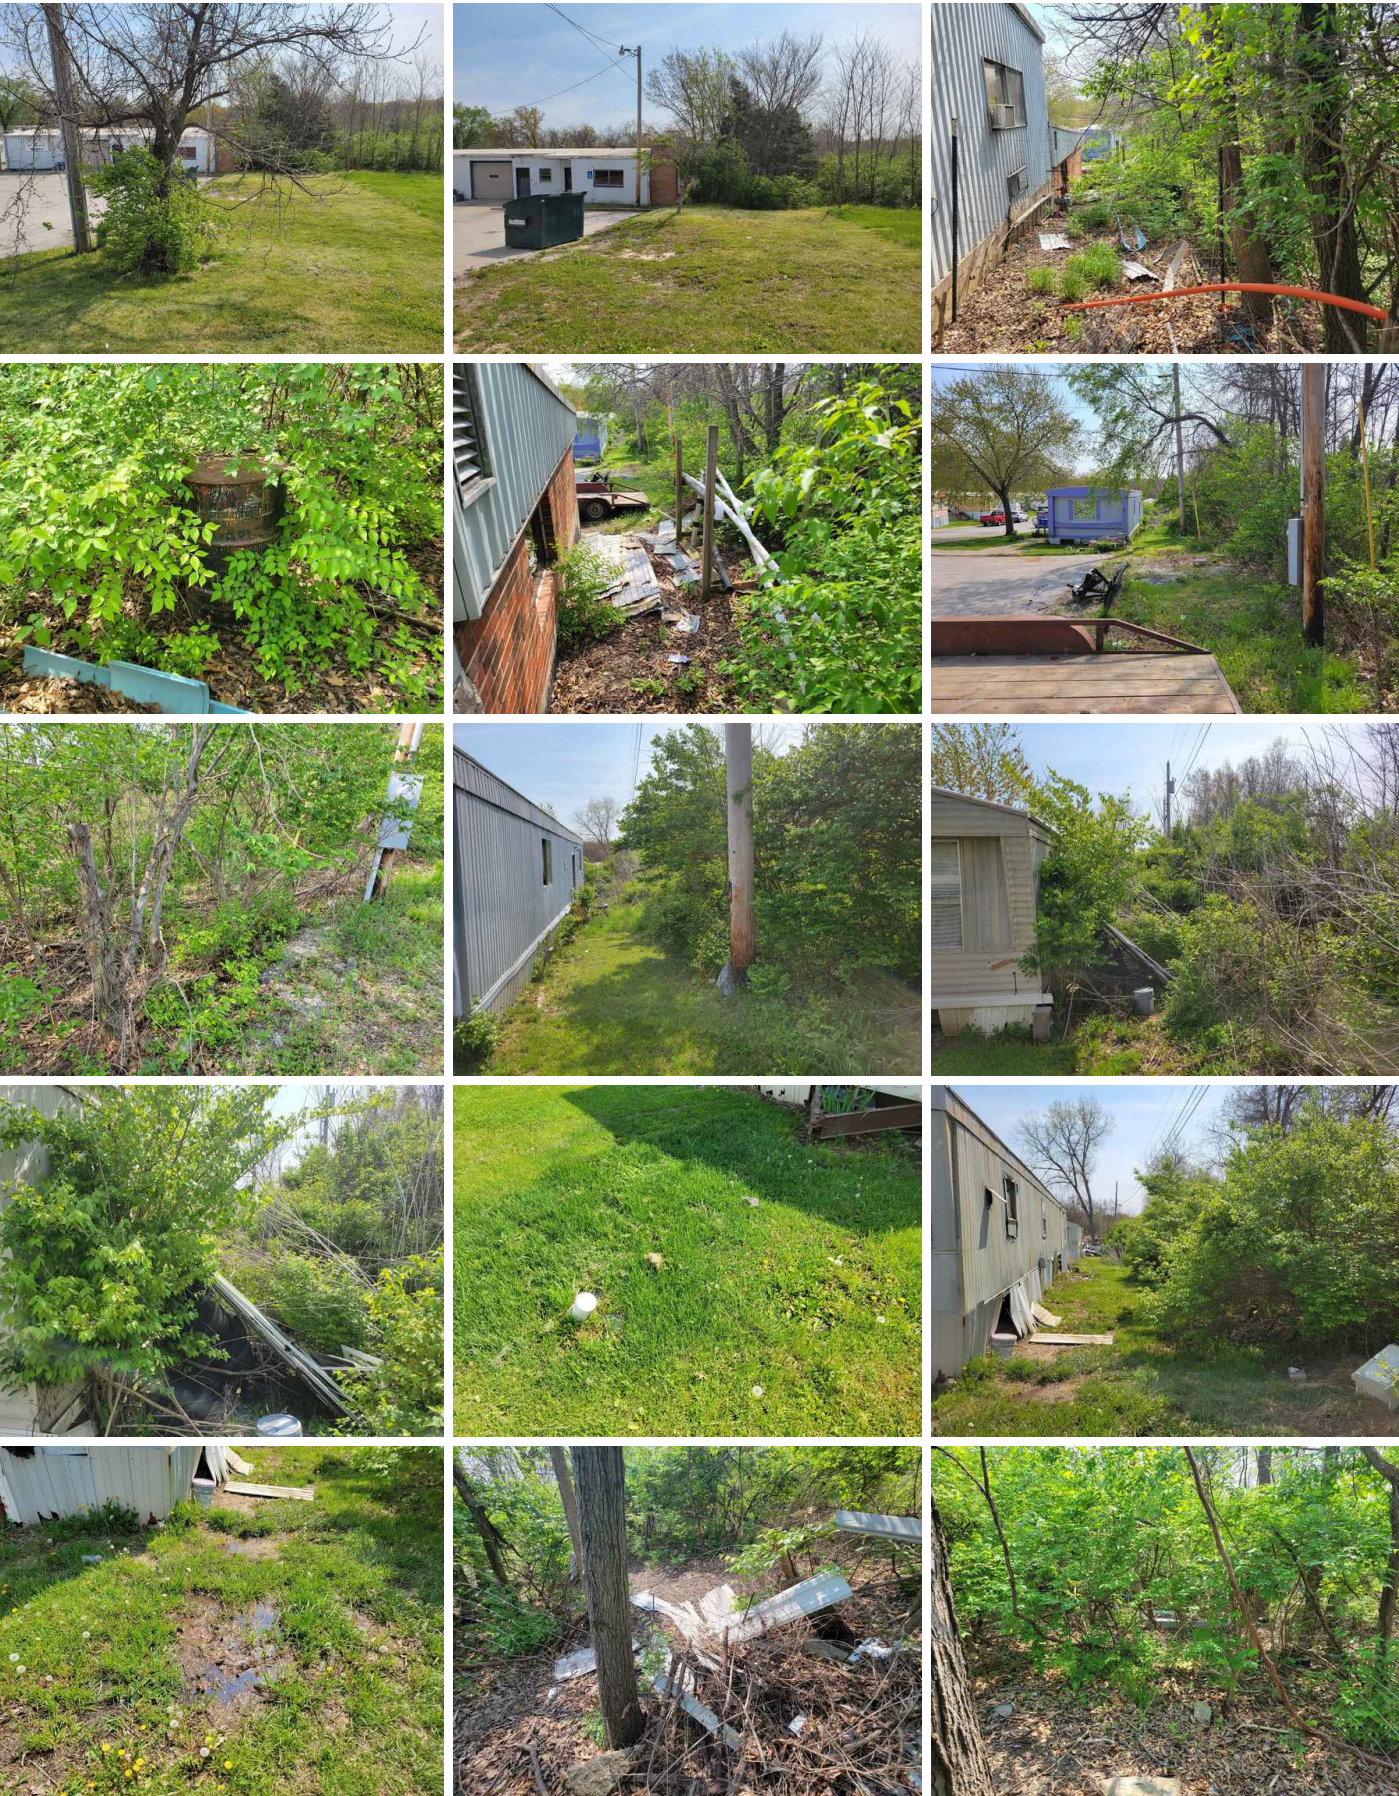
Summary and Pictures 1

There was approximately 40% of the property that was fenced. The materials were hog wire and barbed wire. None of the fence was in good condition. The fence was overgrown with trees and brush and was barely visible in most cases. The location of the fencing was on the south and south west side of the property.

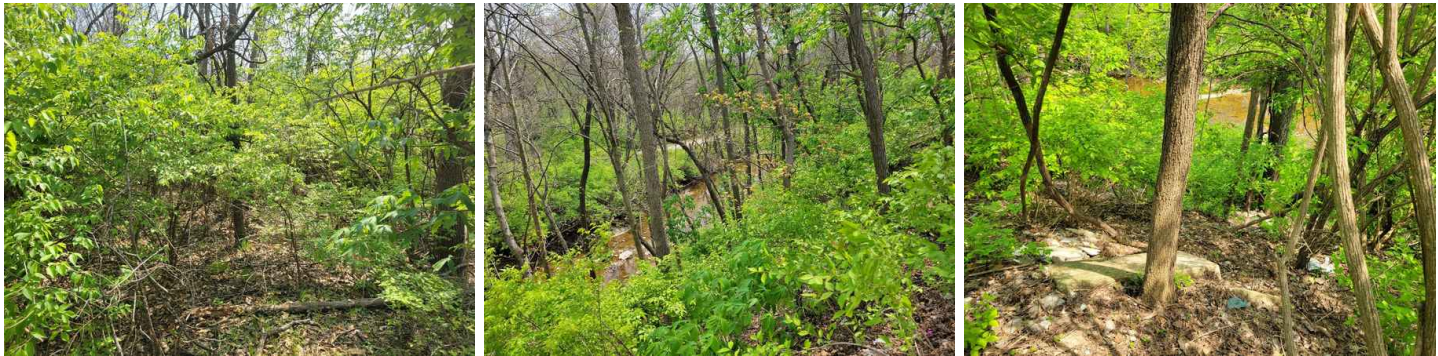
IMPASSABLE AREA

East side of property was impassable due to 30-50 foot cliff into creek. Slope and detail aerial shown on Drone mapping.

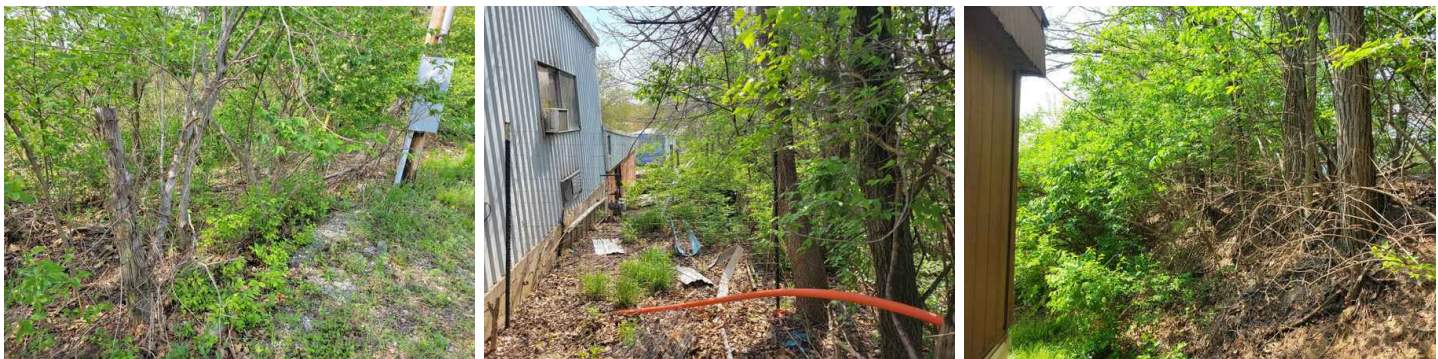
4.1.1 Fence Condition

BROKEN FENCE (MORE THAN 20%)

Industry average cost: \$20-\$50 per foot (wood or chain-link parts & labor). Abt 50% considered bad condition.

MEDIUM: 10K ~ 50K Est.

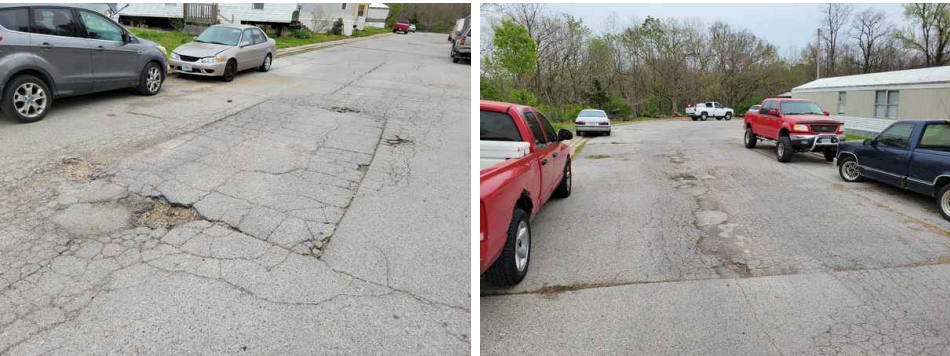
5.1.1 Road Condition

Number of pot holes counted and average severity description: **14 small potholes**
Sizing: Small (diameter of less than a foot), medium (one to two feet), larger (diameter greater than 2 feet).
Average pothole and crack repair cost for asphalt: \$100-\$300 per depending on size, depth, and severity.

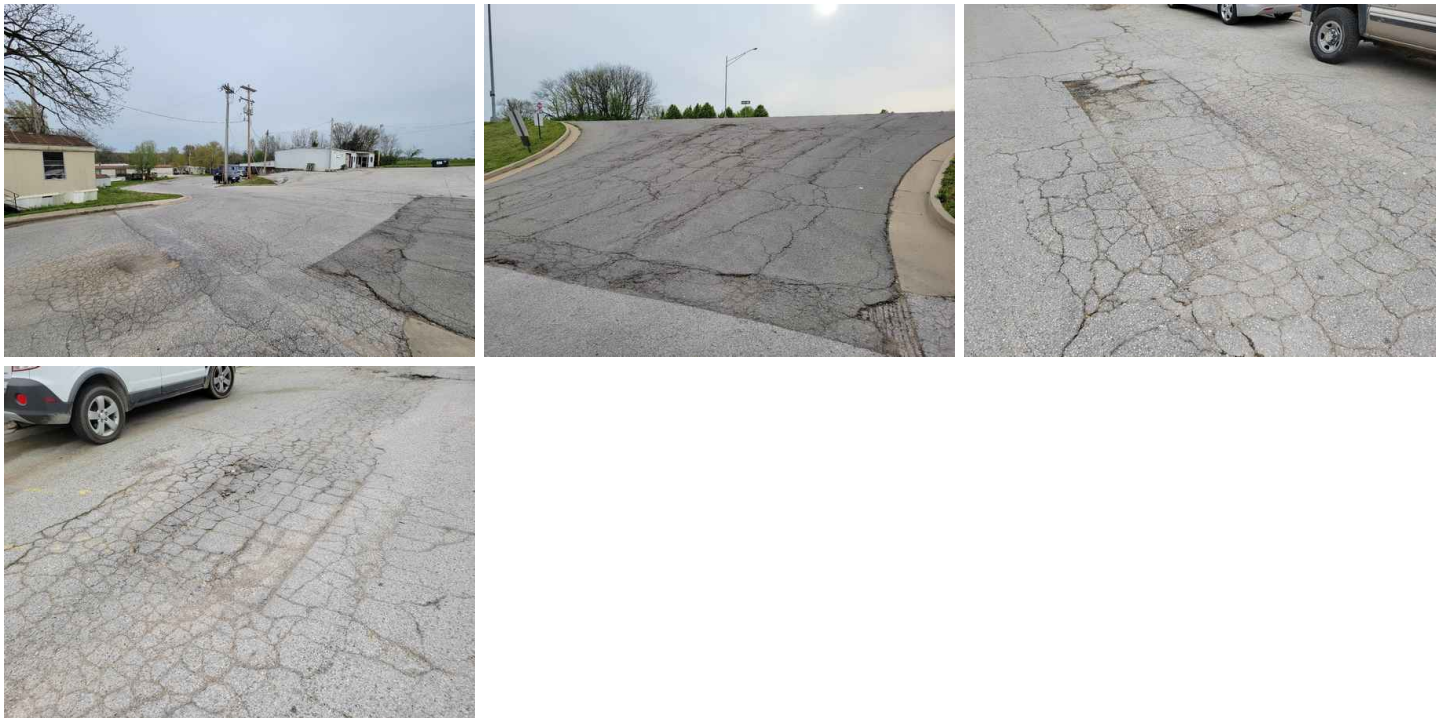
5.1.2 Road Condition

SPIDER CRACKING

This is also called crocodile cracking and can commonly occur on asphalt pavements. This form of surface damage usually indicates some structural failure.

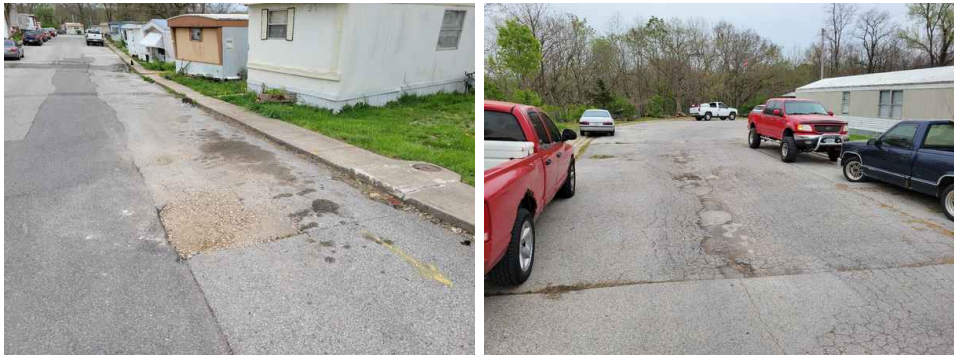
5.1.3 Road Condition

BAD AREA

Bad area is an area of road that is in poor or unusable condition that may not be described as a pot hole or spider cracking.

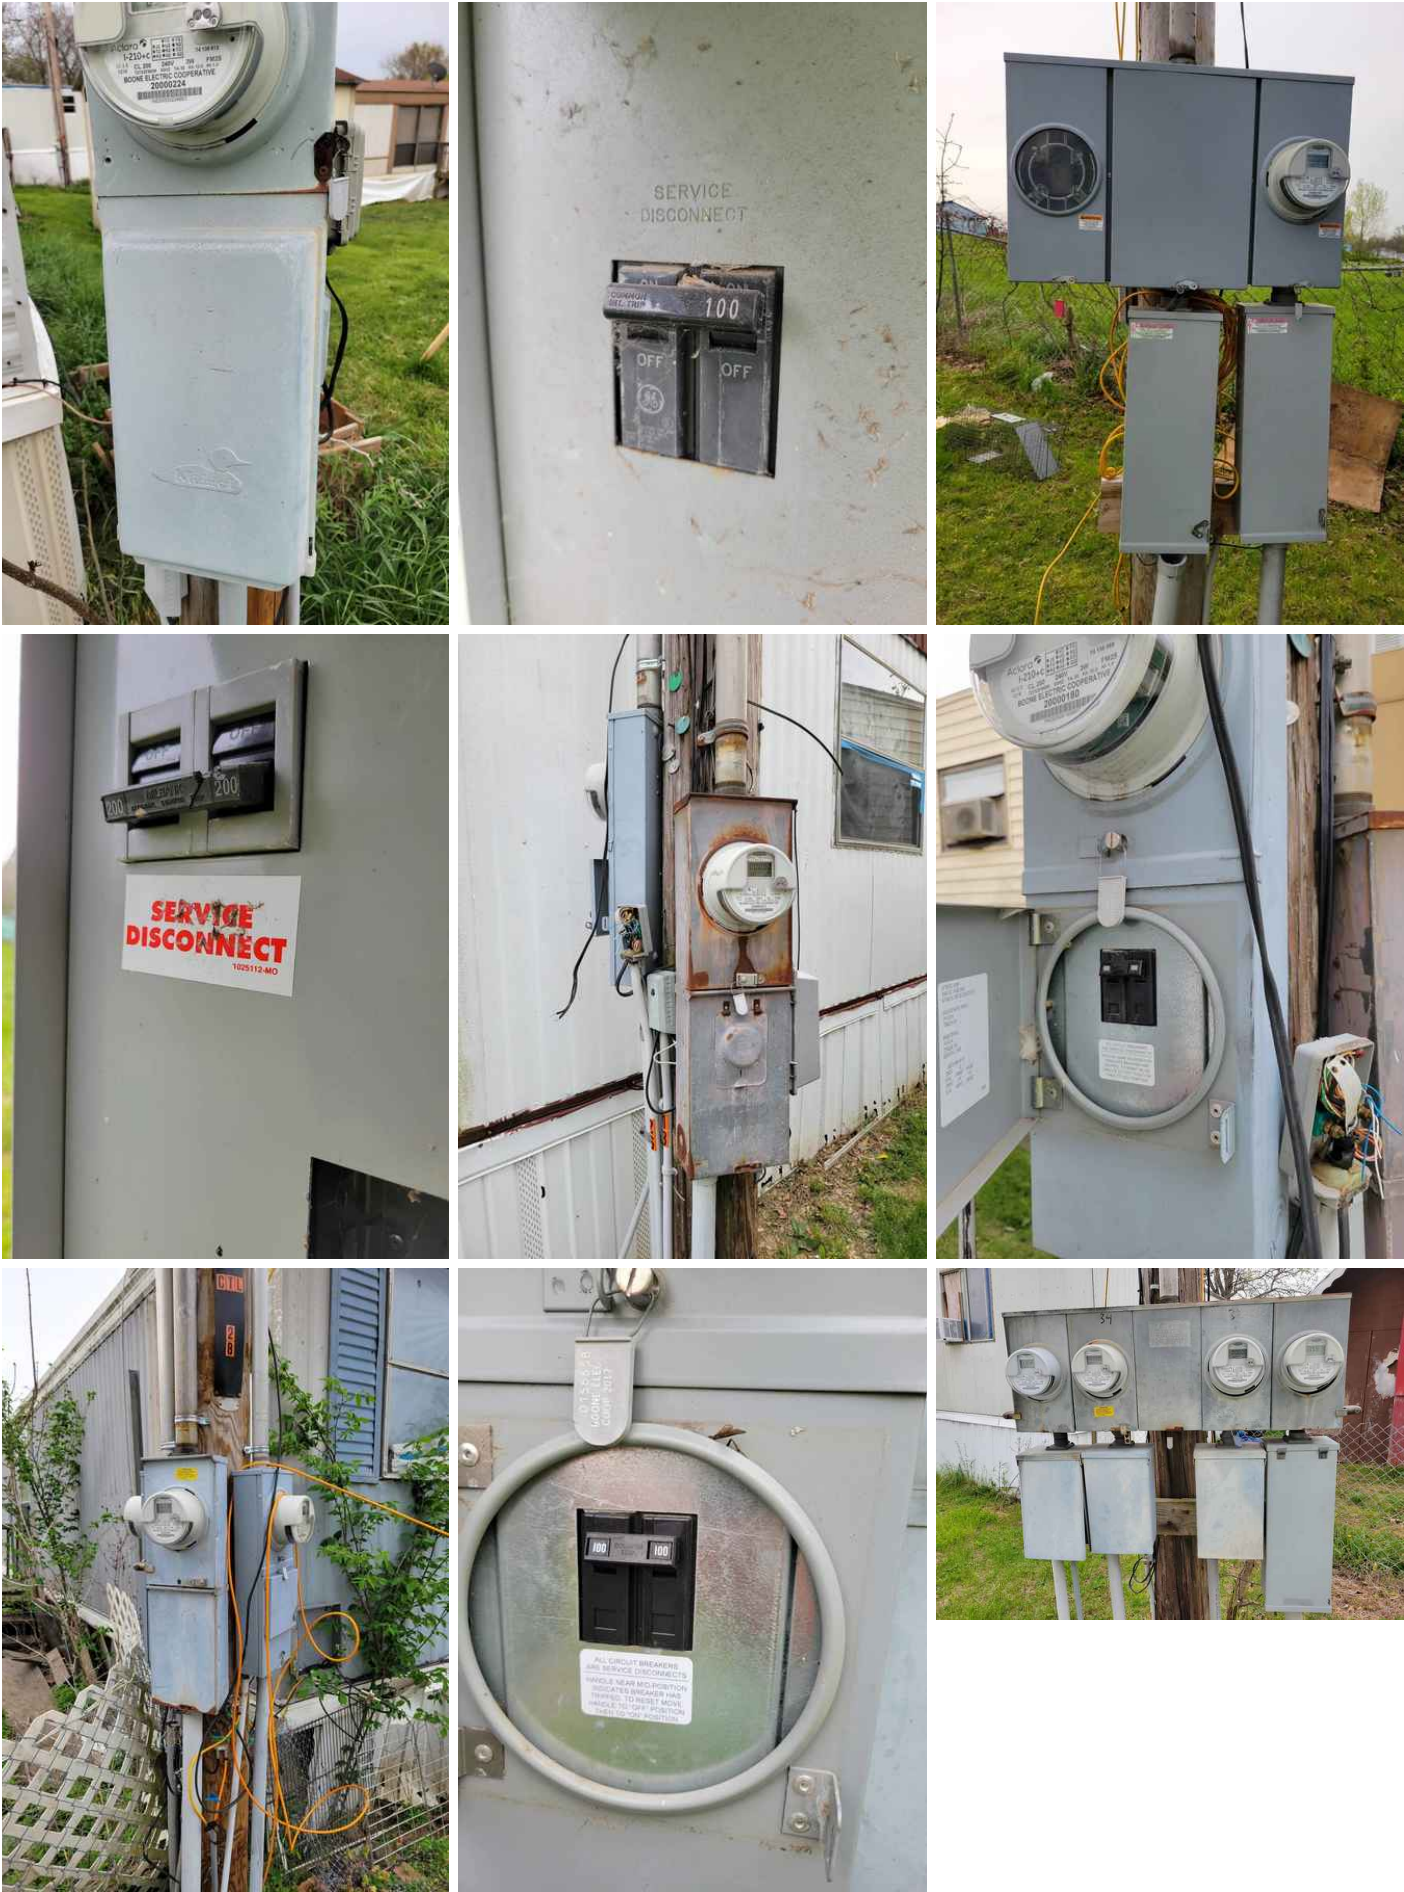
Summary: The park had fair electrical overall. The north circular portion of the park was 90% 100 amp and 10% 200 amp. The south portion of the park (L shaped) was 90% 200 amp and 10% 100 amp. The condition of the pedestals and boxes were 85% good condition and 15% bad condition. Most of the 200 amp were new, however there were ~4 bad pedestals that were bent or leaning. The 100 amp pedestals were older and constituted most of the bad boxes.

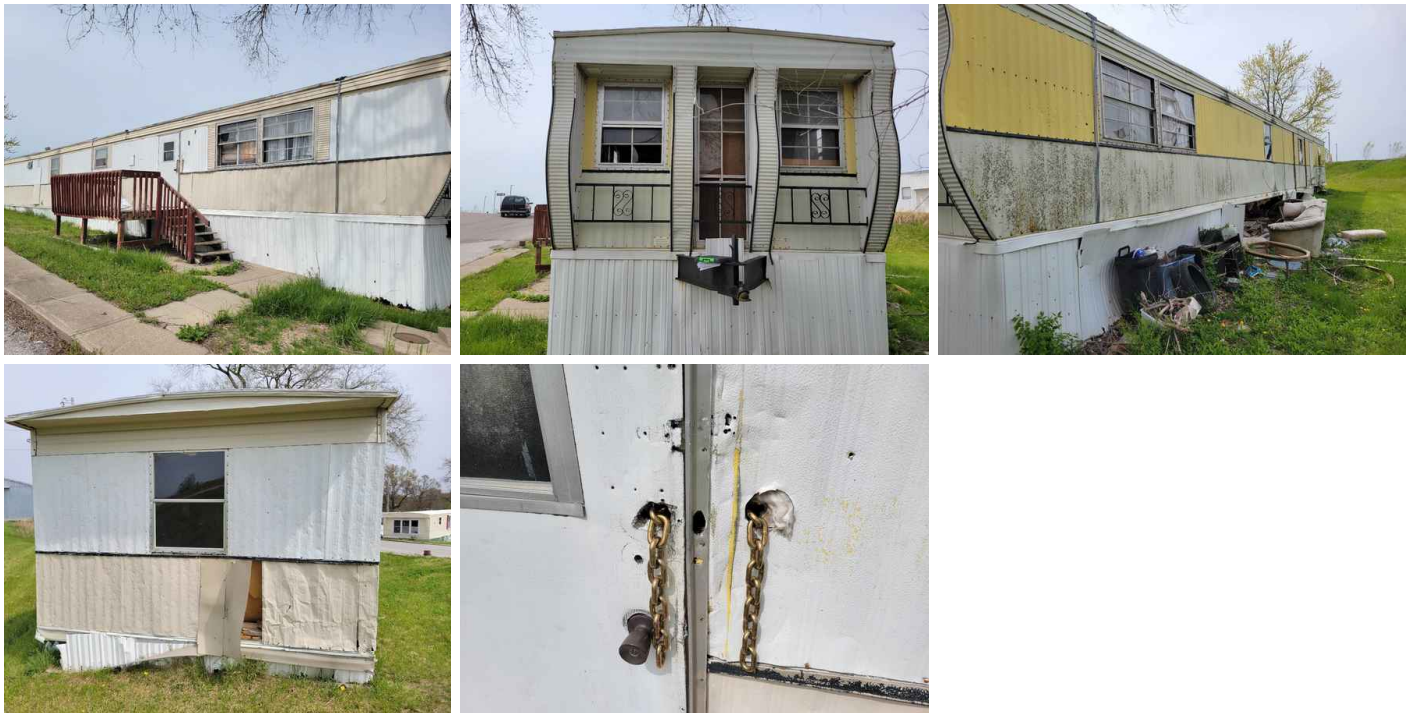
LOT 1, Vacant: Exterior Description
Poor Condition

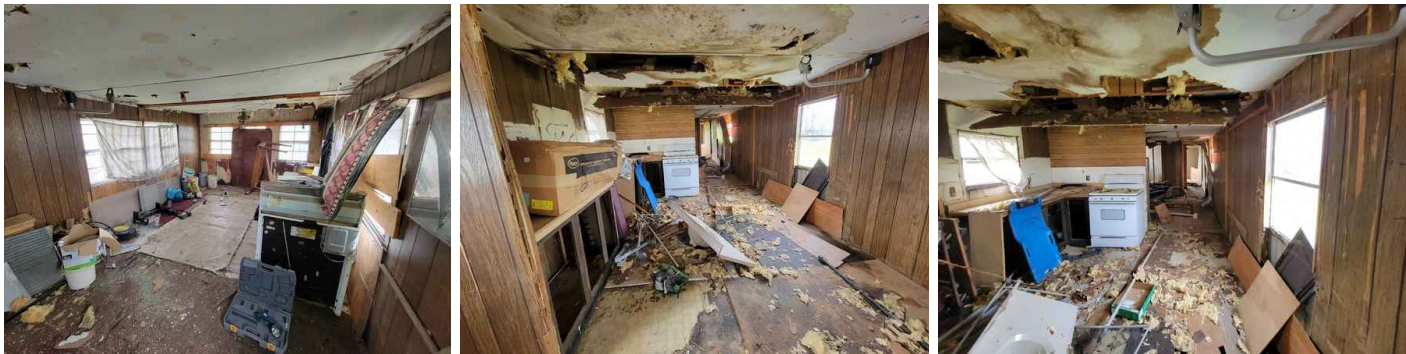
LOT 1, Vacant: Interior Description
Bad Condition, Smell/Odor

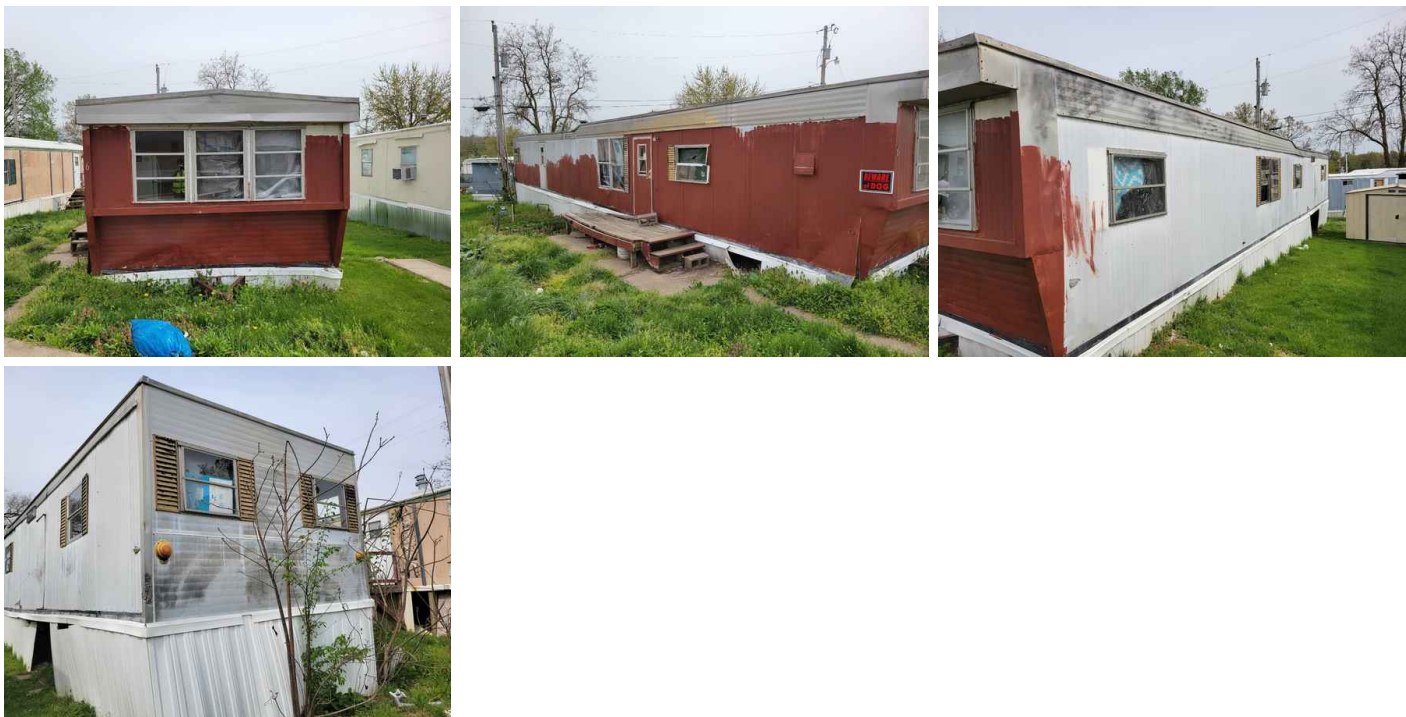
LOT 6, Vacant: Exterior Description
Poor Condition

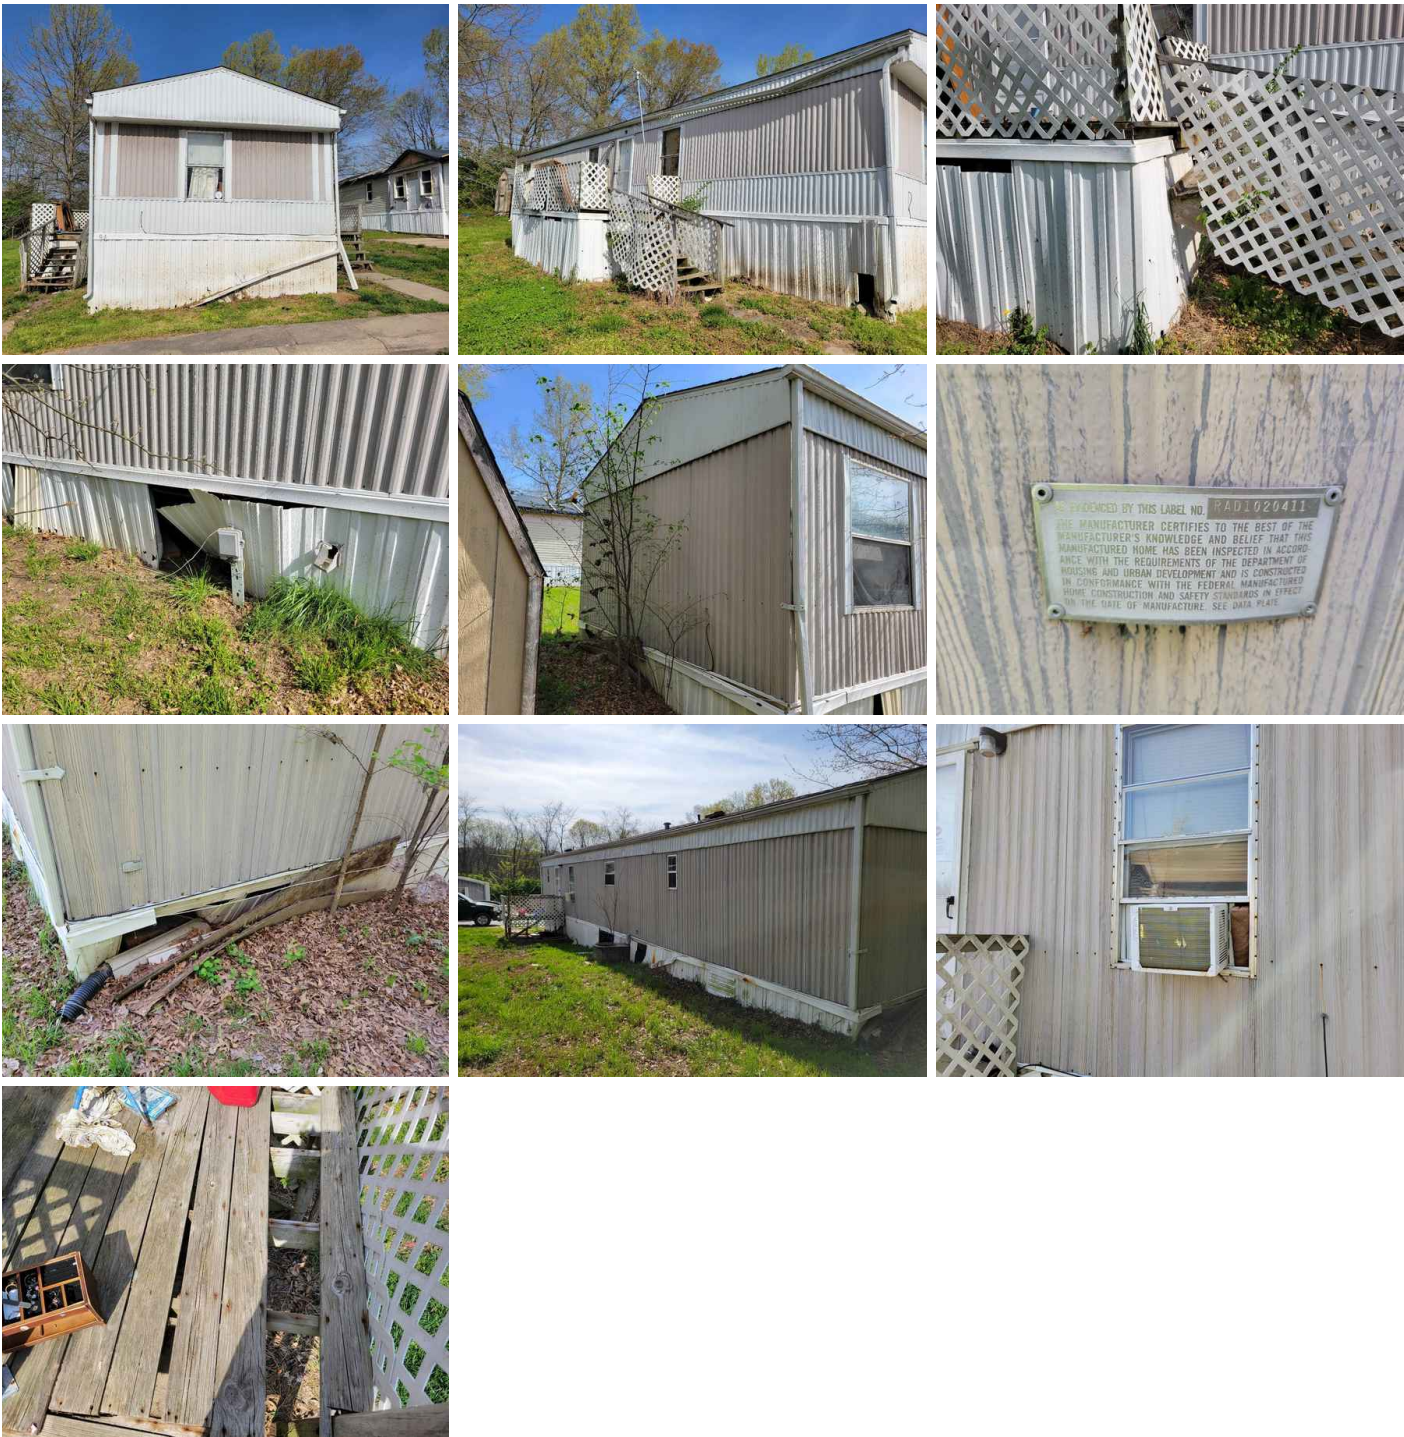
LOT 94, Occupied: Exterior Description

Poor Condition, Window Units, HUD Label Visible

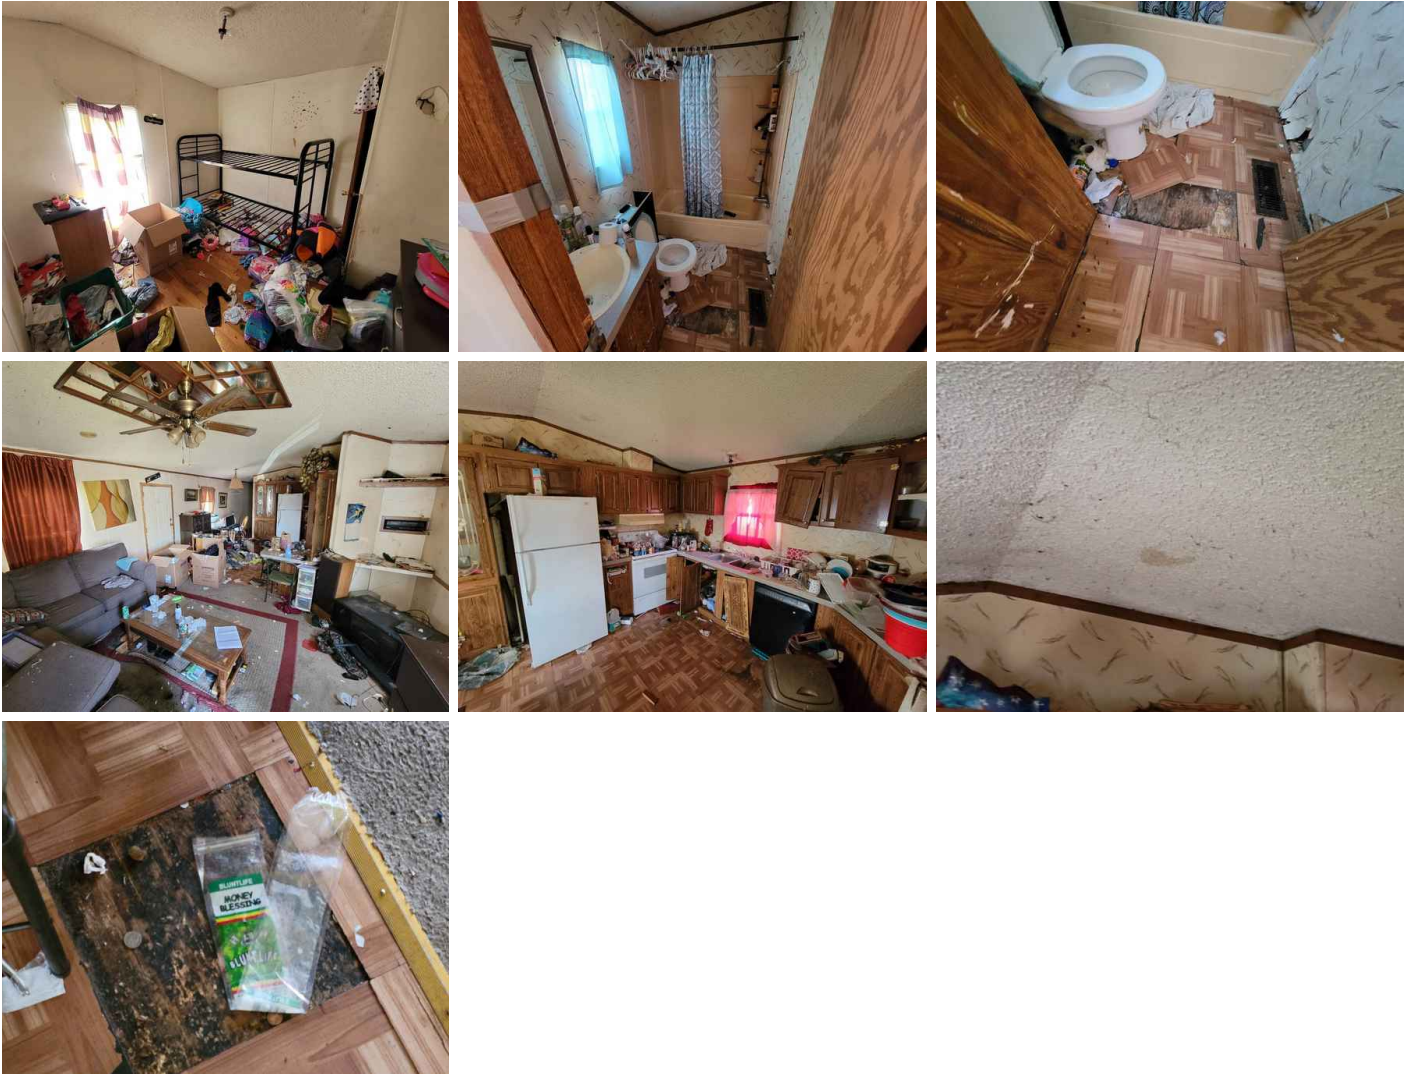
LOT 94, Occupied: Interior Description

Bad Condition, Smell/Odor

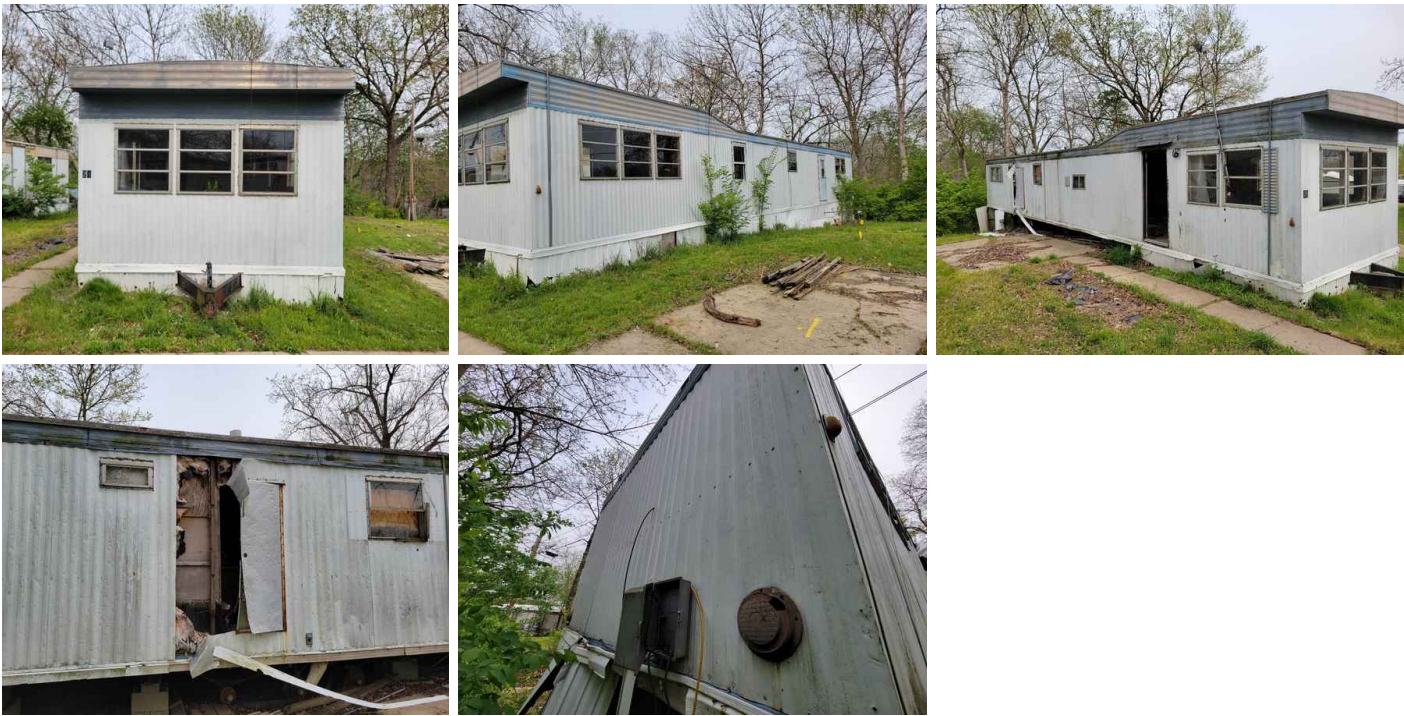
LOT 24, Vacant: Exterior Description
Poor Condition

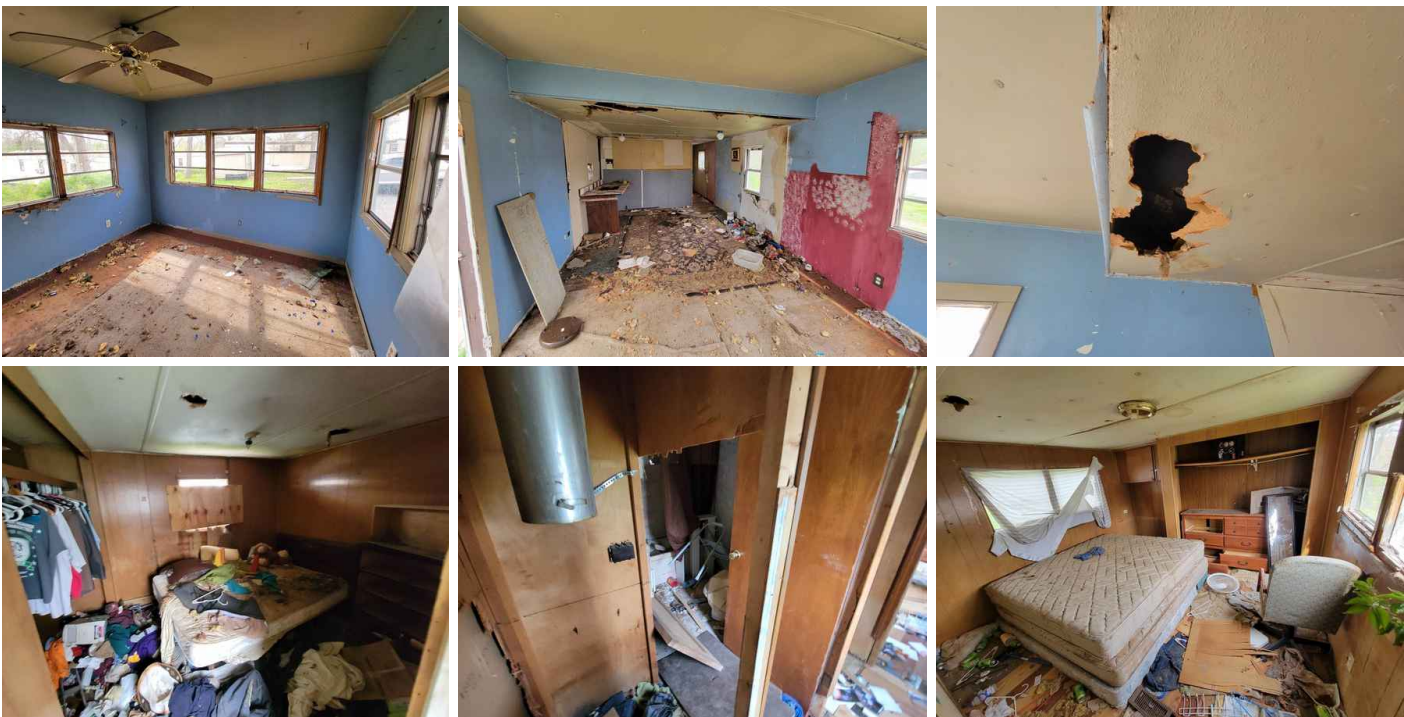
LOT 24, Vacant: Interior Description
Bad Condition, Smell/Odor

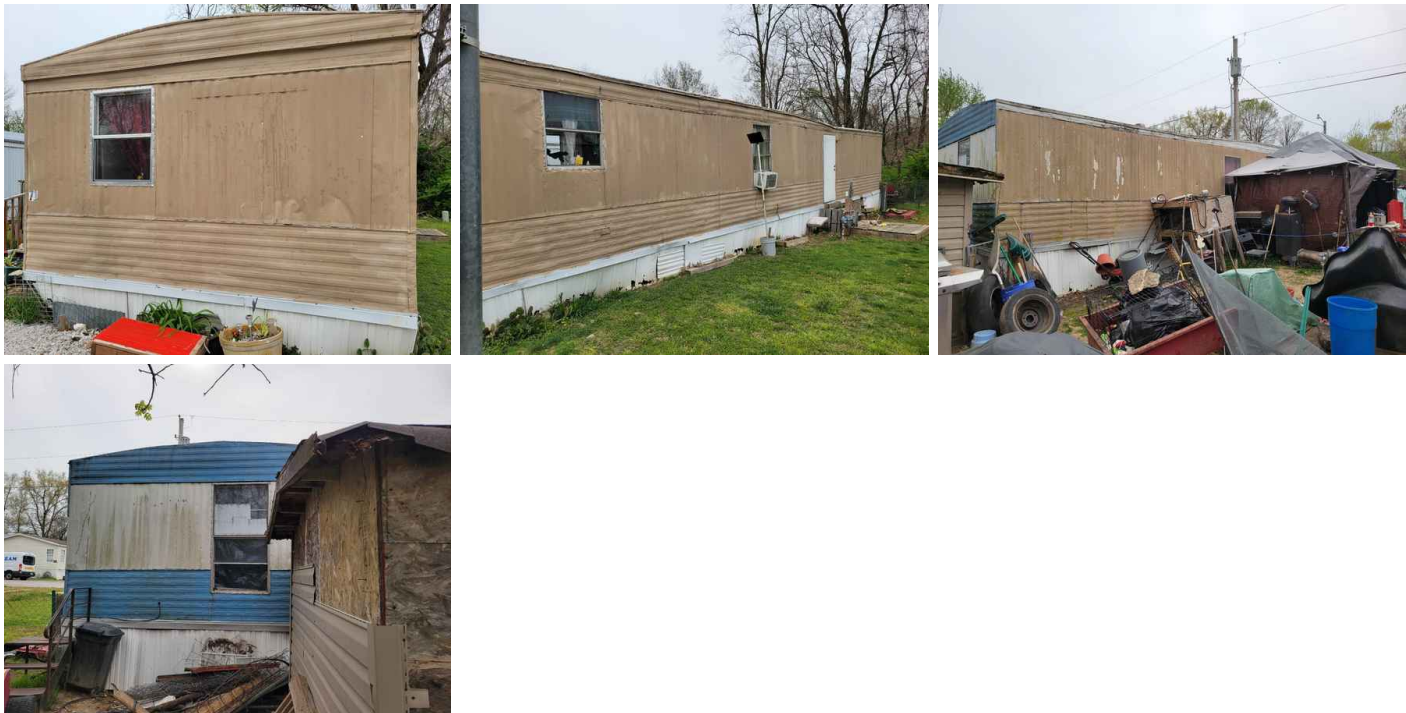
LOT 71, Occupied: Exterior Description
Poor Condition

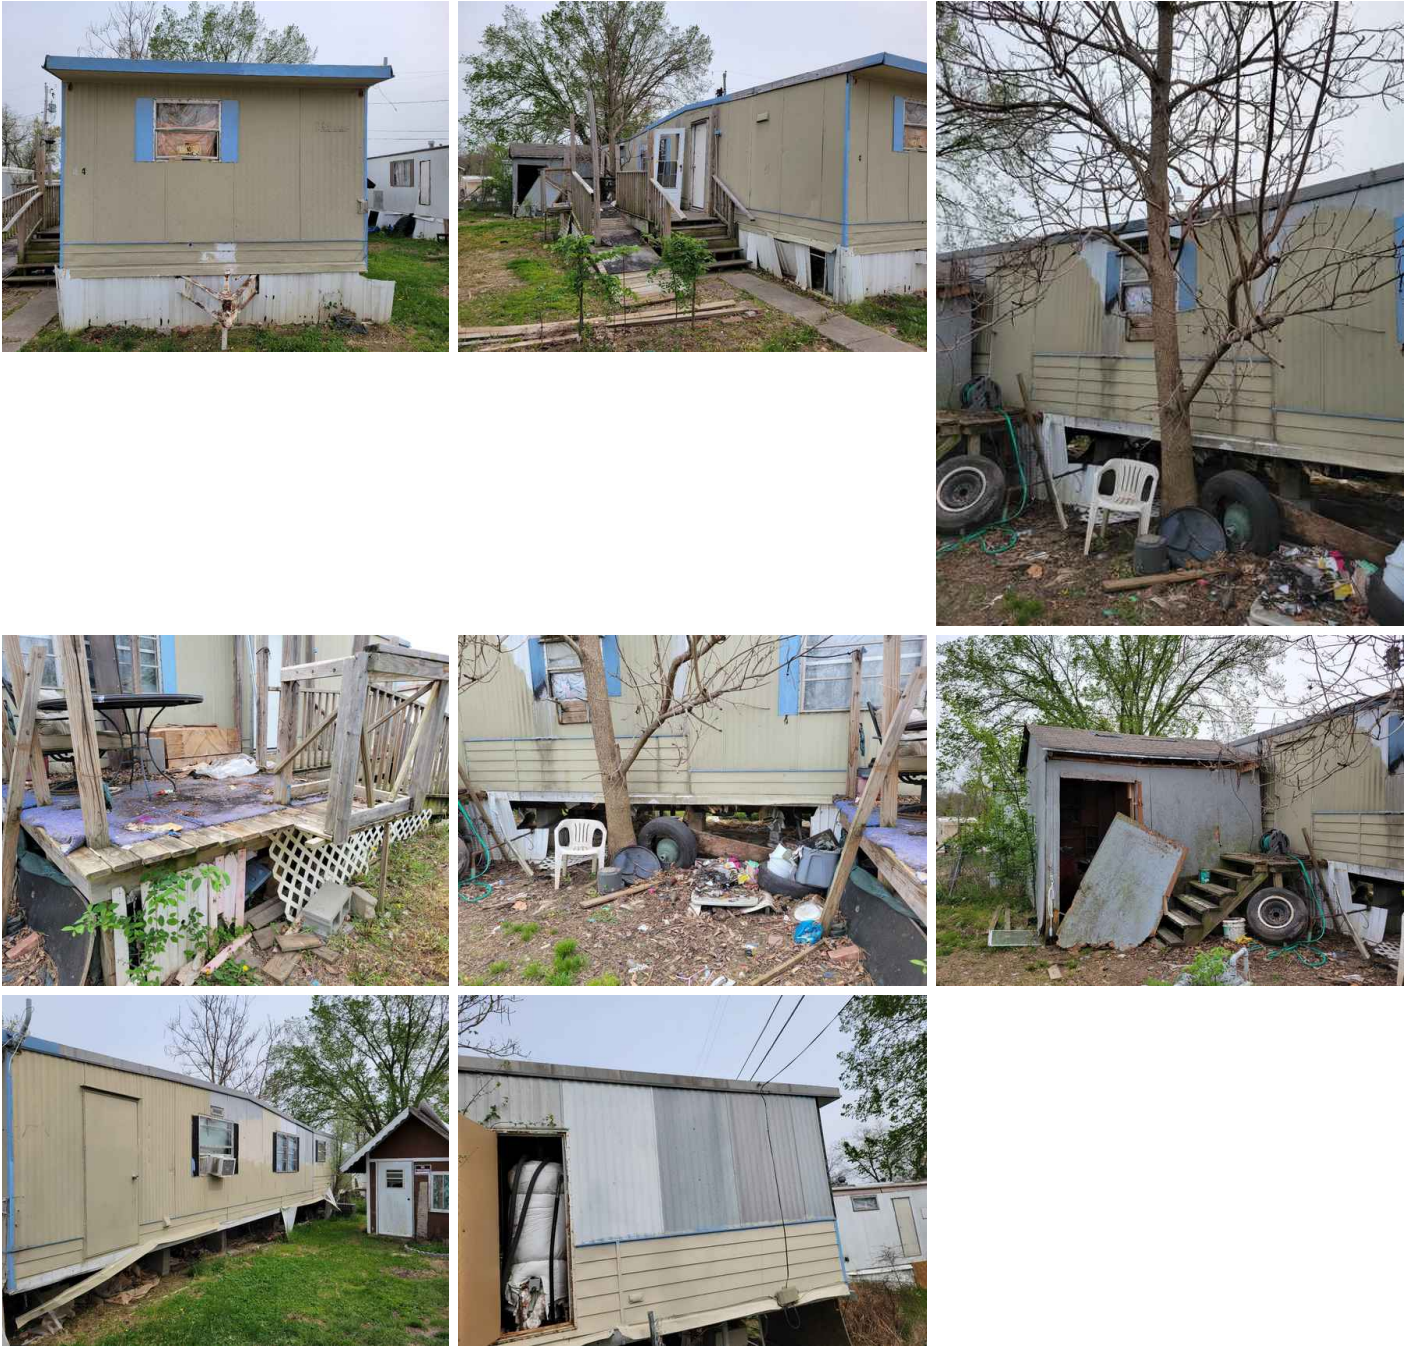
LOT 14, Vacant: Exterior Description

Poor Condition

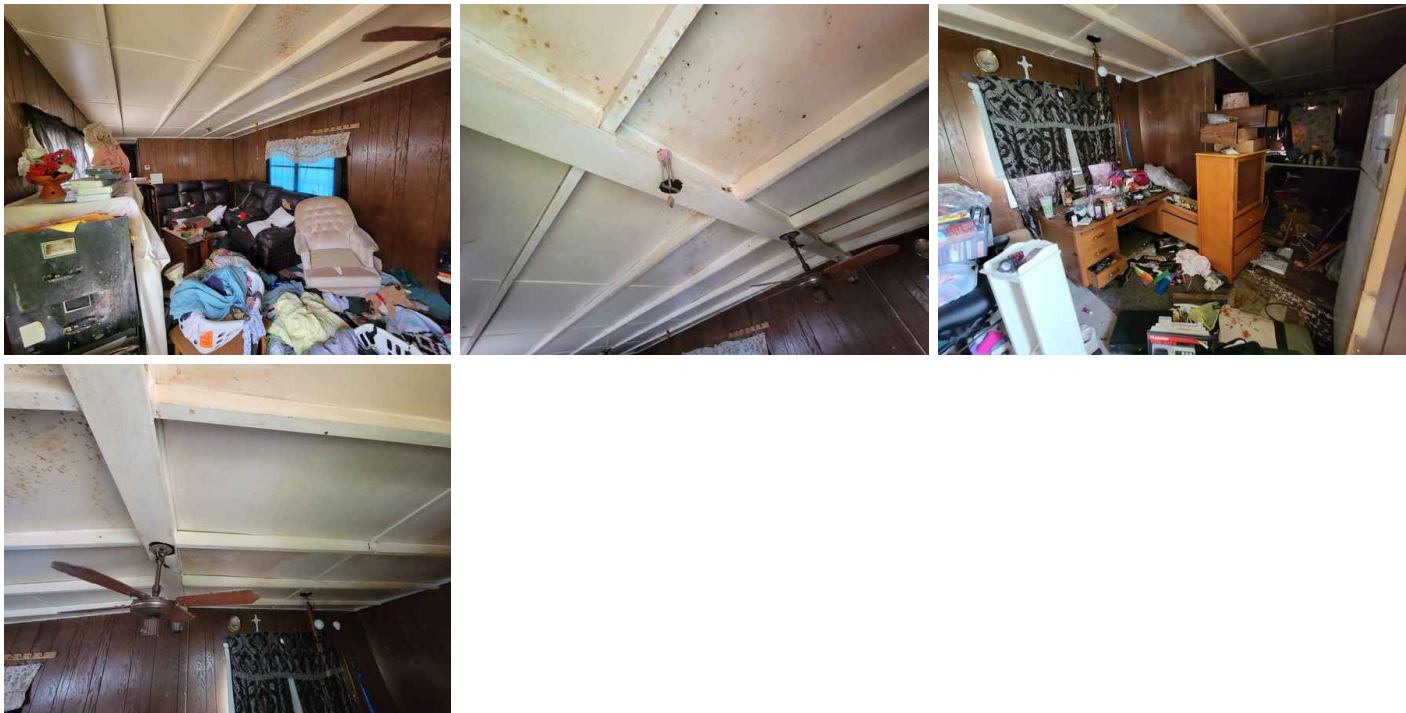
LOT 14, Vacant: Interior Description
Bad Condition, Smell/Odor, Hoarder

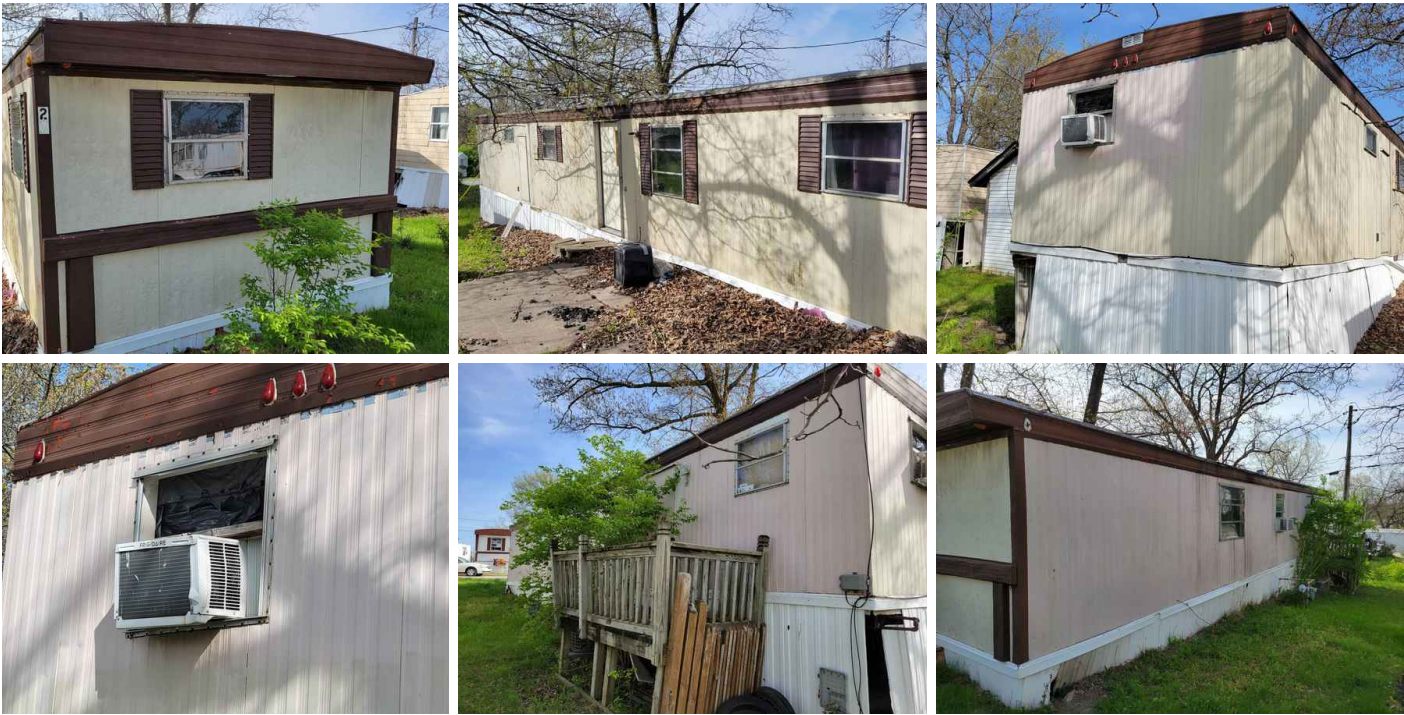
LOT 27, Vacant: Exterior Description

Poor Condition, Window Units

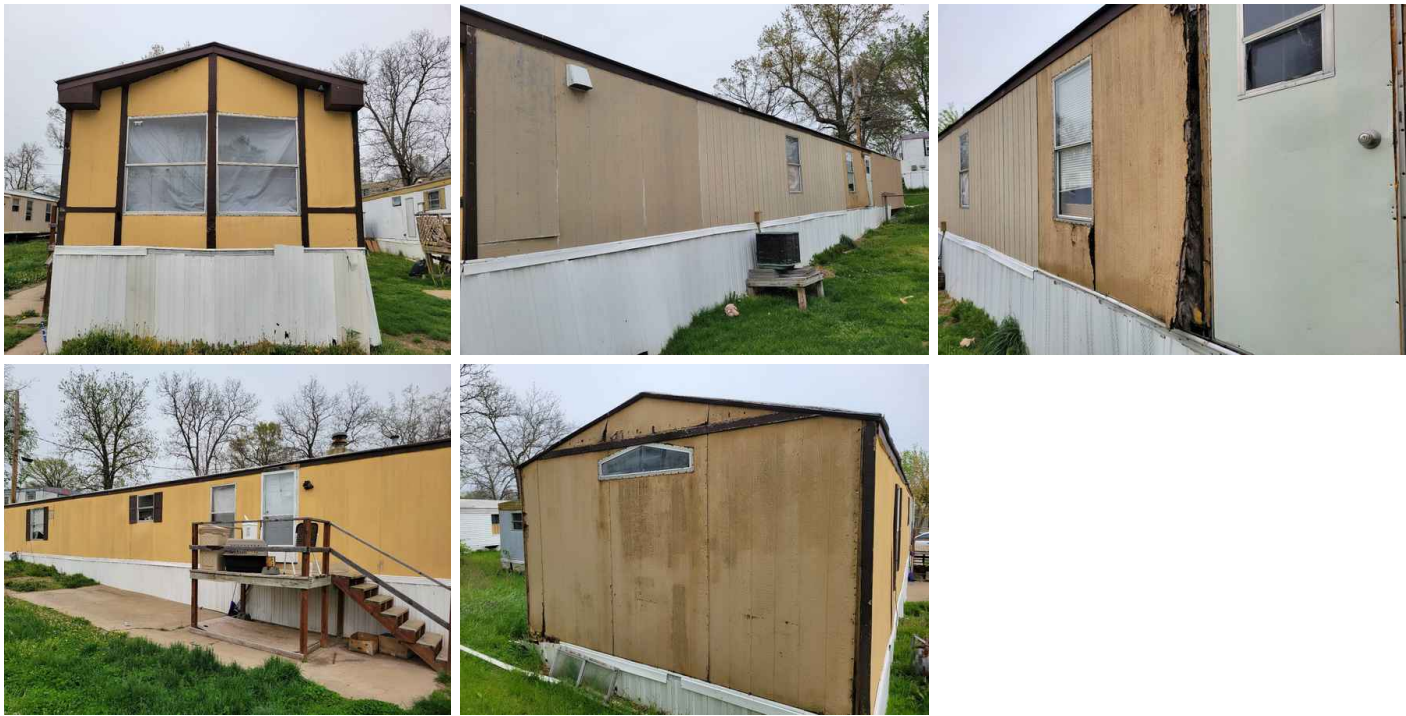
LOT 55, Occupied: Exterior Description
Poor Condition
