DDP RECON REPORT COPY

Sample Recon Report - 691 San Marcos St
Giddings, TX 78942

APRIL 29, 2021

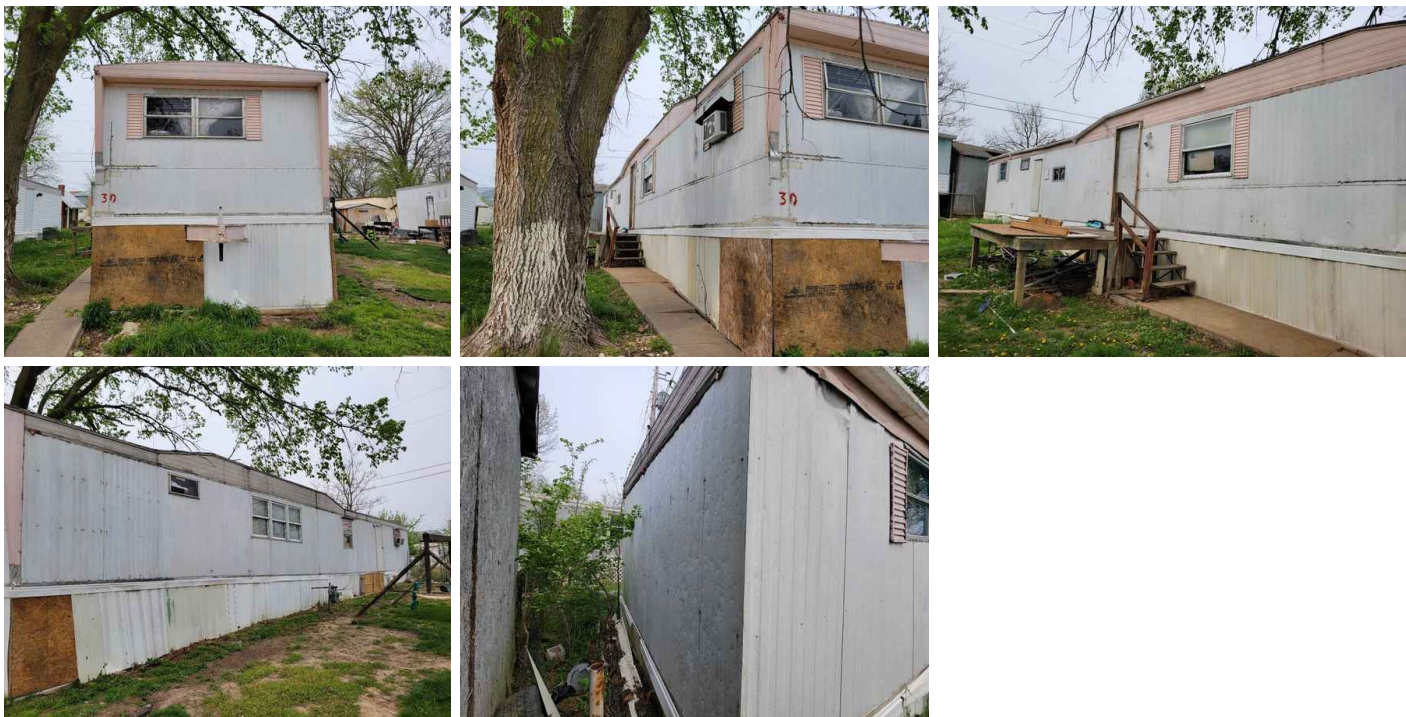
LOT 30, Occupied: Exterior Description
Poor Condition, Window Units

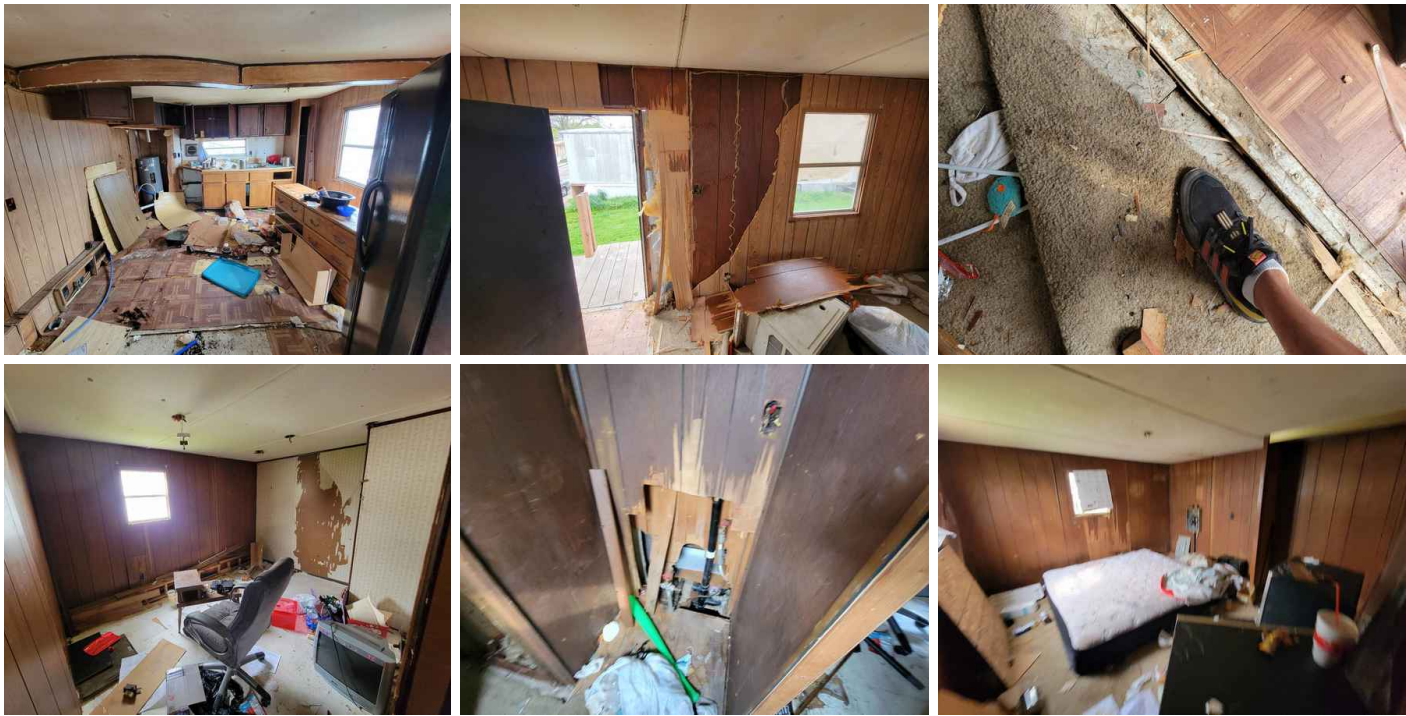
LOT 34, Vacant: Interior Description
Bad Condition, Smell/Odor

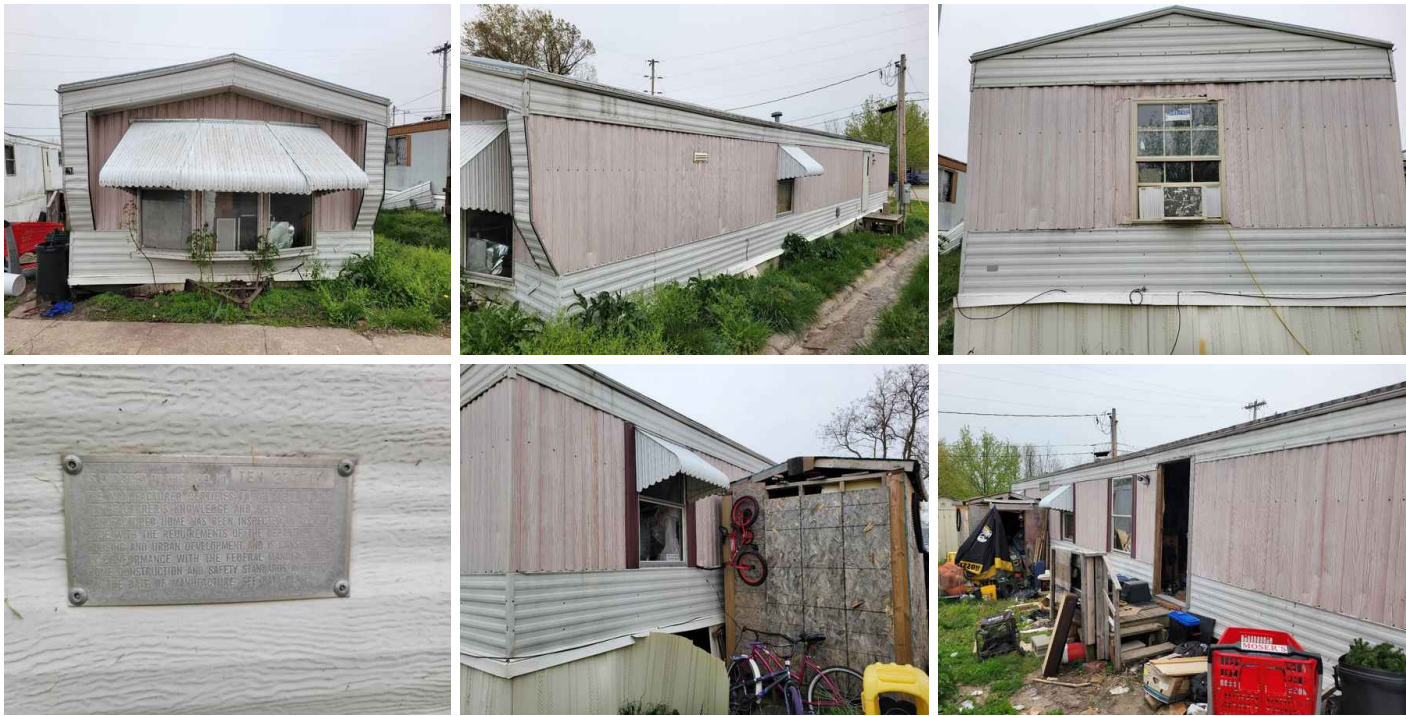
LOT 37, Vacant: Exterior Description

Poor Condition, HUD Label Visible

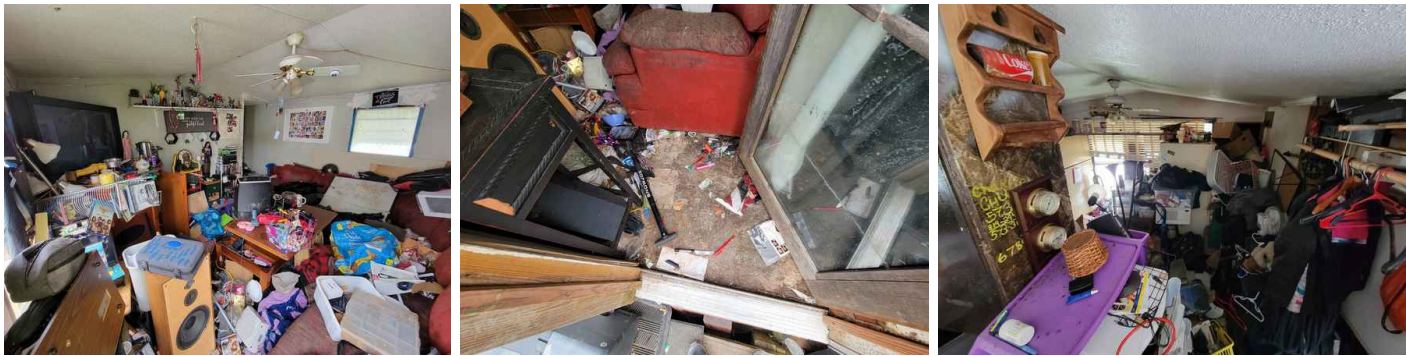
LOT 37, Vacant: Interior Description

Bad Condition, Smell/Odor, Hoarder

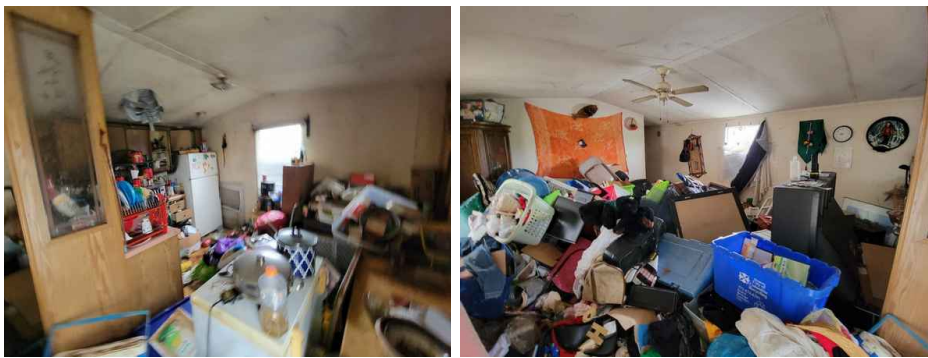
LOT 44, Vacant: Interior Description
Bad Condition, Smell/Odor, Hoarder

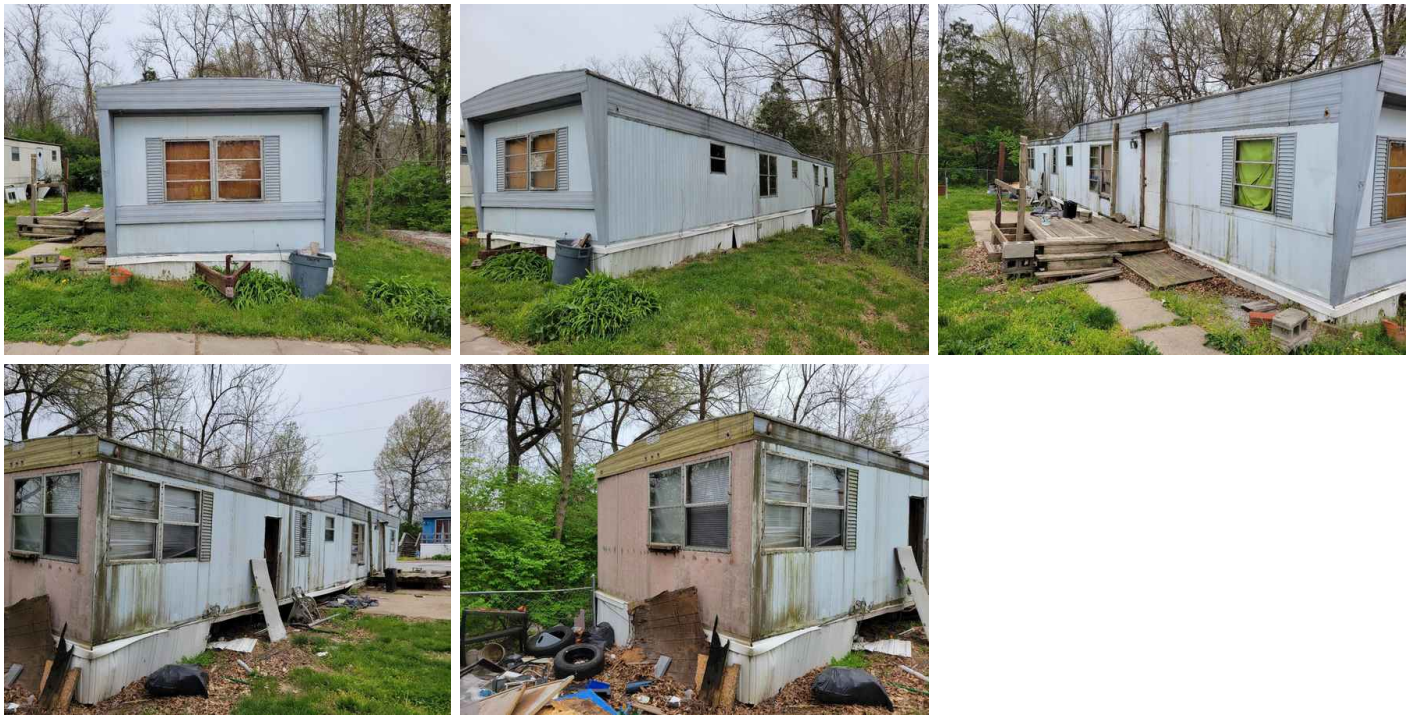
LOT 95, Vacant: Exterior Description
Poor Condition

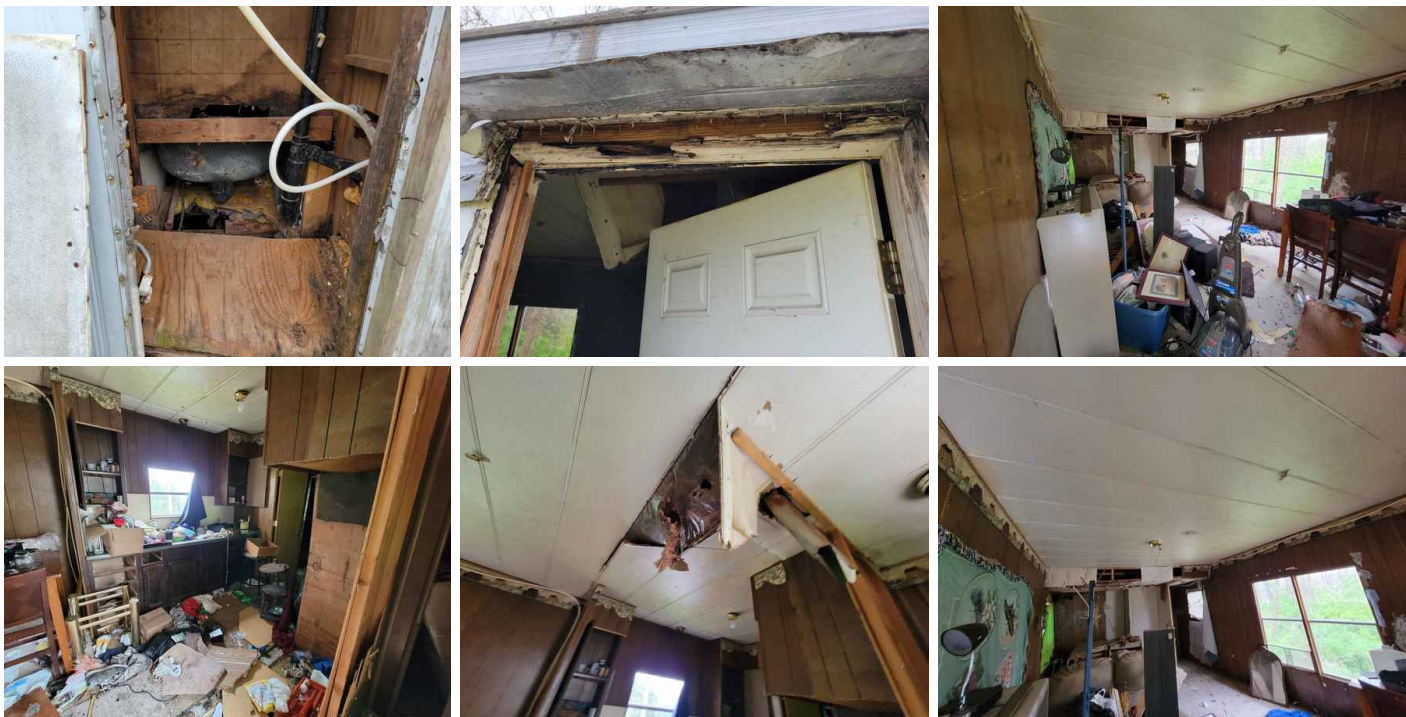
LOT 95, Vacant: Interior Description
Bad Condition, Smell/Odor

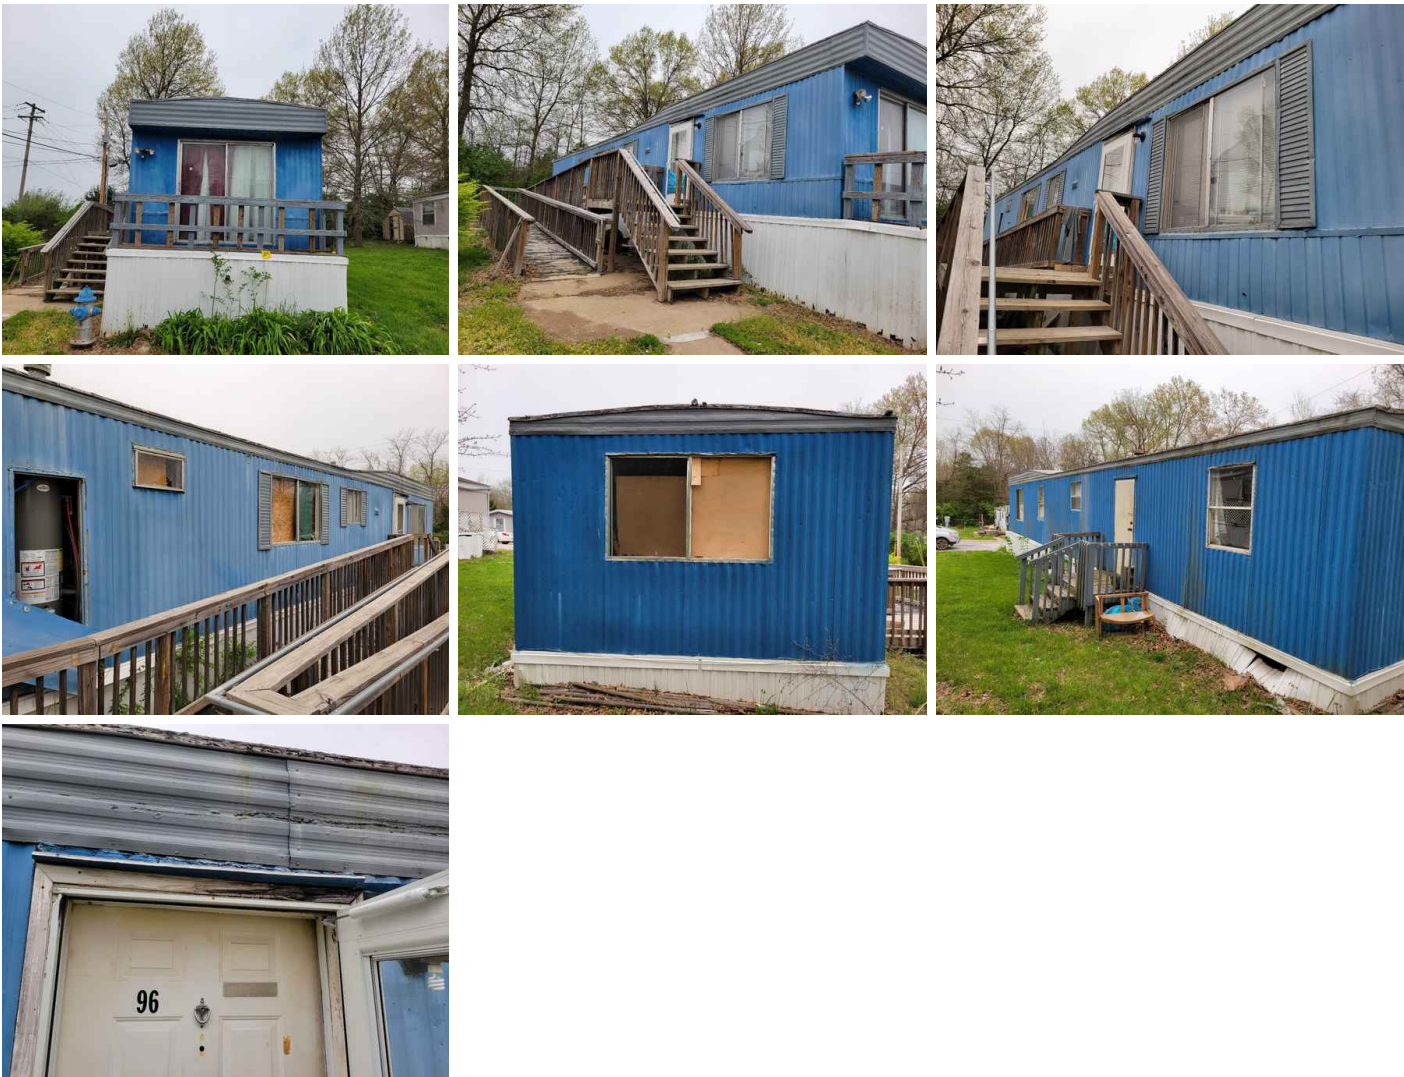
LOT 96, Vacant: Exterior Description

Poor Condition

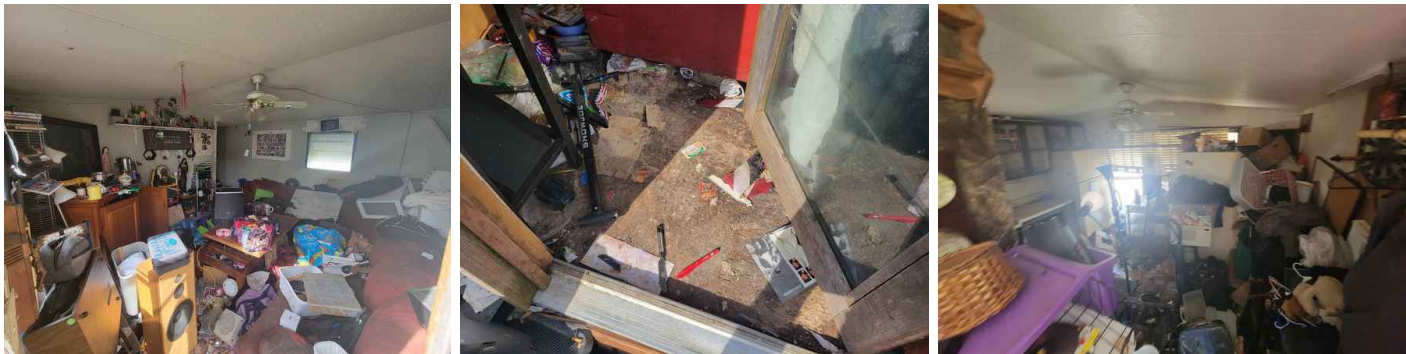
LOT 39, Vacant: Interior Description
Bad Condition, Smell/Odor, Hoarder

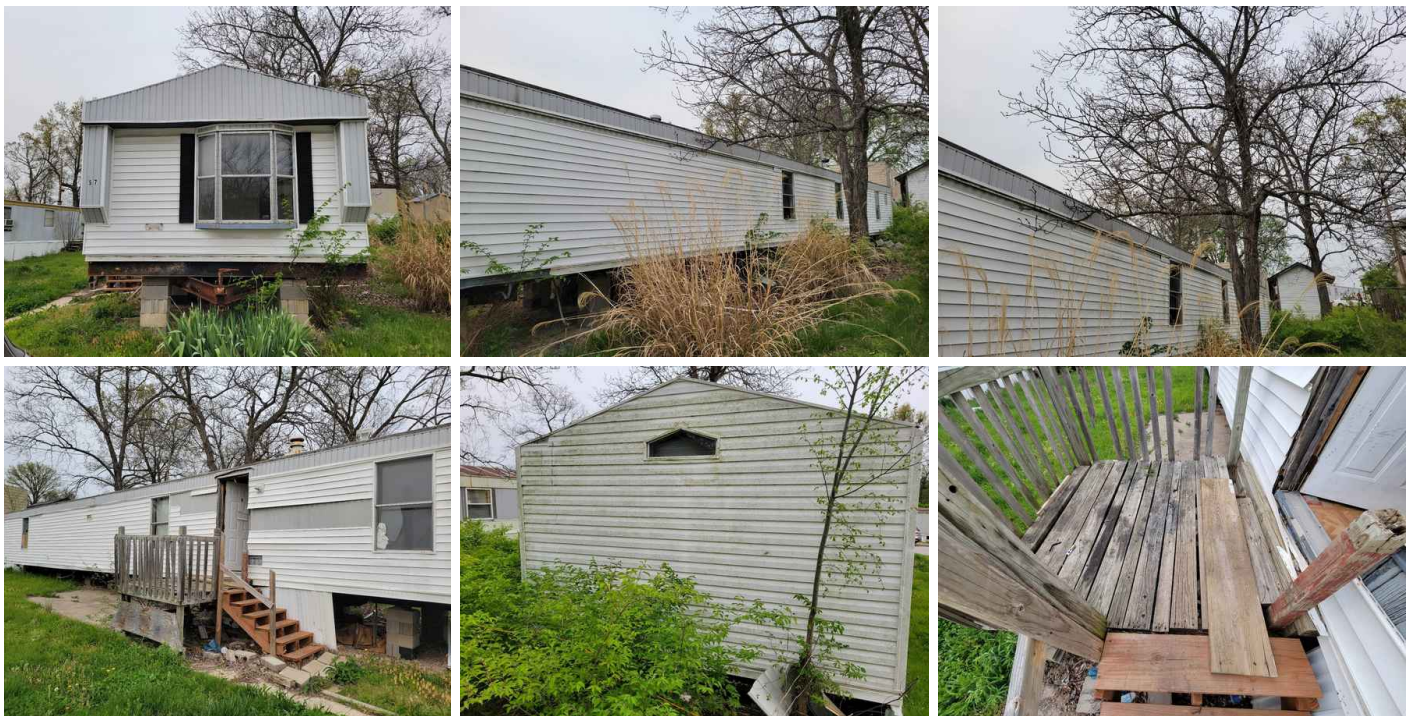
LOT 57, Vacant: Exterior Description
Poor Condition

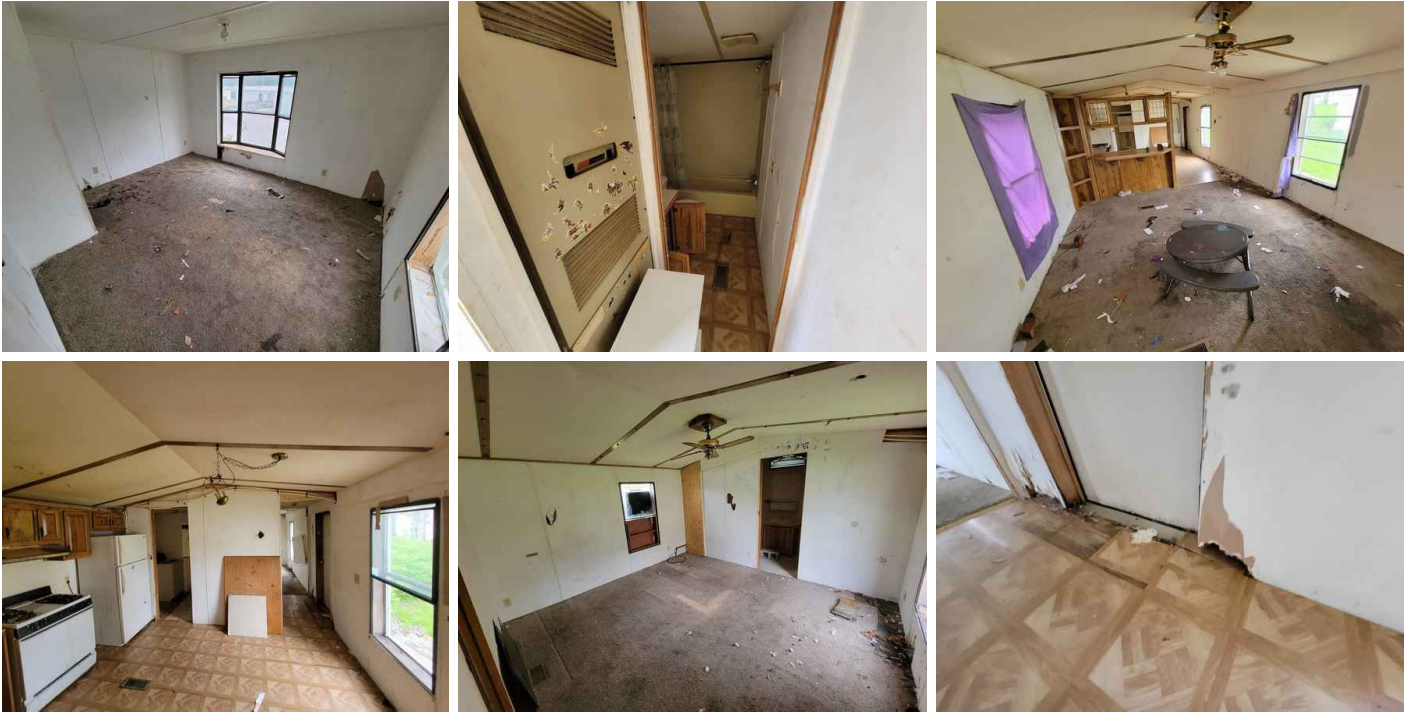
LOT 57, Vacant: Interior Description

Bad Condition, Smell/Odor

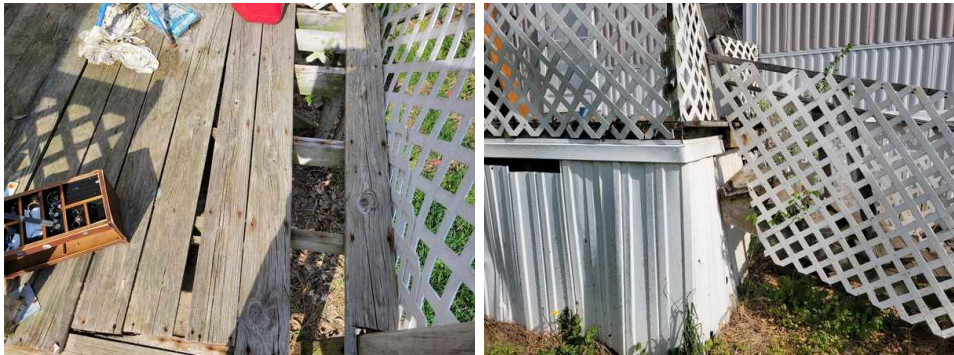
10.6.5 LOT 94, Occupied

EXT: BROKEN DOOR/WINDOW/DECK

A broken window, door, or deck was observed. Average replacement cost:

- Door: \$478-956
- Window: \$175-\$650
- Decks: \$15-\$30 p/sq/ft: 10 x 10: \$1,500 - \$3,000

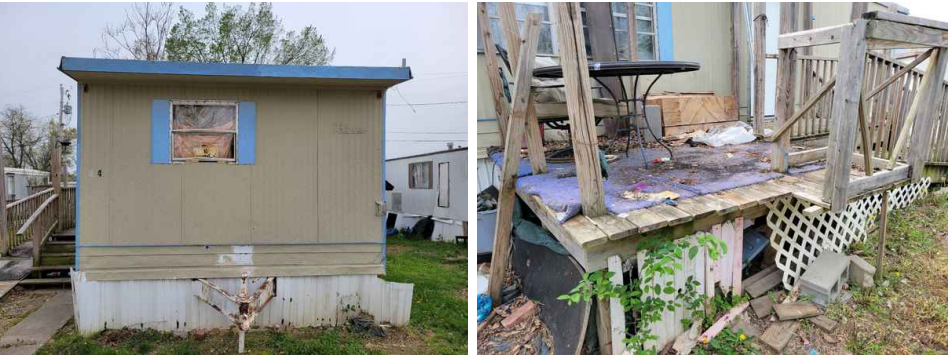
10.9.4 LOT 14, Vacant

EXT: BROKEN DOOR/WINDOW/DECK

A broken window, door, or deck was observed. Average replacement cost:

- Door: \$478-956
- Window: \$175-\$650
- Decks: \$15-\$30 p/sq/ft: 10 x 10: \$1,500 - \$3,000

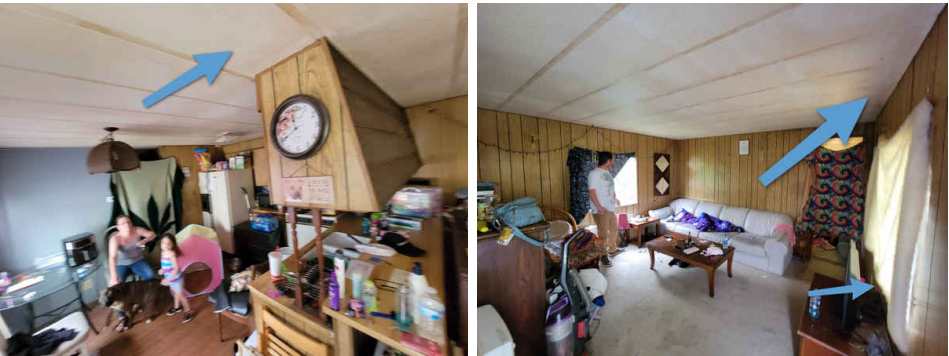
10.12.1 LOT 62, Occupied

INT/EXT: LEAK OR MOLD

Leak or mold was observed. Seek a qualified vendor to determine severity and estimate.

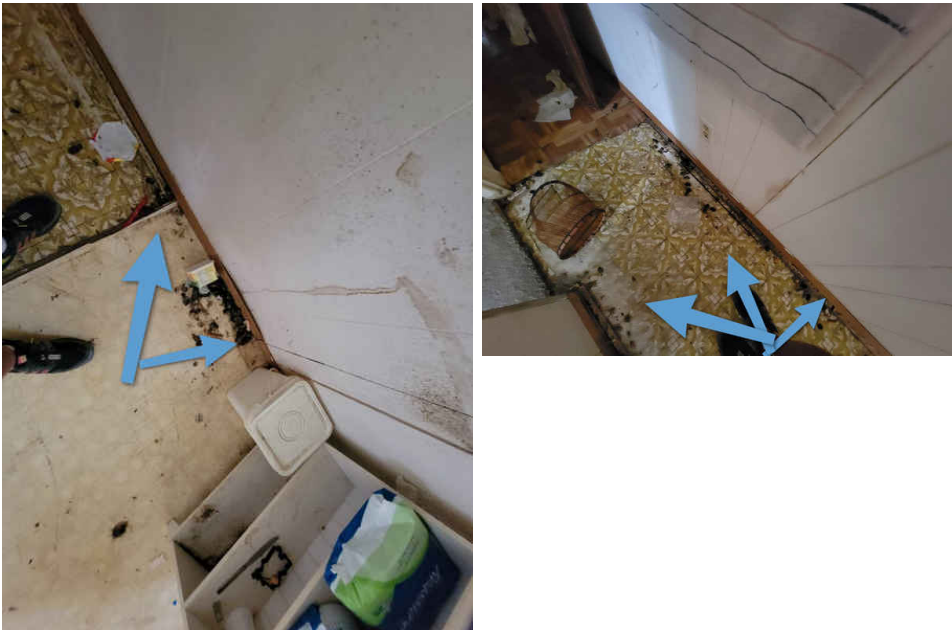
10.22.2 LOT 96, Vacant

INT: FLOORING PROBLEM

- soft spot (y/n):
- missing flooring (y/n):
- deteriorated (y/n):

Estimated Cost
\$7 - \$15

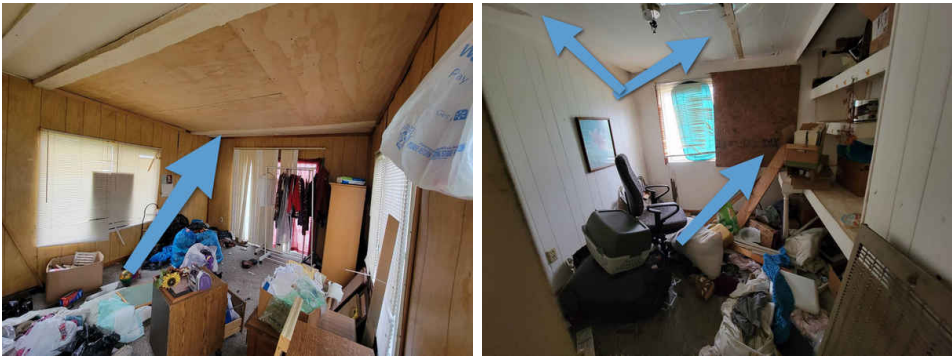
10.22.3 LOT 96, Vacant

INT: WALL OR CEILING

Wall or ceiling problem was observed. Seek qualified rehabber for estimate.

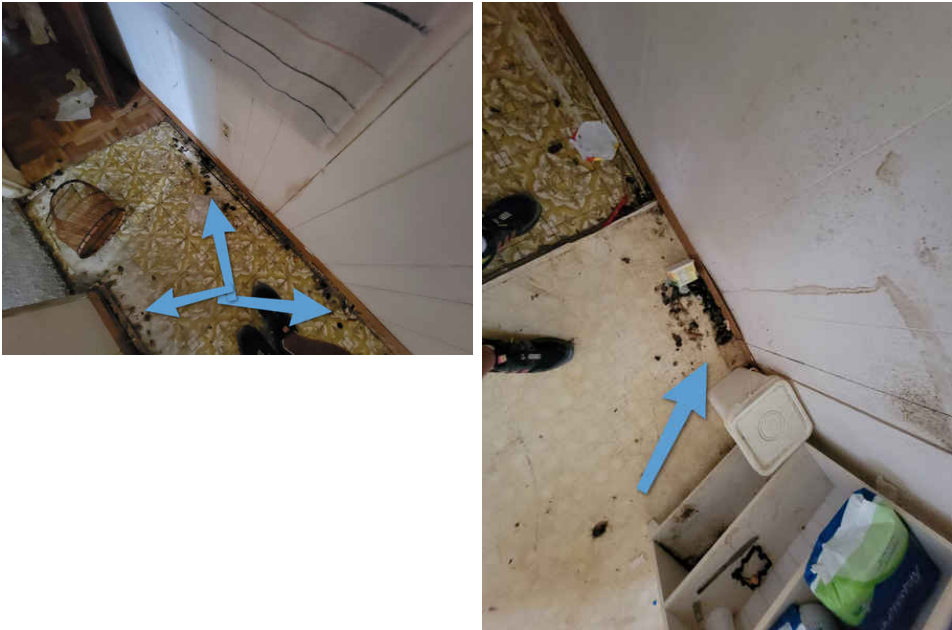
10.22.4 LOT 96, Vacant

INT: ANIMAL ALERT

Animal noticed. Note, approval per lot is unknown. Pictures are taken (if possible) of animal because animal may not be approved and/or causing damage. It will be noted if there appears to be a 'service animal' epidemic.

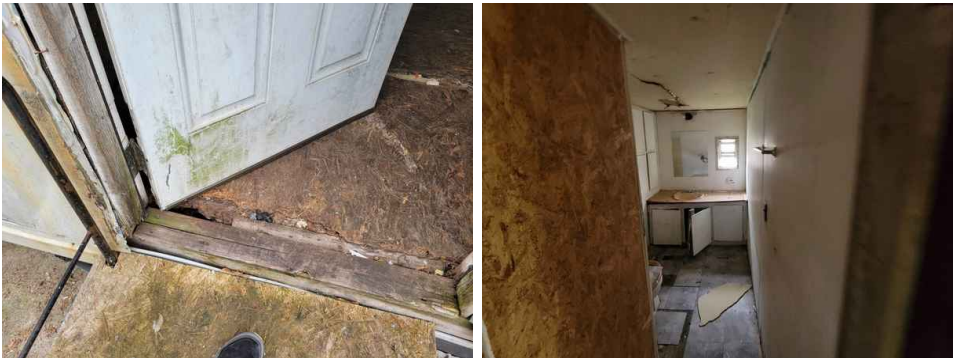
10.25.2 LOT 64, Vacant

Flooring problem was observed. See 'Standards of Practice' for industry average details (per square foot).

Estimated Cost
\$7 - \$15

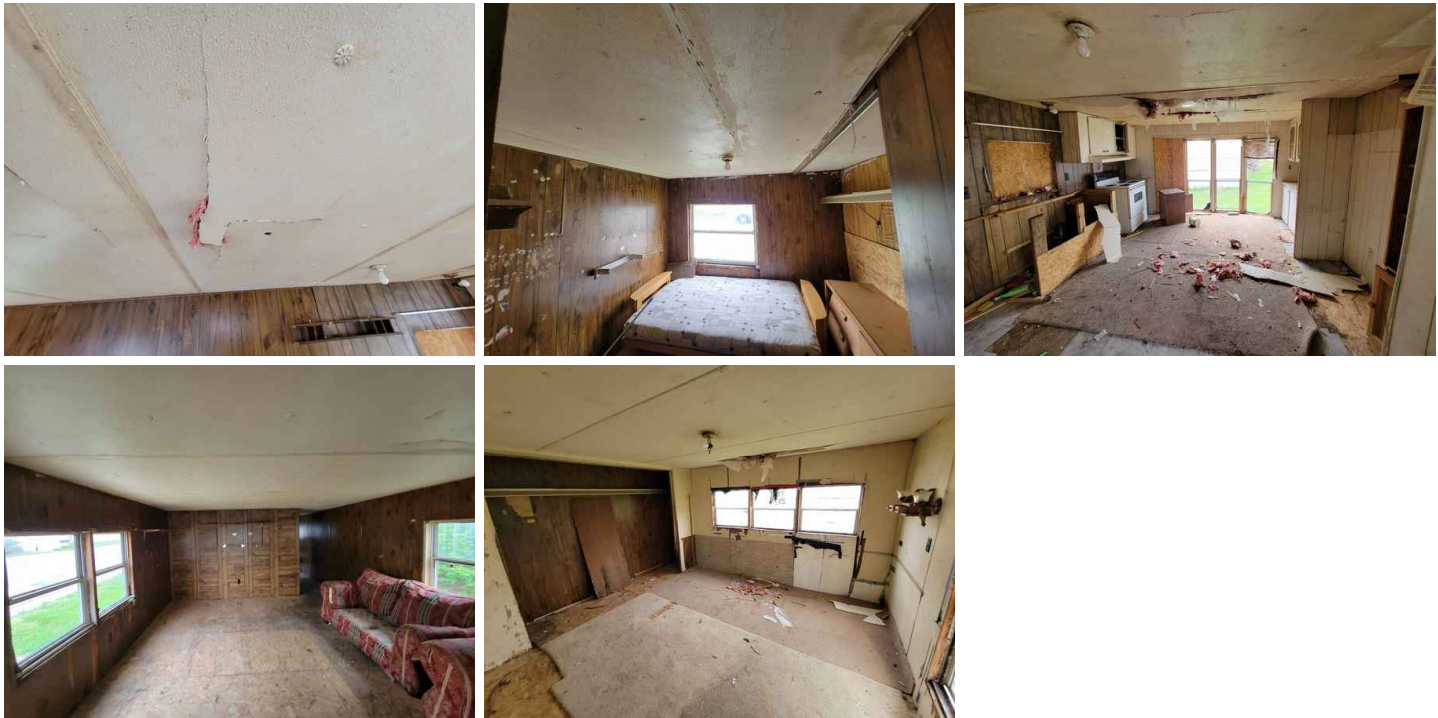
10.25.3 LOT 64, Vacant

INT: WALL OR CEILING

Wall or ceiling problem was observed. Seek qualified rehabber for estimate.

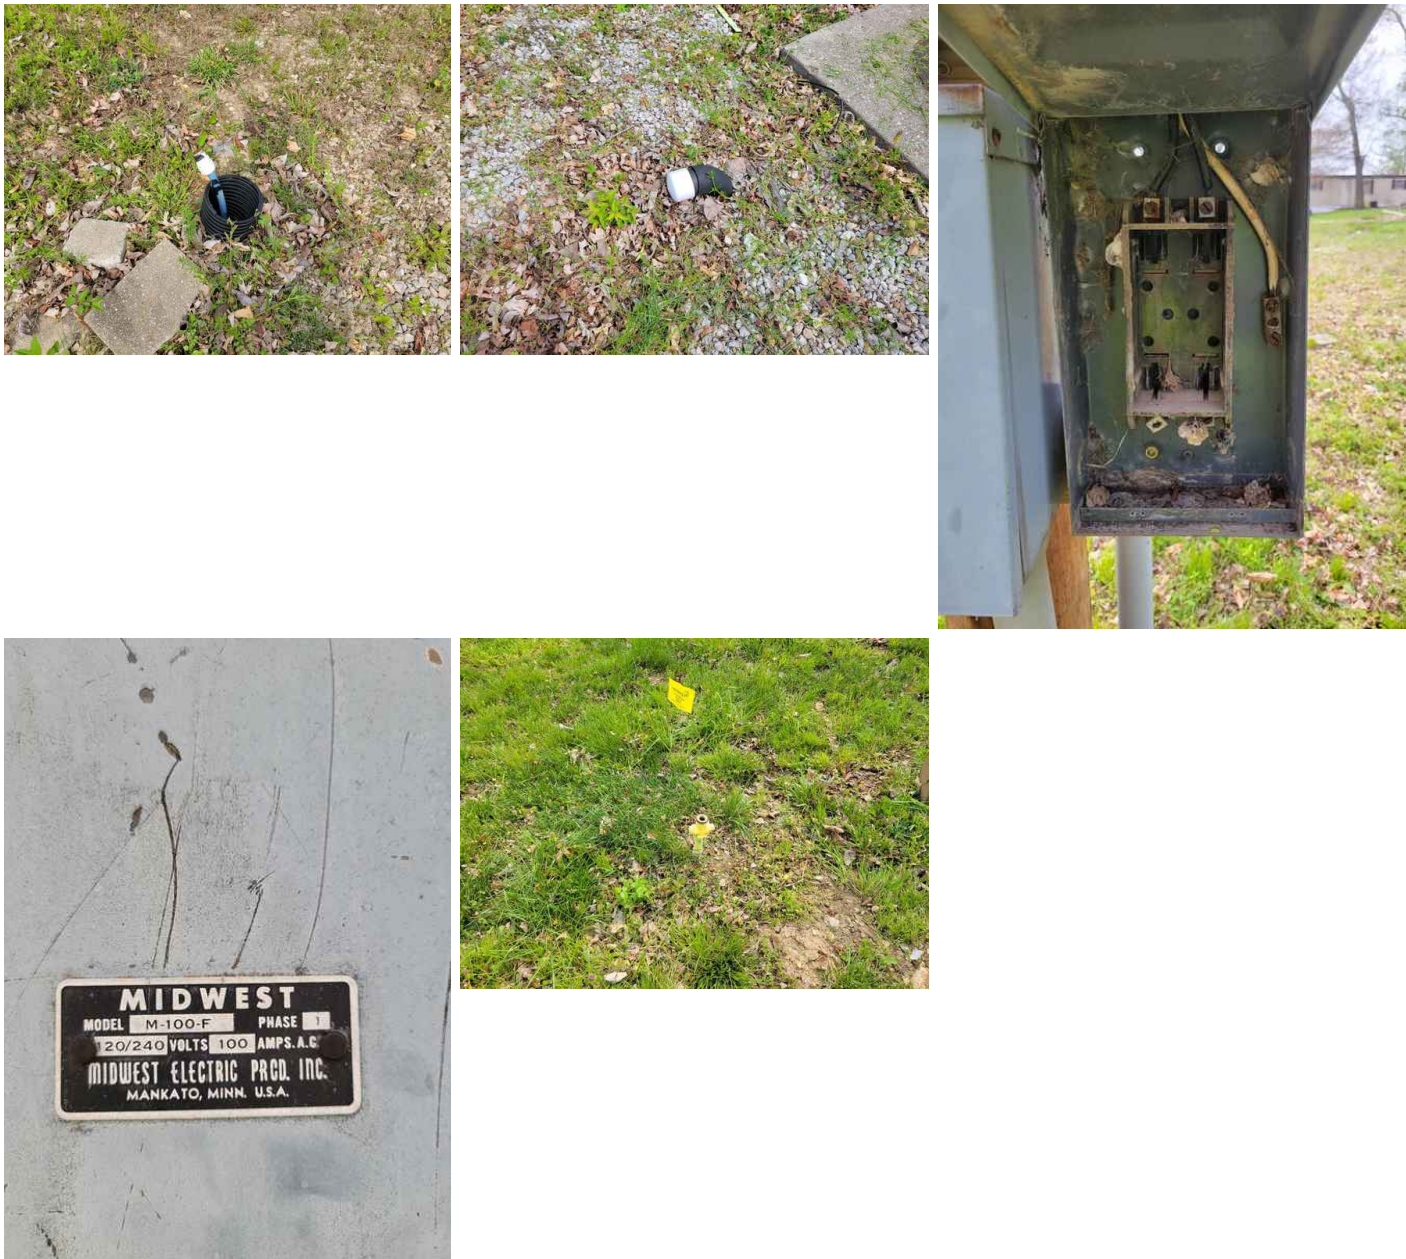
Lot # 25: Connections Found
Water: Good, Sewer: Good, Electric: 50 ~ 150, Electric: Bad, Gas Connection

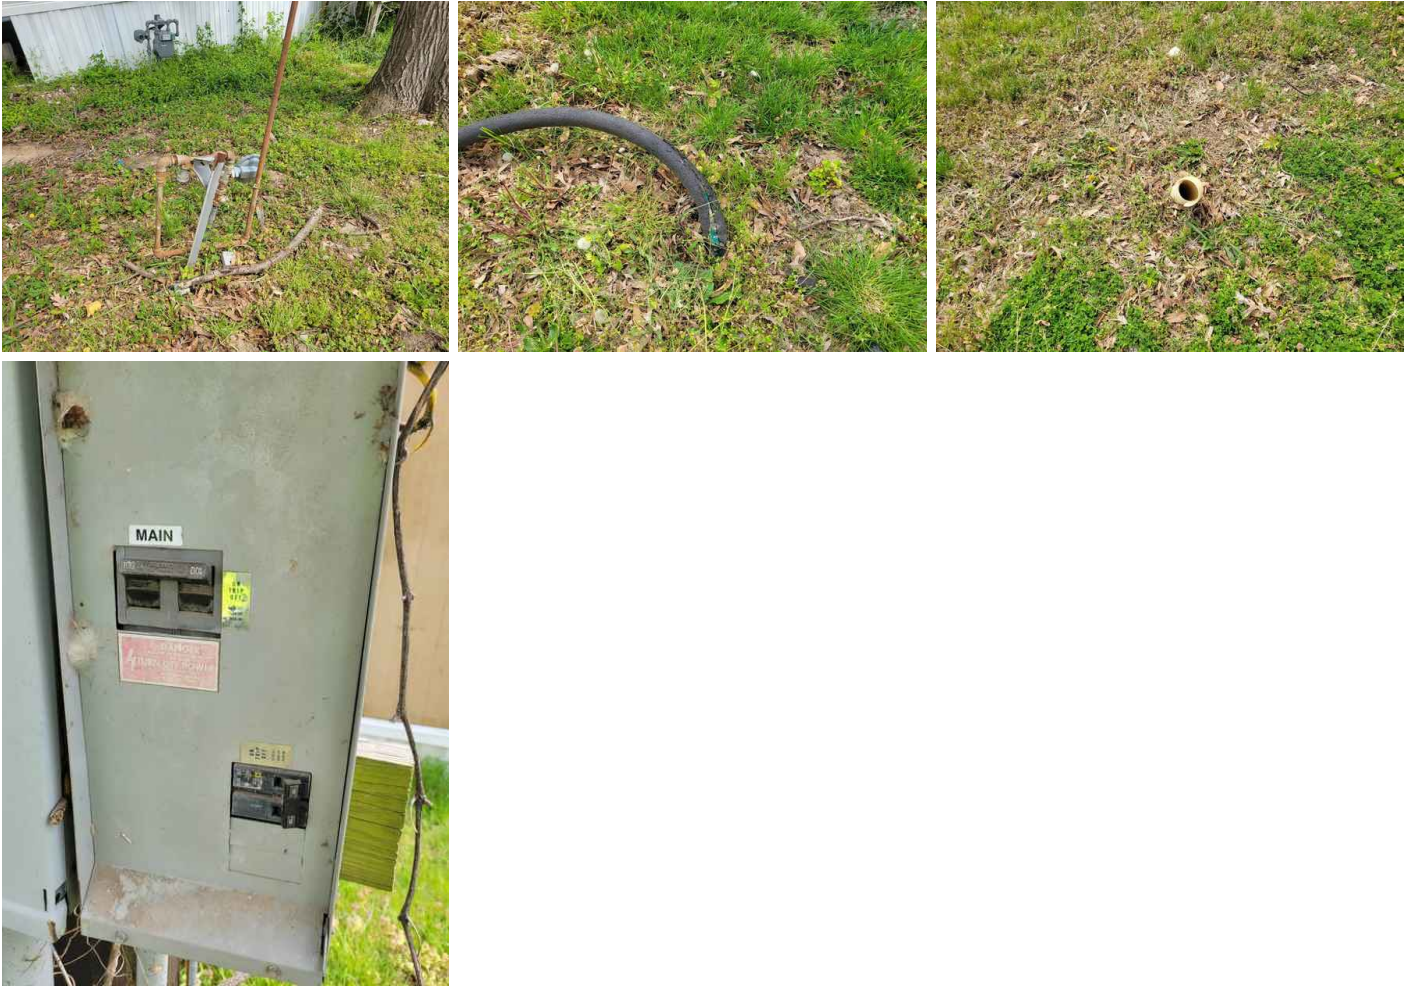
Lot # 33: Connections Found
Water: Good, Sewer: Good, Electric: 50 ~ 150, Gas Connection

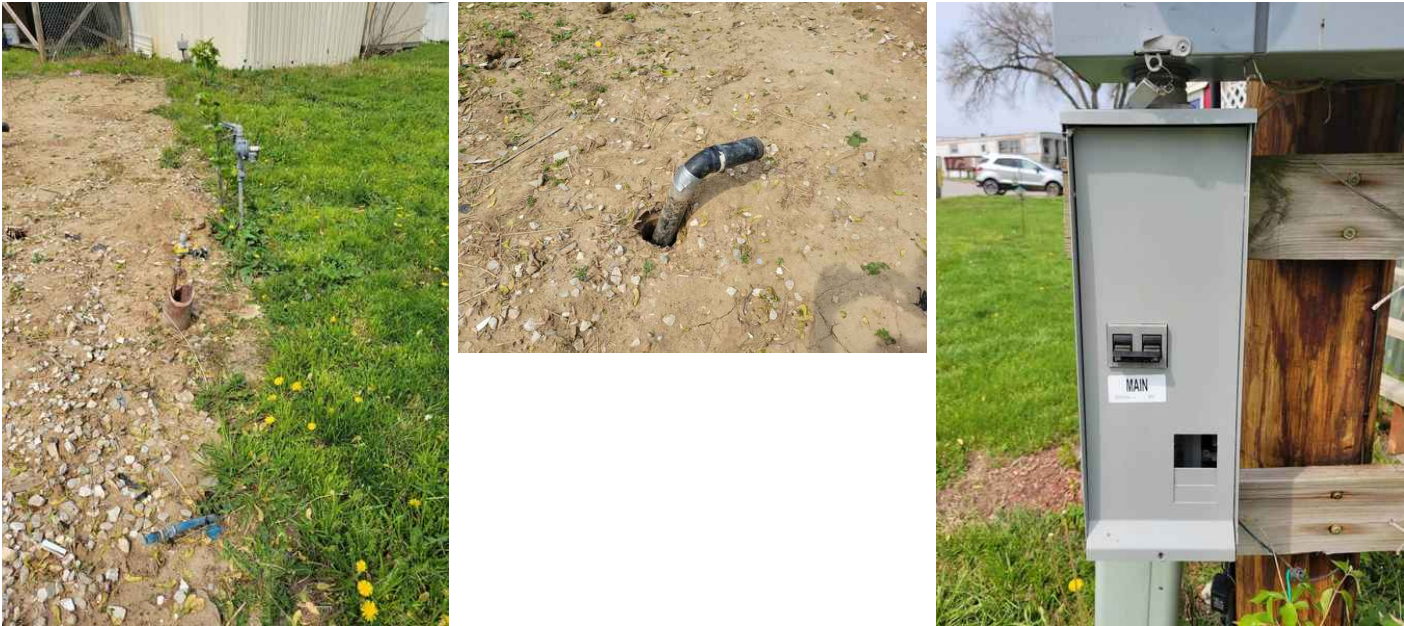
Lot # 42: Connections Found
Water: Good, Sewer: Bad, Electric: 200 amp
