DDP RECON REPORT COPY

Sample Recon Report - 691 San Marcos St
Giddings, TX 78942

APRIL 29, 2021

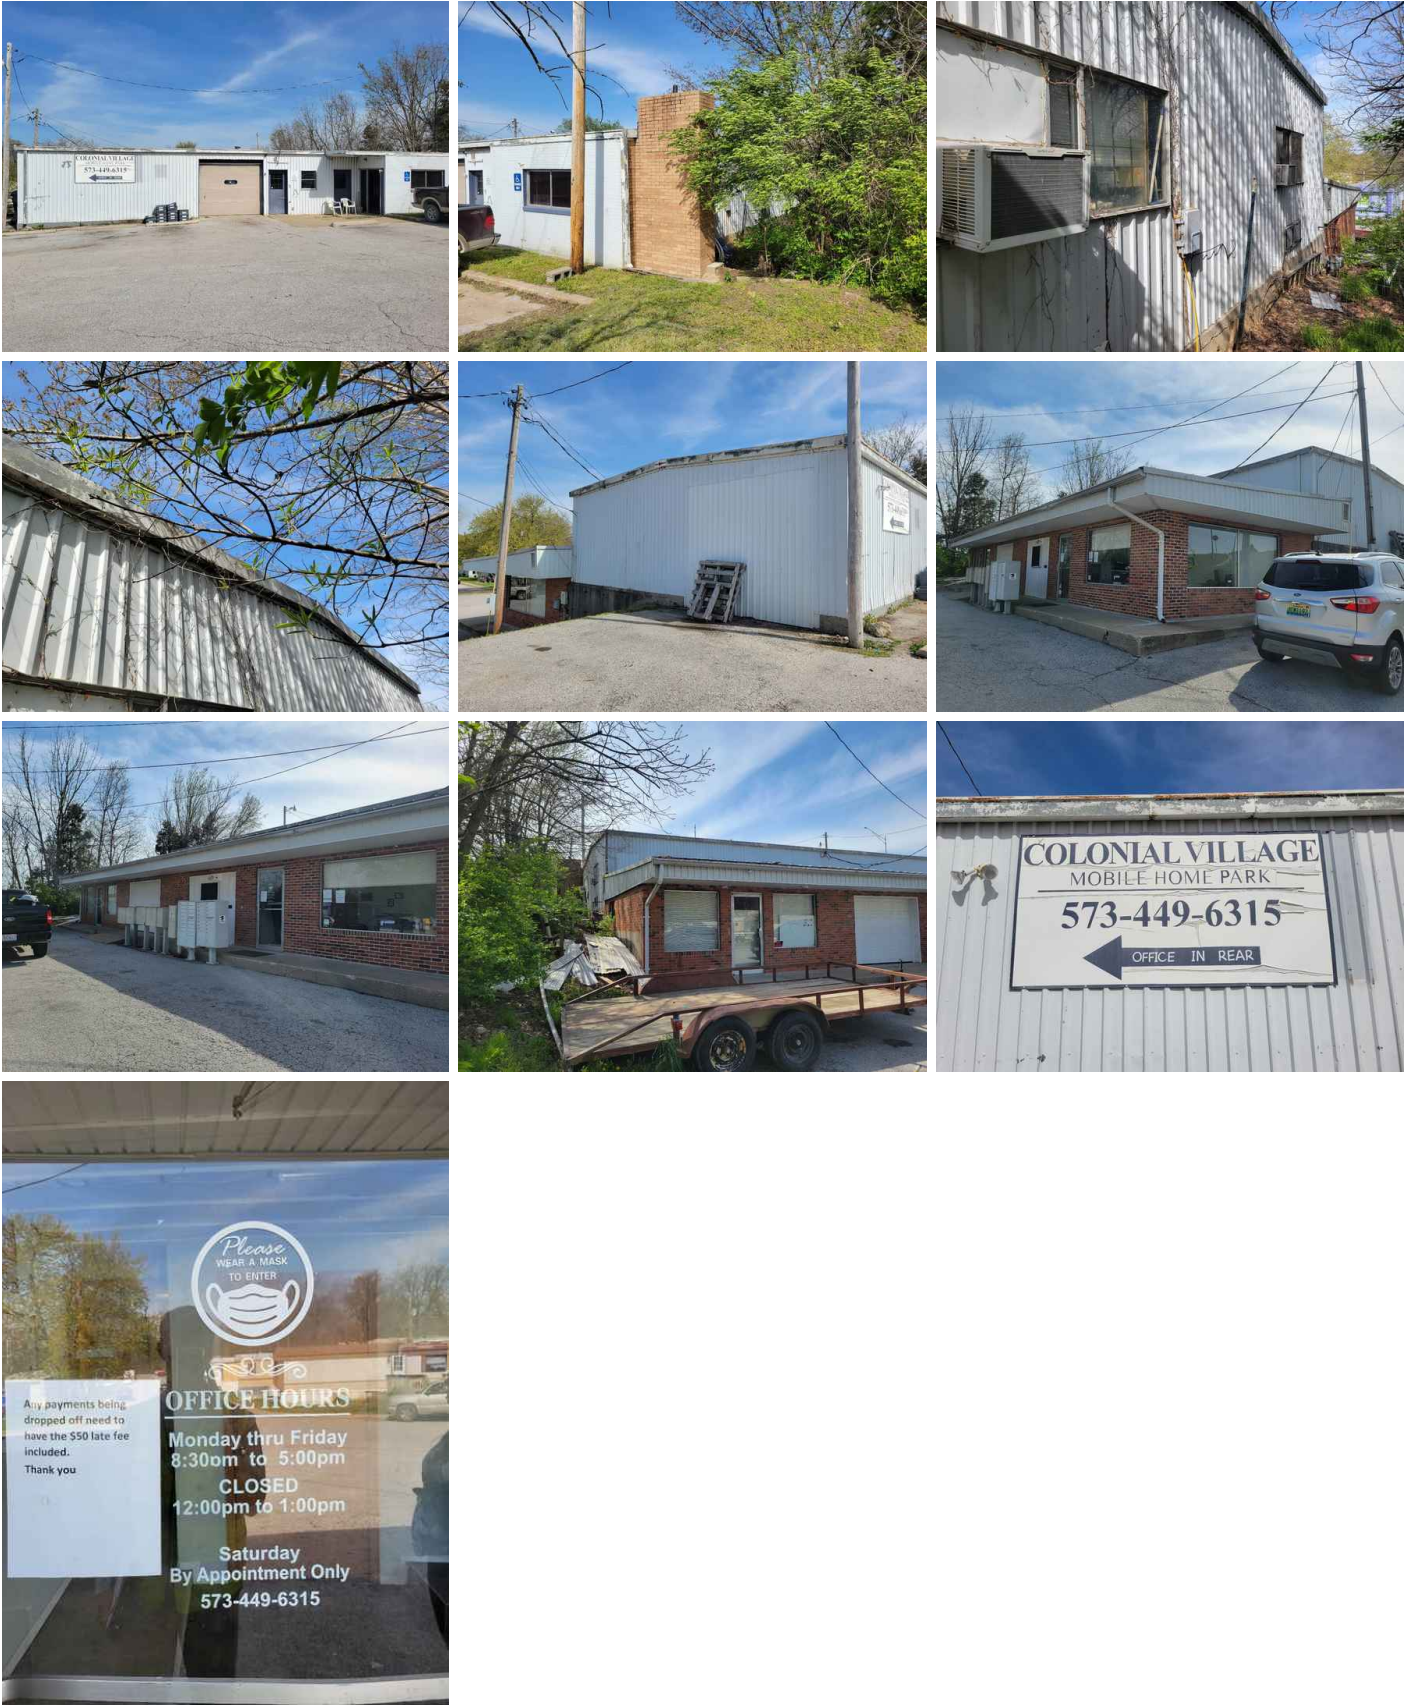
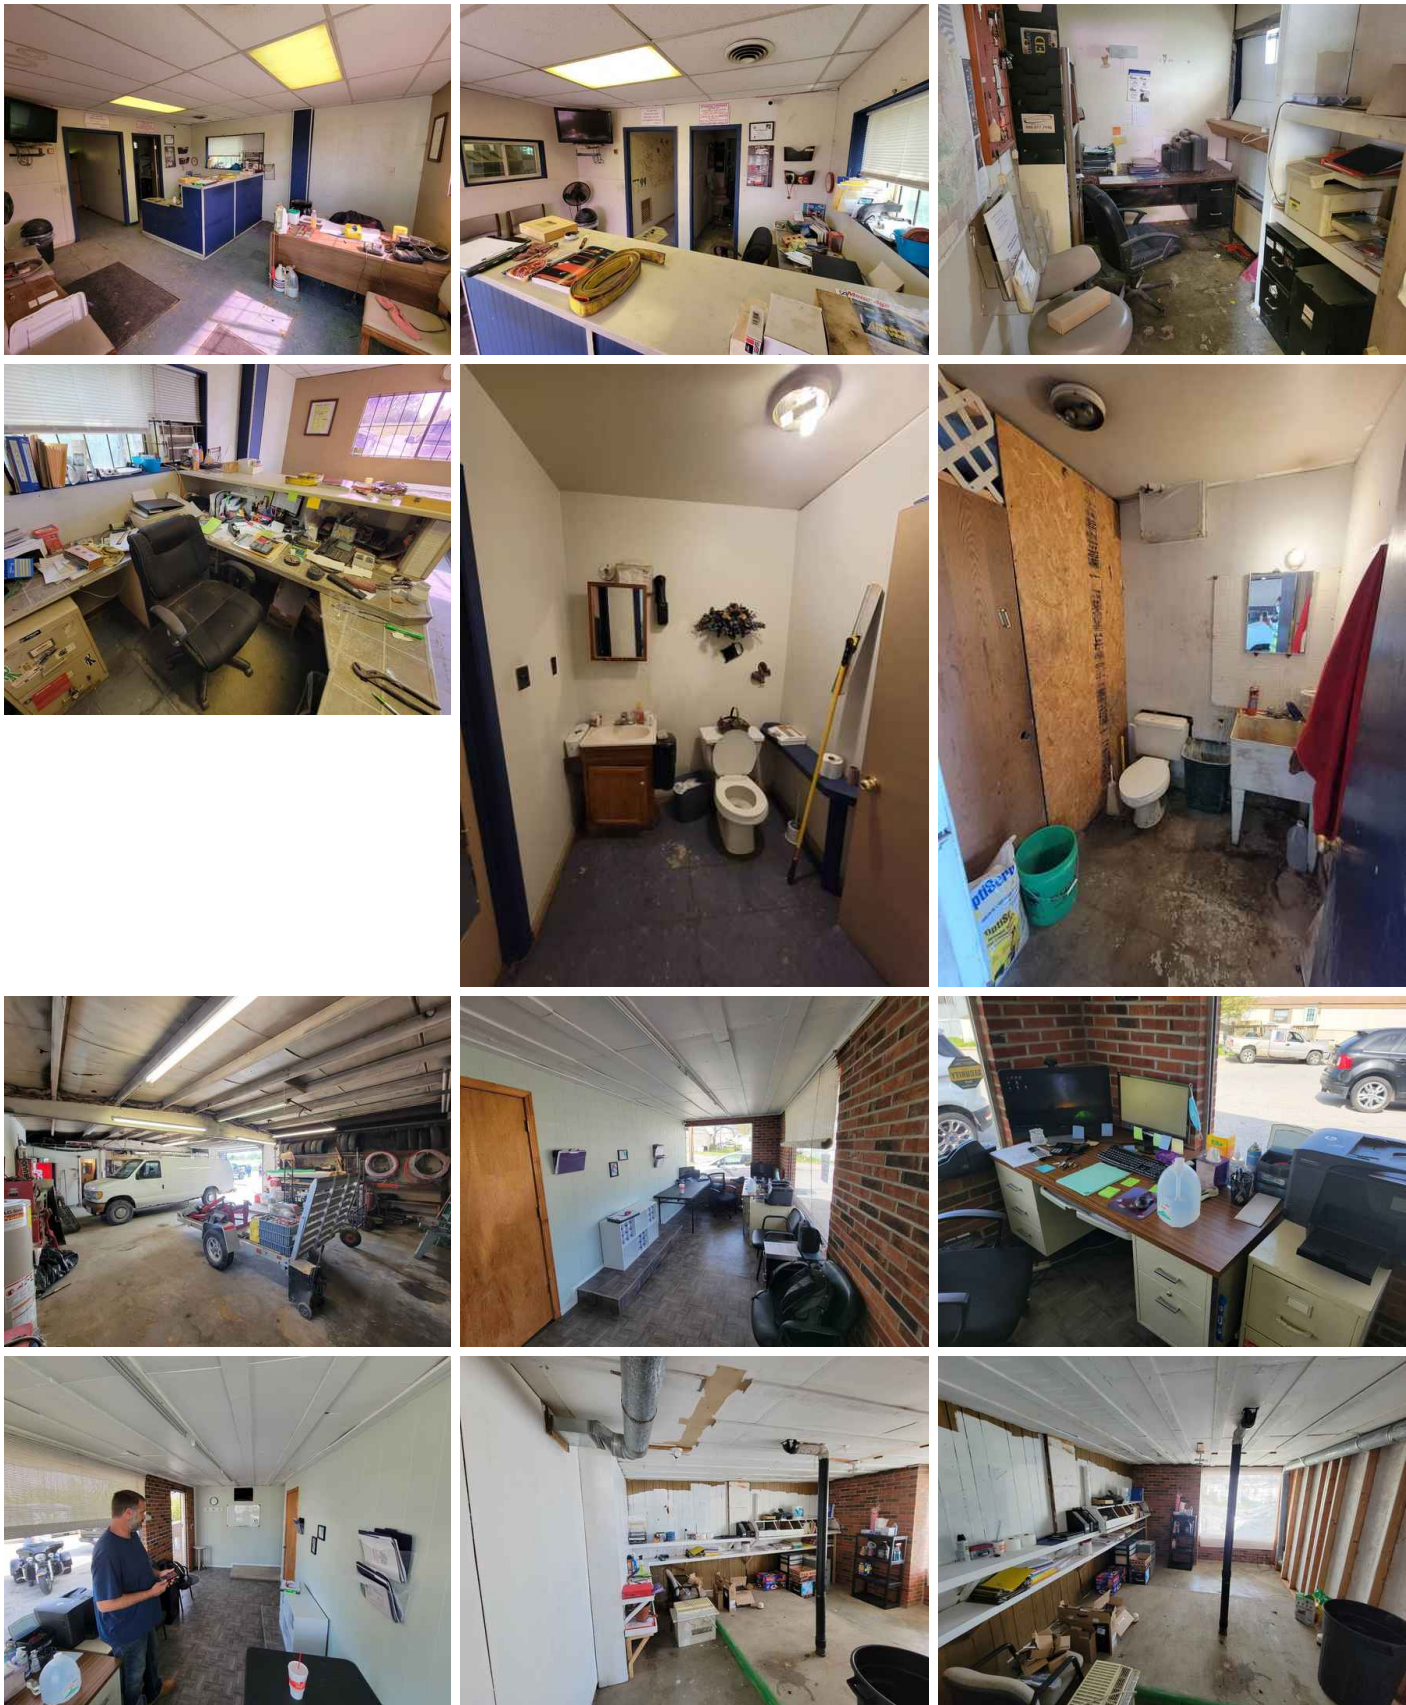
Condition of Structure(s): Exterior Images

Average condition of the structure(s): **Fair**. The office/commercial space is in fair structural condition, but the interior is in poor condition. The space is very unfinished and the restrooms are old and hardly private. The office is in good condition, but the remaining downstairs space should be considered storage. The upstairs is an automotive shop / warehouse.

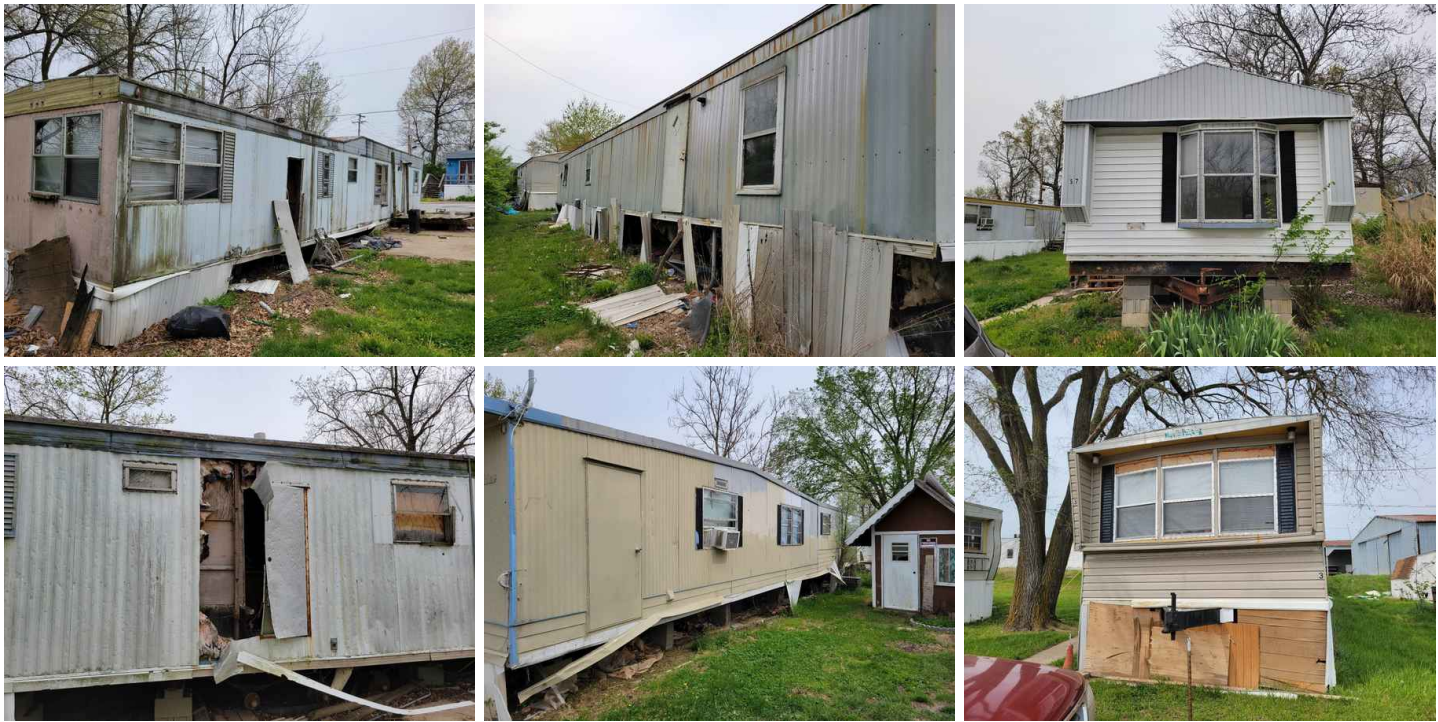
16.1.5 Items Observed

MISSING SKIRTING (MORE THAN 10%)

MEDIUM: 10K ~ 50K Est.

Estimated Cost
\$400 - \$4,000

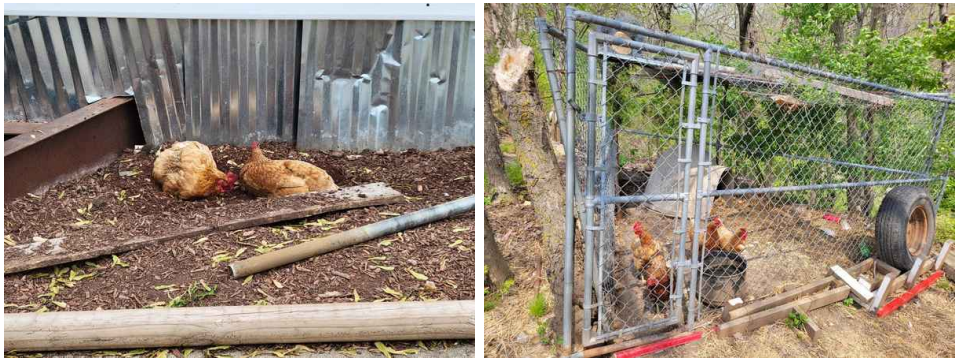
16.1.6 Items Observed
CHICKEN/ANIMAL COOP

Chicken or other animal coop found. Assuming tenant removal.

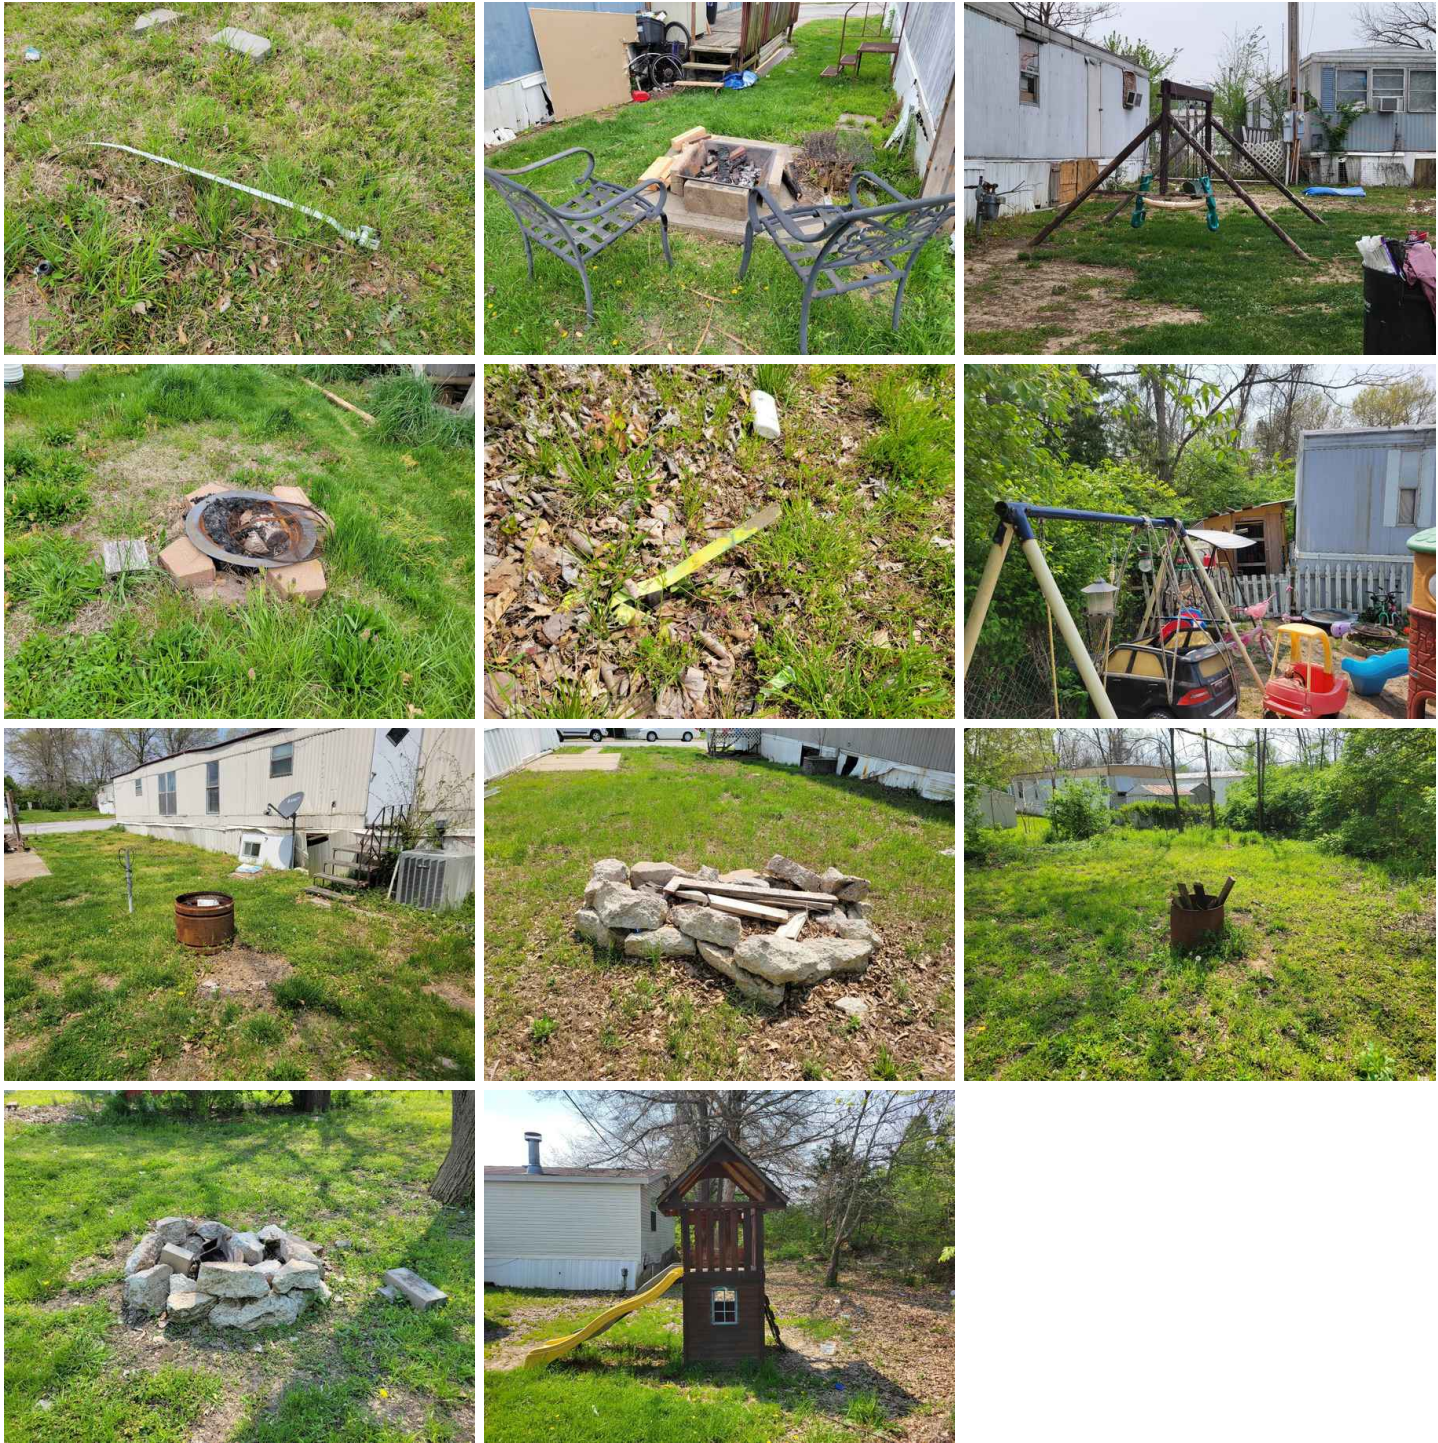
16.1.7 Items Observed
MATERIAL HAZARD

Material Hazard may include puncture/cutting objects, unsanitary items, and any other dangerous items. No cost, assuming tenant removal.
