Sample Report
TX 12345

PROPERTY INSPECTION REPORT

Concerning: Sample Report, TX 12345
(Address or Other Identification of Inspected Property)

By: Junior Darsan - Professional Home Inspector TREC #25023 09/17/2021 10:00
(Name and License Number of Inspector) am (Date)

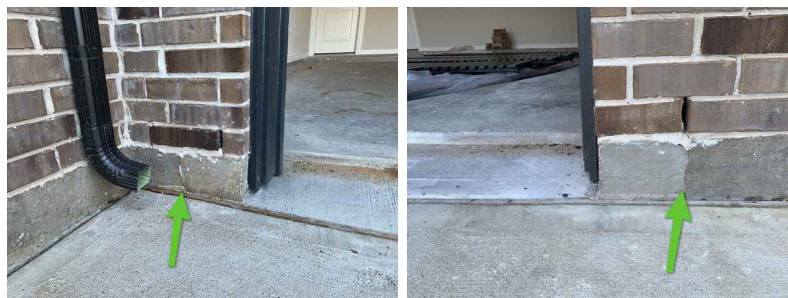
1: Foundation Cracks - Minor

Minor cracking was noted at the foundation on both sides of the main garage. These cracks appear to be cold joints which occurs when concrete is poured at two different times.

Recommendation: Contact a qualified professional.

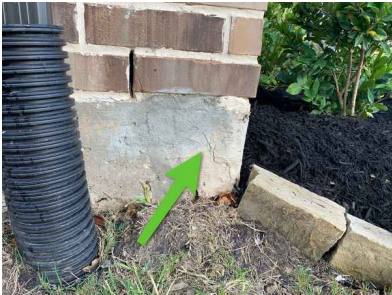
2: Corner Cracks

There are cracks at the left front corner of the foundation. Corner cracks are commonly found on slab foundations. They are generally cosmetic in nature. However, they may require minor repair to prevent water and pest penetration.

Recommendation: Contact a qualified professional.

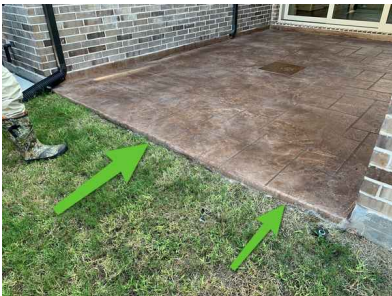
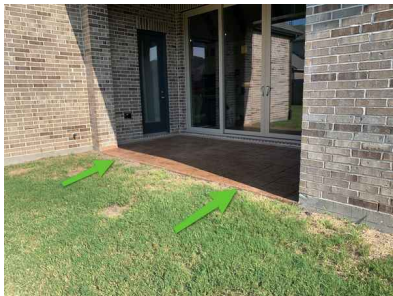
3: Slab Not Visible

The right side and rear porch patio areas were tiled and prevented those sections of the slab foundation from being observed. The inspector cannot verify the condition of the foundation in areas not visible.

Recommendation: Contact a qualified professional.

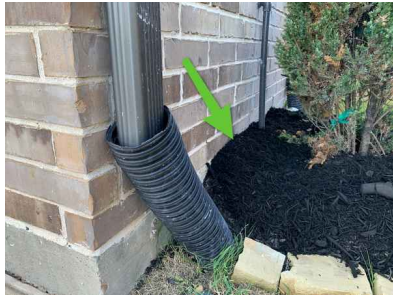
1: High Soil

There is high soil at the right side of the home behind the fence area to the rear corner of the foundation.

Recommendation: Contact a qualified professional.

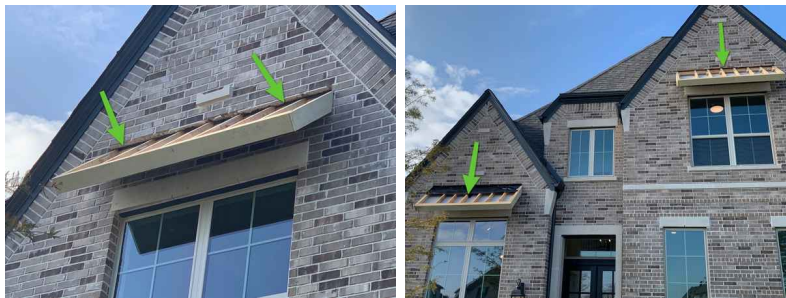
1: Damaged Coverings

Roofing shingle and flashings on the small roofing sections over upper front windows were missing.

Recommend a qualified roofer evaluate and repair.

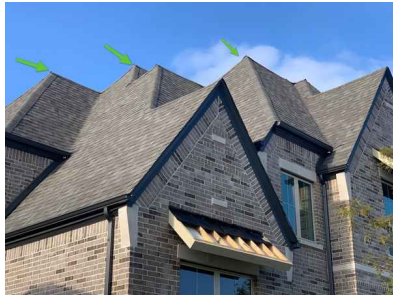
Left Front Side View

The ends of each ridge section of the roof was over projecting. This shingle overhang may be more easily lifted off by high winds. Recommend evaluation and repair by a qualified roofing contractor.

Recommendation: Contact a qualified professional.

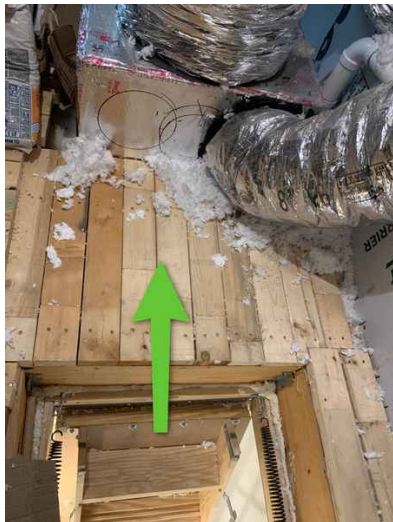
There is inadequate access to the attic equipment. The top of the attic stairs should have a 36"x36" minimum landing.

Recommendation: Contact a qualified professional.

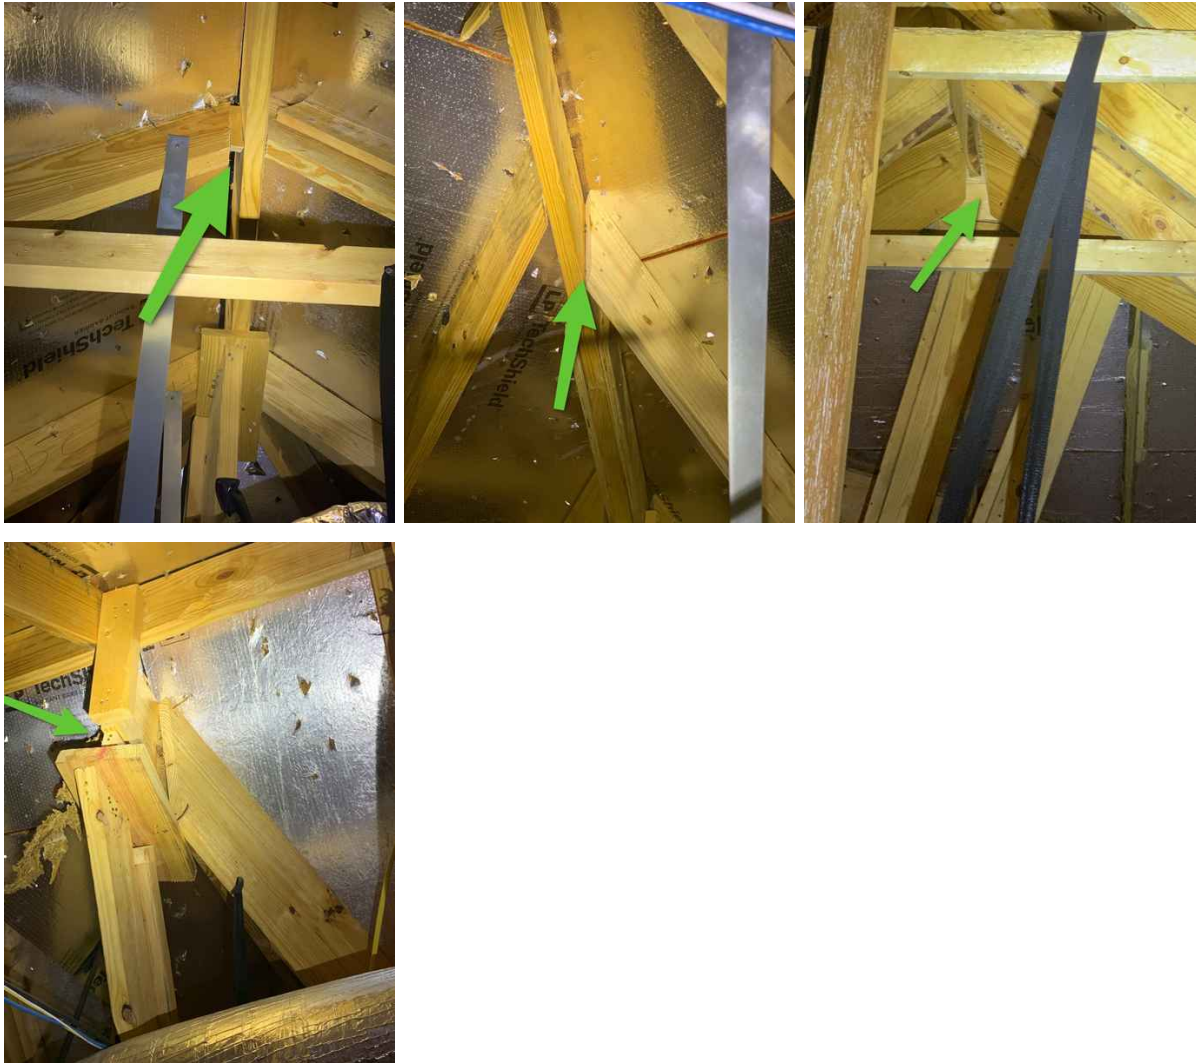
2: Attic/Roof Support

There were several areas of the roof support framing that were inadequately fastened. Several joints were not cut at the correct angles to make a secure connection to other framing members.

Recommend a qualified contractor evaluate and repair.

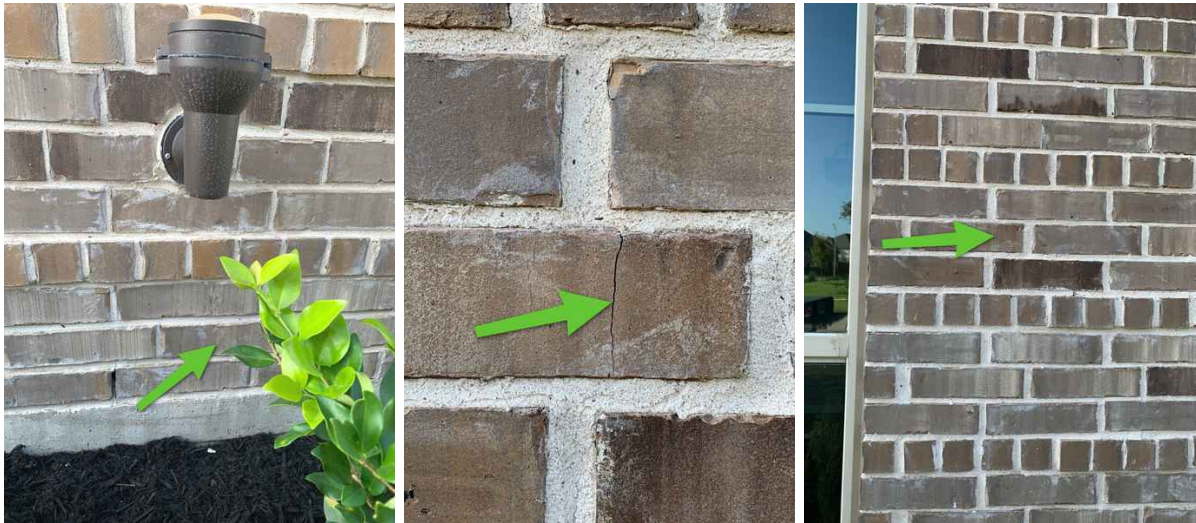
1: Cracks - Minor

Minor cracking was observed in front wall structure. I recommend recommend monitoring.

Recommendation: Recommended DIY Project

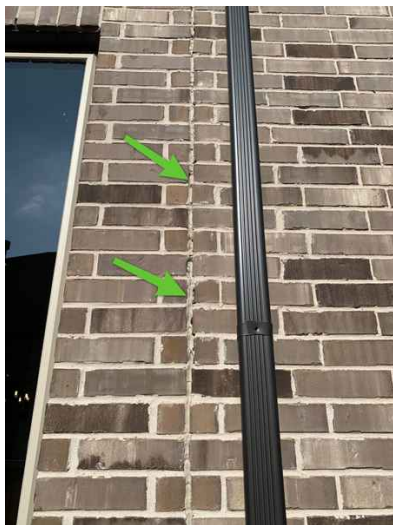
Left side wall

There are areas with deteriorated/ missing caulking in the expansion joint on the left side of the house. This can permit entry of moisture ad pest into the house.

Recommend repair by a qualified contractor.

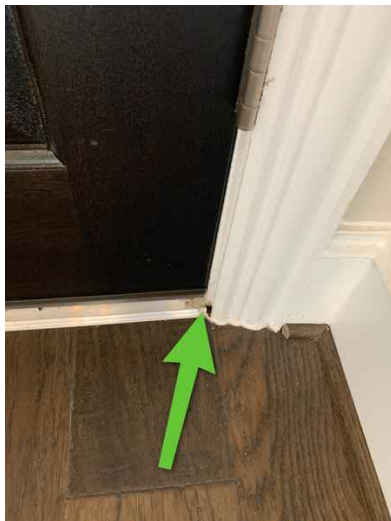
Front door

There were areas of missing/inadequate caulking at the front entry door corners.

Recommend repair by a qualified contractor.

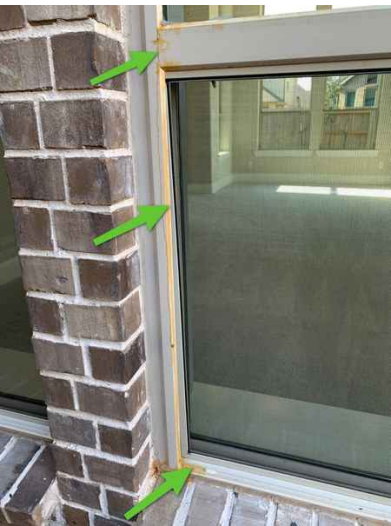
Right side patio

One window had rust stains, but are operational. Recommend a window professional clean, lubricate & adjust as necessary.

Recommendation: Contact a qualified window repair/installation contractor.

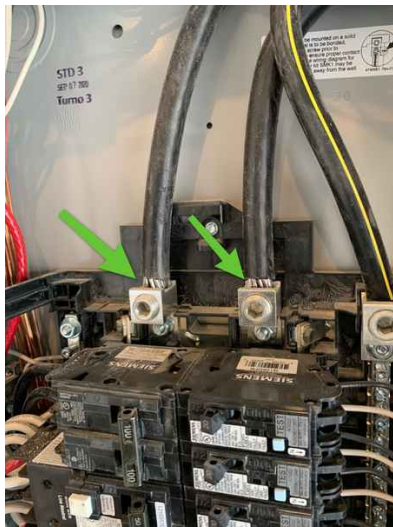
1: No Antioxidant Grease on Aluminium Wires

Terminals screws on service wires not tightened enough.

Recommendation: Contact a qualified professional.

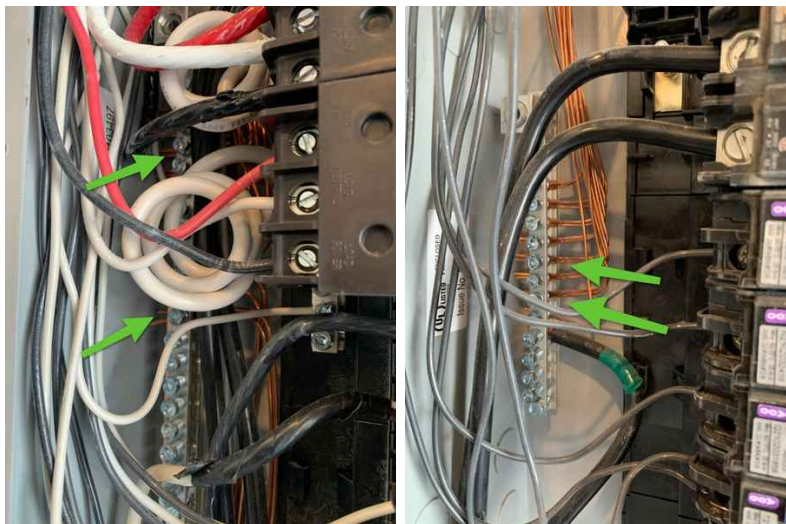
2: Double Tapping

Double tapping was observed on the ground bus of the sub-panels. While this may be a common practice, there is room on the bus bar for each wire to be individually grounded. This would reduce the possibility of having any ground wire loosely connected, therefore reducing the possibility for any circuit to not have proper grounding protection.

Recommendation: Contact a qualified professional.

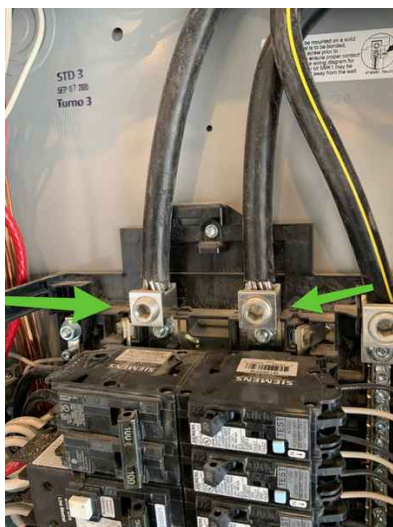
4: Service Terminal Caps

A non-conductive plastic cap/cover should be installed over the hot service terminal connections. The absence of this protective cover presents an electrocution and fire risk.

Recommendation: Contact a qualified professional.

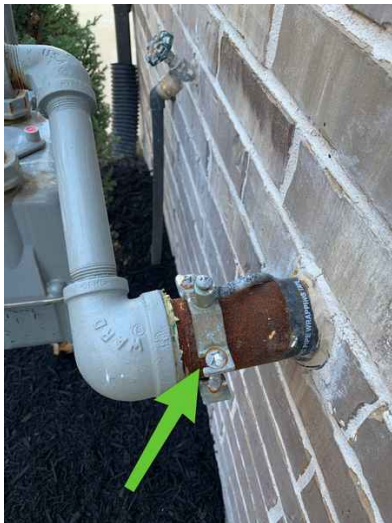
4: Poor Bonding on Gas Line

There is evidence of poor bonding on the main gas line on the right side of the house. The rusting on the gas line prevents a proper connection to the grounding clamp and reduces effective bonding. This area should be properly cleaned and the bonding clamp reattached.

Recommendation: Contact a qualified professional.

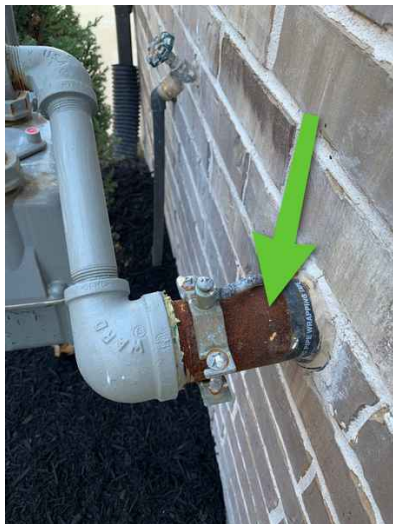
A section of the main gas line entering the home is rusted. This should be cleaned and painted with anti-corrosion or rust inhibiting paint.

Recommendation: Contact a qualified professional.

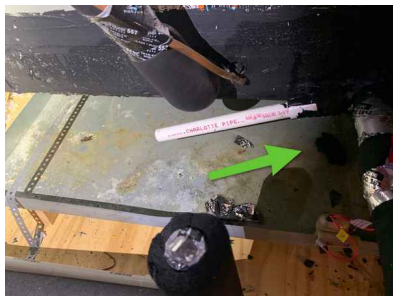
1: Condensation Pan

There was moisture leaking from the left A/C unit onto the condensation unit. Recommend evaluation by a qualified HVAC contractor.

Recommendation: Contact a qualified professional.

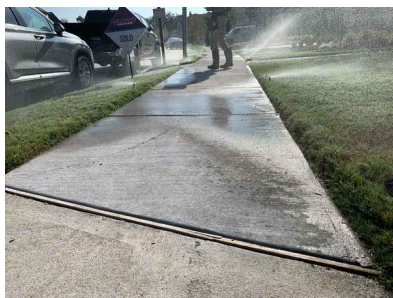
Front walkway

Several sprinkler heads were spraying excessively onto walkways, fences and the exterior walls. Recommend repair by an irrigation contractor.

Recommendation: Contact a qualified professional.

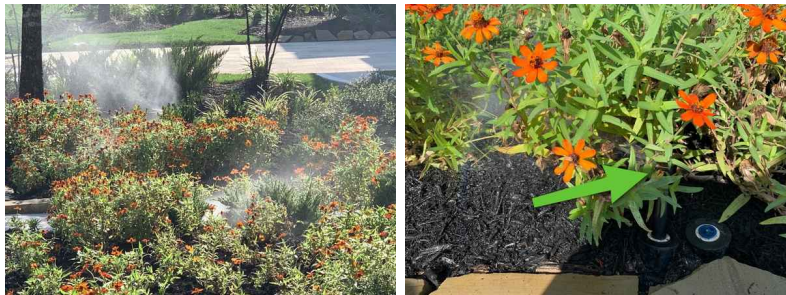
2: Sprinkler Head Not Popping Up

The sprinkler heads may need to be raised / adjusted.

Recommendation: Contact a qualified professional.
