# COMMON CONCERNS HOME INSPECTIONS

## CRAWLSPACE ASSESSMENT COPY

1234 Sample CrawlSpace Assessment  
Puyallup WA 98373

Sample Client  
JUNE 25, 2019

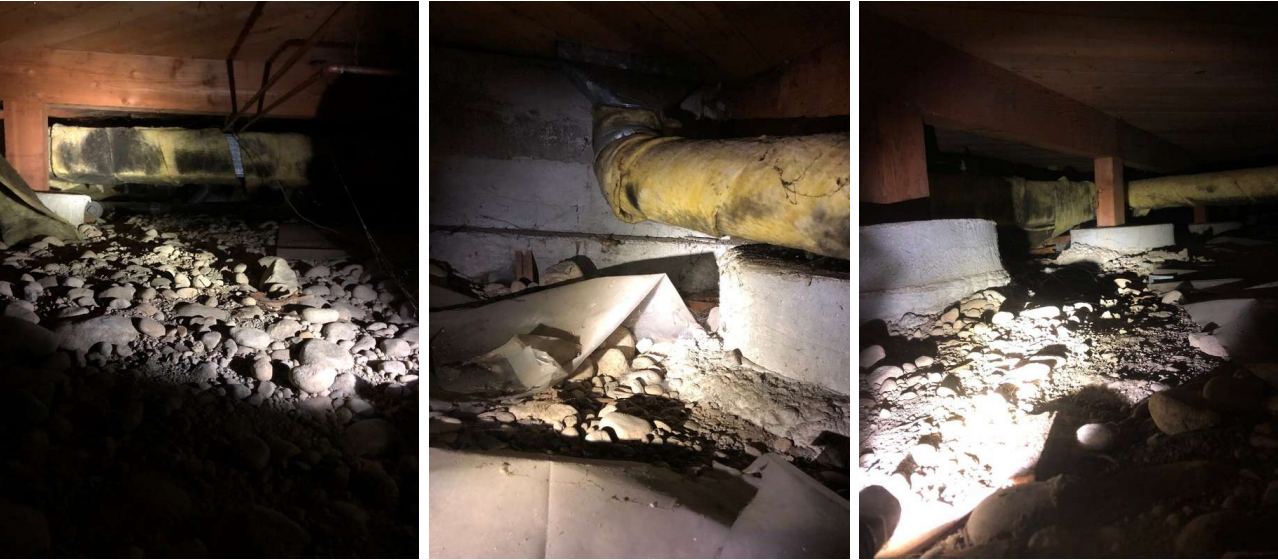
3.1.1 Ground  
INCOMPLETE VAPOR BARRIER

A vapor barrier was not installed or was insufficiently covering the ground. The purpose of the vapor barrier is to prevent moisture from migrating from an area of higher moisture density to an area of lower moisture density. A vapor barrier that is not completely covering the ground could result in condensation when the warmer and moister air comes in contact with a cooler area or surface.

Recommendation  
Contact a handyman or DIY project

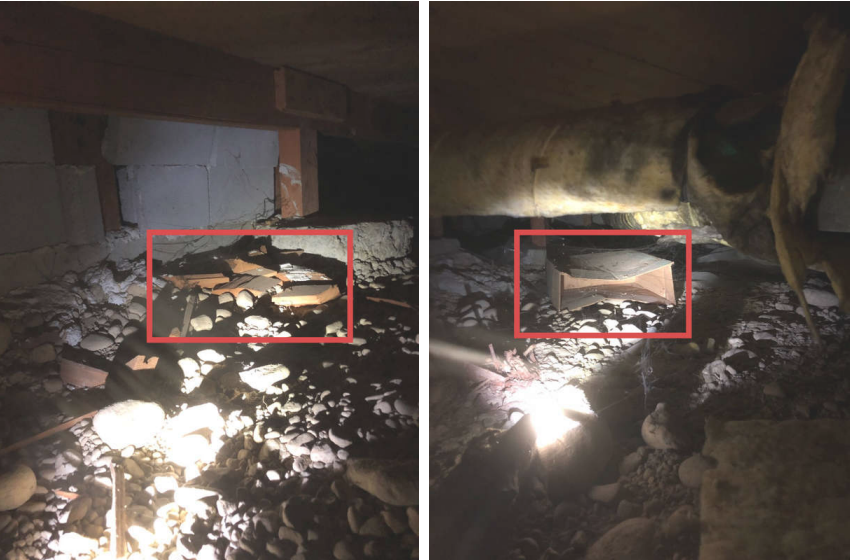
3.1.2 Ground

CONDUCTIVE DEBRIS

Conductive debris was observed in the crawl space. Cellulose or noncellulose material that provides no structural support but can be a source of food or provide habitat for wood destroying insects and rodents. This definition includes, but is not limited to, tree roots, stumps, formboards, scrap wood, paper, wood product, paper product, or other natural or manufactured products.

Recommendation

Contact a handyman or DIY project

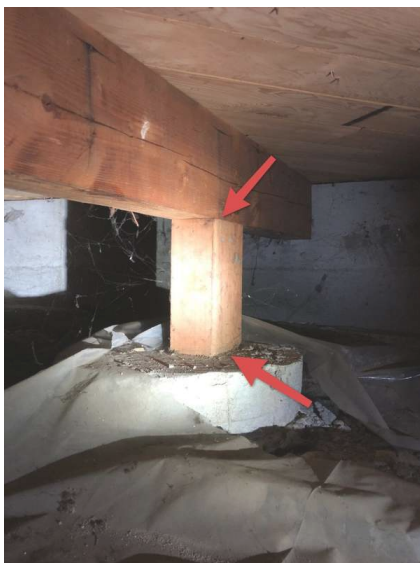
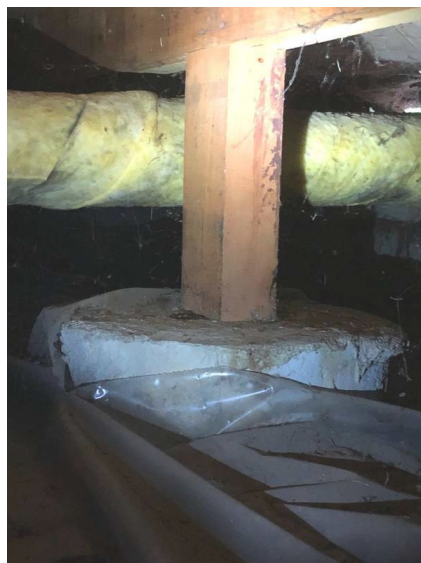
### 5.1.1 Floor Supports

#### **INSUFFICIENTLY SECURED**

#### THROUGHOUT

The floor supports were either not secured to both their footings and the floor structure or were insufficiently secured. Supports should be secured to the supported member to prevent lateral movement of the column and to resist wind uplift or seismic events.

#### Recommendation

Contact a qualified general contractor.

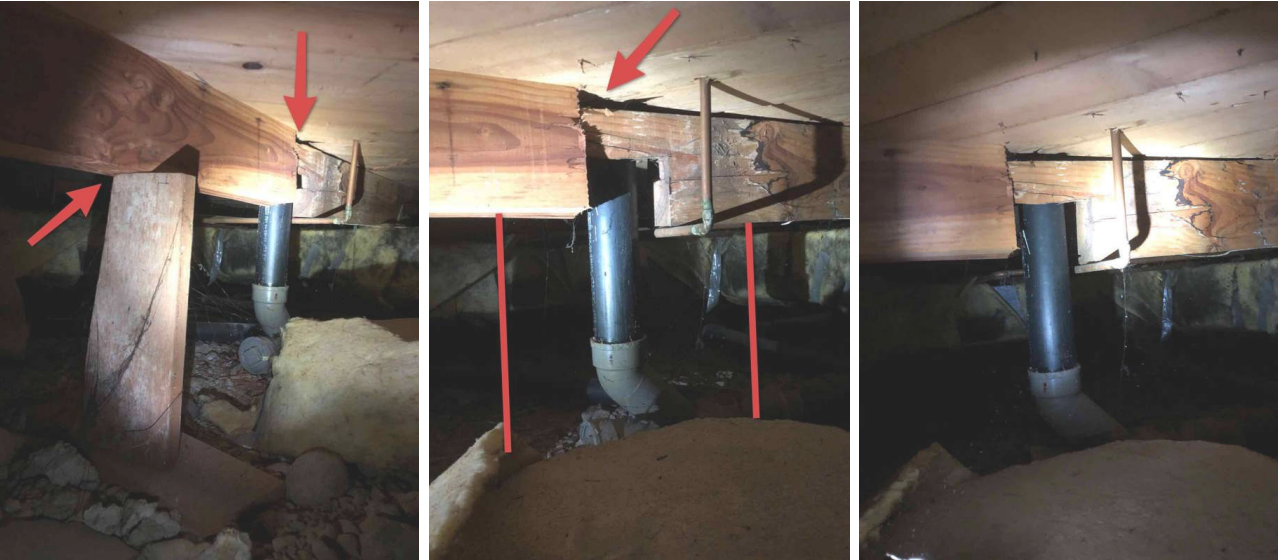
5.1.2 Floor Supports

INSUFFICIENTLY SUPPORTED

UNDER KITCHEN AREA

An insufficiently supported beam was observed. Structural beams are crucial to providing proper transfer of floor and wall loads to components such as the foundation, load-bearing walls, and support columns or posts. Beams not supported properly can result in sloping floors and other structural issues with the floor system. Further evaluation is required.

Recommendation  
Contact a qualified professional.

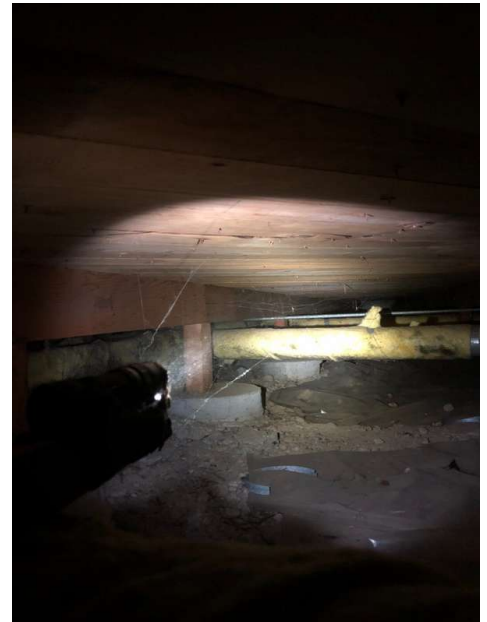
6.1.1 Floor

UNDER-FLOOR INSULATION: MISSING

Under-floor insulation was missing throughout the crawl space. Insulation under the floor is installed to help maintain the desired temperature within the home. Missing insulation will result in greater than intended heat loss or gain.

Recommendation  
Contact a qualified insulation contractor.

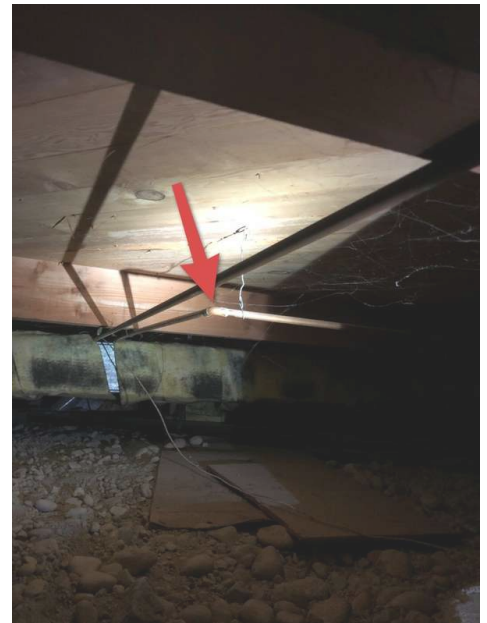
#### 6.2.1 Pipe

### **WATER PIPE INSULATION: INCOMPLETE THROUGHOUT**

Water supply pipe insulation was missing or incomplete. Insufficient insulation coverage will result in greater than intended heat loss or gain, and possibly result in condensation issues in the affected area. Freezing temperatures can cause cold, uninsulated pipes to burst under certain conditions.

#### Recommendation

Contact a handyman or DIY project

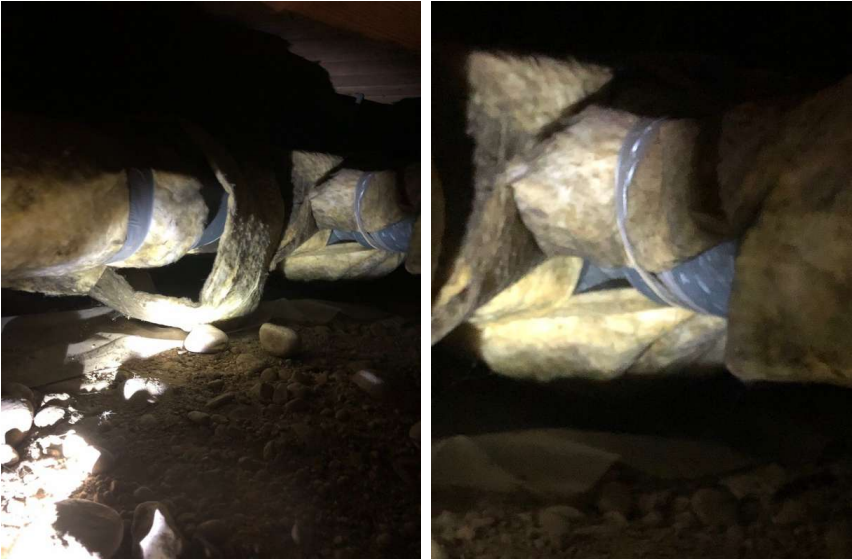
#### 6.3.1 Ducting

### **DUCTING INSULATION: INSUFFICIENT**

HVAC ducts were missing insulation or were observed inadequately insulated. Missing or inadequate insulation contributes to system inefficiencies and increases the expense of heating or cooling

#### Recommendation

Contact a qualified HVAC professional.

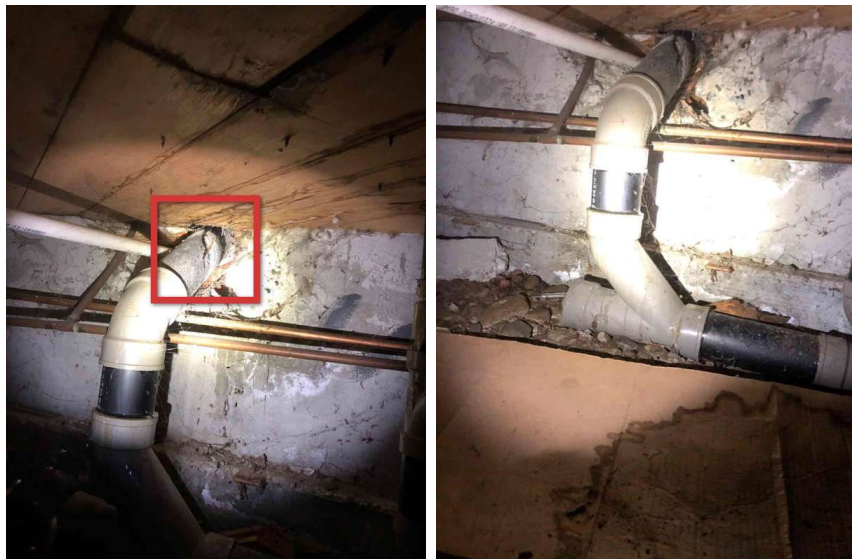
#### 7.2.1 Drain

#### LEAKING DRAIN PIPES

##### UNDER MASTER BATH AREA

Leaking was observed from the drain pipes in the crawl space. Leaks in water pipes can lead to moisture damage to surrounding components and can result in expensive repairs. Left uncorrected, minor leaks can permit mold and rot to occur which can have significant effects on the health of the home's occupants and the integrity of the structure.

##### Recommendation

Contact a qualified plumbing contractor.

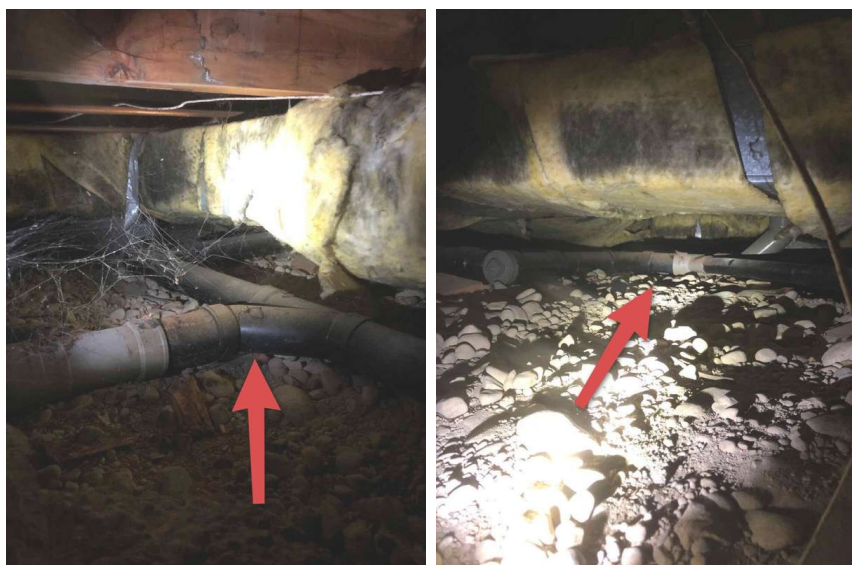
### 7.2.2 Drain

#### **POORLY SLOPED/SUPPORTED**

##### UNDER KITCHEN AREA

Some waste pipes were poorly supported or had an improper slope. Waste pipes that are not sloped or supported properly can result in slow draining of wastewater or backups.

##### Recommendation

Contact a qualified plumbing contractor.
