RESIDENTIAL HOME INSPECTION

1544 Lark Lane St SE Kentwood MI 49508

> Kendal Wabeke AUGUST 12, 2020

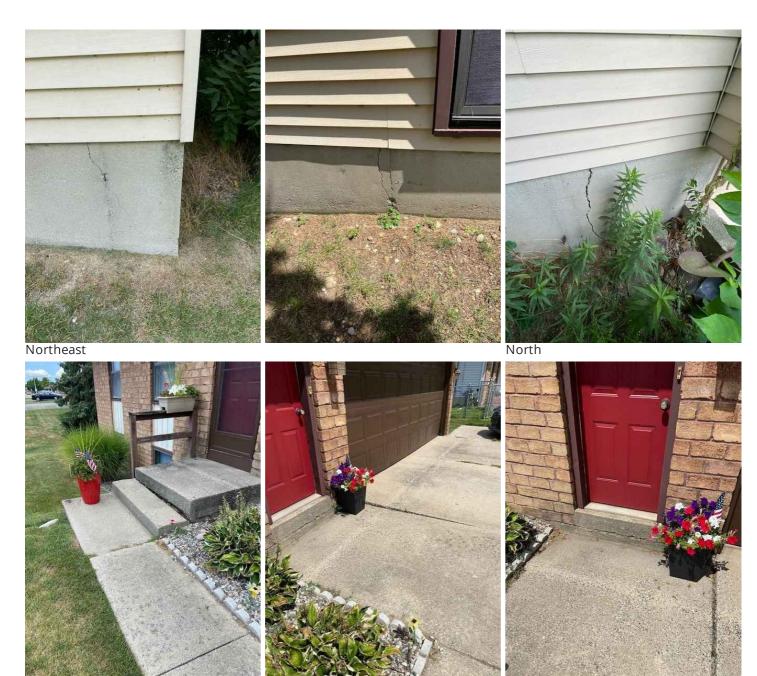
South, Walkway and Entry

FOUNDATION CRACKS - SIGNIFICANT EXPENSE

Severe cracking noted at the foundation. This is typically consistent with soil movement and could lead to serious damage to structural components, foundation and/or slab. There were large vertical cracks through the foundation and some abnormal settling in multiple locations that should be further evaluated by a foundation/structural specialist. Vertical cracking larger than 1/8" can lead to larger structural problems and may require immediate attention or repairs.

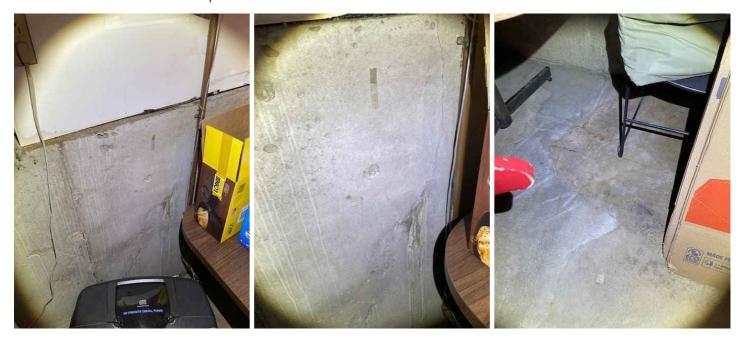
STANDING WATER

Observed signs that standing water may have been present on basement floor. Recommend a qualified contractor evaluate and find potential source of moisture.

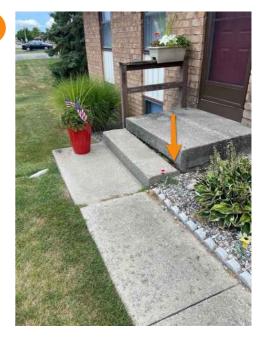
FRONT ENTRY

PATIO CRACKING/SETTLING - MAJOR

Significant settling & cracking observed. Further deterioration could result. Recommend concrete contractor evaluate & repair.

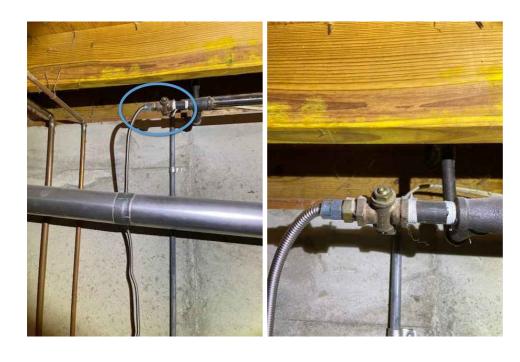
BASEMENT - GAS DRYER

DAMAGED GAS VALVE

Damaged gas valve should be replaced to allow for proper function and to avoid potential leaking. Recommend replacement by a qualified professional (Plumber or HVAC contractor).

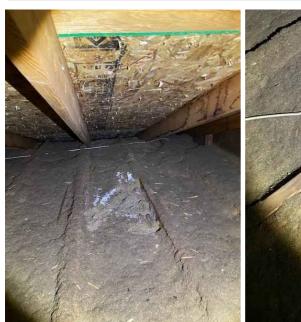
INSUFFICIENT INSULATION

Insulation depth was inadequate. Recommend a qualified attic insulation contractor install additional insulation to reach an approximate R40 value.

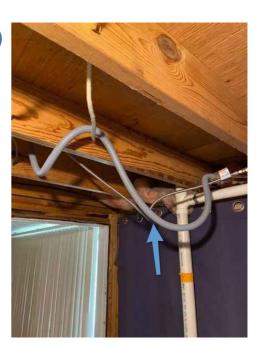
DISHWASHER MISSING AIR GAP OR HIGH LOOP

The dishwasher drain did not have a visible high loop on the flex line before reaching the main drain connection, which is a general standard for all dishwashers (some newer models will have a high loop pre-installed on the

waste tee install side of the unit). We recommend adding – this can be as simple as securing the flexible drain to the bottom of the countertop or framing above.

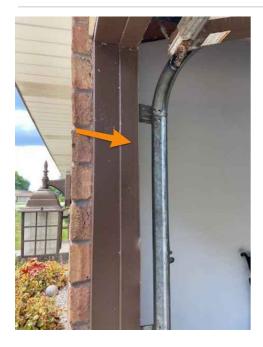
GARAGE DOOR

IMPROPER INSTALLATION

Weatherstripping missing around door perimeter. Recommend installation for proper weather seal.
