SUPREME INSPECTIONS LLC

SEWER INSPECTION (SAMPLE)

DECEMBER 31, 2020

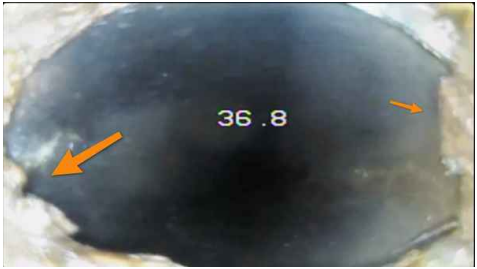
3.1.2 Drain System

OFFSET (MODERATE)

There is a minor offset in the drain line where two pipes are not properly connected and there is a "lip" which can cause clogging. Although the system was functioning/flowing at the time of the inspection, we recommend further review and repair as needed.

Recommendation
Contact a qualified professional.

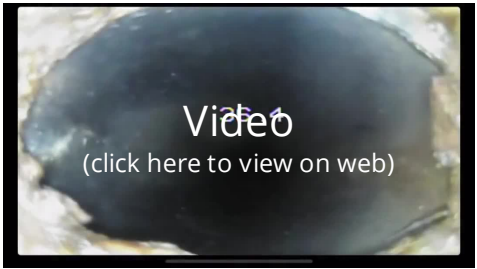
3.1.3 Drain System

Moderate Debris/Build Up

There was moderate debris build up in the line, we recommend further review and clearing as needed to prevent clogging.

Recommendation
Contact a qualified professional.
