AVALON PRE-DRYWALL INSPECTION

1206 Coldwater Ct
Griffin GA 30224

MARCH 9, 2021

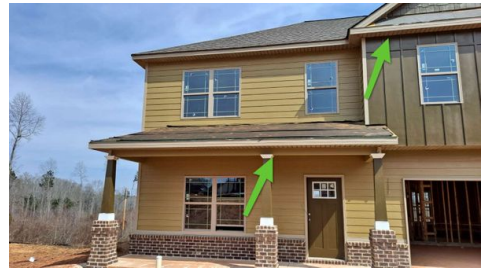
NOT INSTALLED

Roof System was not installed at the front of home in two areas. This will be installed at a later time.

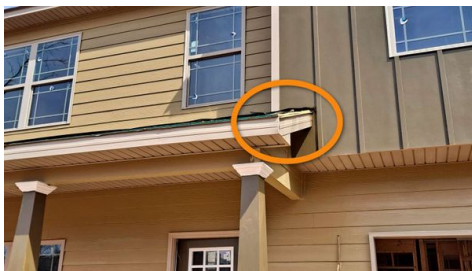
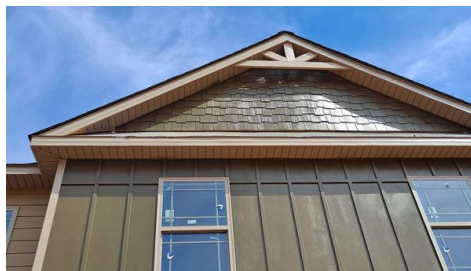
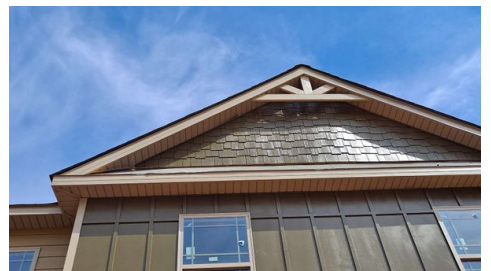
3.1.1 Roof Covering

MISSING UNDERLAYMENT IN AREAS

There is missing/insufficient underlayment at the referenced areas. This should be corrected prior to shingle installation.

Contact a qualified roofing professional.

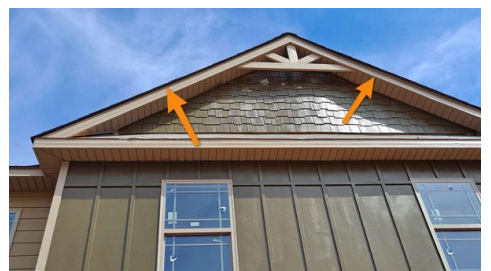
3.4.1 Roof,Chimney, Flashing Installed

DRIP EDGE FLASHING-MISSING

Drip edge flashing was not present in areas that were checked. Drip edge flashing is recommended to be installed at the eaves and rakes of the roof (called rake edge at the gables), to protect the edges of the sheathing from sustaining water damage. The installation of proper drip edge flashing is recommended to be conducted by a roofing contractor.

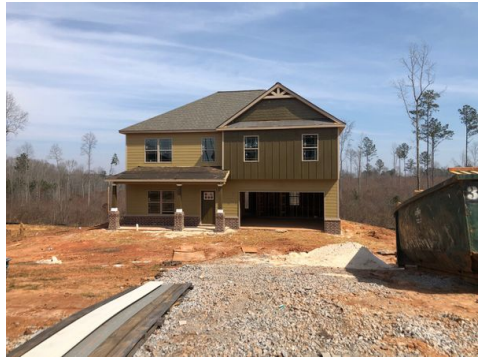
SIDING INSTALLED

Siding was already installed at the time of inspection. Could not visibly inspect the building wrap at the time of inspection.

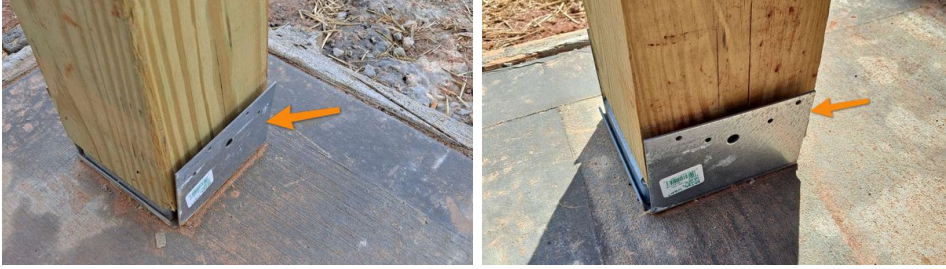
4.6.1 Porches

POST BRACKETS MISSING FASTENERS

The posts at the rear of home have brackets that are missing fasteners. These should be installed.

Contact your builder.

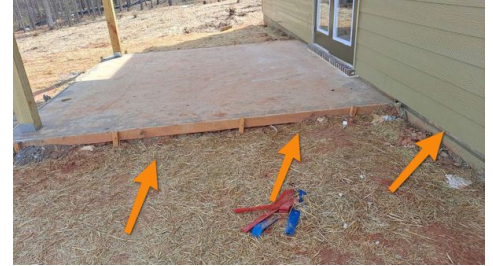
4.7.1 Foundation

FORM BOARDS REMAINING

Contact your builder.

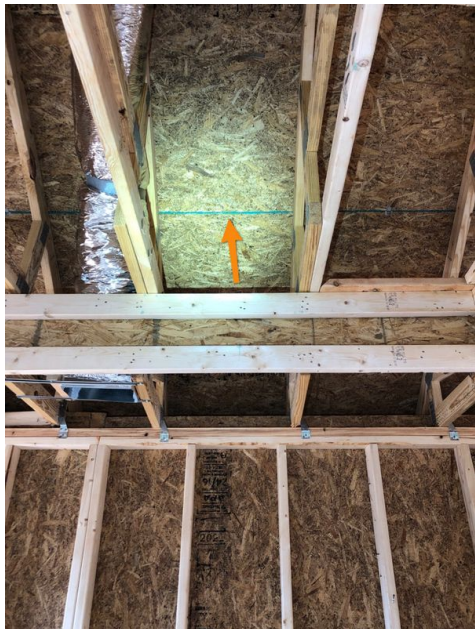
Master Bedroom

MISSING H CLIPS

Missing "H" clips in between roof deck sheathing in various areas. This can cause dips in the sheathing that is noticeable roof line from outside. I recommend qualified roofing contractor install clips when roof is replaced as this is the most cost effective approach

Contact a qualified professional.

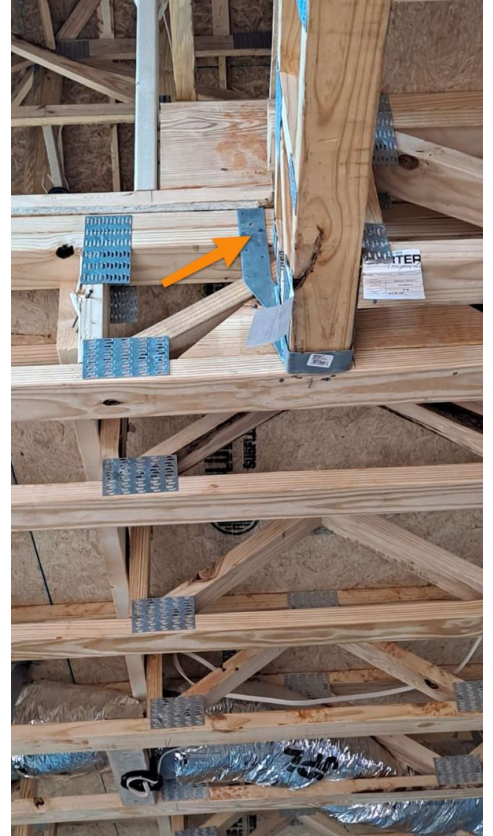
5.3.1 Ceilings Structure

JOIST HANGER MISSING FASTENERS

Joist hanger(s) missing fasteners at referenced area. There should be a proper amount of fasteners for the hanger to prevent settling/failure.

Contact a qualified professional.

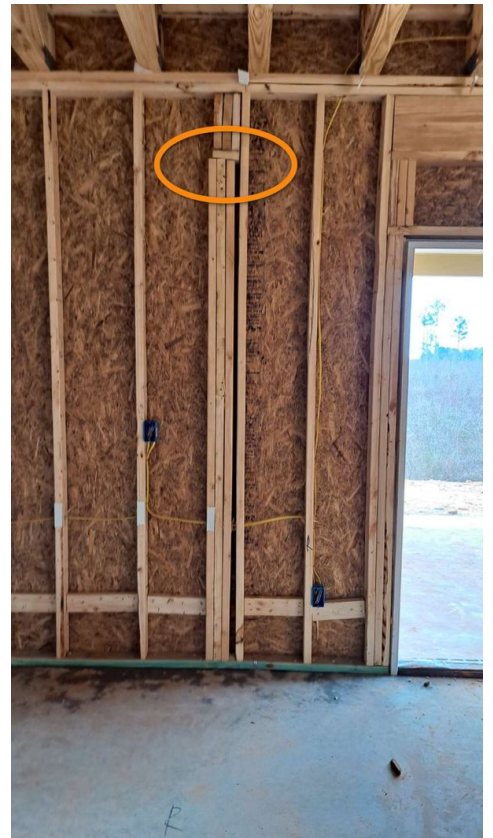
5.9.1 Headers Properly Sized & Supported

BRACING NOT EVEN WITH BEAM

Contact your builder.

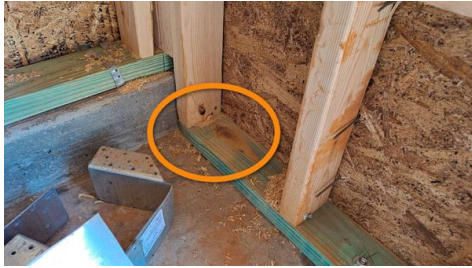
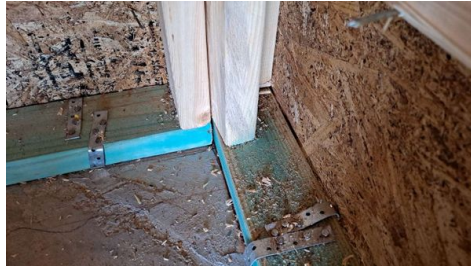
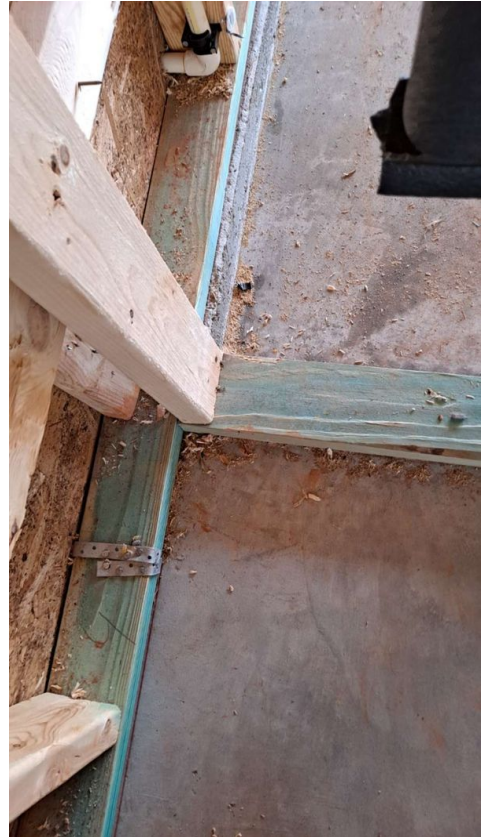
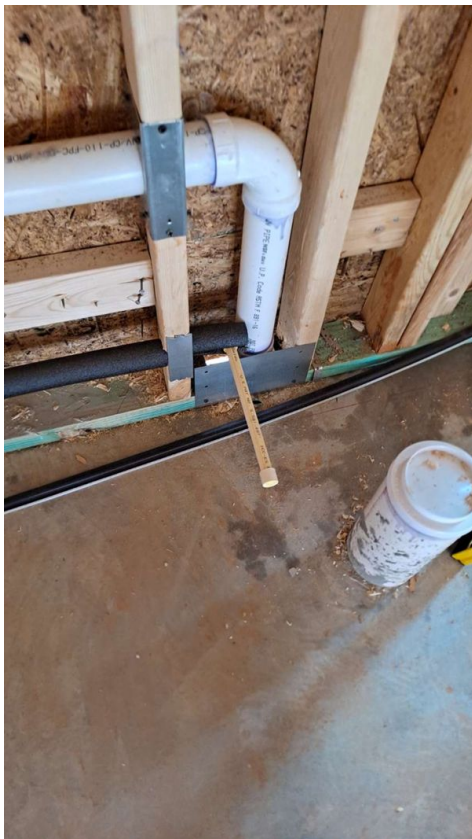
5.14.1 Proper Stud Spacing, Anchor bolt nuts

ANCHOR BOLTS

Missing bolt at mudsill at the perimeter exterior wall in several areas. These should be installed at every end cut and 36in of sill. This should be correct by qualified builder.

Contact your builder.

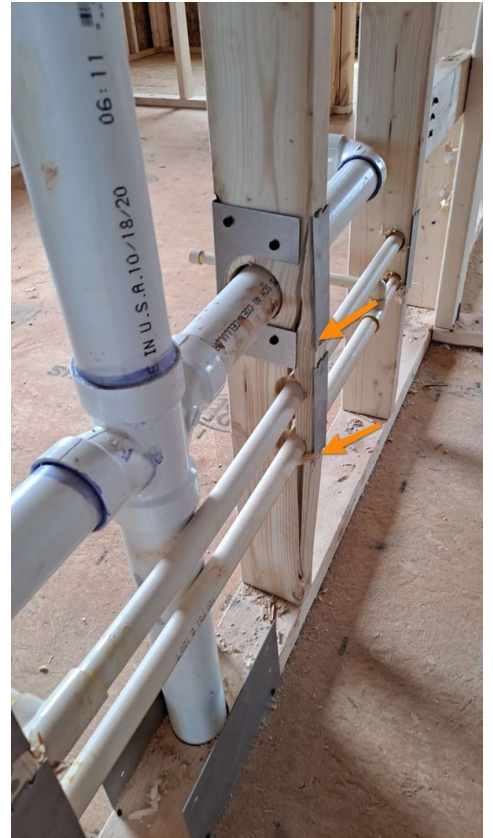
5.14.2 Proper Stud Spacing, Anchor bolt nuts

DAMAGED STUD

The Wall Stud was cut/damaged at the time of inspection. We recommend to inspect and repair.

Contact your builder.

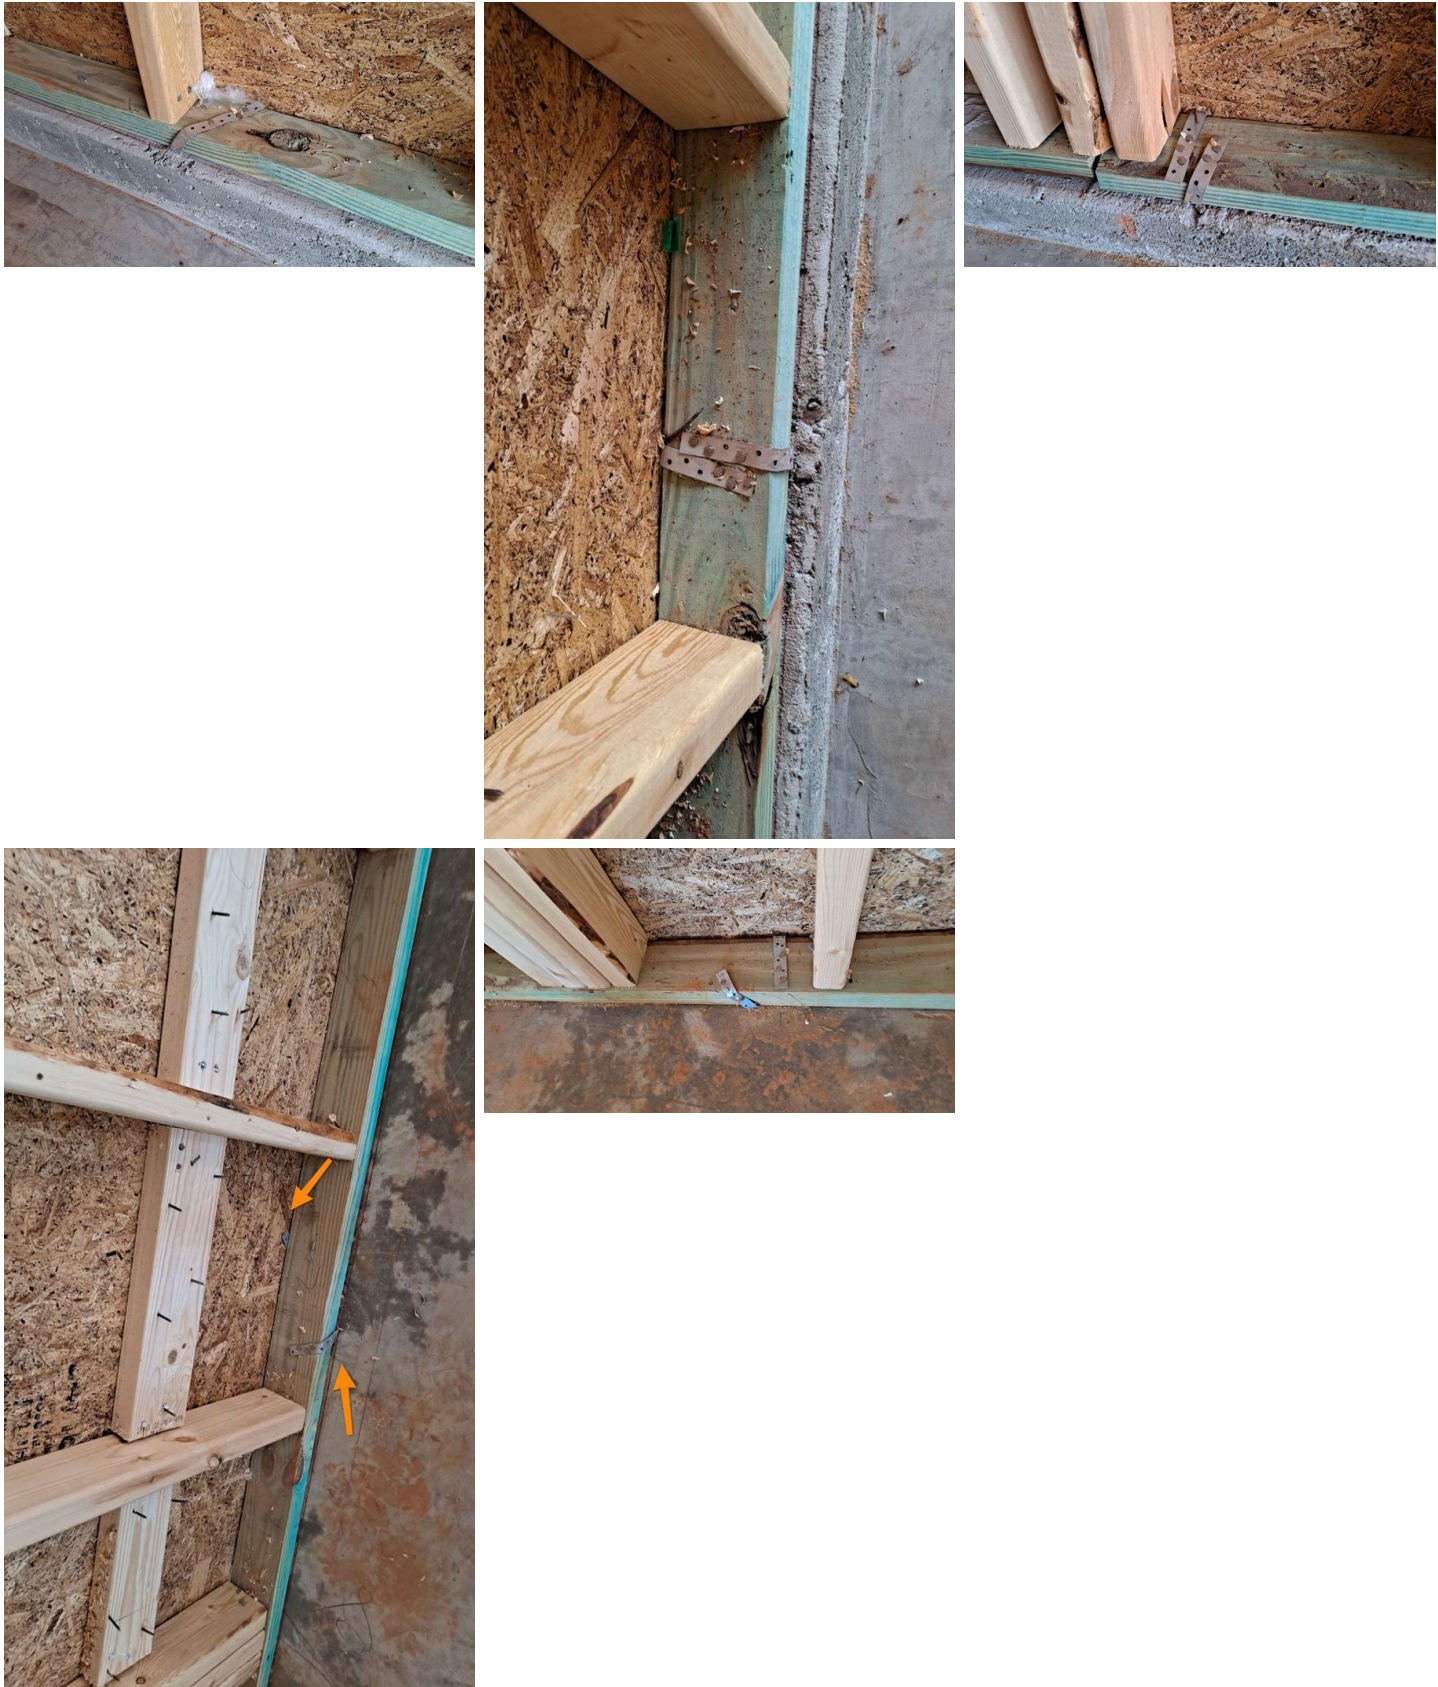
5.14.3 Proper Stud Spacing, Anchor bolt nuts

MUDSILL STRAPS

The perimeter mudsill straps are missing/do not have sufficient amount of fasteners installed. I recommend having corrected according to local jurisdictions requirements.

Contact your builder.

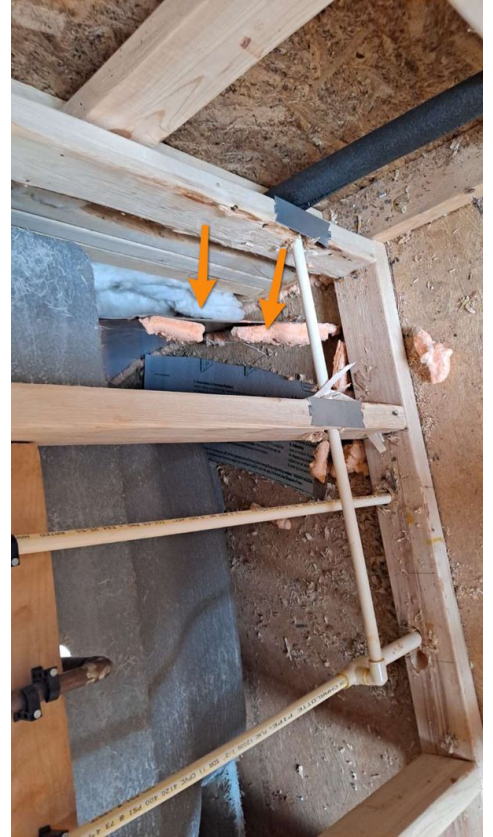
5.14.4 Proper Stud Spacing, Anchor bolt nuts
BATHROOM WALL SHEATHING LOOSE/DAMAGED
MASTER BATHROOM

The interior sheathing at the wall has been damaged or come loose at the referenced area. This should be properly secured and sealed.

Contact a qualified appliance repair professional.

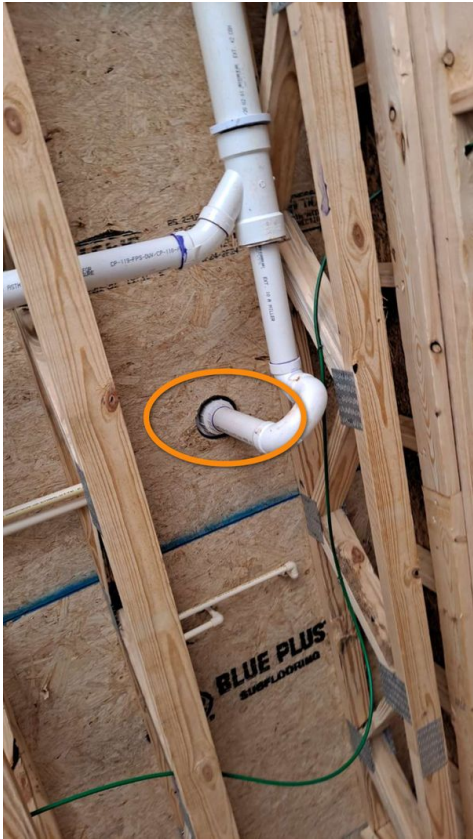
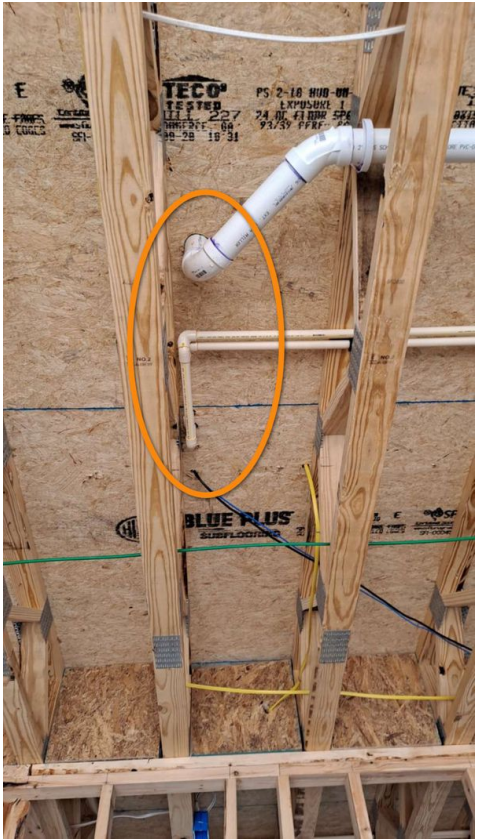
5.15.1 Fireblocks & Fire Stops in Place

MISSING FIRE STOP

Fire Stop was missing in various areas at the time of inspection. We recommend to inspect and apply as needed.

Contact your builder.

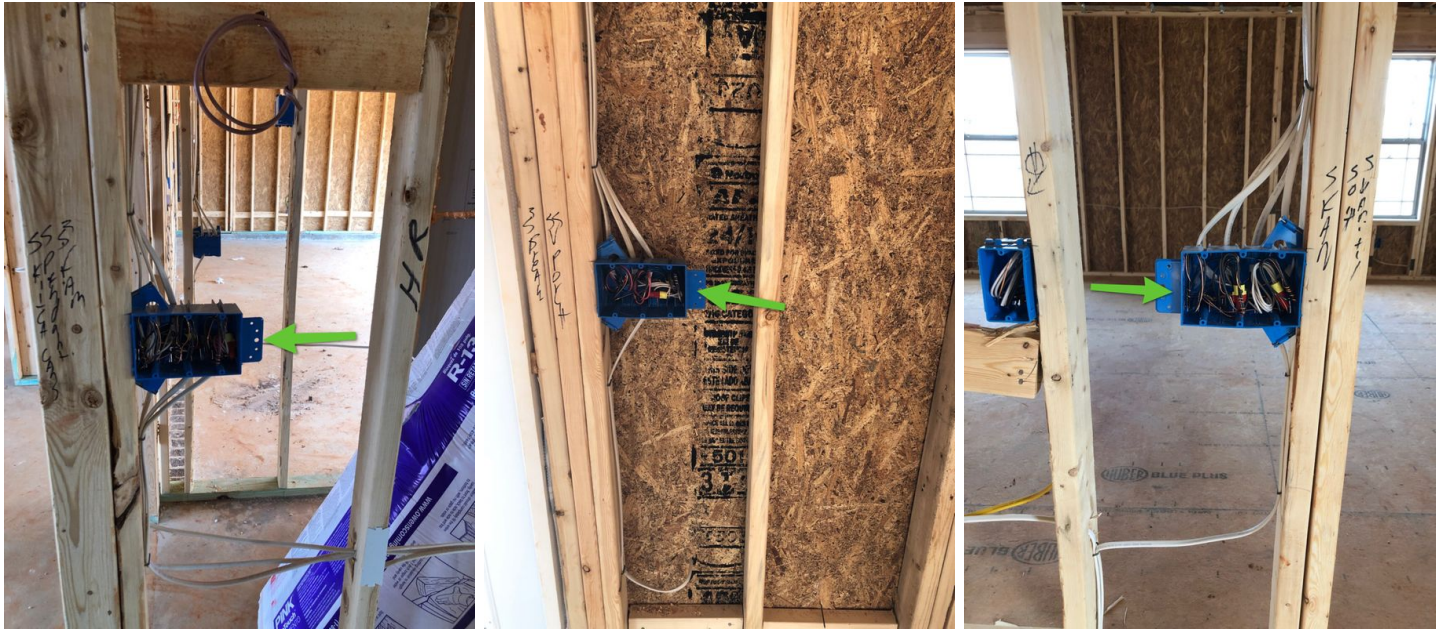
GANG BOX SUPPORT

electrical gang box is missing proper support and is in need of correction.

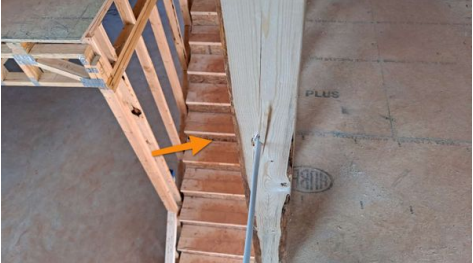
Foyer wall

MISSING NAIL GUARDS

Nail Guards were missing in various locations at the time of inspection. Provided a few reference photos. Builder should inspect entire home and install as per code requirements.

Recommendation
Contact your builder.

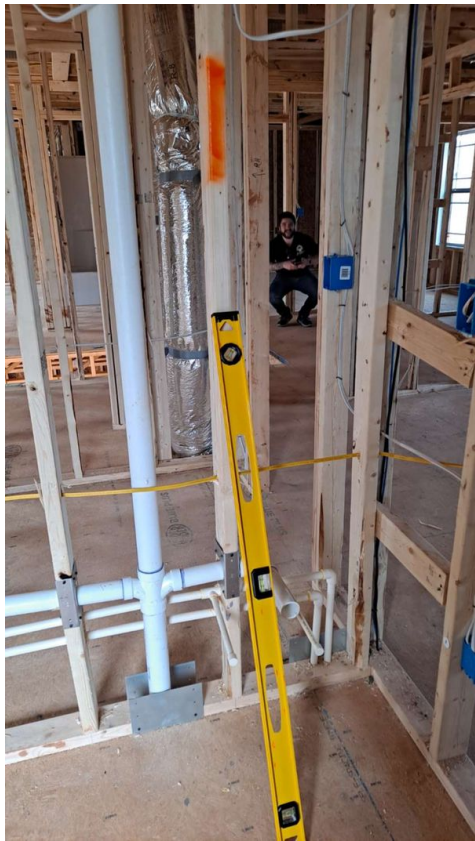
Master Bathroom

The Framed Wall had bows in various areas at the time of inspection. We recommend to inspect and repair prior to drywall.

Corrective Measure: The contractor will repair the wall to meet the performance guideline.

Contact your builder.

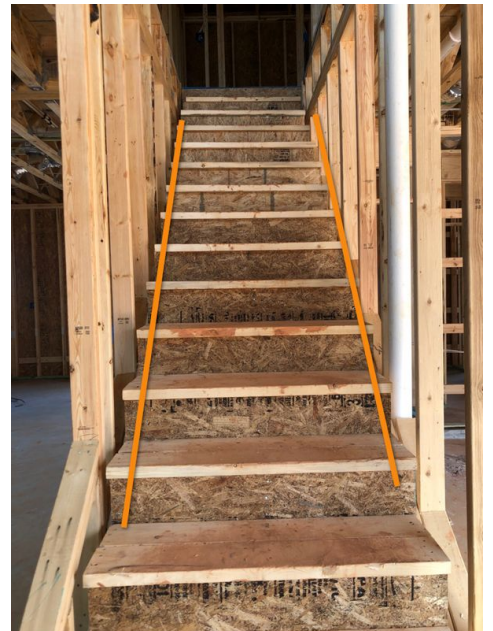
10.4.1 Stairs Properly Framed and Railing Block Installed

MISSING HANDRAIL

Contact a qualified professional.
