**1000 Sample Report  
Dallas TX 75289**

Tristan Eager  
AUGUST 17, 2018

# PROPERTY INSPECTION REPORT

Concerning: 1000 Sample Report, Dallas TX 75289

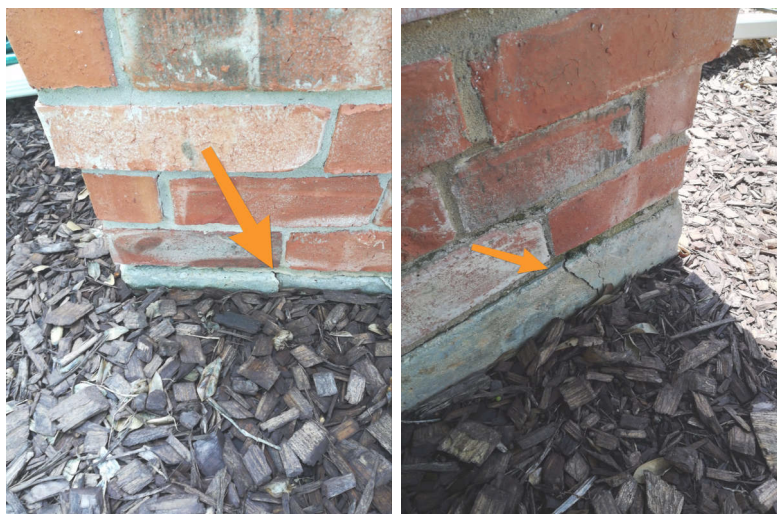
#### **1: Corner Crack**

Northeast, Northwest

Slab corner cracks are typically caused by thermal expansion of brick. As long as the bricks are adequately supported by the foundation, it is not a problem. However, if the bricks are not supported by the brick ledge (foundation) the bricks may crack or separate from wall. Recommend monitoring bricks for cracking. If brick cracking appears, professional evaluation and repair is recommended.

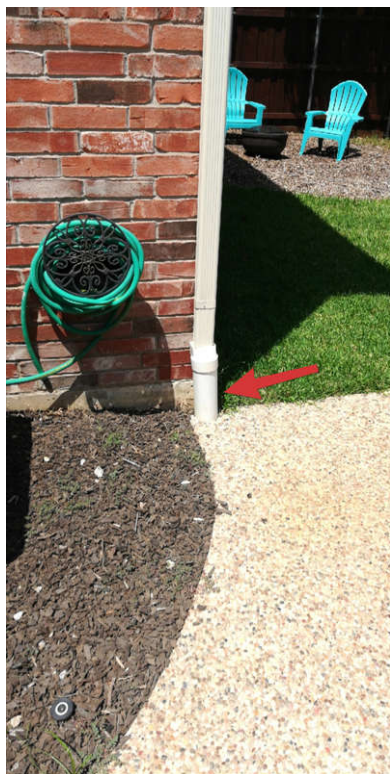
**1: Insufficient Slope away from Foundation**

North, East

Insufficient slope away from foundation. The International Residential Code requires a minimum of 6" of fall in 10' away from the foundation. This is to prevent water intrusion during rain events and to prevent soil saturation near the foundation. Foundation performance could be affected by these conditions.

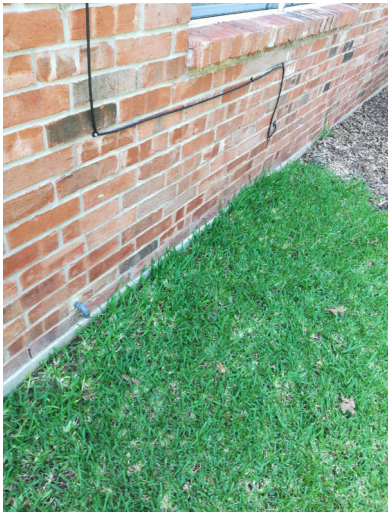
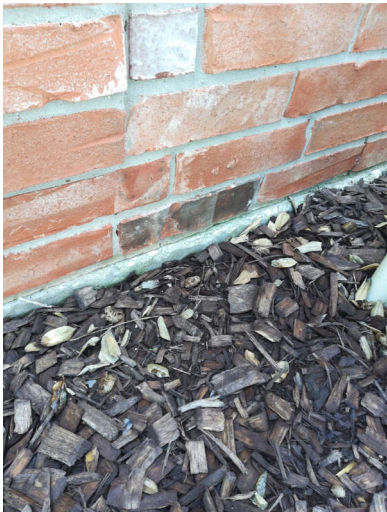
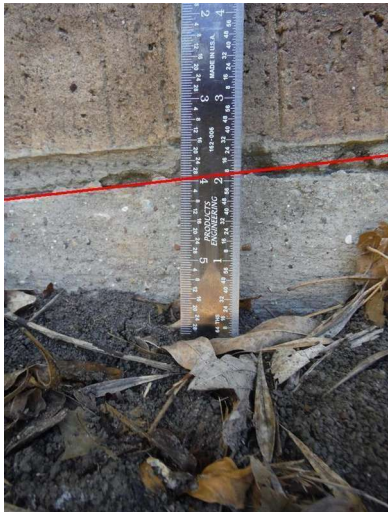
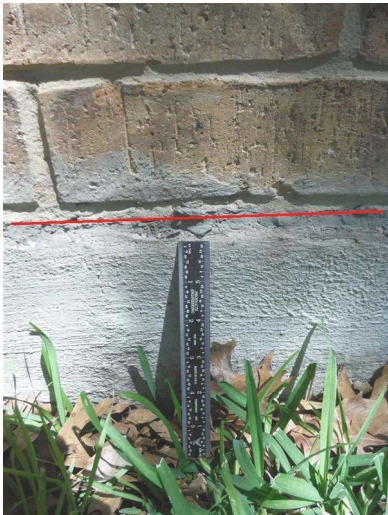
**2: High Soil Line at Masonry**

North, East

High soil line at masonry . Soil and landscaping materials need to be a minimum of 4" below the brick ledge (base of bricks) to prevent moisture and insect intrusion into walls. Brick walls are designed to be permeable to moisture and have weep holes (ventilation) at the base of the wall. Soil and plant material near the weep holes will encourage high moisture inside the wall which can lead to deterioration.

Insufficient Clearance to brickledge 2"  
(EXAMPLE)

Sufficient clearance to brickledge 6"+  
(example)

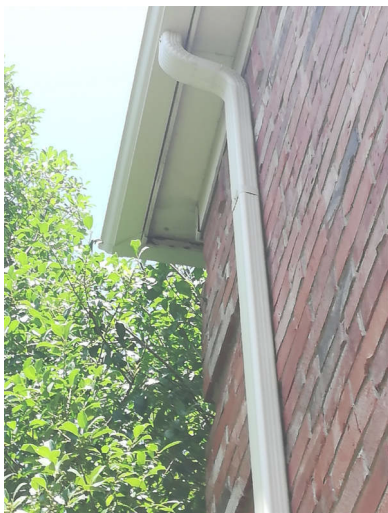
**4: Cut Back Vegetation**

Multiple Locations

Cut back all trees and plants that are touching the house. Plant material adjacent to wall, foundation and roof promote high moisture and insect intrusion.

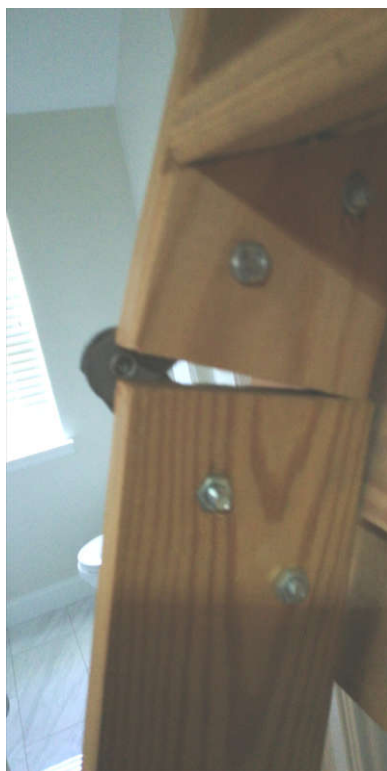
**1: Attic Ladder Legs not cut to proper Length**

**▲ Safety Hazard**

2nd floor attic

Attic ladder legs are not cut to proper length per manufacturer's installation instructions. There should not be a gap between the leg sections. This will decrease the load carrying capacity of the ladder and could make it a safety hazard.

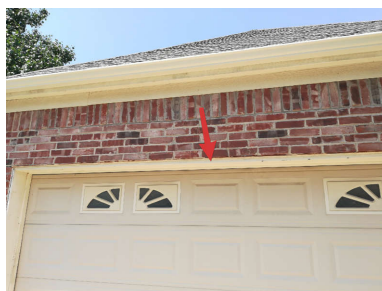
**2: Weep holes not installed above lintels**

Garage door, multiple windows, exterior doors

Weep holes help reduce moisture inside the walls and are needed to allow walls to breathe.

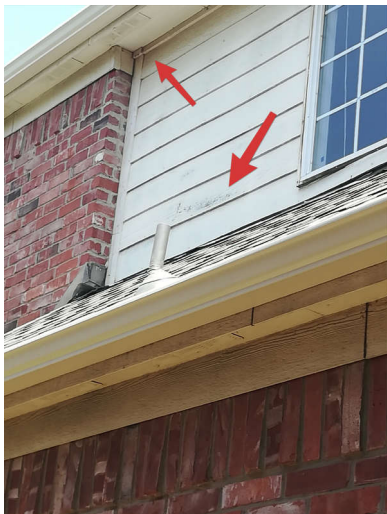
### 3: Fascia, siding and siding trim is showing signs of deterioration

Multiple Locations

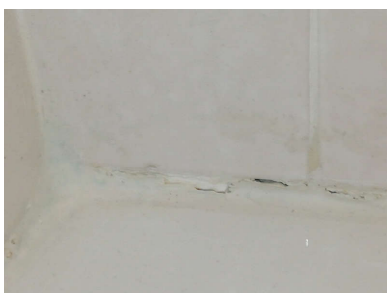
### 4: Bathtub Caulking/Grout

2nd Floor Hall Bathroom

Bathtub caulking/grout needs to be updated to prevent water intrusion.

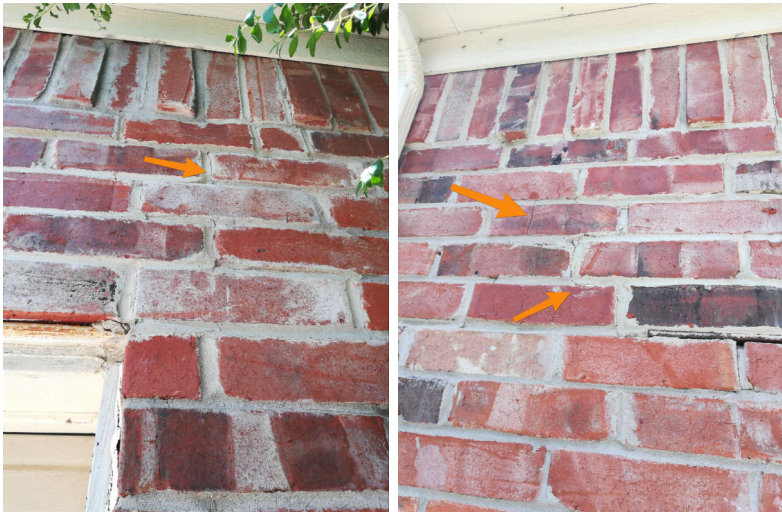
### 7: Cracking around garage door lintel

Garage

This cracking may be caused by rusting lintels. Lintels that rust can expand and cause brick cracking. Rusting lintels will eventually lose strength and can cause damage to the wall.

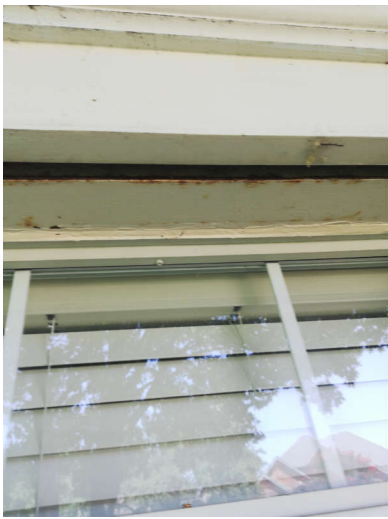
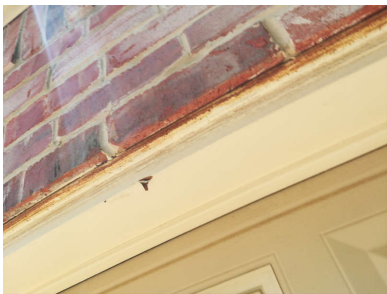
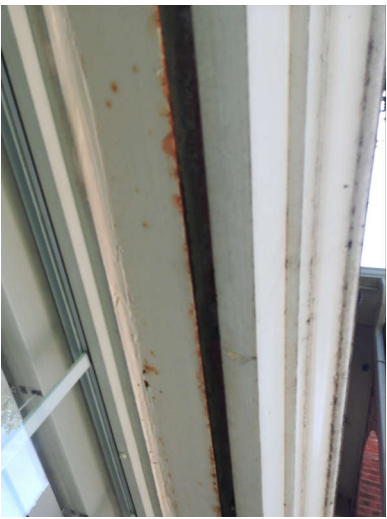
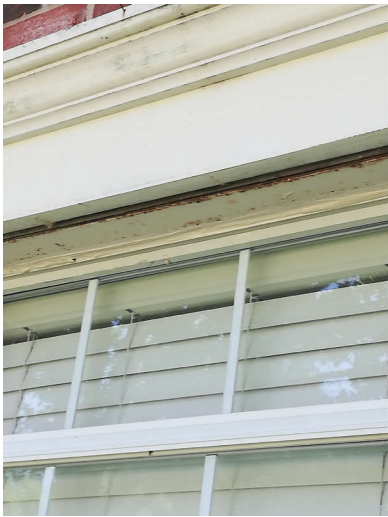
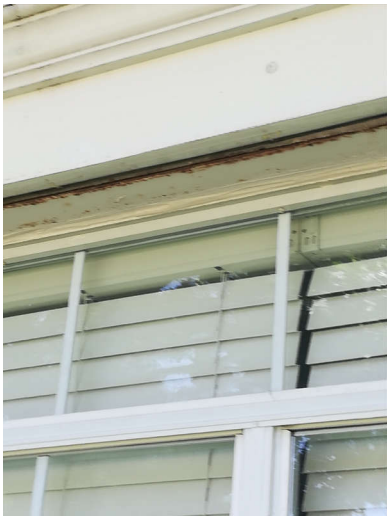
8: Rusting Lintels

Multiple windows, garage door

Rusting observed on lintel. It should be cleaned and painted to prevent further deterioration. Lintels support brick above wall openings. Lintels that rust can expand and cause brick cracking. Rusting lintels will eventually loose strength and can cause damage to the wall.

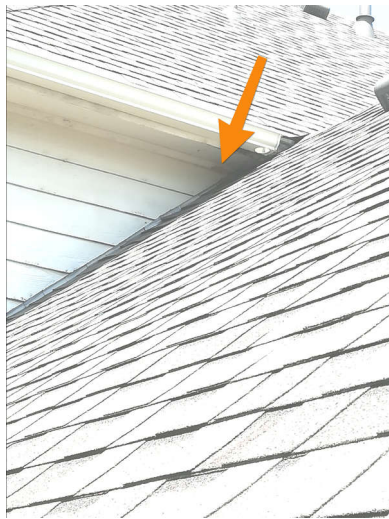
**9: Damaged soffet, possible attempted rodent entry point**

West

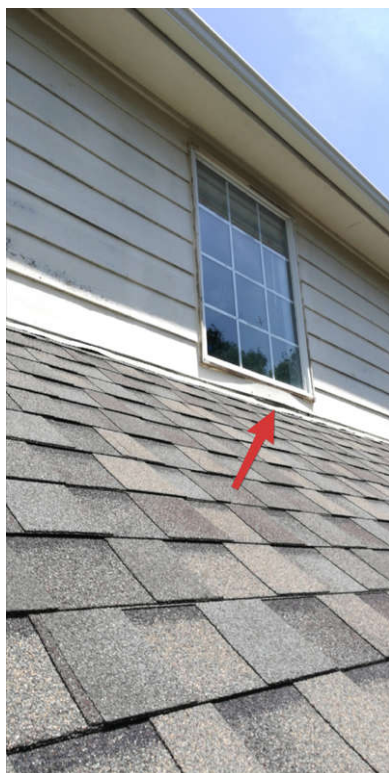
**10: Siding is warped and not flush with wall surface**

West

This could be caused by an installation defect or physical damage. This may allow water penetration into the wall.

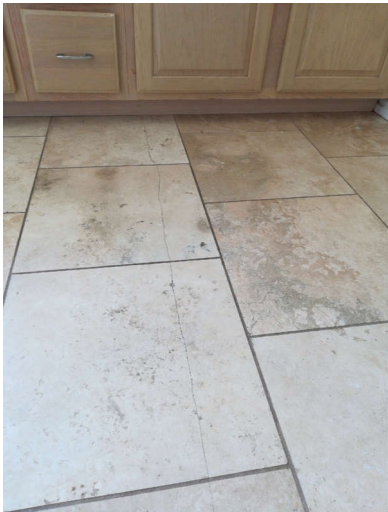
**1: Crack spanning multiple tiles**

Master Bathroom (multiple cracks)

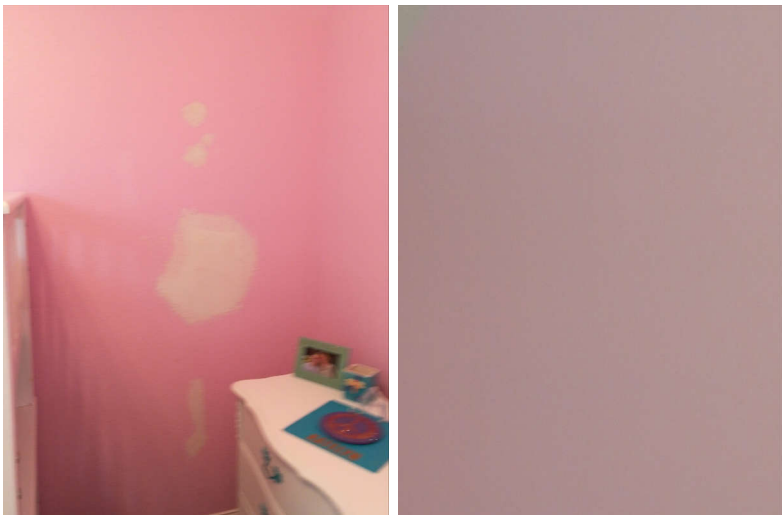
**2: Patched Nail pop observed on ceiling and wall**

Multiple Locations

Nail pops can be caused by movement of the framing. This could be caused by various conditions such as foundation movement, pallets of shingles being placed on the roof or high winds.

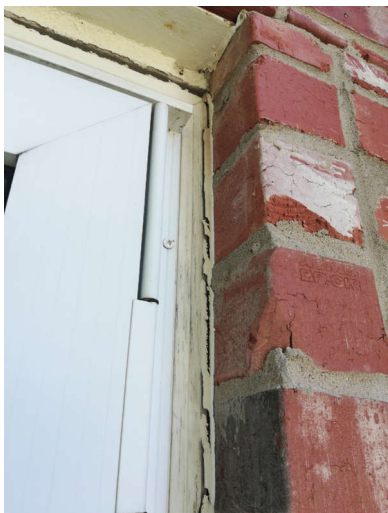
**1: Caulking needs to be updated around door**

Front door

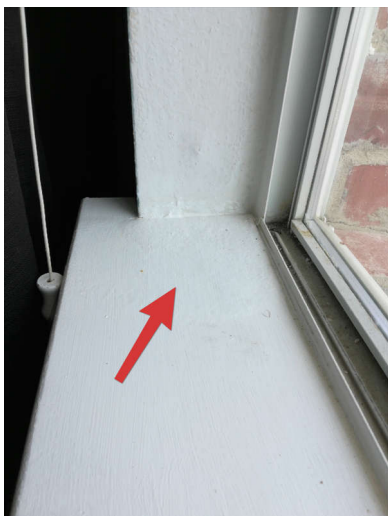
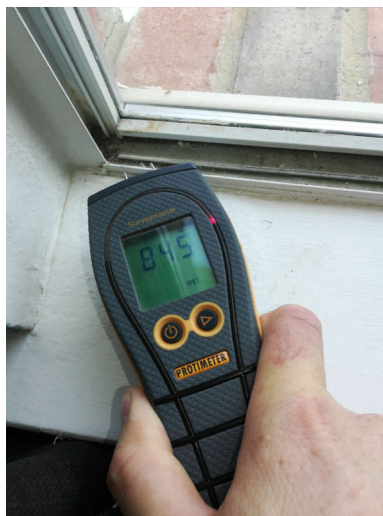
**1: Water staining and wood swelling observed on window sill**

Master Bathroom, 2nd Floor Southeast Bedroom (damp), window to left of front door (damp), game room (damp), Multiple Locations

This could be caused by a window that was left open, clogged weep holes at window framing or an improperly flashed window.

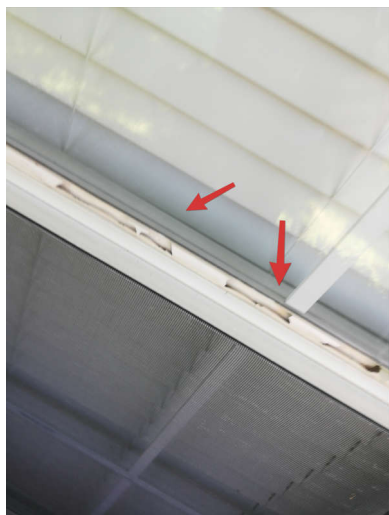
## 3: Window trim has been damaged by hail

Multiple Locations

Inspector can not determine if this defect has an effect on the life expectancy of the windows.

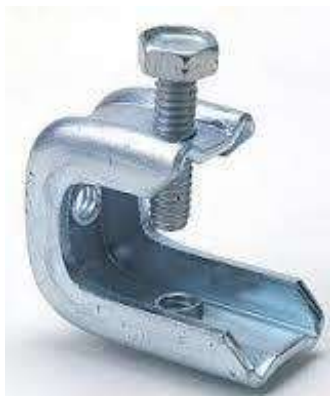
## 1: Damper clamp

▲ Safety Hazard

Fireplace damper needs a damper stop. Damper stops are required for gas fireplaces to prevent the fireplace from being operated with the damper closed. They are not required for wood burning fireplaces because a closed damper would be immediately obvious because of smoke produced by burning wood. A gas fireplace would not produce smoke, but would produce carbon monoxide, which is a safety hazard.

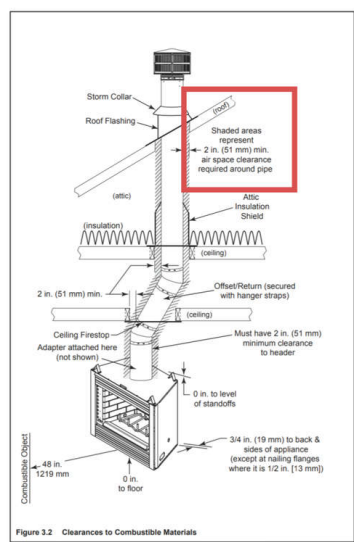
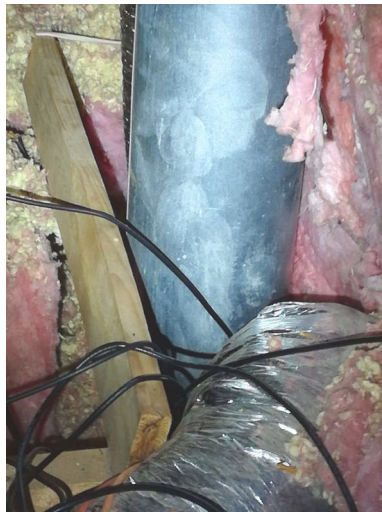
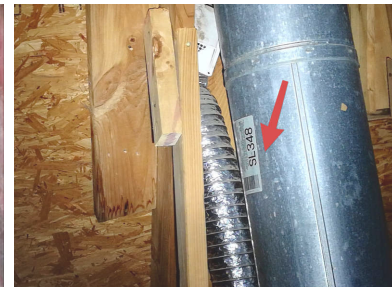
**2: Insulation in contact with fireplace vent in attic****▲ Safety Hazard**

Attic

Insulation and other materials was in contact with fireplace vent in attic. Typical double wall vents require a minimum of 2 inches of clear space around the vent. This is a fire hazard.

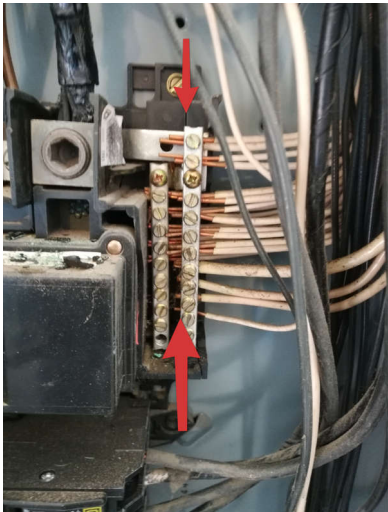
**1: Double Tapped Neutral Conductors****▲ Safety Hazard**

Garage

In the service panel, neutral conductors are double tapped. This is not allowed by code. This condition can cause over voltage conditions when the panel is being serviced.

Field reference exists for individual termination requirements in the product standards. Multiple neutral conductors in a single termination create a significant problem when the circuit needs to be isolated. In order to isolate the circuit, the branch breaker is turned off and the neutral is disconnected by removing it from the terminal. If the terminal is shared with another circuit, the connection on the other (still energized) circuit will be loosened as well. Loosening of the second neutral (line of neutral) under load is a safety hazard, and may establish an arcing condition on lighting and appliances if the neutral is part of a 120/240V three-wire branch circuit. Also, the neutral electrode is not evaluated with multiple neutral conductors in the same terminal.

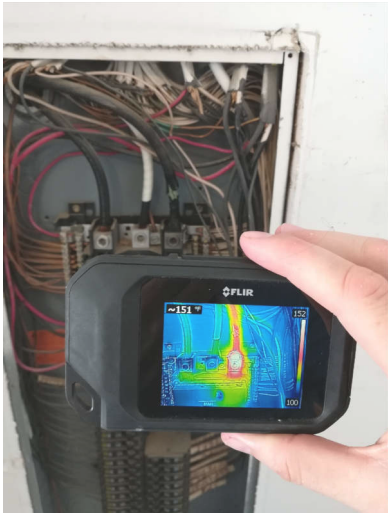
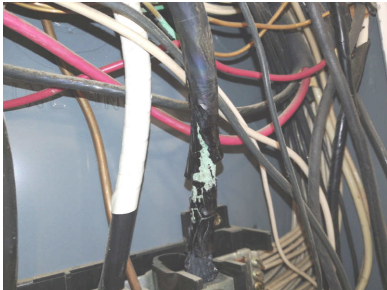
2: Service conductor is damaged and overheating

⚠ Safety Hazard

Burnned conductor and melted insulator observed at the service panel lugs. This may have previous shorted, cause of shorting is unknown. The insulation on the conductor is missing and damaged. This is a safety hazard. Additionally, the conductor is overheating. This is probably due to a poor connection at the lug. This needs to be evaluated and repaired by an electrician. This is a fire and electrocution hazard. If the insulation on the service conductor continues to deteriorate, it will short out on the service panel cover.

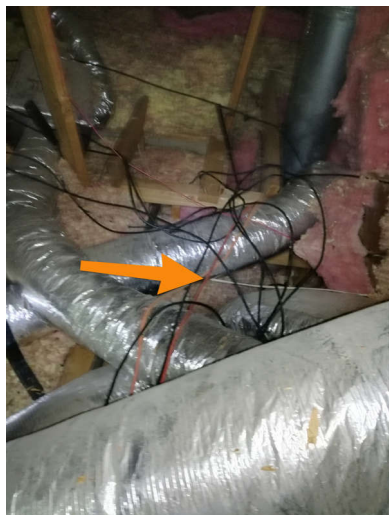
Attic

This is a building code requirement. Devices being powered by extension cord were not observed.

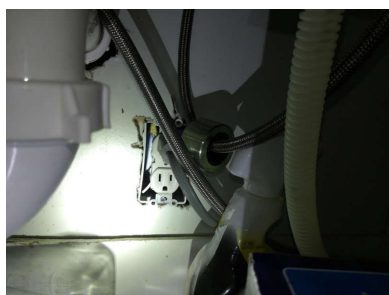
**6: Electrical outlet missing cover plate**

▲ Safety Hazard

Under kitchen sink

This is a shock hazard, especially for children.

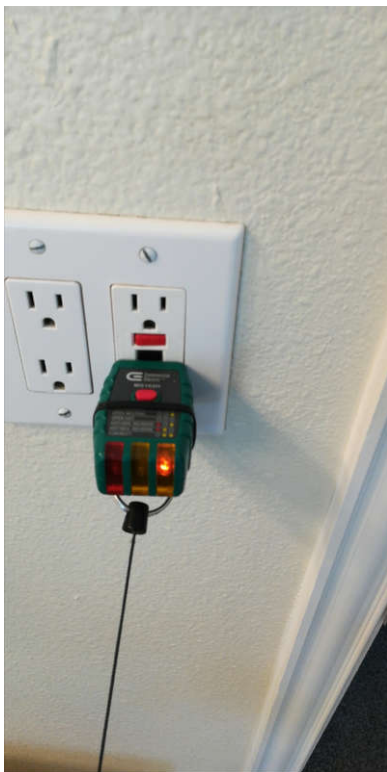
**7: GFCI outlet not properly functioning**

Master Bathroom

Tester indicated that the GFCI did not have a ground. After the outlet was manually tripped and reset. It appeared to have a ground. Outlet is not properly functioning and may not provide shock protection.

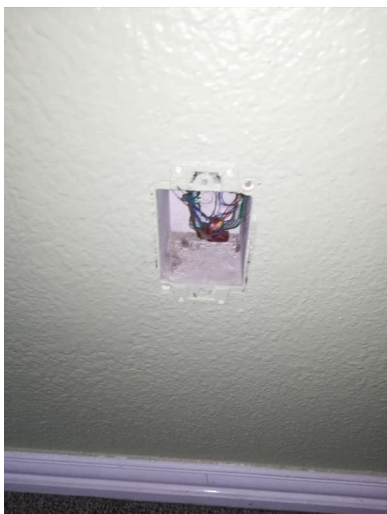
**8: Communications box is missing a cover**

2nd Floor- west wall of game room

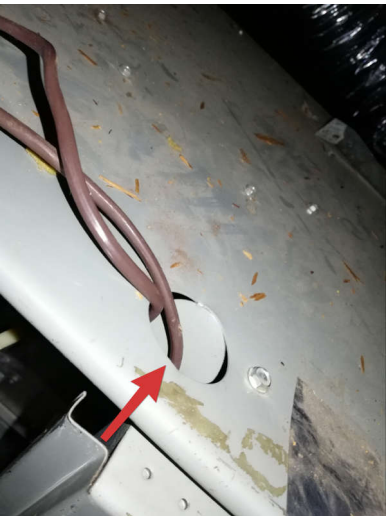
1: Wiring entering air handler is not protected with a wire clamp  
Both units

The vibrations of the air handler will cause the edges of the air handler to wear through the wiring. The wiring should be secured with a wire clamp where it enters the air handler.

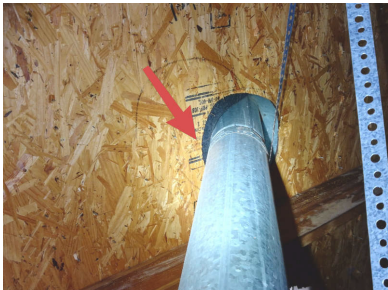
2: Type B Duct Clearances

▲ Safety Hazard

Type B combustible gas vent is in contact with roof underlayment. Type B ducts need 1" clearance to combustible materials or materials that could melt. This is a fire hazard.

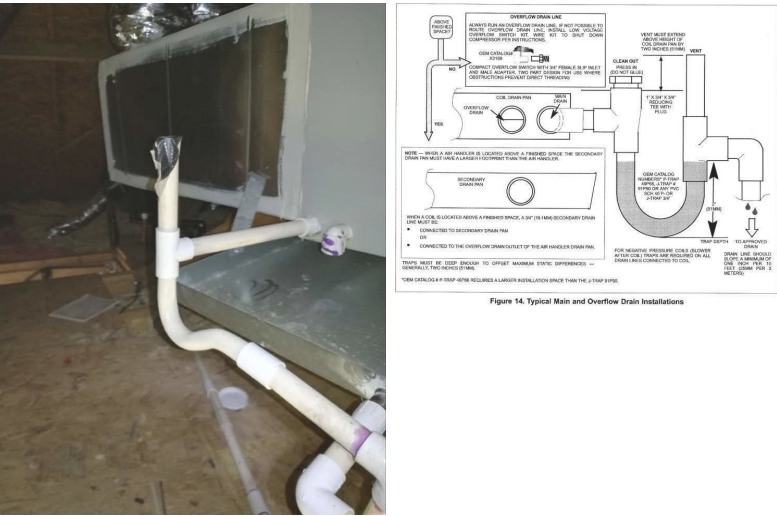
**1: P-Trap is not properly configured**  
Both units  
Vent should be installed downstream of the trap to prevent siphoning of the trap water.

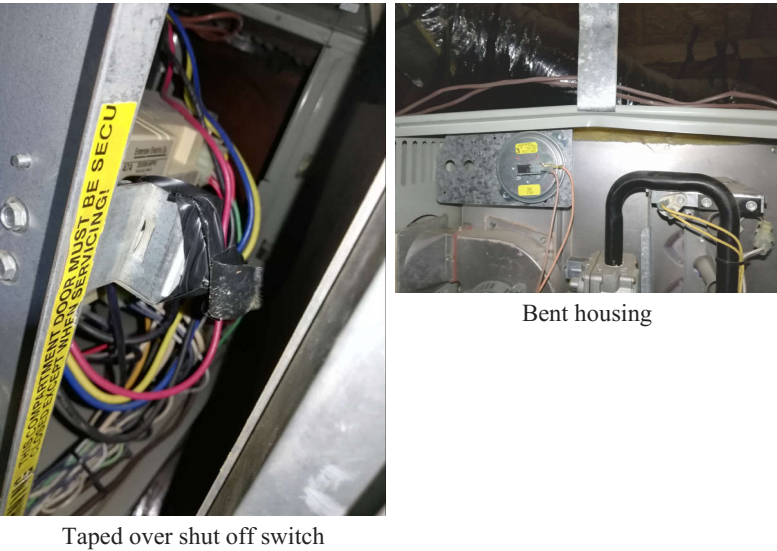
**1: Blower door does not seal**  
Both units  
Blower door does not adequately seal. Shut off switch has been taped over to prevent unit from shutting off for downstairs unit. Housing has been bent which may be the source of the problem. This will allow unfiltered air into the unit and can clog the evaporator and heat exchanger. Professional evaluation and cleaning is recommended.

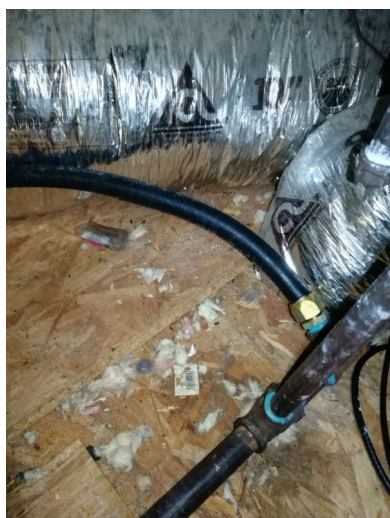
▲ Safety Hazard

Typically CSST is a yellow gas line. There are newer products (black CSST) that are superior to the older yellow CSST. The improvements to the newer CSST include greater resistance to burn through in the event of an indirect lightning strike. The black CSST that is installed does not appear to be directly bonded. This is an important safety upgrade that can prevent fires. In the event of a lightning strike, bonding allows electricity to bypass the CSST. Unbonded CSST will conduct electricity, but its metal liner can melt and result in a fire.

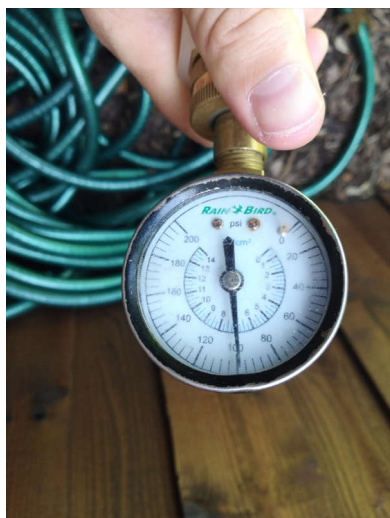
### 2: High Water Pressure

Water pressure was in excess of 80 PSI . This is the maximum pressure allowed by code. This will place additional stress on flexible water lines and appliances. Consider installing a pressure regulator and expansion tank.

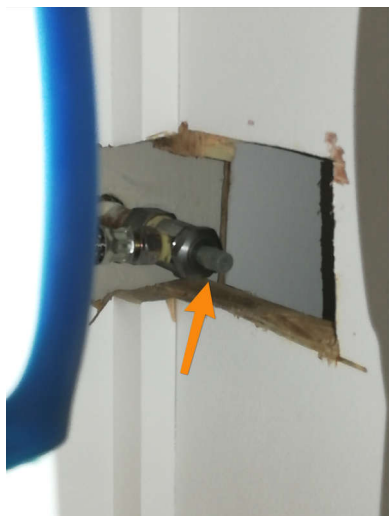
**4: Valve handle not installed**

2nd Floor Hall Bathroom (2 valves)

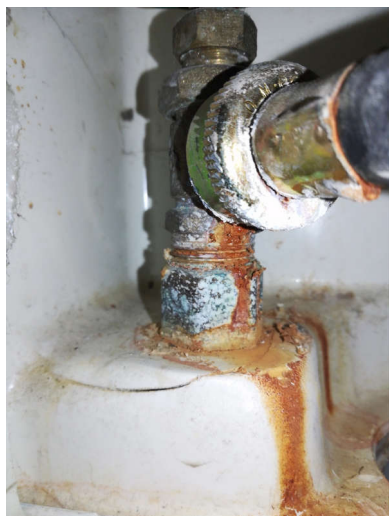
**6: Corrosion at washing machine connections**

May have previously leaked based in staining

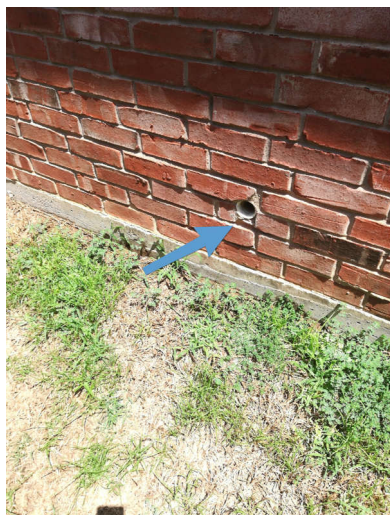
West

This is an access port for servicing the sewer lines. It should be capped to prevent sewer gases from escaping and to keep foreign objects out of the sewer.

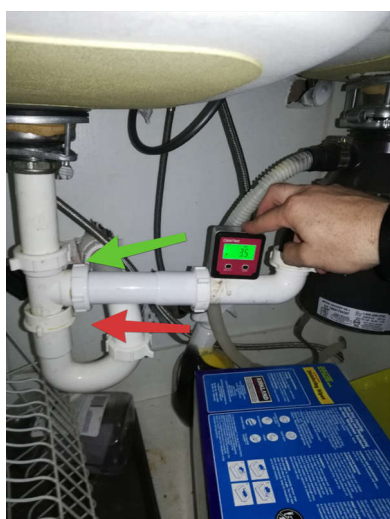
### 2: Drain pipe needs to slope downward

Kitchen sink

Drains need to slope continually downward to prevent ponding water and sediment deposit.

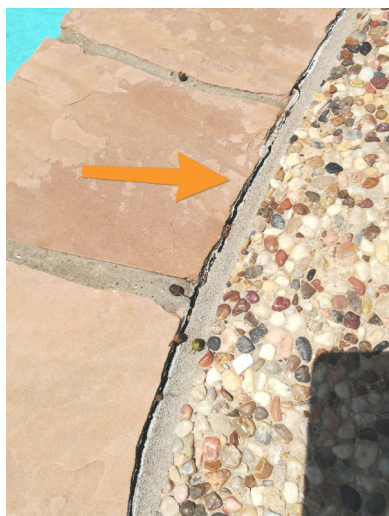
### 1: Expansion Joint Needs Repair

The expansion joint between the perimeter coping and pool deck is not filled with sealant. Caulking prevents the expansion joint from filling with debris. If the joint is filled with debris or water it can damage the coping and pool deck.

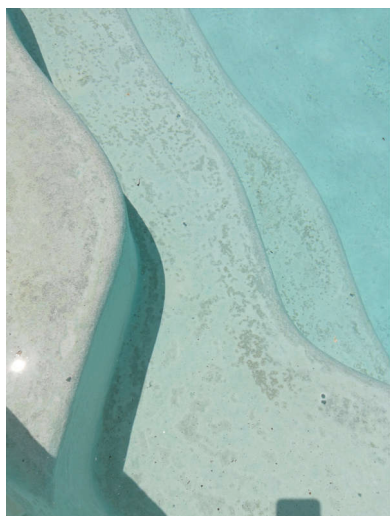
### 1: Plaster Aging

Plaster is showing signs of pitting and is rough. This is part of the plaster aging process. Plaster needs to be periodically replaced to prevent water from leaking through the concrete liner.

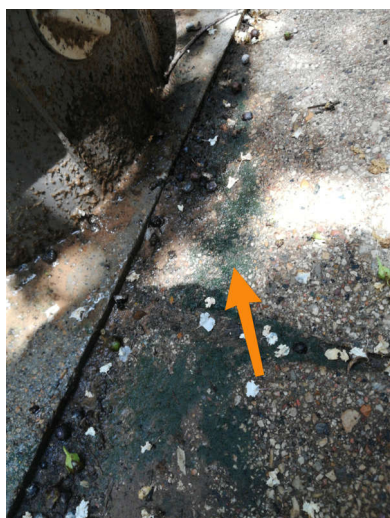
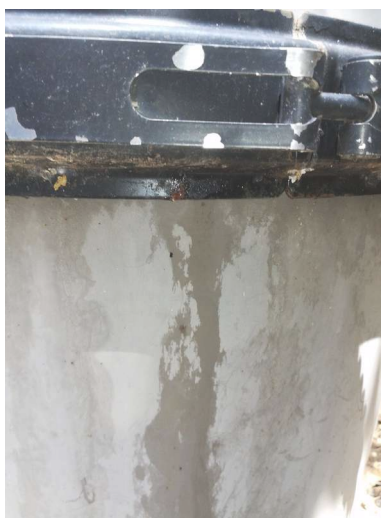
### 1: Leak observed at filter

Algae
