MOUNTAINS TO SOUND HOME INSPECTION LLC

HOME INSPECTION REPORT COPY

1806 S 9th St
Tacoma WA 98405

Jennifer Garner
SEPTEMBER 4, 2019

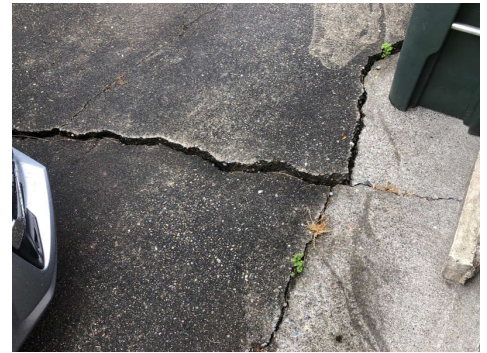
LARGE DRIVEWAY CRACKS

Large driveway cracks were observed. This is most likely due to improper installation or unstable soil. Recommend repair or replacement.

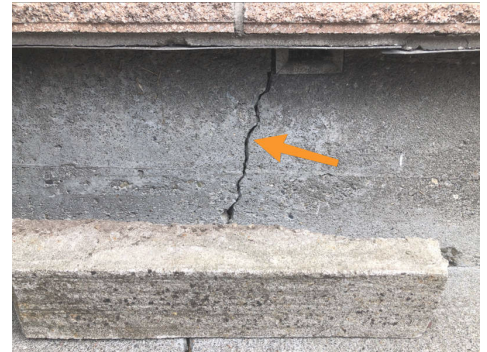
3.6.1 Foundation as Viewed from the Exterior

PATCHED CRACK (MODERATE)

a moderate sized foundation crack was patched. Recommend monitoring.

Contact a qualified professional.

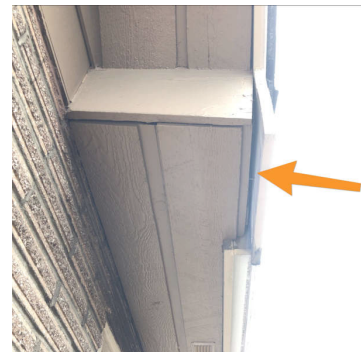
3.7.1 Fascia, Trim & Eaves

One or more gaps in the eaves were observed. Recommend sealing to prevent pest intrusion.

Contact a qualified professional.

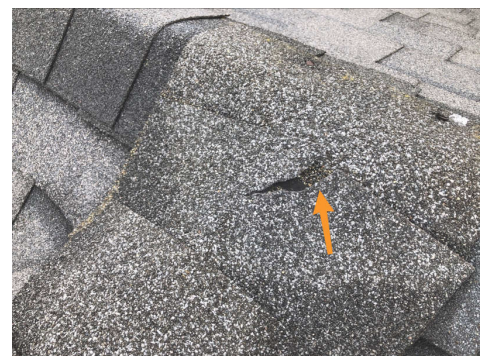
DAMAGED SHINGLES

There were one or more damaged shingles. Recommend repair.

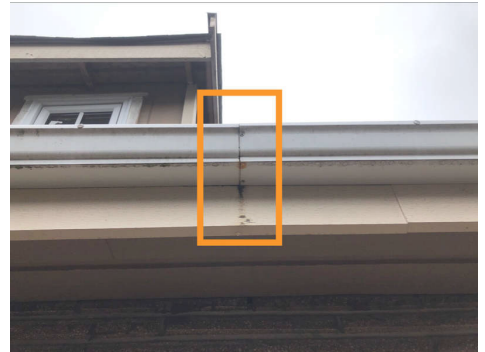
4.6.2 Gutters & Drainage

**LEAKING GUTTER**

The gutter was leaking. Recommend repairs to prevent further leaking.

Contact a qualified professional.

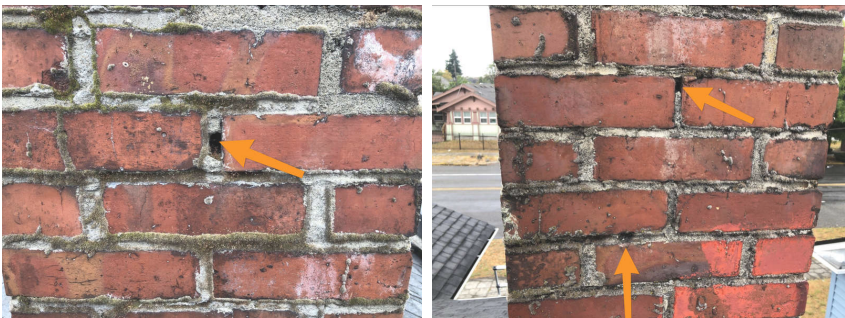
4.7.1 Chimney On Roof & Photo

**LOOSE MORTAR**

The exposed sections of the exterior of the chimney needs re-pointing (tuck-pointing) due to having loose or deteriorated mortar joints. Repair of old and or eroded mortar joints is known as re-pointing and is recommended.

Contact a qualified professional.

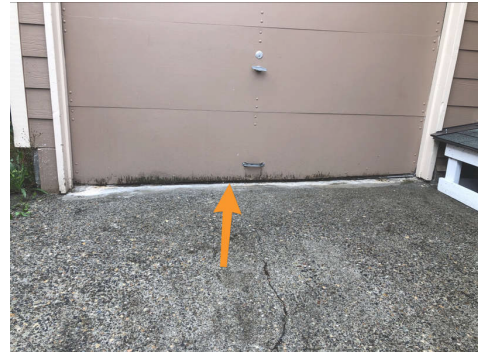
5.3.2 Garage Door & Hardware

GARAGE DOOR MOISTURE DAMAGE

The bottom edge of the garage door has some moisture damage. Recommend repairs or replacement as needed.

Contact a qualified professional.

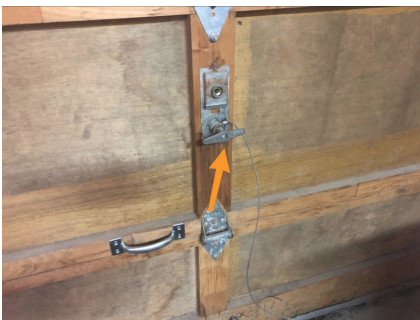
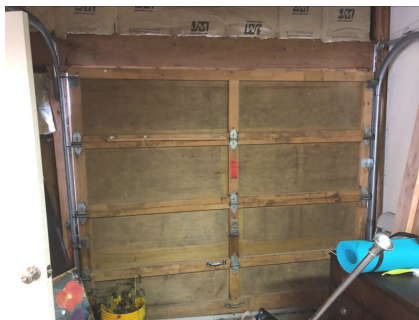
5.3.3 Garage Door & Hardware

BROKEN LOCK

The garage door lock is broken and the door does not stay open. Recommend repairs.

Contact a qualified professional.

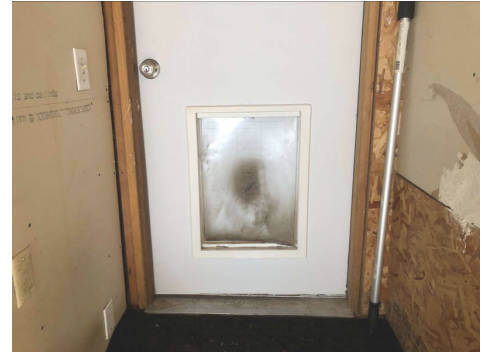
5.4.2 Entry Door Into the House

PET DOOR

The pet door installed in the main entry door eliminates the doors function as a fire rated door. We advise repair or replacement of the door to return it's use as a fire rated door.

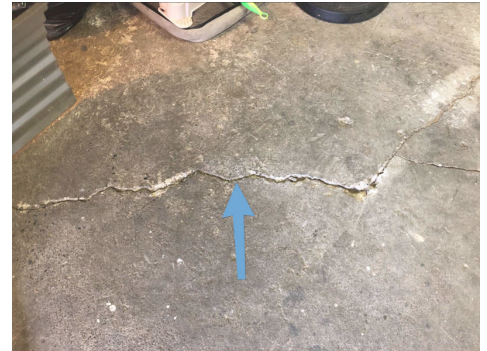
5.5.1 Slab Floor

GARAGE FLOOR CRACKED- FURTHER EVALUATION

The garage floor is cracked and further evaluation is recommended.

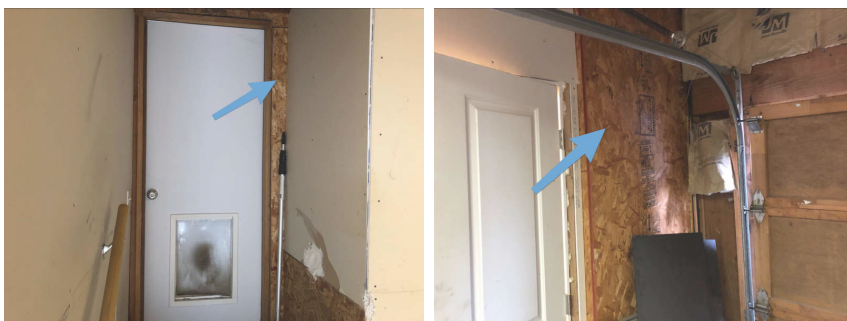
5.8.1 Firewall Separation

THE VOIDS IN THE GARAGE FIREWALL MUST BE REPAIRED

The voids in the garage firewall must be repaired, in order to maintain the necessary firewall separation between the garage and the residence.

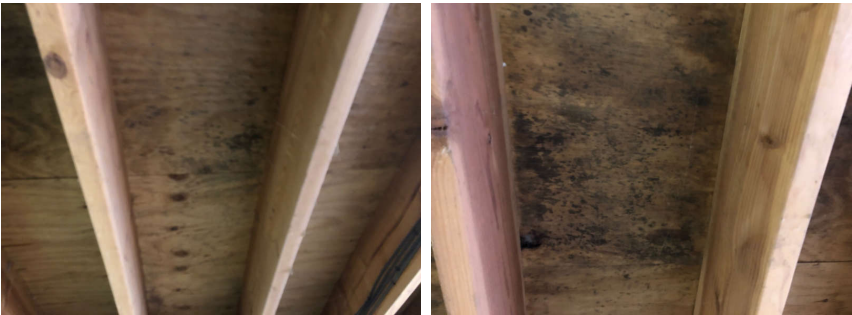
5.9.1 Walls and Ceiling

MOISTURE STAIN ON THE CEILING

There is a small moisture stain on the ceiling that should be monitored and serviced as necessary. I recommend at least locating and correcting the leak source and repairing affected areas as necessary.

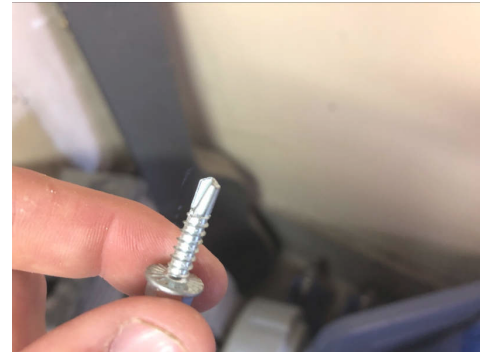
6.4.2 Panel Cover Condition

POINTED OR IMPROPER SCREWS

The main electrical main interior panel cover includes pointed or improper screws which should be replaced with ones appropriate for electrical use. This is important to help prevent damage to wiring within the panel.

Contact a qualified electrical contractor.

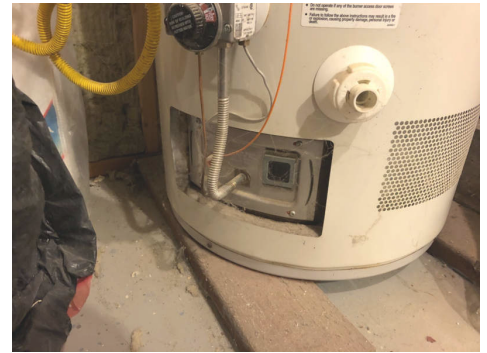
8.1.2 Water Heating System

MISSING FLAME COVER

Contact a qualified professional.

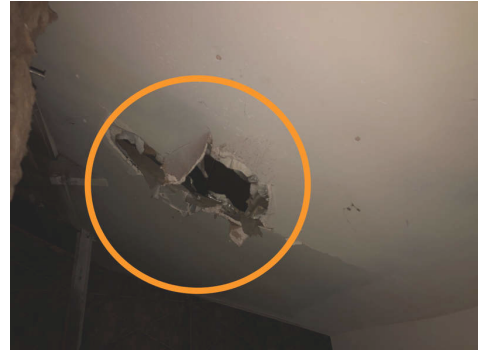
13.4.1 Walls and Ceiling

WALL/CEILING DAMAGED

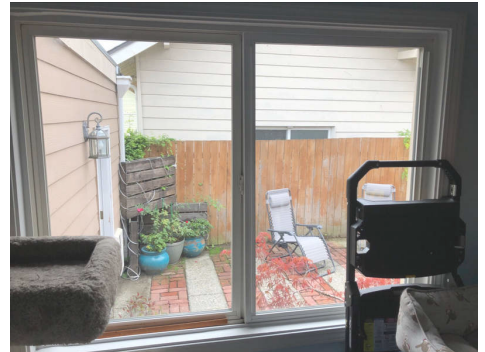
13.5.1 Windows

SCREENS DAMAGED/MISSING

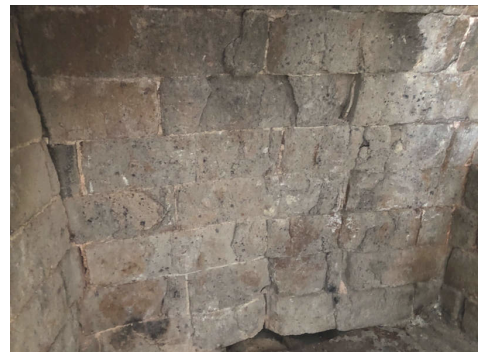
13.9.1 Fireplace Notes

MINOR FIREPLACE CRACKING

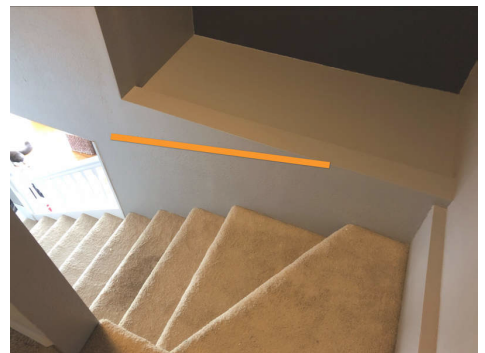
13.10.1 Handrails & Guardrails

NO HANDRAIL ON THE STAIRS

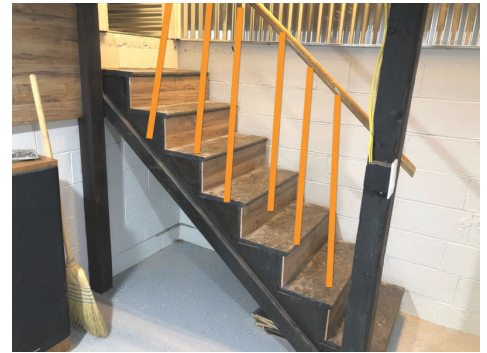
13.10.2 Handrails & Guardrails

MISSING BALUSTERS

Contact a qualified professional.

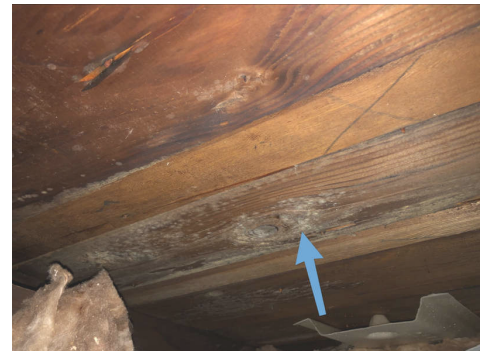
**Low Priority****DECK STAINING**

Discoloration and dark staining was observed on the roof sheathing. This is often caused by poor ventilation and is commonly considered a microbial growth. Recommend improving ventilation and cleaning.

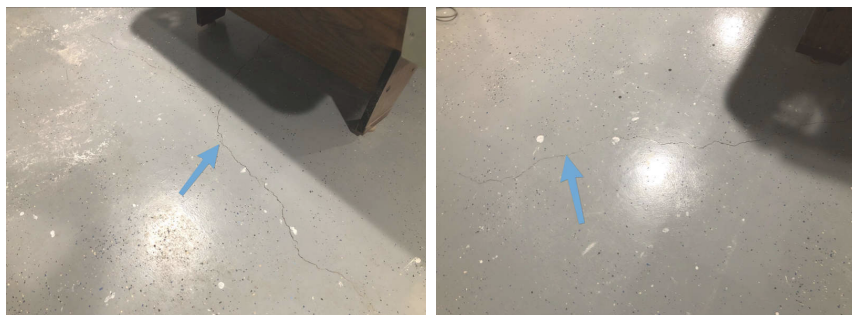
15.3.1 Basement

BASEMENT FLOOR CRACKS

Contact a qualified professional.
