## FOUR POINT INSPECTION

3251 NW 66th St  
Fort Lauderdale FL 33309

Keith Grant  
JANUARY 12, 2019

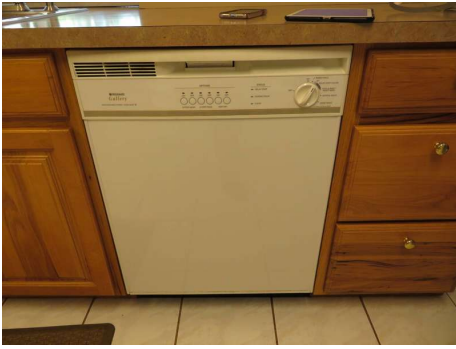
## Deficiencies

Dishwasher has a leak and was inoperable during inspection.

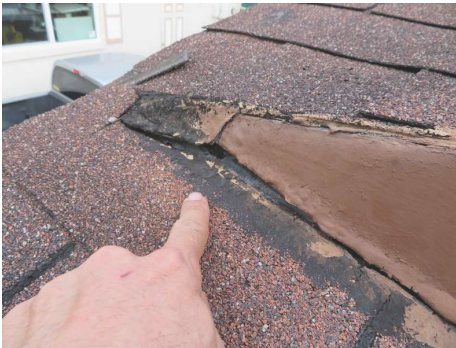
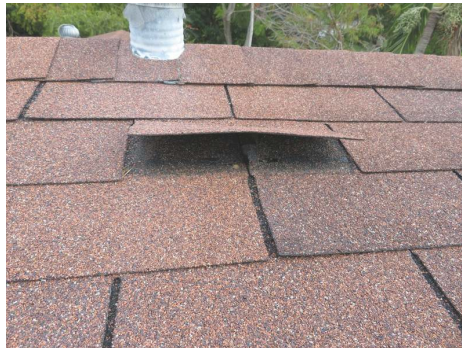
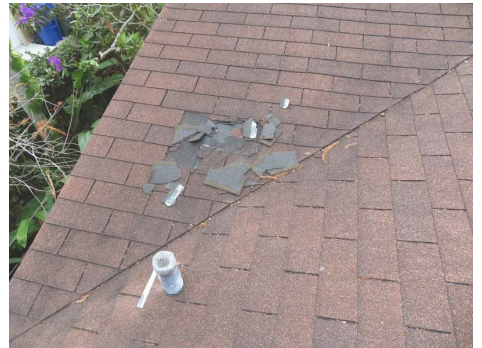
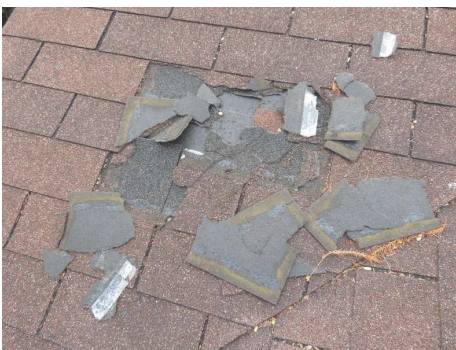
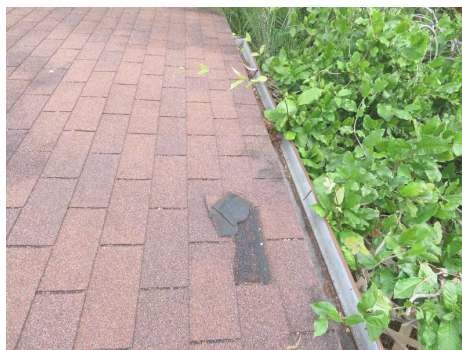
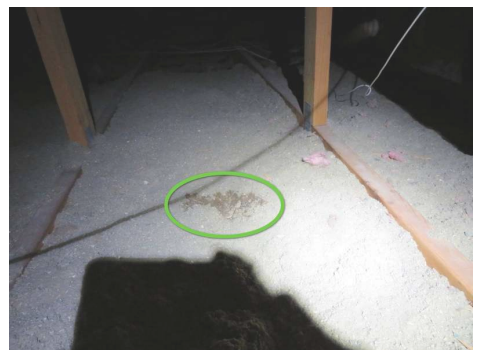
## Deficiencies

Sign of leak in attic due to discoloration on insulation that corresponds to area of ripped shingle.
