ELEVATE HOME INSPECTION

123 Court St
Columbus OH 43221

NOVEMBER 4, 2021

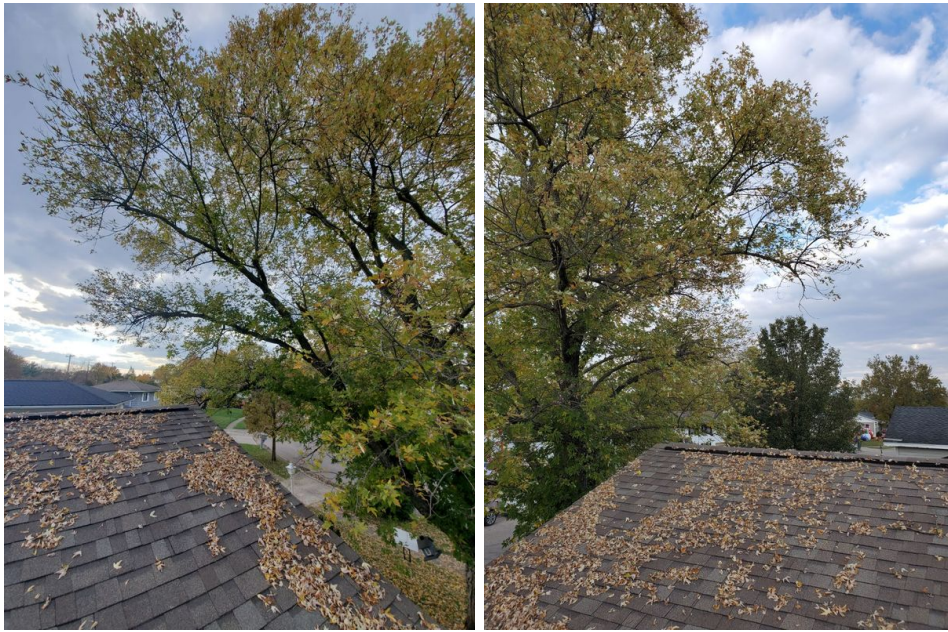
We observed that a tree/branch was overhanging the roof and may be in contact with it. This can damage the roofing system and allow pest entry into the house.

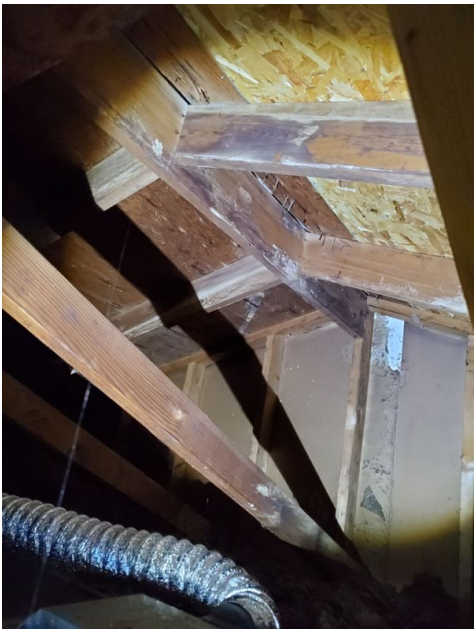
We observed indications of organic growth in the attic. We recommend that this area be further evaluated by a qualified mold professional. This is a safety concern.

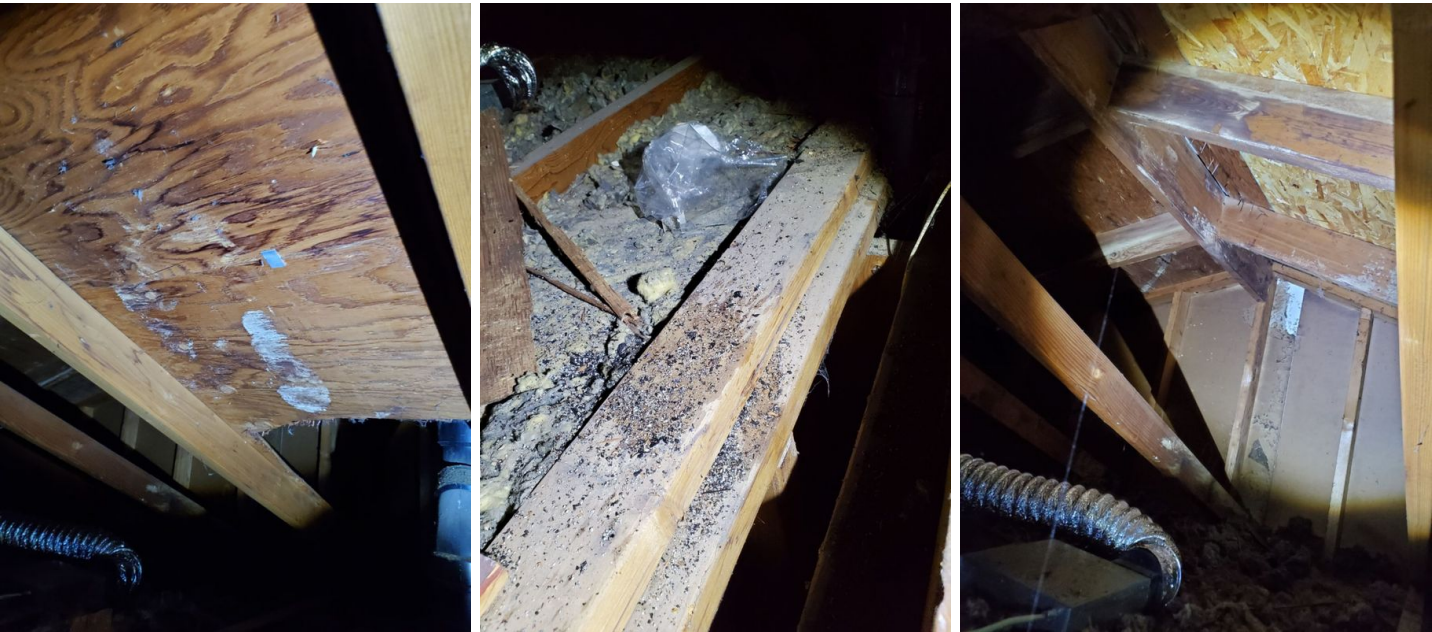
4.1.2 Structure

SIGNS OF PAST WATER ISSUES

We observed indications that sometime in the past there was likely water penetration into the attic. At the time of the inspection, an active leak in this area was not observed, but we recommend you ask the seller about this area and monitor this area closely to ensure that any water issue has been fully corrected.

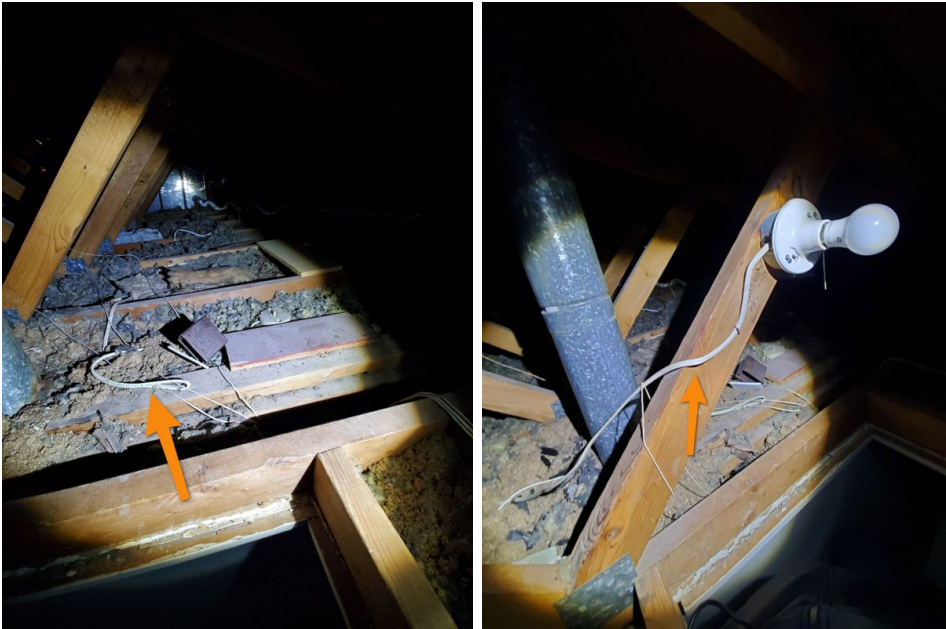
4.1.3 Structure

LOOSE/UNPROTECTED ELECTRICAL

We observed loose electrical lines near the attic access that were exposed and unprotected. This is a safety concern.

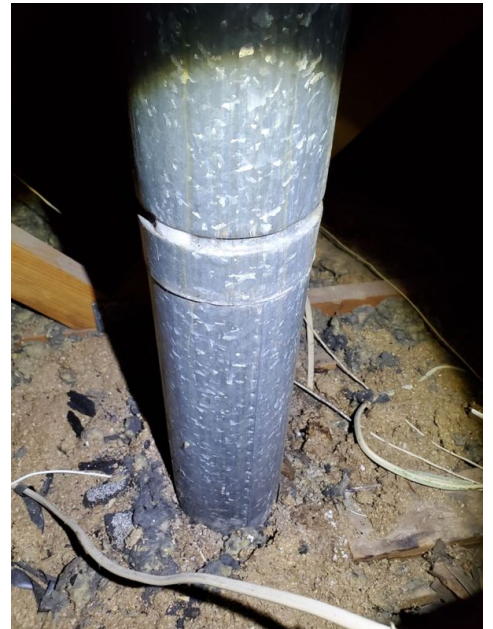
4.2.1 Insulation

CONTACT HAZARD

We observed that combustible insulation was in direct contact with a vent, component, or system that is not rated for contact with combustibles. This is a safety concern and fire hazard.

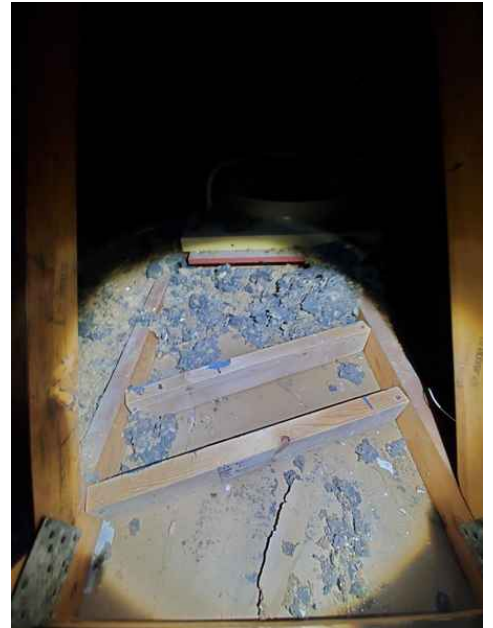
We observed sections of insulation that were damaged and/or improperly installed. It is not likely to function as intended.

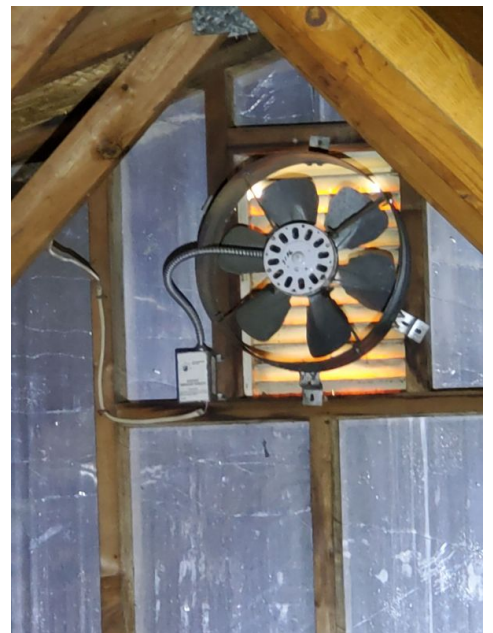
4.3.1 Ventilation

ATTIC FAN INOPERABLE

We observed that the attic fan was inoperable at time of inspection.

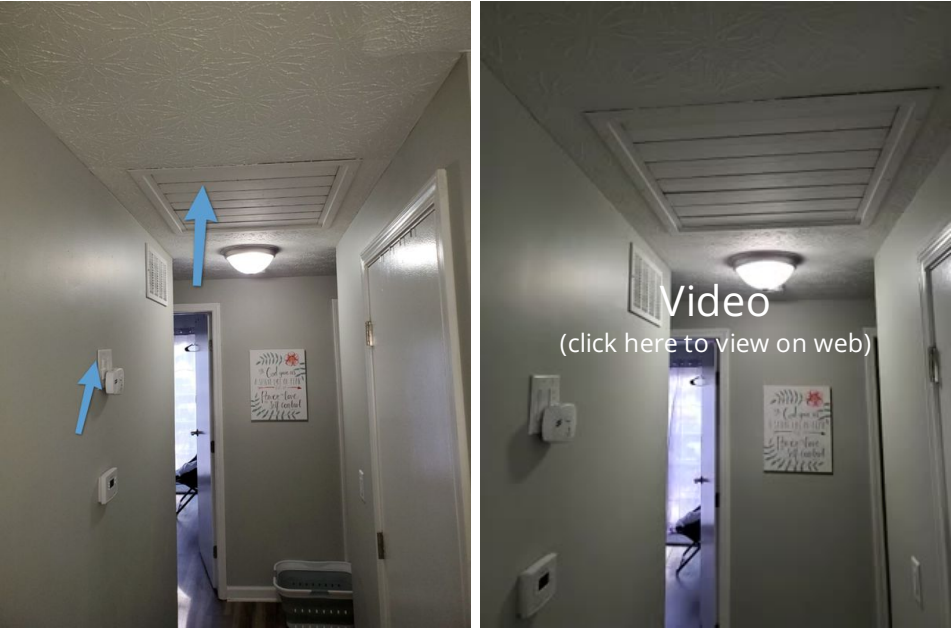
We observed that the whole house fan was inoperable or damaged at time of inspection.

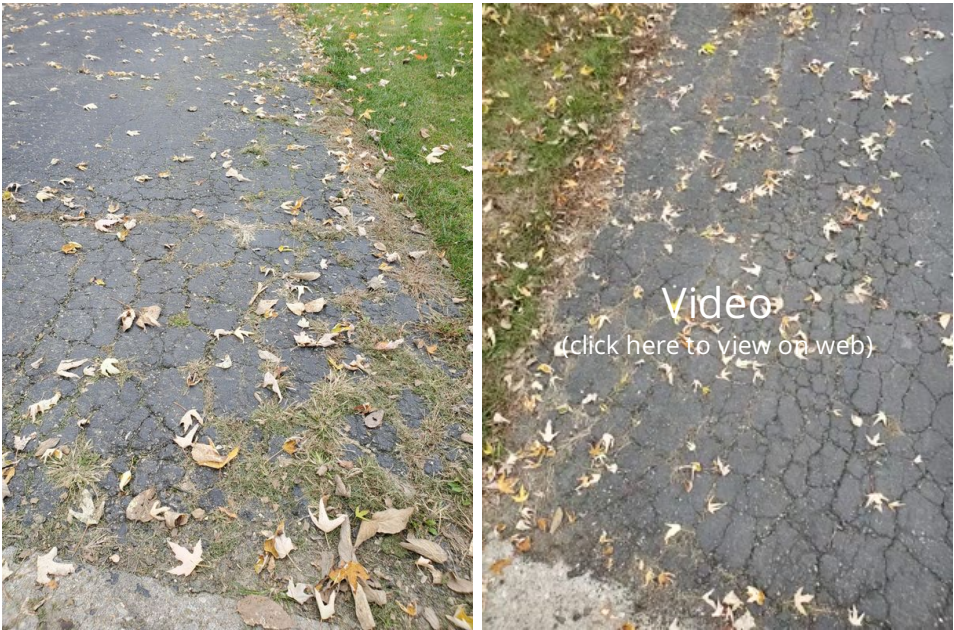
CRACKS

We observed cracks on a hard surface indicating that the cracked section of the surface may be near the end of its useful life. We recommend sealing the cracks and monitoring these areas for additional movement.

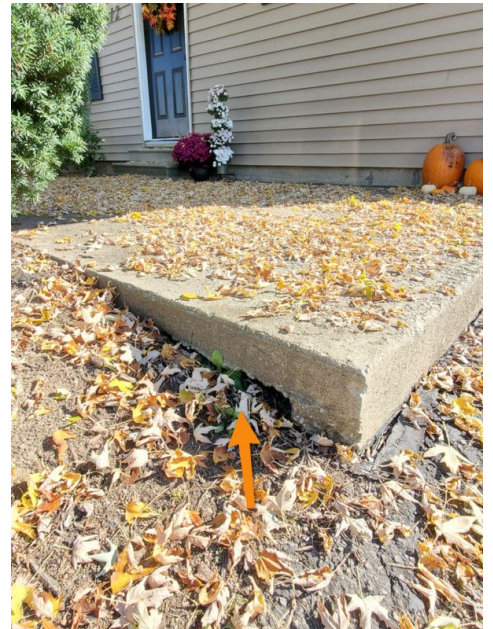
We observed an area of hard surface where the soil has washed out/eroded the ground underneath. This should be backfilled to prevent cracking and potential safety issues.

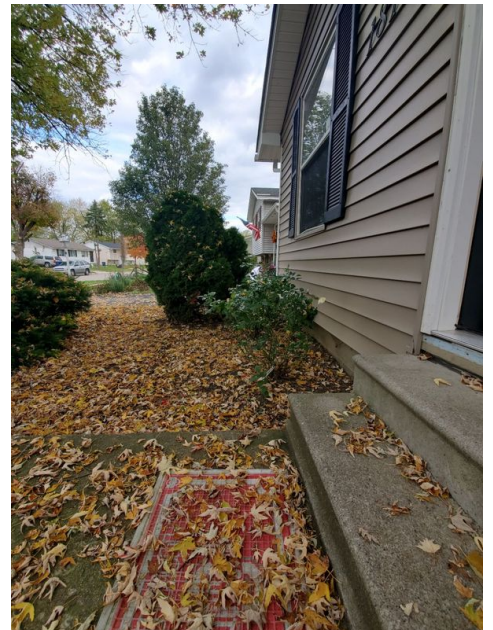
We observed grading that is flat or sloping towards the home. This could lead to water intrusion and foundation issues. The ground around a house should slope away from all sides, ideally at least 6 inches within the first 10 feet from the house's foundation.

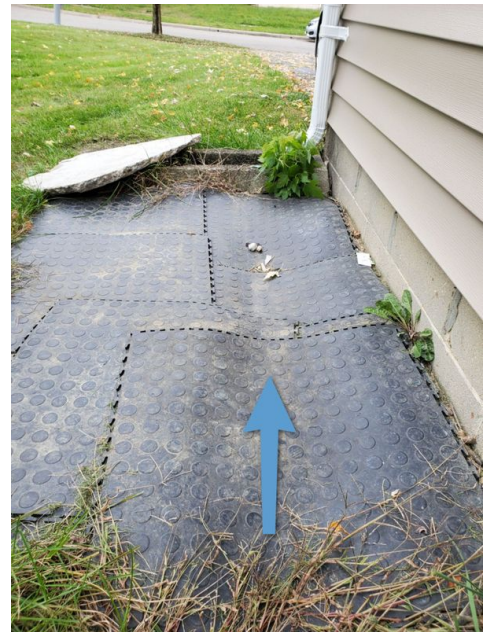
We observed water puddles/areas that will hold water on the ground surface near the house foundation. There shouldn't be any areas that allow standing water. The ground surface should be properly sloped in order to drain away the surface water.

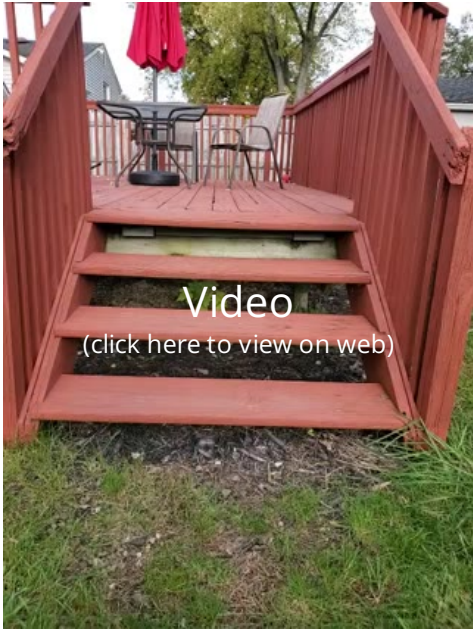
5.8.1 Stairs, Ramps, & Handrails

TRIP HAZARD

We observed a trip hazard, which we consider for cracks on walking surfaces with vertical displacement 1 inch or more, or improper riser heights of steps. This condition is a safety concern.

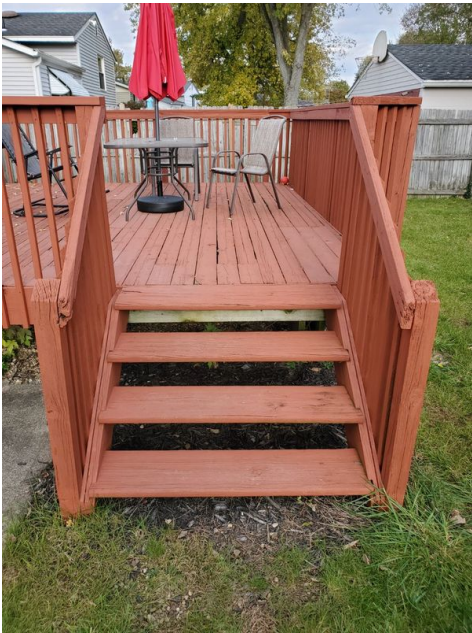
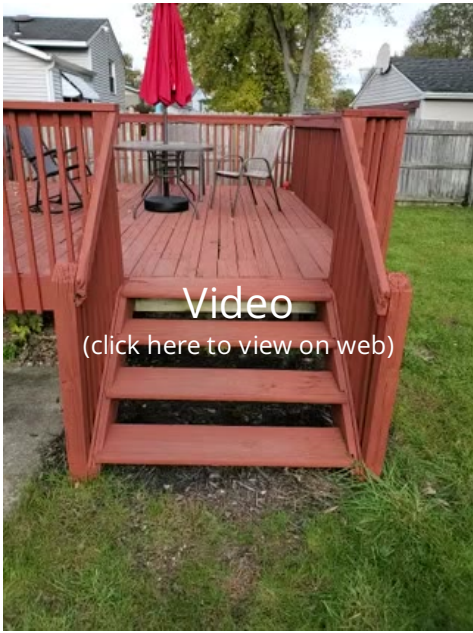
5.8.2 Stairs, Ramps, & Handrails

HANDRAIL MISSING

We observed a missing handrail at exterior steps. Steps with 4 or more risers require a handrail. This is a safety concern.

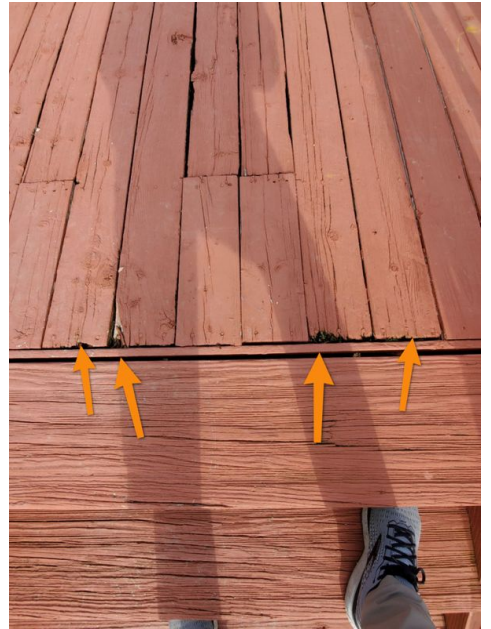
5.9.1 House-Adjacent Structures

WOOD ROT

We observed wood rot at the deck. This is a safety concern.

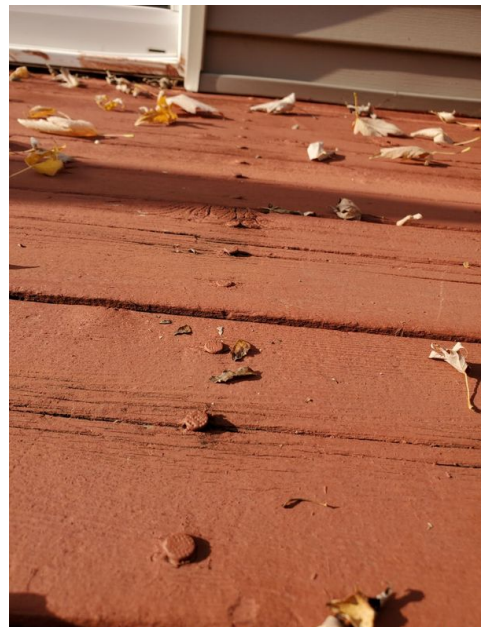
5.9.2 House-Adjacent Structures

DECK NAILS EXPOSED

We observed nails exposed and elevated above the deck surface. This is a safety concern.

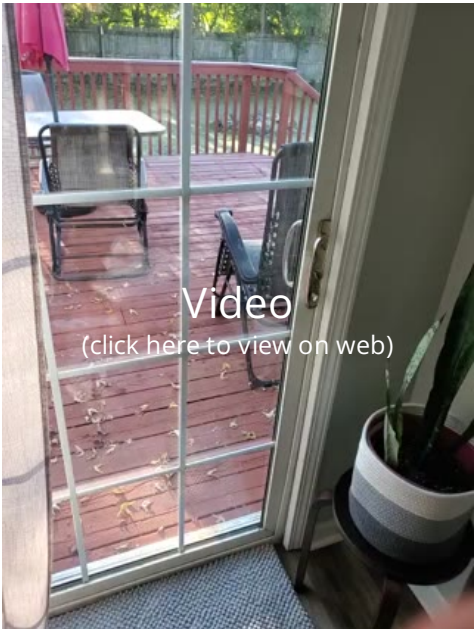
5.13.1 Exterior Doors

SLIDER DOOR DEFECT

We observed a defect at the slider door that affects its ease of use and/or security.

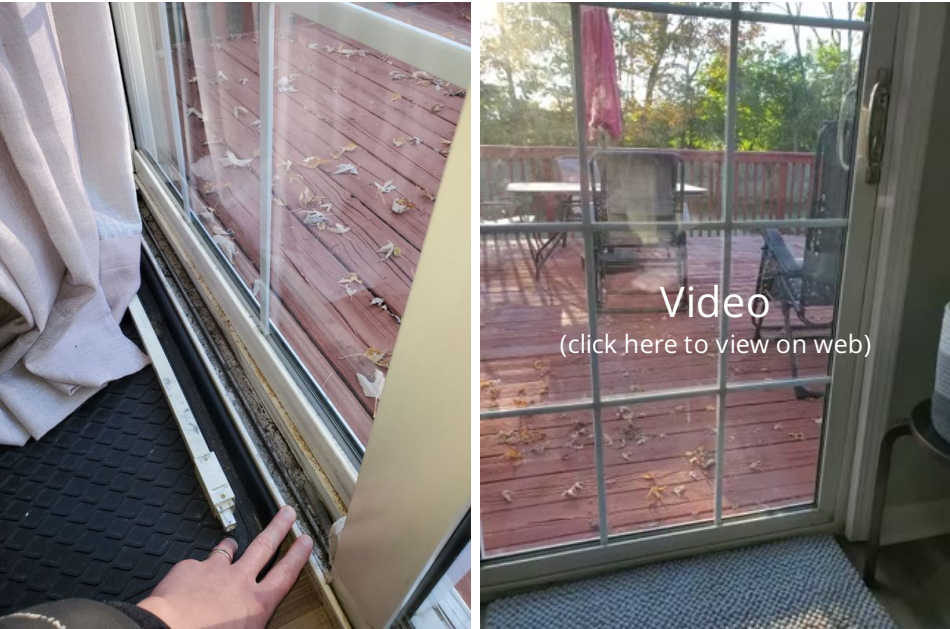
5.13.2 Exterior Doors

SLIDER DOOR WATER ENTRY LIKELY

We observed indications that water may be penetrating through the sliding door system. We recommend you monitor this area and seal any potential water entry points.

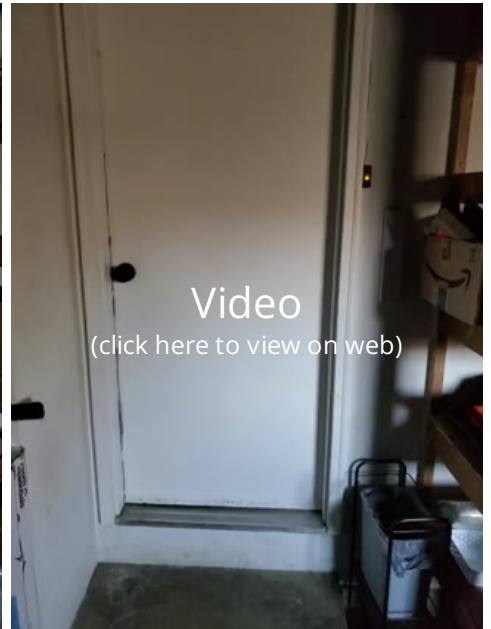
We observed that the door between the garage and the house was not self-closing. This is a safety concern. We highly recommend a closer or self-closing hinges be installed to keep harmful fumes out of the home and maintain an intact fire-separation wall.

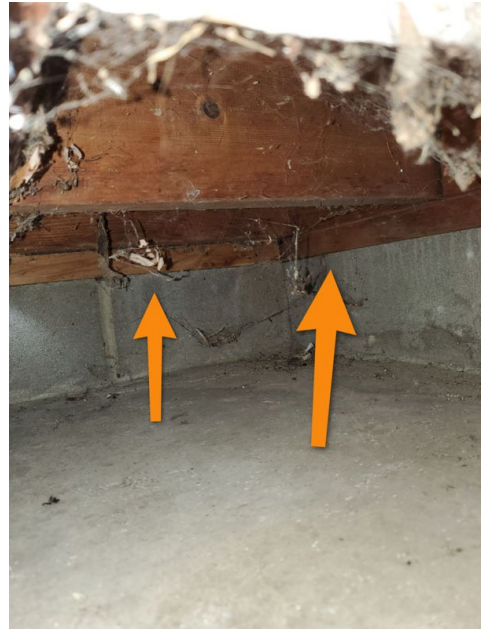
6.3.2 Garage Interior

FIRE-SEPARATION BREACH

We observed a breach/deficiency in the garage fire-separation wall. There must not be any openings in this wall of the garage and the fire-separation wall must be made of approved materials. This is a safety concern. [Here is a link to more information about garage fire-separation walls.](#)

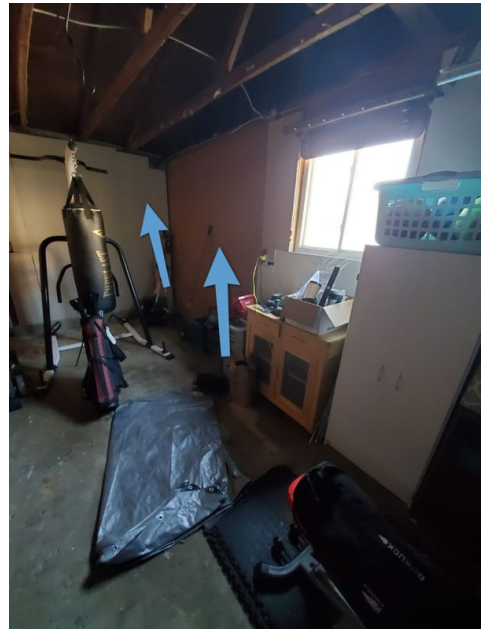
6.3.3 Garage Interior

DAMAGED DRYWALL

We observed that a garage area (not a firewall) had damaged drywall. One section of drywall was installed backwards.

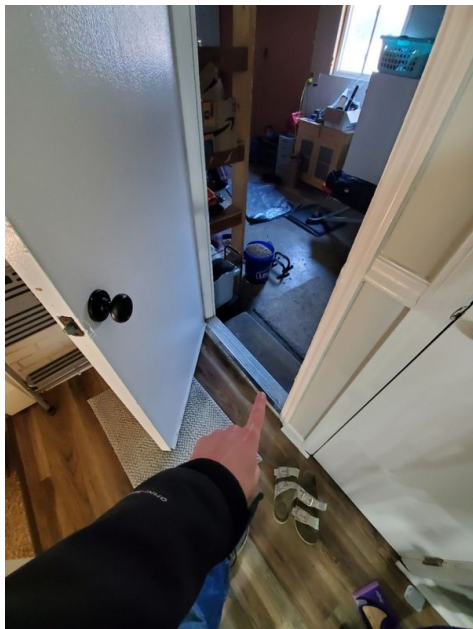
6.3.4 Garage Interior

DOOR FRAME RUBS

We observed that the garage door rubbed against the frame making it difficult to use.

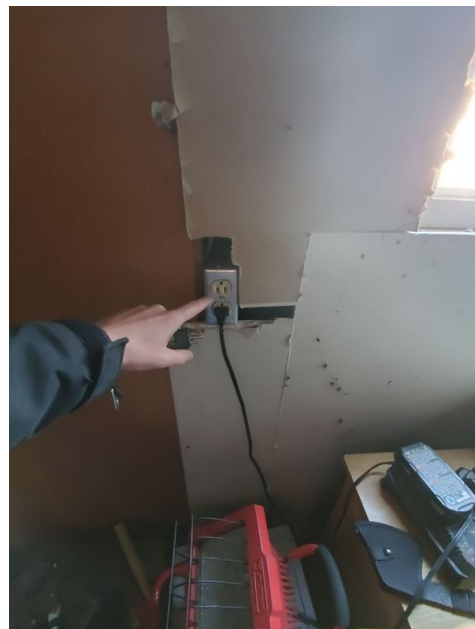
6.5.1 Garage Electric

MISSING GFCI PROTECTION

We observed a receptacle in the attached garage without GFCI protection. GFCI protection is required for all 15 & 20 amp receptacles in the garage, including outlets for appliances & garage door openers.

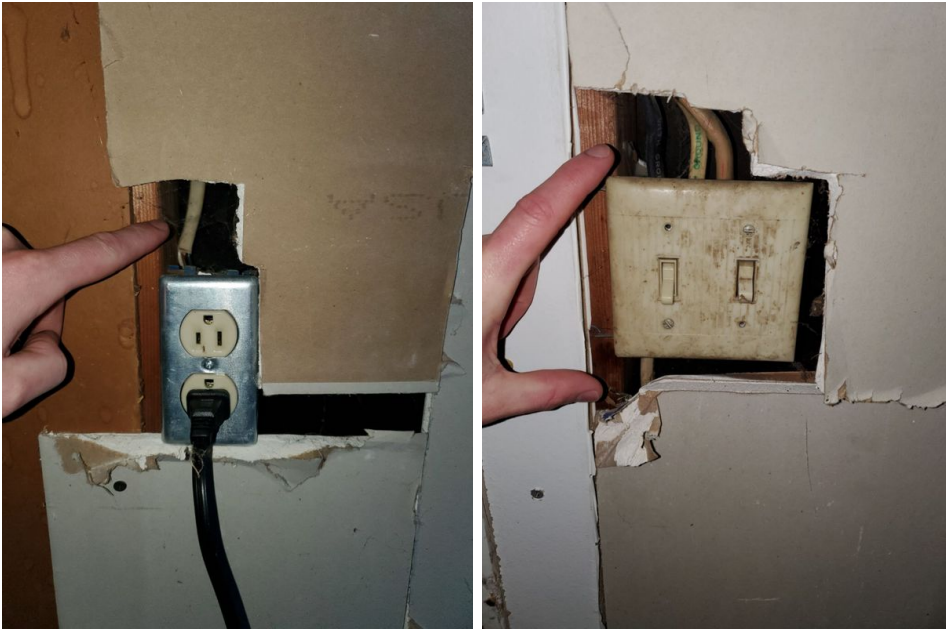
6.5.2 Garage Electric

LOOSE/UNPROTECTED ELECTRICAL

We observed electrical lines that were loose and/or unprotected. This can be an indication of "handyman work" that is often incorrectly installed.

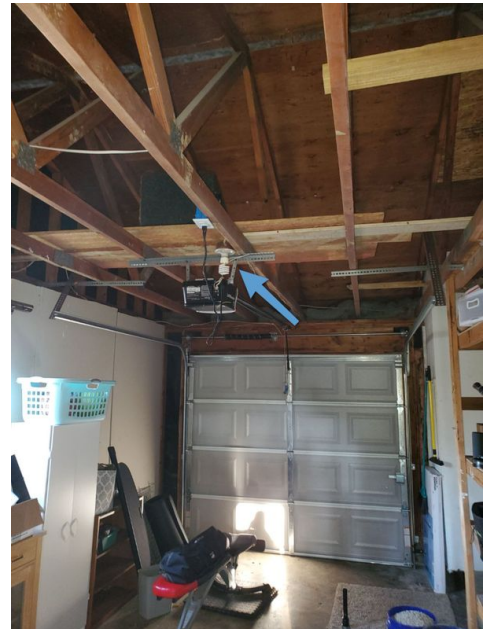
6.5.3 Garage Electric

LIGHT FIXTURE ISSUE (COULD BE BULB)

We observed one or more light fixtures that did not illuminate when tested during the inspection. A new light bulb may fix the problem, but we can't say for sure. We recommend asking the homeowner about why this light fixture did not turn on.

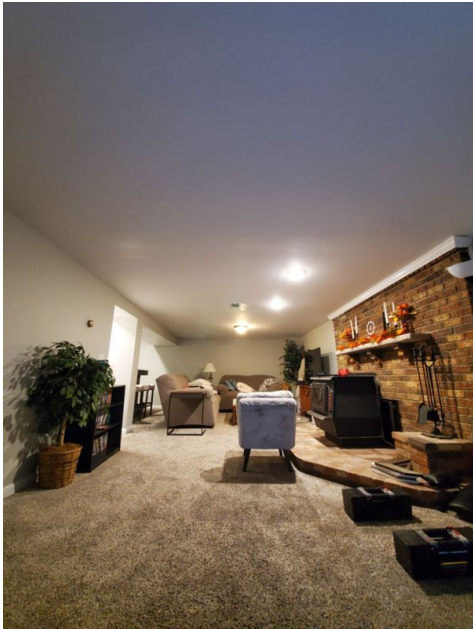
We observed that a smoke detector is missing from an area where it is recommended. Each bedroom should have a smoke detector and there should be at least one on each floor of the house. This is a safety concern.

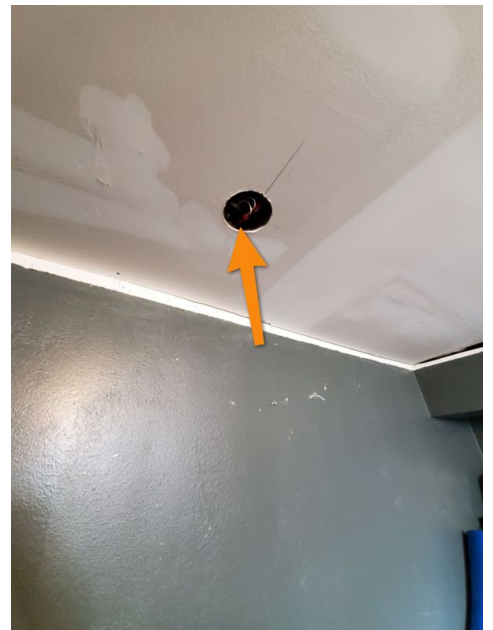
We observed that a receptacle box has a damaged or missing cover plate. This is a safety concern.

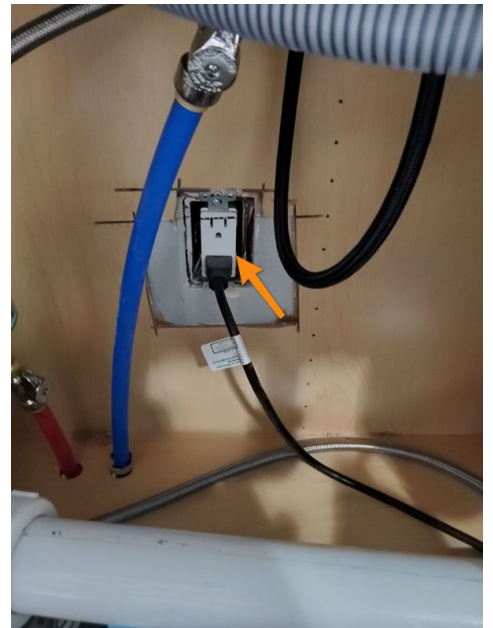
We observed that a receptacle box has a damaged or missing cover plate. This is a safety concern.

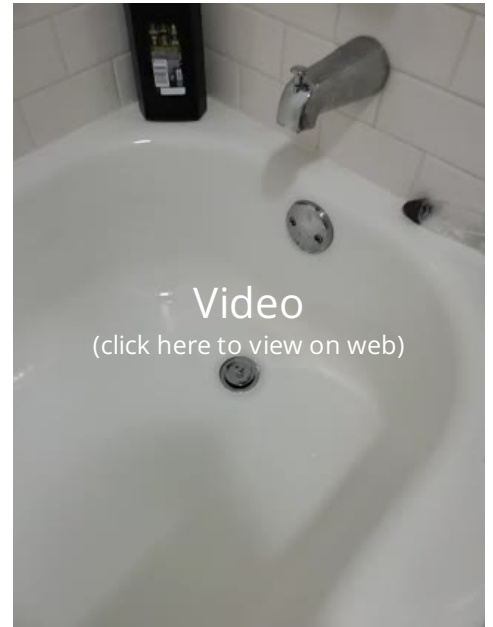
We observed a slow drain at the tub/shower, likely due to a clog.

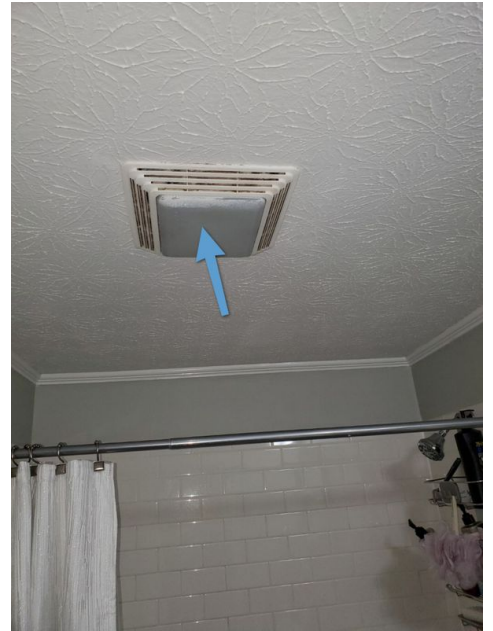
We observed a light that didn't turn on as expected. Could be a light bulb, but can't say for sure.

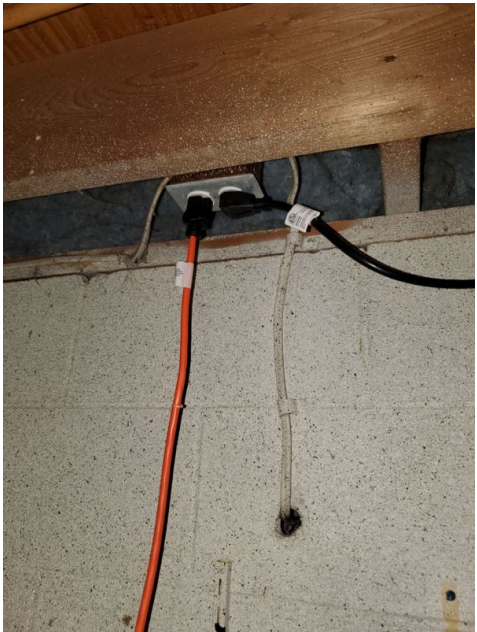
We observed missing GFCI protection for one or more laundry receptacles. GFCI protection is required in laundry areas.

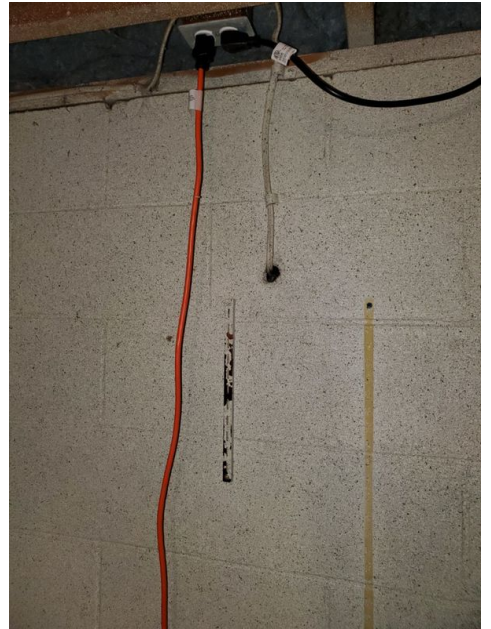
We observed an extension cord being used for the washing machine. We do not recommend any permanent use of an extension cord. We recommend a new dedicated GFCI-protected outlet is added closer to the washing machine.

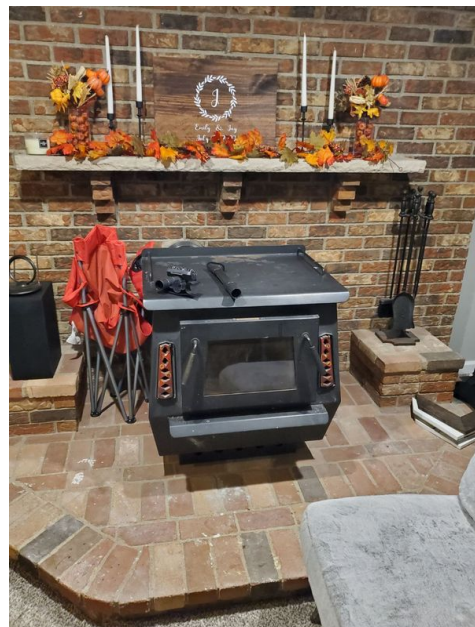
We observed an installed wood-burning stove. Inspection of these is not included in our home inspection, so we highly recommend it is inspected by a heating stove specialist.

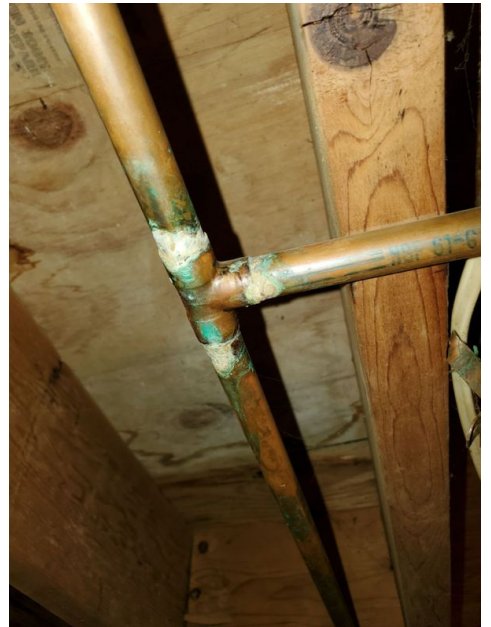
We observed more-than-expected corrosion at pipe fittings in one or more areas. Continued corrosion can cause leaks, but no active leaks were observed. We recommend this is further evaluated by a qualified professional.

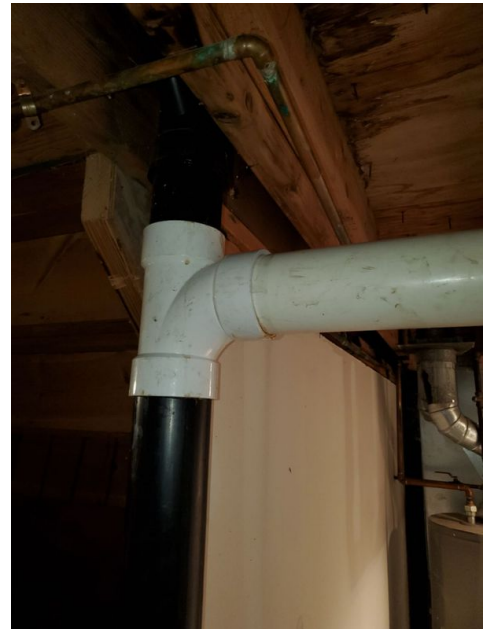
We observed PVC pipe connected to ABS pipe. This is generally not allowed, although there is one type of pipe adhesive for this purpose. We cannot tell if this adhesive was used. We recommend using a rubber Fernco fitting to connect ABS & PVC and monitoring this area for leaks.

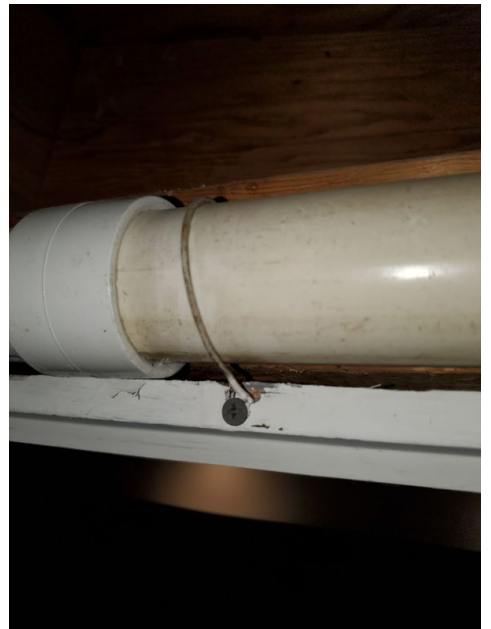
We observed a section of pipe that needs more support.

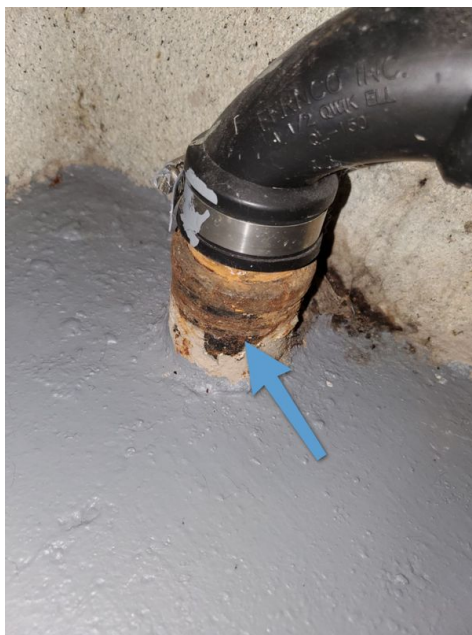
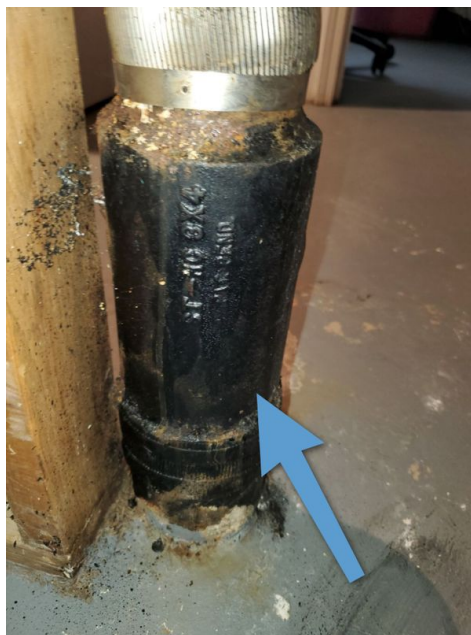
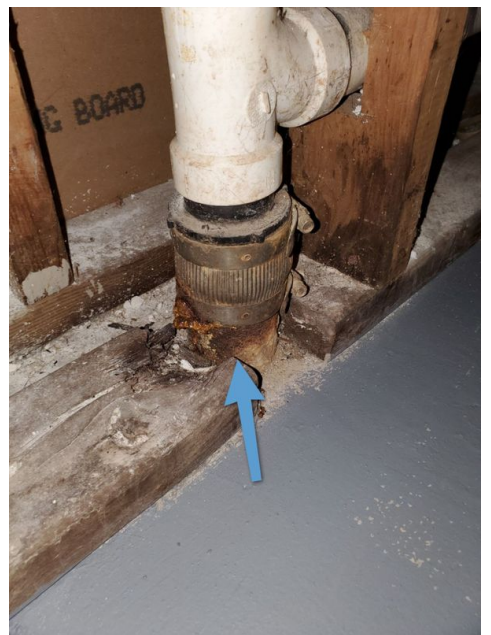
We observed that the drain pipes appeared to be made from cast iron. As such, they are old and may be near the end of its service life and may not perform reliably. We recommend budgeting for replacement.

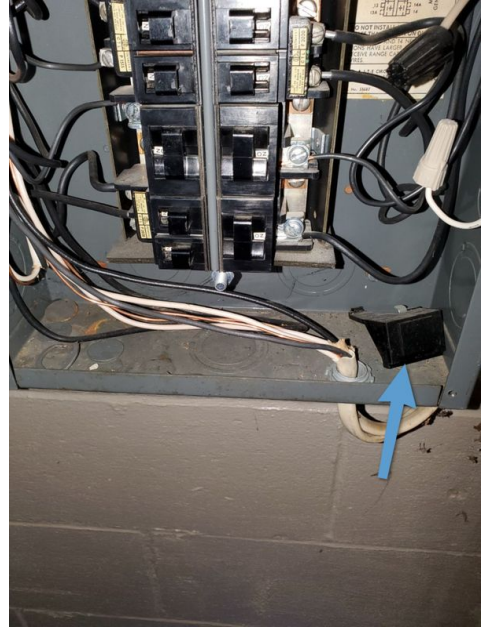
We observed that there were foreign objects inside the electrical panel. These should be removed.

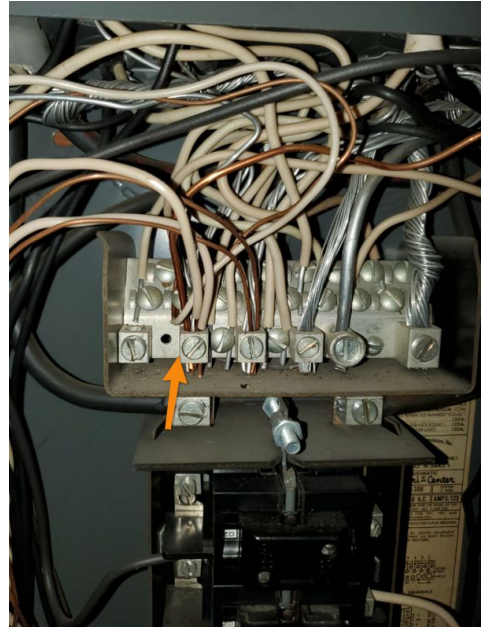
We observed doubled ground wires of different sizes connected under the same single lug, which is not allowed.

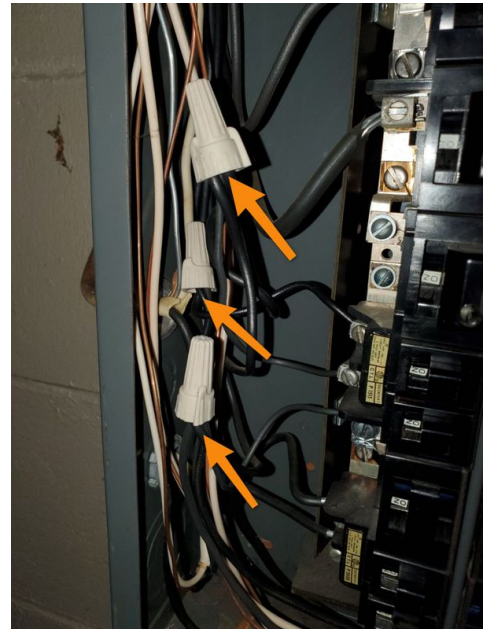
We observed pigtailed hot conductor wires connected to the same breaker, which is not allowed.

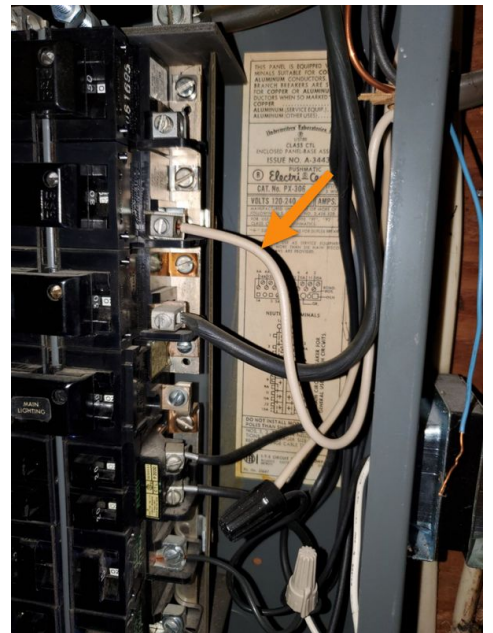
We observed a white wire carrying power from a standard breaker. The wire needs to be marked black with tape or marker.

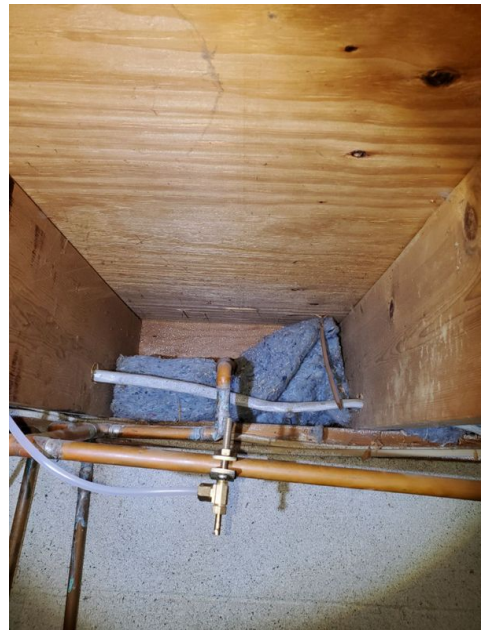
We observed the general absence of insulation in the basement. We highly recommend insulation in the rim joists, as this is a major heat loss area.

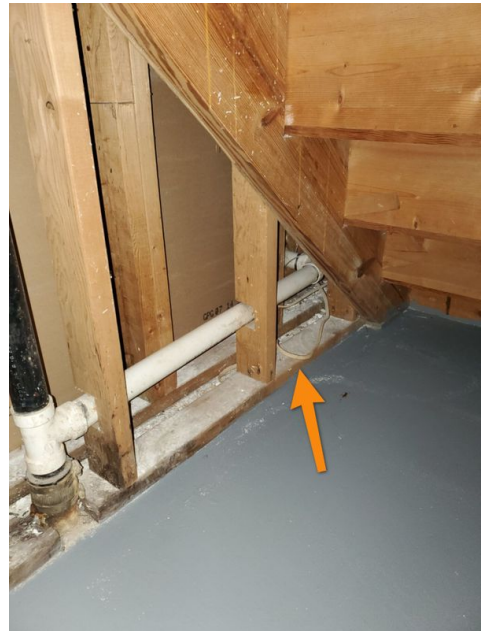
We observed electrical wiring that is subject to damage and should be protected inside a finished wall or a conduit. This is a safety concern.

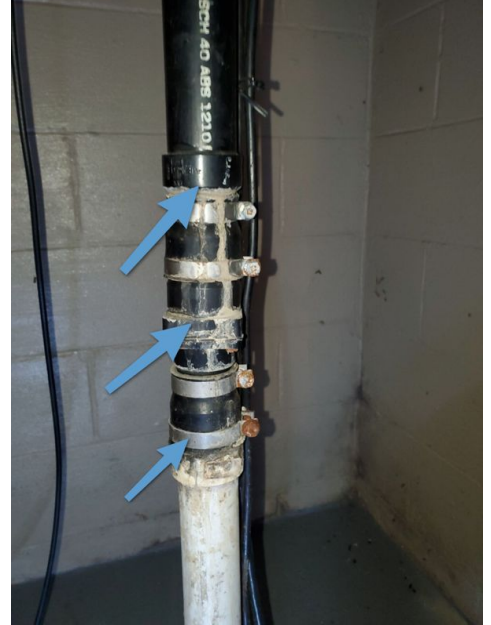
We observed that the sump pump drain pipes showed signs of past leaks. No active leaks were observed in this area.
