## HOME MAINTENANCE INSPECTION REPORT

1234 Oak Street Anytown Colorado 81234

> John Smith JANUARY 6, 2019

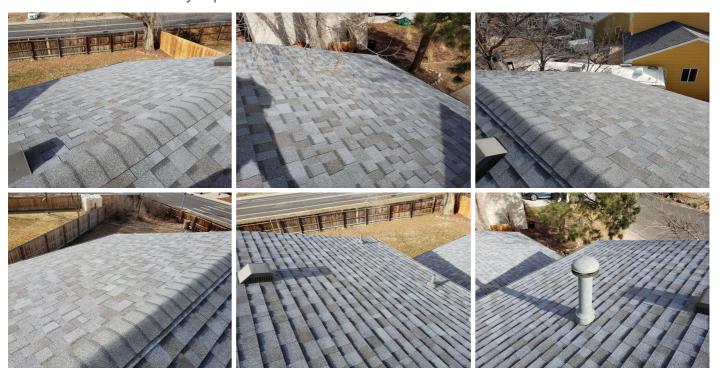
### **ROOF COVERINGS: Roof walked - no concerns noted**

The roof was walked and fully inspected. No concerns or defects were noted at this time.
