RESIDENTIAL INSPECTION

1801 College Pkwy
Lewisville TX 75077

APRIL 19, 2020

PROPERTY INSPECTION REPORT

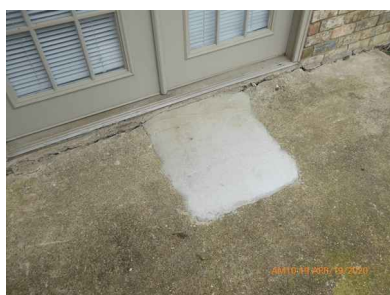
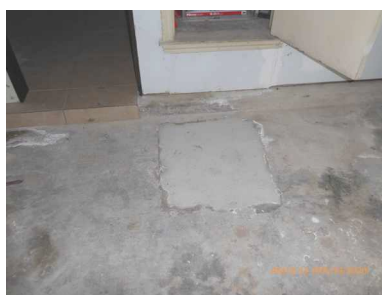
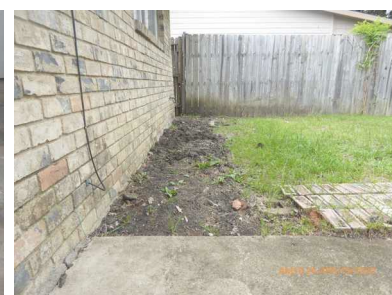
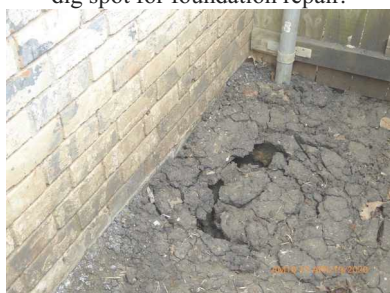
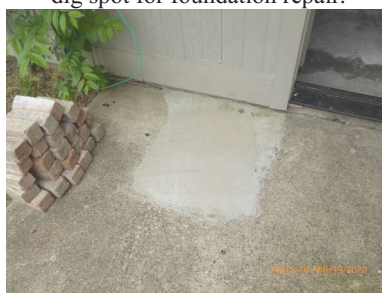
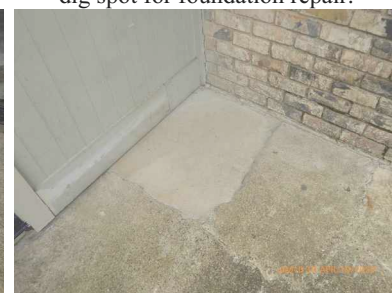
This foundation was repaired prior to inspection. I will send the foundation repair documentation as well as the engineers report at the end of this inspection report. Due to recent repairs, I am not able to conclude that any of the signs of foundation movement are active. This includes cracks in walls and ceilings. I would recommend monitoring these cracks over the next few months.

dig spot for foundation repair.

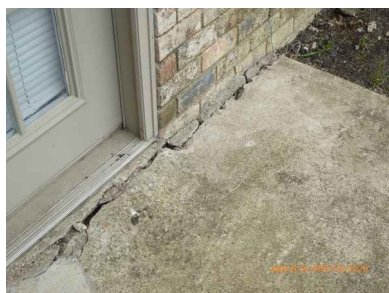
The floor slab shows movement/settling due to soil movement. This can compromise the structural integrity of the home. Recommend a qualified structural engineer evaluate and advise on how to remedy.

back patio door. Slab separating from patio.

Recommendation: Contact a qualified structural engineer.

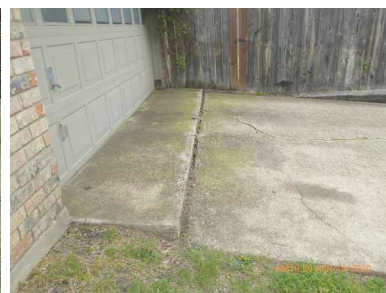
driveway at garage door. Drive separating from garage floor.

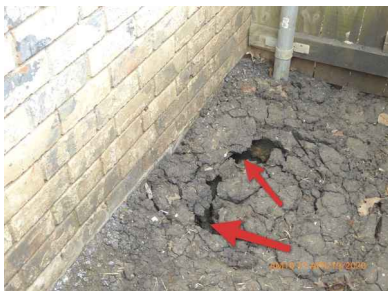
Improper or sub-standard construction practices were noted at the foundation wall or slabs/piers. In my opinion this northwest wall was improperly back filled after foundation repair was finished. Recommend a foundation repair company evaluate and advise on how to bring the construction up to standards.

hole is hollow under foundation wall.

Recommendation: Contact a qualified professional.

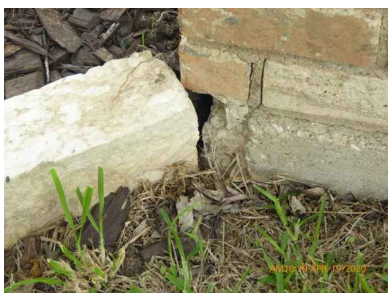
3: Wedge crack (truncated cone fracture)

Common cracks or concrete spalling, sometimes referred to as corner or wedge cracks (truncated cone fractures) were observed at the outside corners of the slab foundation. These cracks develop as a result of a shear stress at the interface between the brick and the concrete. Because brick walls expand and concrete foundations shrink, differential movement will cause shearing stresses when these materials are bonded together. A bond break or flashing between the brickwork and the concrete will permit movement to occur without damaged to the structure. It is recommended that you cosmetically patch these with bonding agent and a non-shrink epoxy grout to aid in dissuading termite activity in the crack. Additionally, should the cracks spread over a significant distance, support for the brick veneer may be compromised. These require repair as per industry standards.

Recommendation: Contact a qualified professional.

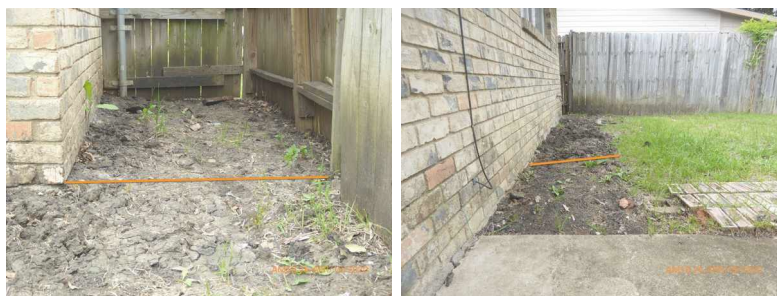
Grading is sloping towards the home in some areas. This could lead to water intrusion and foundation issues. Recommend qualified landscaper or foundation contractor regrade so water flows away from home.

I identified two main concerns with negative grading. Both on the north and northwest corner of the home. I would recommend monitoring the back fill settlement in these two places specifically.

Recommendation: Contact a qualified landscaping contractor

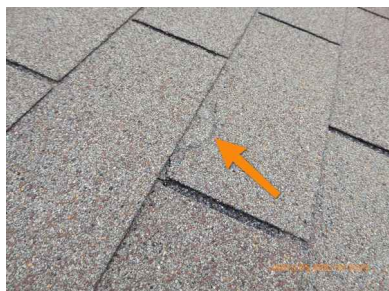
Roof coverings exhibited general damage that could affect performance. Recommend a qualified roofer evaluate and repair.

Damaged shingle

Recommendation: Contact a qualified roofing professional.

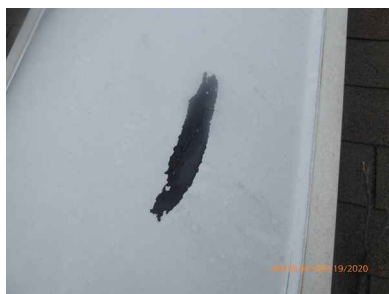
2: Damaged skylight

Skylight dome was cracked. There was an attempt to repair this crack. I can't say how affective this repair is. I would reccomend having a qualified professional evaluate.

Recommendation: Contact a qualified professional.

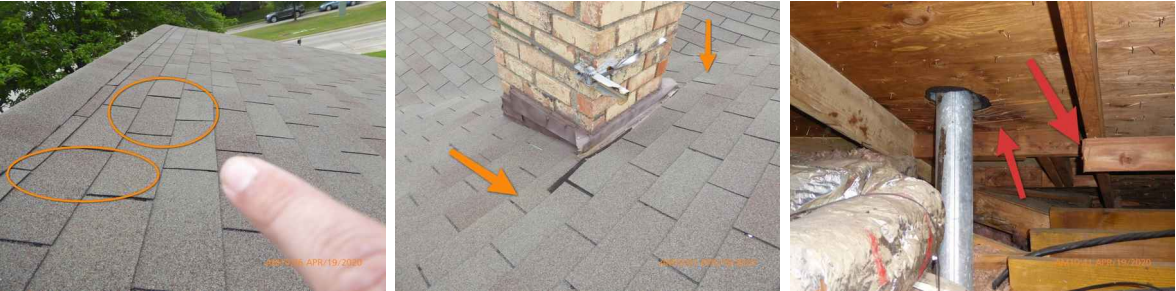
Multiple areas of the roof sagged, indicating sheathing or rafter deficiencies. Some rafter supports were cut in attic structure. Highly recommend a qualified roofer evaluate and repair.

showing rafter support was cut for gas flue pipe clearance. Also shows rotted decking from roof leak.

Recommendation: Contact a qualified roofing professional.

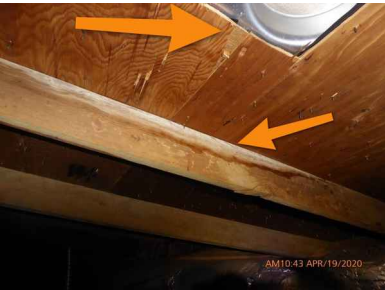
Roof sheathing appears to be soft/thin in certain areas. This can be from decay in the underlying wood panels & structure. This was noted in multiple locations in attic. Recommend further examination by a qualified roofer.

thin brittle sheathing and water damaged rafters.

Recommendation: Contact a qualified roofing professional.

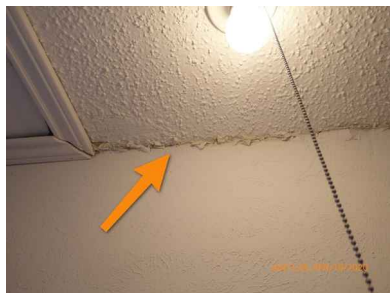
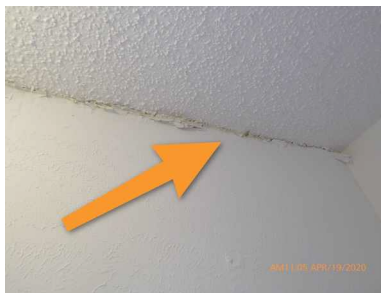
Major cracking observed in wall structure. This could be from moisture intrusion at the structure and/or soil movement. I believe this damage was caused prior to the most recent foundation repair. I recommend monitoring the cracks.

separation from wall and ceiling at north west bedroom.

Recommendation: Contact a qualified structural engineer.

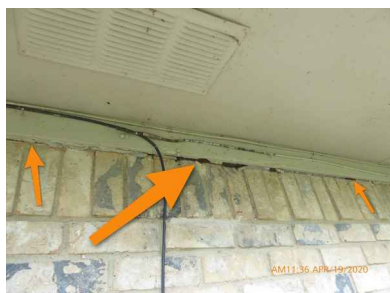
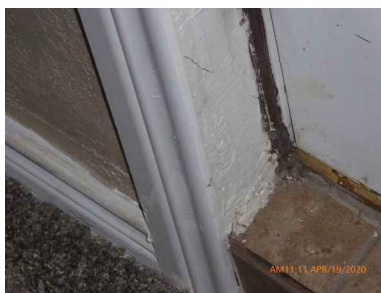
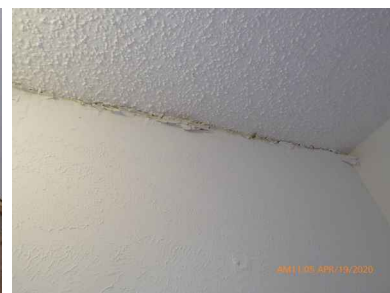
3: Evidence of Structural Damage

Evidence of structural damage was found in multiple locations. I believe this damage was caused prior to the most recent foundation repair. I recommend monitoring the cracks.

Recommendation: Contact a qualified structural engineer.

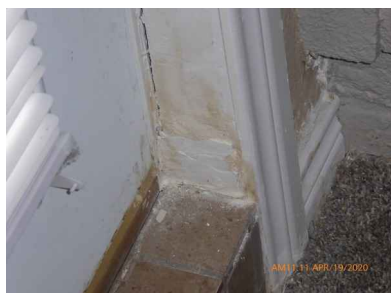
Wall structure showed signs of water intrusion, which could lead to more serious structural damage. Recommend a qualified contractor identify source or moisture and remedy.

door to backyard

Recommendation: Contact a qualified structural engineer.

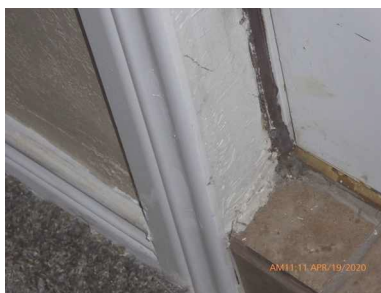
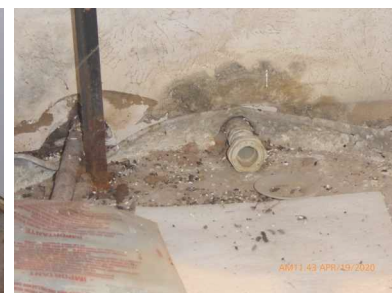
this is under the water heater in laundry closet

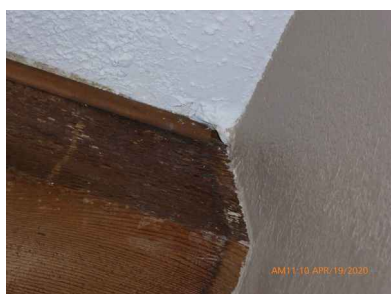
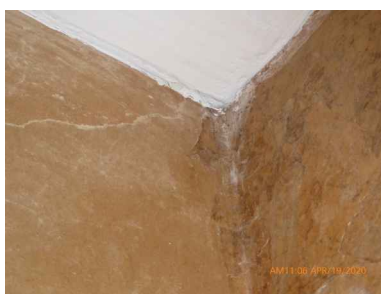
1: Ceiling - Minor Damage

Minor damage or deterioration to the ceiling was visible at the time of the inspection.

Recommendation: Contact a qualified drywall contractor.

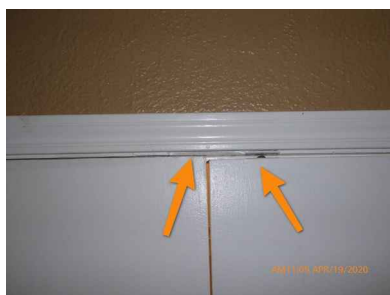
One or more gaps could result in energy loss. Recommend handyman or door contractor evaluate.

closet doors in back bedroom

Recommendation: Contact a qualified door repair/installation contractor.

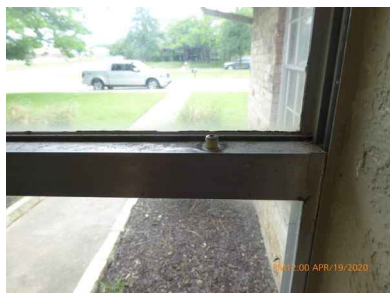
All windows appears to have general damage, but most are operational. Three different windows in the home do not open. Multiples are missing locks. Recommend a window professional replace as necessary.

broken lock

Recommendation: Contact a qualified window repair/installation contractor.

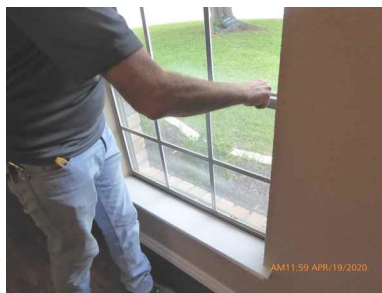
Bedroom window will not open properly.

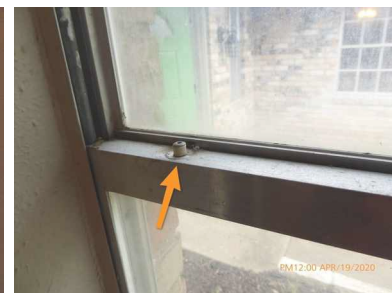
broken lock

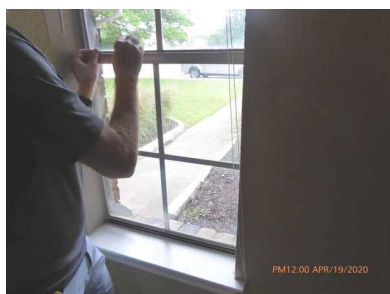
this window next to the front door will not open properly.

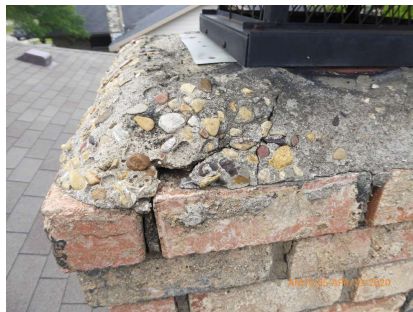
Masonry chimney cap must be repaired or replaced.

Recommendation: Contact a qualified professional.

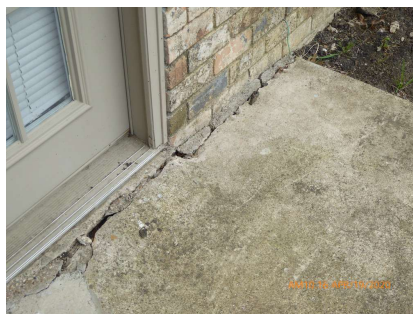
Porch or balcony exterior flooring shows signs of foundation cracking. Recommend a concrete contractor evaluate and repair.

Recommendation: Contact a qualified concrete contractor.

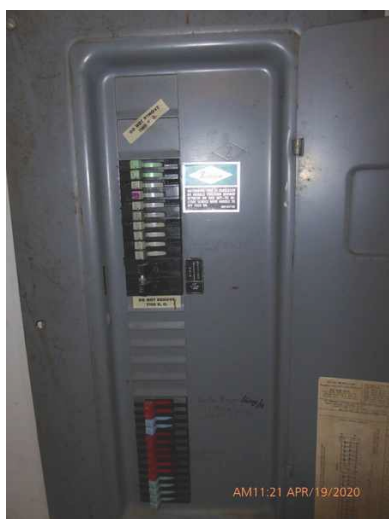
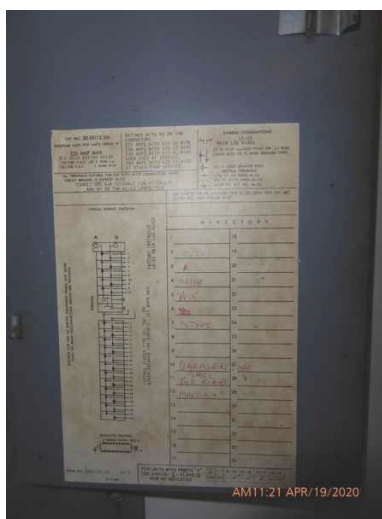
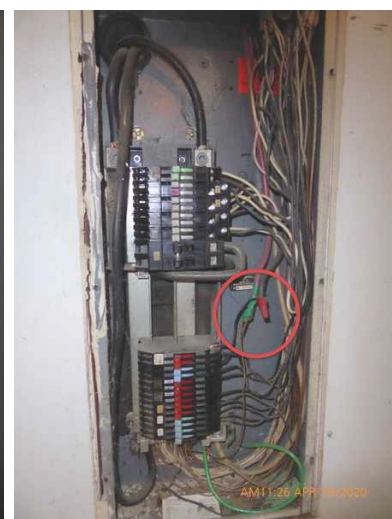
improper connection

You are strongly urged to retain the services of a qualified electrical contractor to perform a full evaluation of this vital electrical component to confirm its current operating condition.

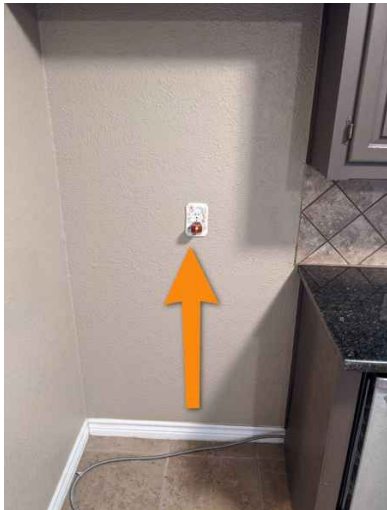
Improper wiring was observed at the time of inspection. I found an open ground in the refrigerator location. Recommend a licensed electrician evaluate and repair.

open ground

Recommendation: Contact a qualified electrical contractor.

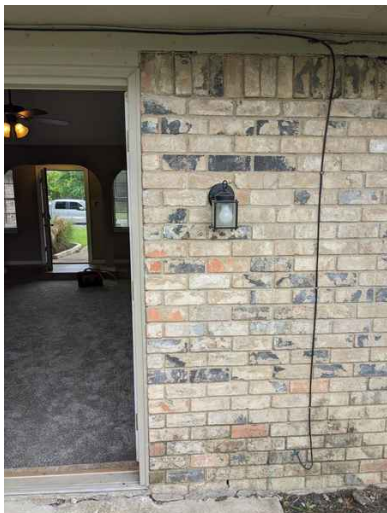
One or more lights are not operating. New light bulb possibly needed.

Recommendation: Contact a qualified electrical contractor.

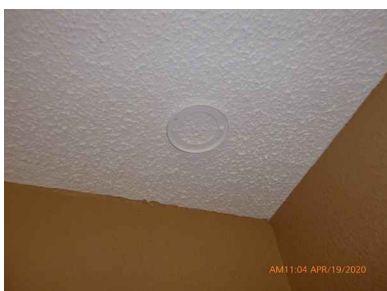
Smoke detector is connected, but not functioning properly. Some missing from bedrooms. Recommend replacement.

Recommendation: Recommended DIY Project

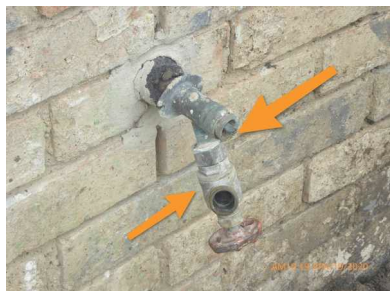
Broken hose bib on the exterior wall of backyard. Recommend replacement.

Handle is broken and another valve with a working handle was placed on broken bib.

Recommendation: Contact a qualified professional.

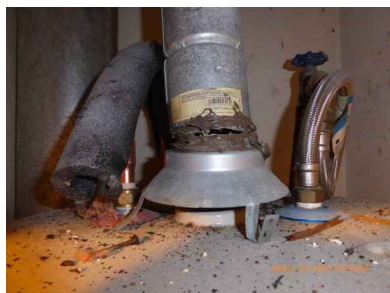
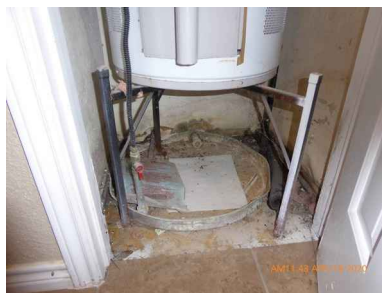
Water heater is improperly installed. Drain pan is improperly installed and the Draft hood is damaged and is a very serious health hazard. Recommend qualified plumber evaluate & repair Immediately .

Recommendation: Contact a qualified plumbing contractor.

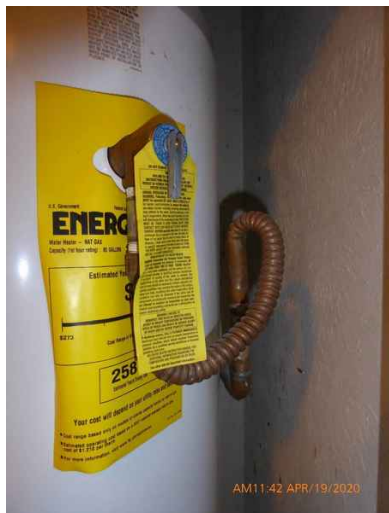
Improper installation of tubing for tpr valve.

line should drain by gravity. This line is flex tubing and is turned upwards.

Recommendation: Contact a qualified professional.

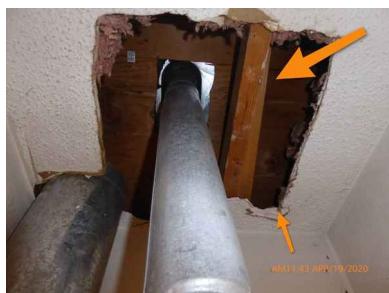
improper vent clearances. Ceiling was cut completely open exposing attic air to conditioned space.

Recommendation: Contact a qualified professional.

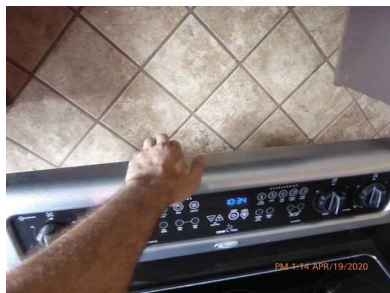
Range was not fastened to the floor. This poses a safety hazard to children. Recommend a qualified contractor secure range so it can't tip.

Recommendation: Contact a qualified handyman.

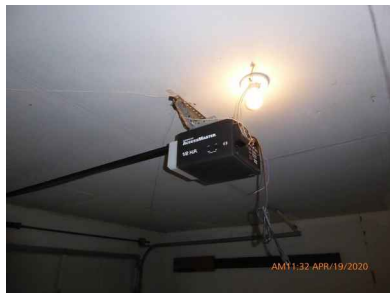
No power was supplied to garage door opener so i could not inspect.

garage door opener was not operational
