HOME INSPECTION REPORT

2133 N 115th St Seattle WA 98133

> Deb Doty JULY 22, 2019

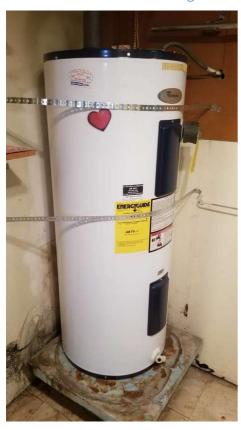
I recommend flushing & servicing your water heater tank annually for optimal performance. Water temperature should be set to at least 120 degrees F to kill microbes and no higher than 130 degrees F to prevent scalding.

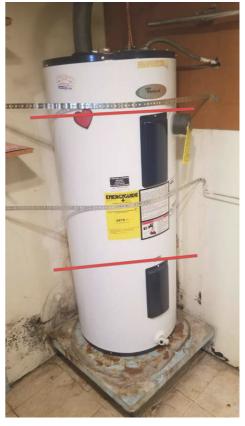
SEISMIC STRAPS - MISSING/INSUFFICIENT

Contact a qualified professional.
