MOUNTAINS TO SOUND HOME INSPECTION LLC

HOME INSPECTION REPORT

10506 22nd Ave E
Tacoma WA 98445

Kim and John Smith
JUNE 9, 2020

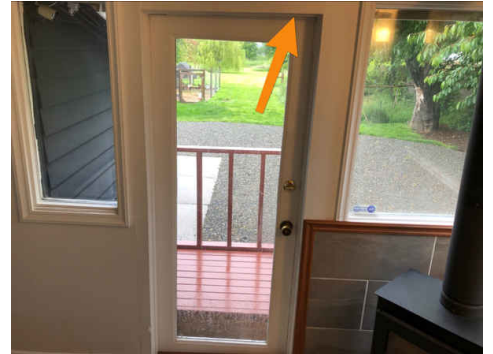
3.11.2 Exterior Doors

DOOR DAMAGE

The rear door has some damage around the trim. Recommend repairs if desired.

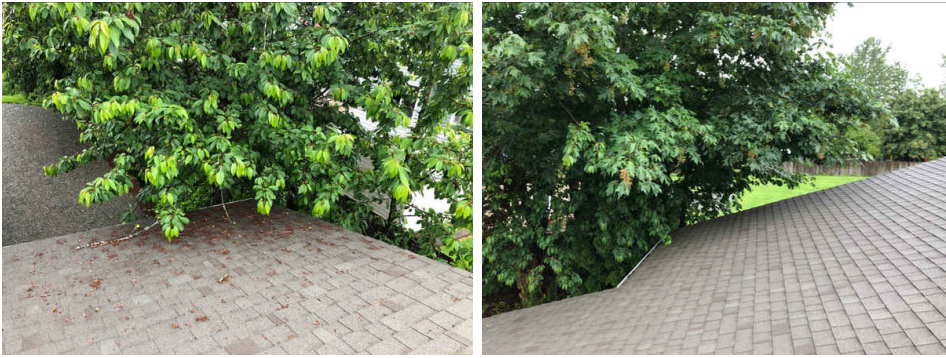
4.3.1 General Observations

Trees near the dwelling have overhanging branches and/or branches in contact with the roof surface, which may cause damage to the roof surface. This condition may also cause the obstruction of roof water runoff and is a access for rodents, animals and carpenter ants. All overhanging or touching branches in contact of the roof surface should be trimmed to eliminate this condition.

Contact a qualified professional.

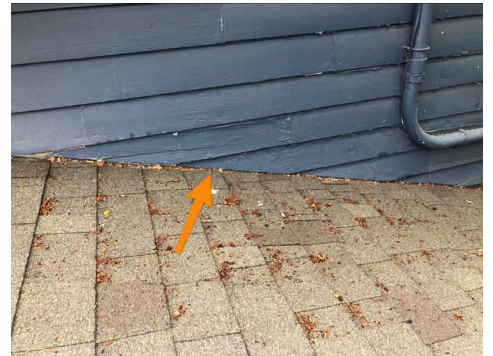
4.4.1 Vents & Flashings

SIDEWALL CONTACT

The siding or trim material is in contact with or very close to the roof surface. This may lead to water damaged siding. Recommend proper installation by leaving a 1-1.5' roof/siding gap and use of sidewall flashing.

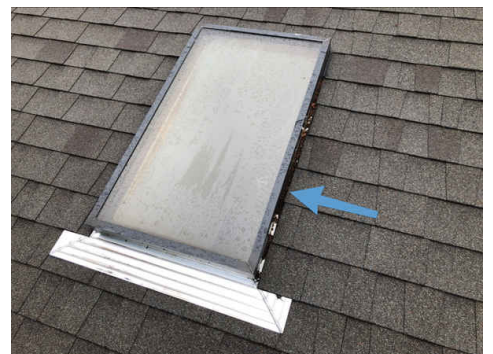
4.6.1 Skylights

CONTINUOUS SKYLIGHT FLASHING

The skylight flashing was continuous rather than Step flashing, as is preferred in today's construction. No problems were evident. We suggest approved flashings be installed the next time the roof is replaced.

Recommend monitoring.

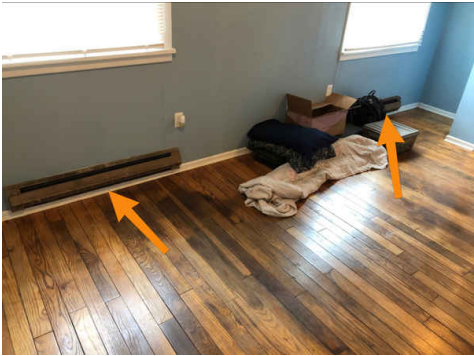
7.1.1 Electric Heating Notes
HEATER DOESN'T WORK
MASTER BEDROOM

The electric heater in one or more rooms doesn't work. Recommend repair.
Recommendation
Contact a qualified professional.

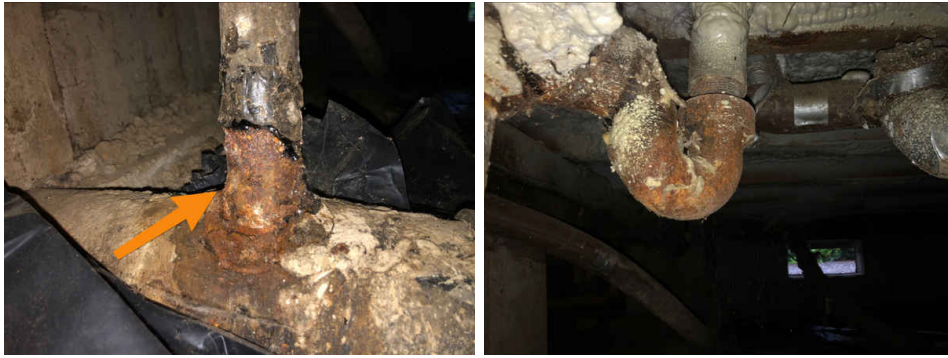
8.3.1 Drain, Waste, & Vent Systems

DETERIORATED PLUMBING

Some of the cast iron plumbing is deteriorated/rusted. Recommend further evaluation and repairs by a licensed plumber.

Contact a qualified professional.

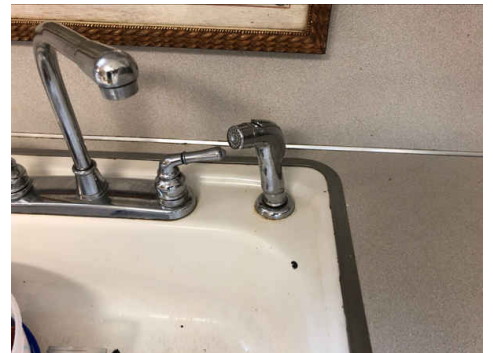
The sink sprayer does not function. Recommend repairs if desired.

Contact a qualified professional.

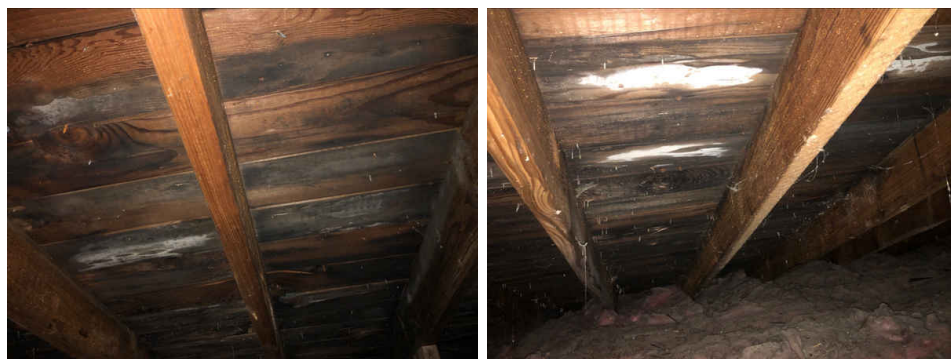
Discoloration and dark staining was observed on the roof sheathing. This is often caused by poor ventilation and is commonly considered a microbial growth. Recommend improving ventilation and cleaning.

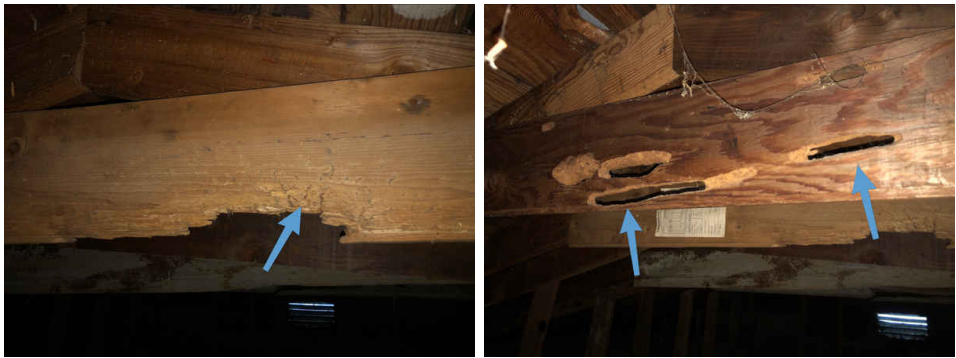
14.6.1 Common Observations

PAST PEST ACTIVITY

Contact a qualified professional.

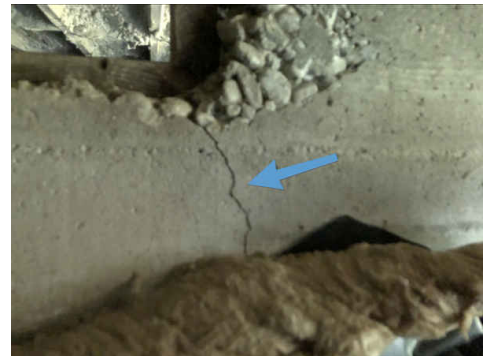
15.2.2 Foundation

SMALL CRACKS

Recommend monitoring.

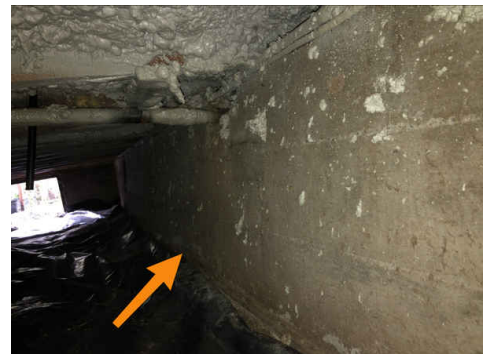
15.2.3 Foundation

WALL(S) BOWING-LEANING

Contact a qualified structural engineer.

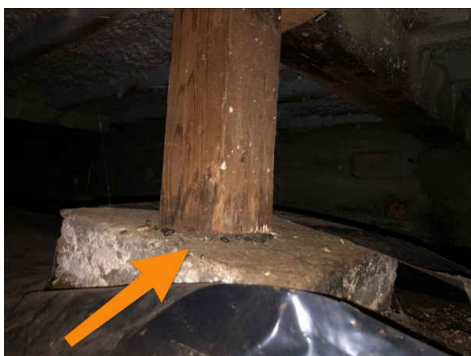
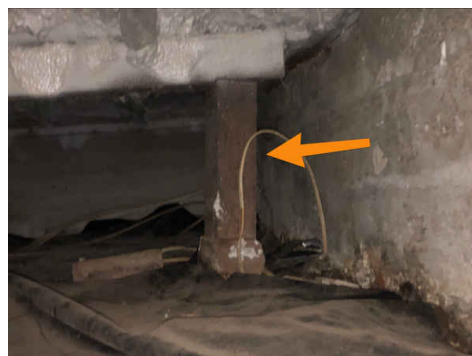
15.3.1 Sub-floor Structure

PIERS/POSTS HAVE SHIFTED OR SETTLED

Contact a qualified professional.
