MOUNTAINS TO SOUND HOME INSPECTION LLC

HOME INSPECTION REPORT

3300 NE 7th Pl
Renton WA 98056

Rachelle Cinque
JULY 23, 2019

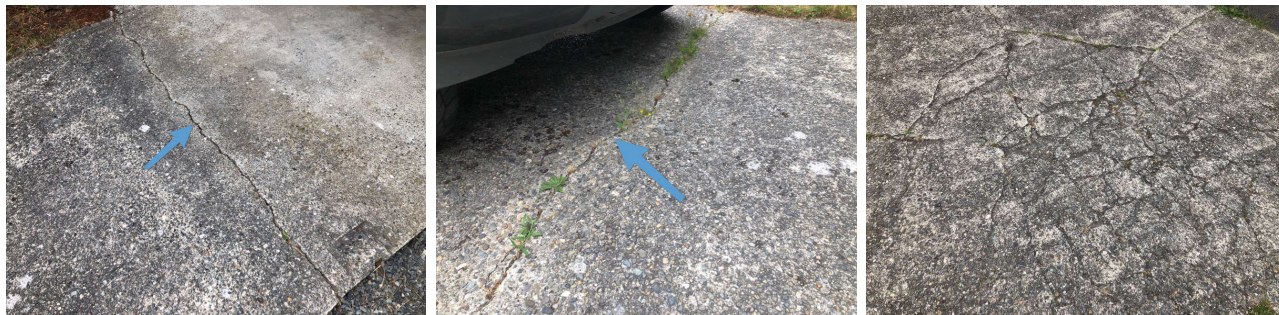
3.2.1 Driveway, Walkways & Patio

MODERATE CRACKS IN DRIVEWAY

There are a few cracks in the driveway which is mostly cosmetic but you may want to view for yourself and repair as necessary.

Recommend monitoring.

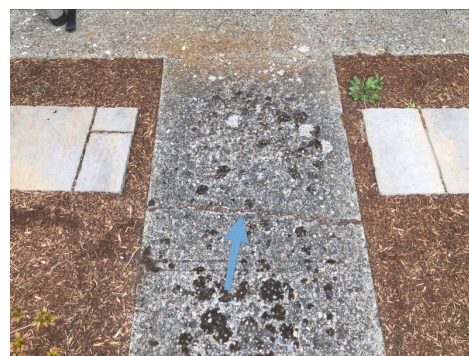
3.2.2 Driveway, Walkways & Patio

CRACKS IN WALKWAYS

There are a few cracks in the walkways around the residence that are mostly cosmetic. We suggest you view these yourself and repair as necessary.

Contact a qualified professional.

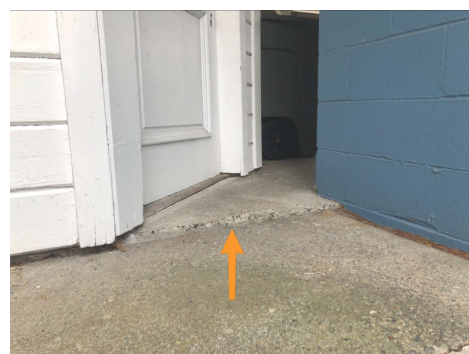
3.2.3 Driveway, Walkways & Patio

WALKWAY-TRIP HAZARD

There is an offset in a walkway that could prove to be a trip-hazard. I recommend using caution when walking in this area.

Contact a qualified concrete contractor.

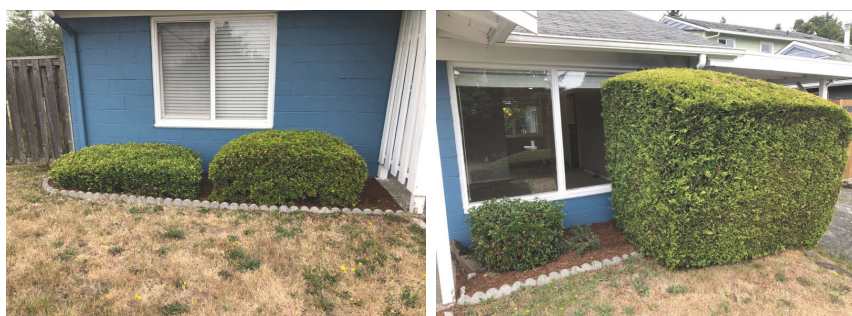
3.5.1 Exterior Siding Notes

VEGETATION IS ENCROACHING

Vegetation is encroaching on the structure, and should be kept a minimum of twelve inches away for the general welfare of the walls and foundation.

Contact a qualified landscaping contractor

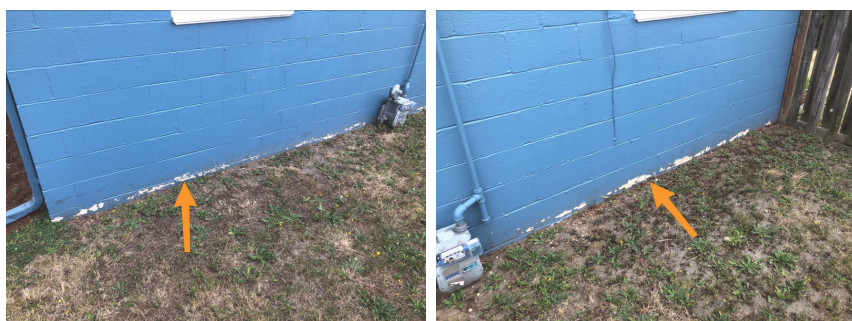
3.5.2 Exterior Siding Notes

TOUCH-UP PAINT/CAULK

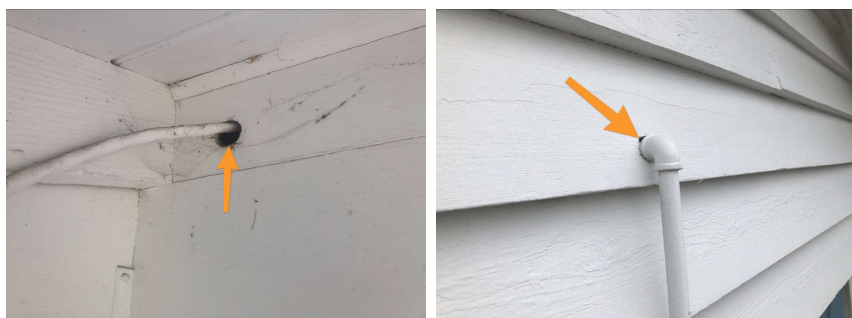
3.5.3 Exterior Siding Notes

SEAL PENETRATIONS/GAPS

Gaps and/or holes were observed on one or more sides in the siding around plumbing, gas, cable, wiring and/or other penetrations. We advise that all the holes and the gaps be caulked and/or sealed to prevent moisture and/or pest intrusion.

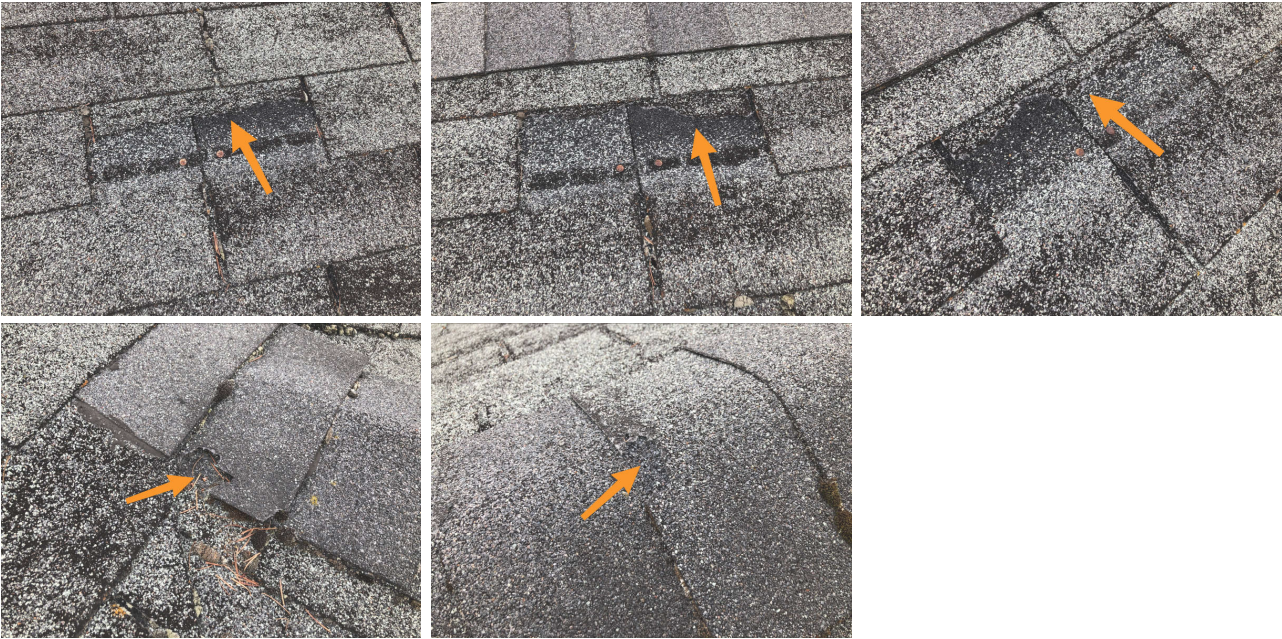
DAMAGED SHINGLES

There were one or more damaged shingles. Recommend repair.

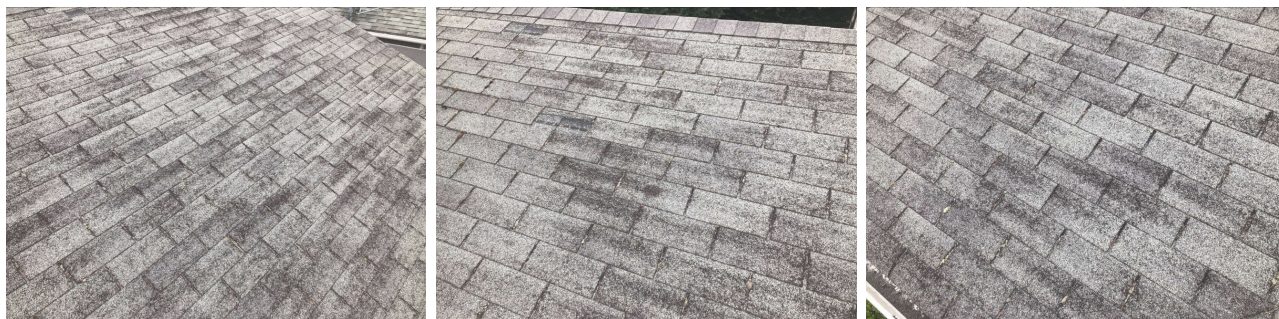
4.2.2 Composition Shingle Roof Notes

Medium Priority**PRIMARY STAGES OF DECOMPOSITION**

Some of the roof is in the primary stages of decomposition, which means that portions of the roof are in decline and can be susceptible to leaks. It will need to be maintained and closely monitored, because it is reaching the end of its serviceable life, we recommend to have a second opinion and unseen issues from a qualified roofer before the close of escrow and to see what future costs will be for replacement.

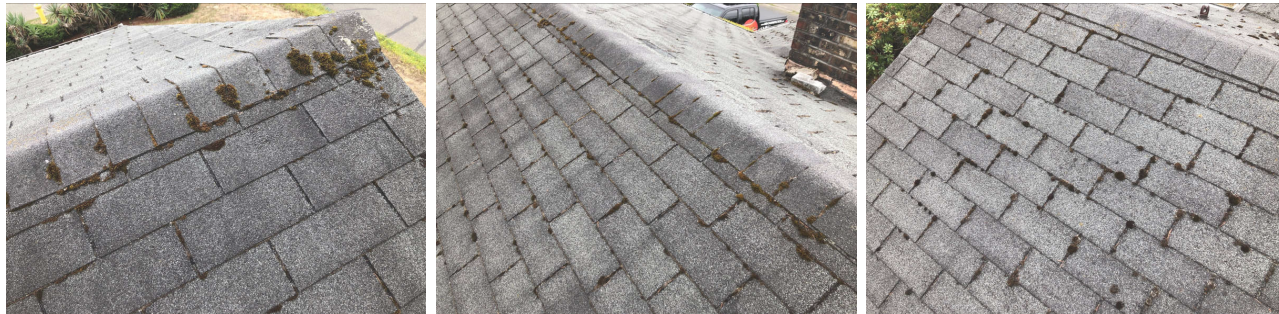
4.3.1 General Observations

Parts of the roof needs to be cleaned of moss and/or debris. This can restrict drainage and lead to moisture intrusion and moisture damage if not corrected.

Contact a qualified professional.

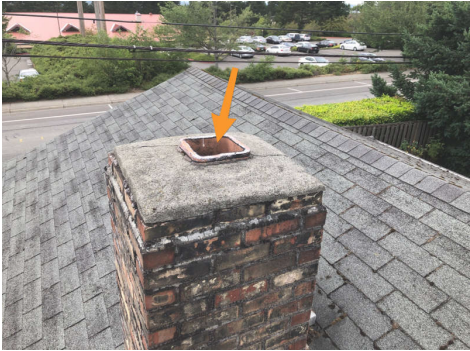
4.6.1 Chimney On Roof & Photo

The chimney does not have a spark arrestor or rain cap as recommended. This will help prevent pests or debris from falling into the flue and causing an obstruction or damage.

Recommendation
Contact a qualified handyman.

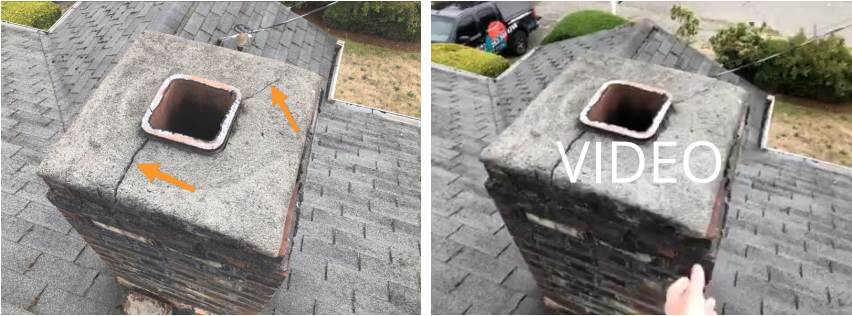
4.6.2 Chimney On Roof & Photo

CROWN DETERIORATED

The crown, which is designed to seal the chimney wall and to shed rainwater, is washed out or deteriorated and should be repaired or replaced.

Recommendation
Contact a qualified masonry professional.

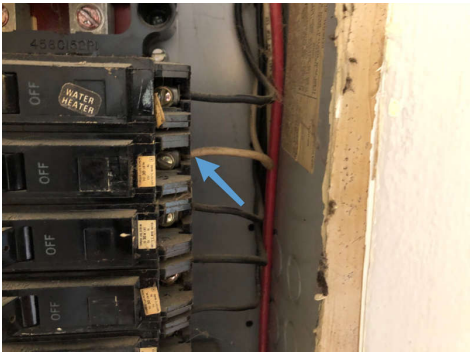
Neutral wires (white) which are being used as hot power, were not taped to show use as HOT. Recommend that black electrical tape be installed on these white wires.

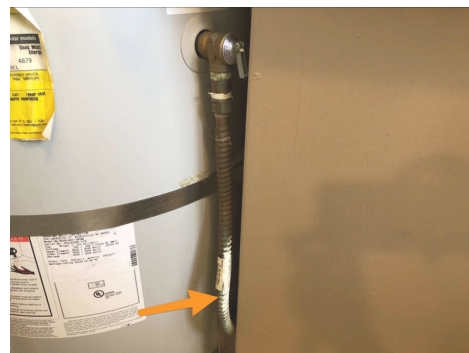
The discharge pipe from the relief valve includes a flexible line and should be replaced with a solid copper discharge pipe. This is because flexible lines can become kinked and possibly prevent the relief valve from working properly in the event it needs to release temperature or pressure and may cause a dangerous situation.

Contact a qualified plumbing contractor.

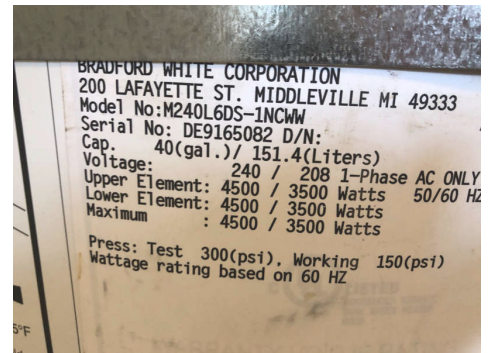
8.1.2 Water Heating System

The water heater is nearing the end of its average expected life of 15 years. Replacement may be needed in the near future.

Contact a qualified plumbing contractor.

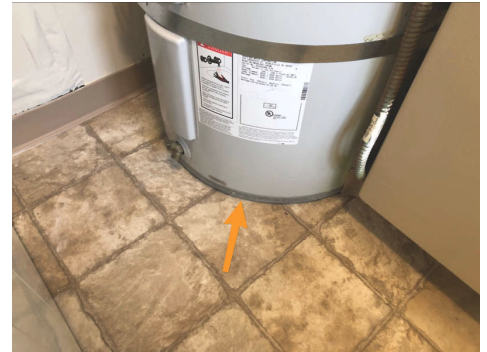
8.1.3 Water Heating System

No drip pan was present to prevent small leaks from causing moisture damage to surrounding area. Recommend installing a drain pan, at least when getting a new water heater.

Contact a qualified plumbing contractor.

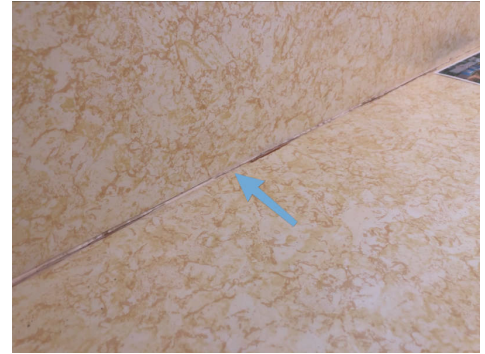
MISSING OR DETERIORATED CAULK/GROUT

The caulking or grout for the backsplash is missing, has gaps and/or not installed properly. We advise caulking/grout be installed and/or gaps filled to prevent possible water intrusion.

Recommended DIY Project

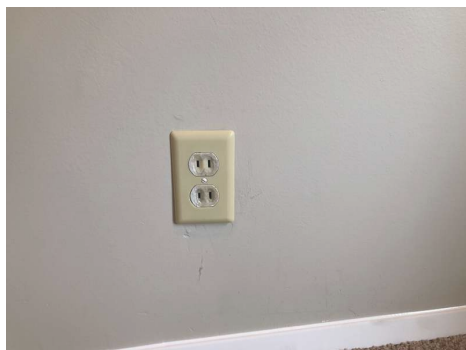
General Notes: Obsolete two prong ungrounded type

Many outlets throughout the residence are an obsolete, two prong, ungrounded type that are recommended to be evaluated by an electrician, before the close of escrow, and upgraded to have ground-fault protection as a modern safety feature.

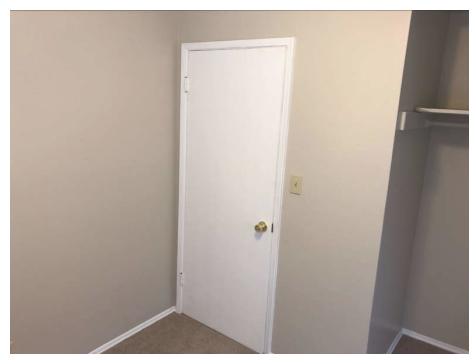
The door rubs and service is recommended.

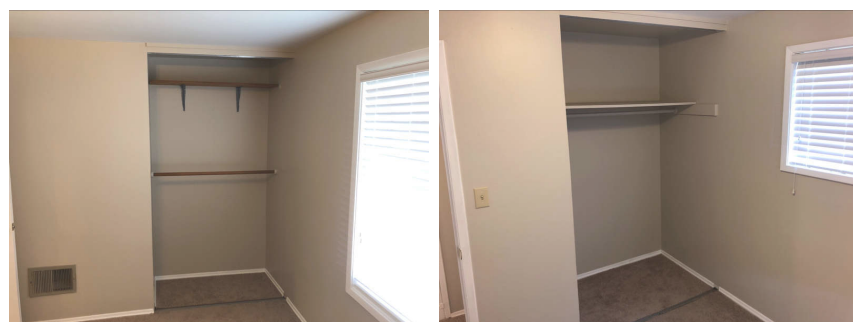
13.6.1 Closet

DOOR MISSING

The door is Missing. Recommend replacement as needed.

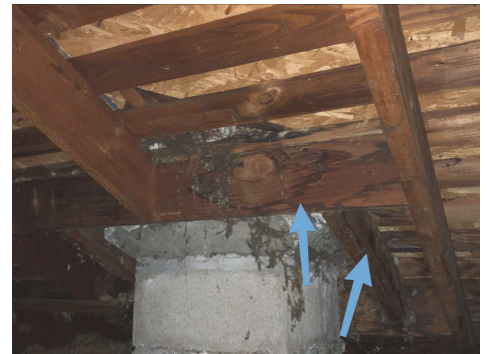
**Low Priority****MOISTURE STAINS ON THE UNDERSIDE DECKING.**

There are obvious moisture stains on the underside of some wood decking, which is predictable and would not necessarily confirm an active roof leak. However, the possibility of an active leak could not be ruled out either. Therefore, you are recommended to have a qualified roof specialist evaluate further, before the close of escrow.

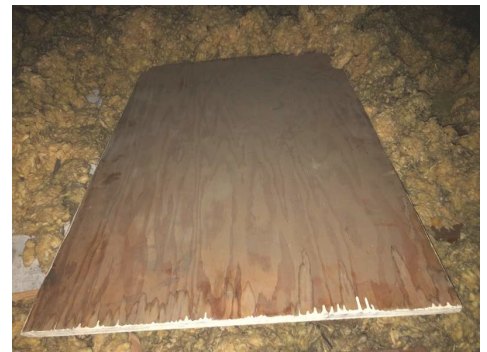
14.5.1 Insulation Notes

**Medium Priority****HATCH MISSING INSULATION**

The attic access hatch was missing insulation. We recommend installing.

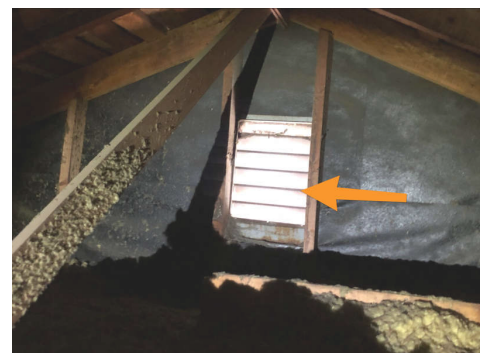
14.8.1 Ventilation

**Medium Priority****SCREEN TORN/MISSING**

One of more vent screens were torn or missing. Recommend repair.
