MOUNTAINS TO SOUND HOME INSPECTION LLC

HOME INSPECTION REPORT

7510 131st St Ct E
Puyallup WA 98373

APRIL 18, 2018

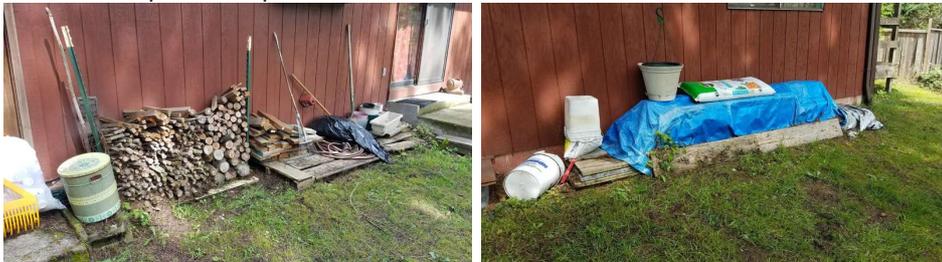
Wood debris was observed near the structure. This is a canoe some condition to Wood string organisms. We recommend removing.

Contact a qualified professional.

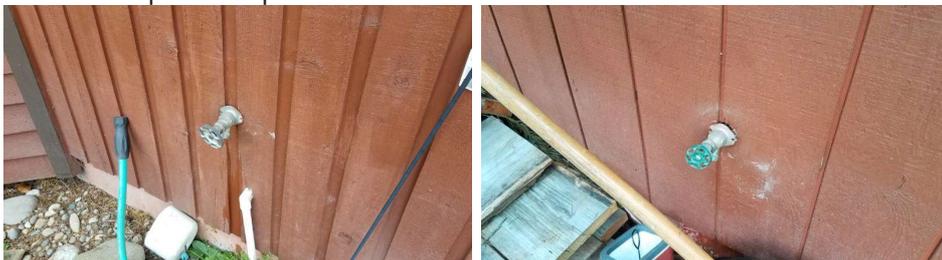
3.8.1 Exterior Plumbing

The hose bib is not secured to the wall. This could potentially damage the Plumbing. Recommend securing.

Contact a qualified professional.

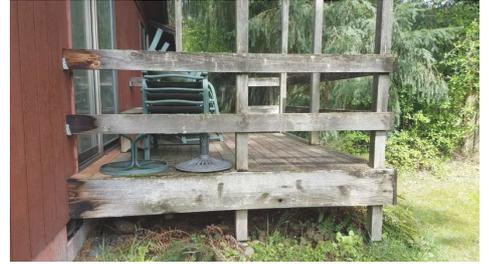
3.17.1 Deck

The balusters around the deck are horizontal. This can allow children to climb and fall easily. Recommend action be taken to prevent this condition.

Contact a qualified professional.

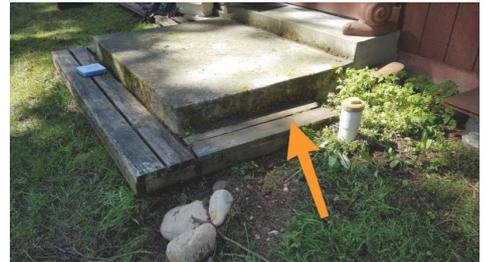
3.17.2 Deck

**STEPS DETERIORATED**

Ome or more steps were damages or deteriorated. We recommend that the affected stairs be replaced.

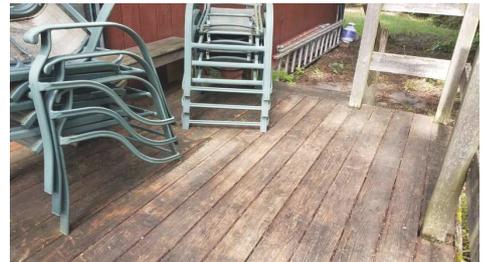
3.17.3 Deck

**WEATHERED**

Portions of the deck we're weathered and in need of minor repairs and maintenance.

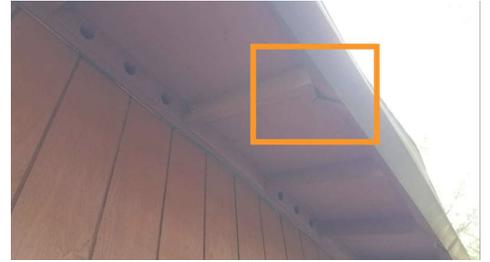
LEAKING GUTTER

The gutter was leaking. Recommend repairs to prevent further leaking.

Contact a qualified professional.

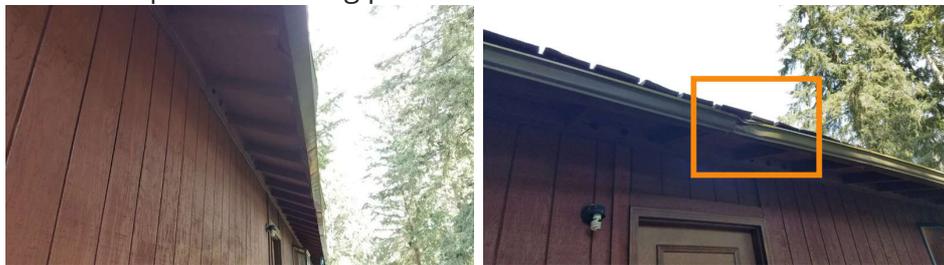
4.5.2 Gutters & Drainage

GUTTERS IN POOR CONDITION

The gutters are in poor condition, and should be repaired or replaced.

Contact a qualified roofing professional.

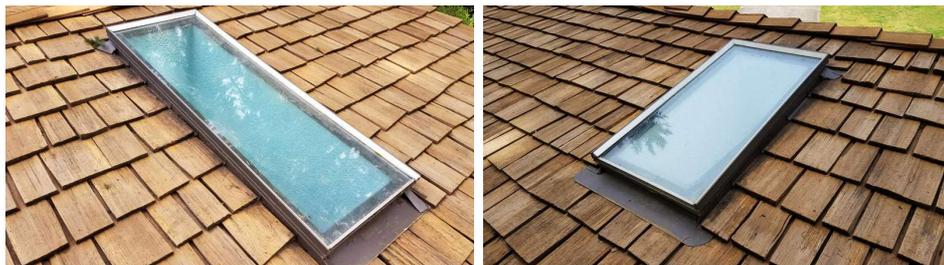
4.6.1 Skylights

SKYLIGHT SEAL

The skylight has a broken seal between the two panes of glass. This allows staining and moisture to develop inside the two panes. This is considered a cosmetic defect and repair or replacement as needed is recommended.

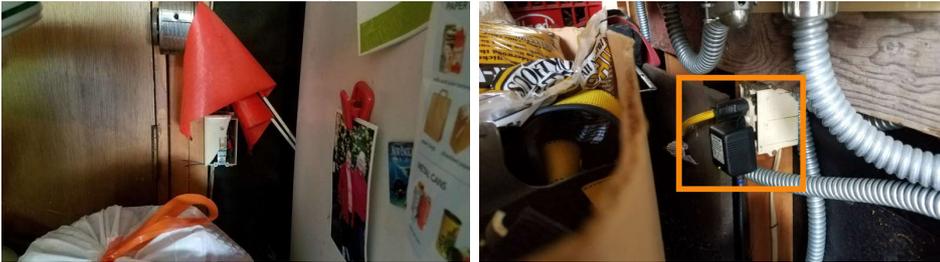
MISSING OR BROKEN COVER.

There was a missing or broken switch or outlet cover that should be replaced or installed.

Contact a qualified handyman.

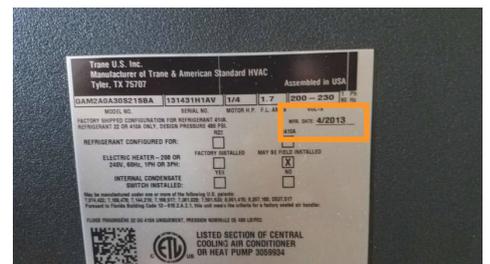
The last know service date of the furnace was over one year ago or a service record was not found on or around the heating system. Recommend a heating contractor thoroughly clean and inspect the heating plant. Servicing would be appropriate prior to closing.

Contact a qualified heating and cooling contractor

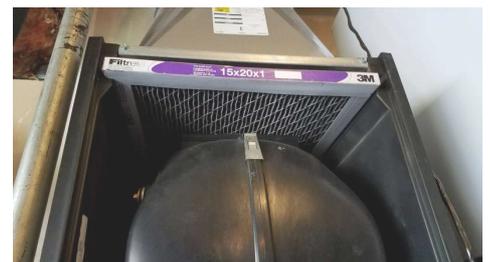
7.7.1 Return-Air Compartment

REPLACE FILTER

Recommended DIY Project

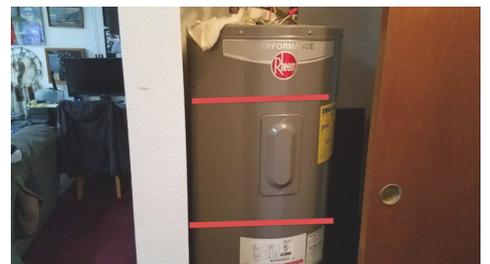
SEISMIC STRAPS - MISSING/INSUFFICIENT

The hot water heater was missing seismic straps or was insufficiently anchored. Recommend two straps to properly secure water heater in the case of an earthquake.

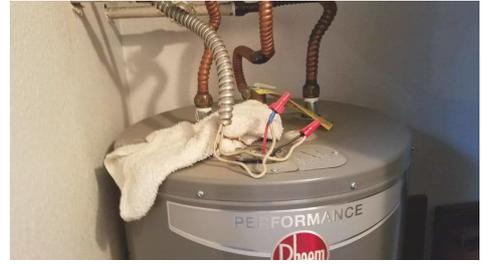
8.1.2 Water Heating System

Recommendations
CONDUIT SEPARATION

The conduit at the electric water heater is separated, and should be repaired by an electrician.

Contact a qualified electrical contractor.

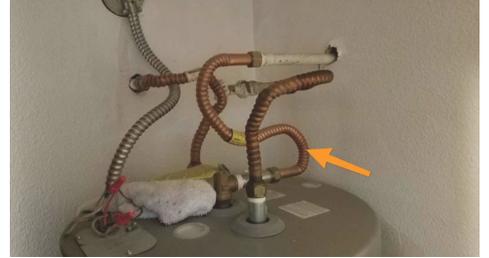
8.1.3 Water Heating System

Recommendations
DISCHARGE PIPE PLUMBED UPHILL

Contact a qualified plumbing contractor.

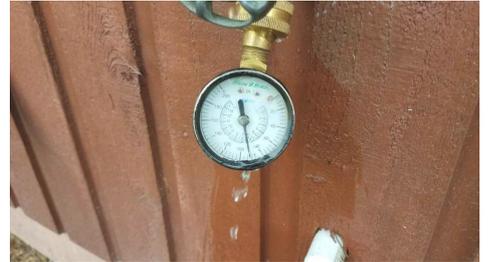
8.2.1 Main Water Shut-Off,
Distribution & Supply

The water pressure inside the residence exceeds 80 psi, (currently ___ psi) and will stress components of the system. Appliances and components such as water heaters, dishwashers, washing machines and most water using appliances will function better and last longer under lower water pressure (usually 40-80 psi). A licensed plumber should evaluate this issue add a water pressure regulator as necessary. This evaluation and service is recommended before the close of escrow.

Contact a qualified plumbing contractor.

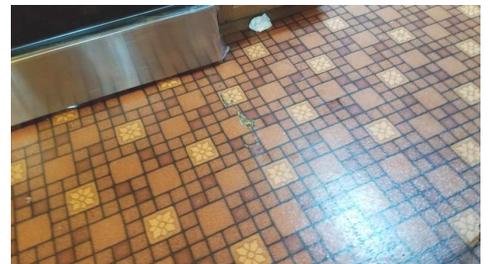
FLOOR WORN OR COSMETICALLY DAMAGED

The floor is worn or cosmetically damaged, which you should view for yourself and correct as desired.

Contact a qualified flooring contractor

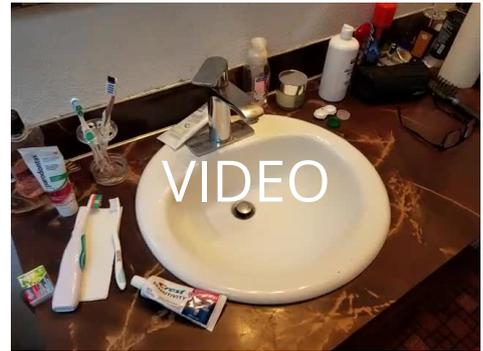
The sinkstopper does not work properly and repair is recommended.

Contact a qualified handyman.

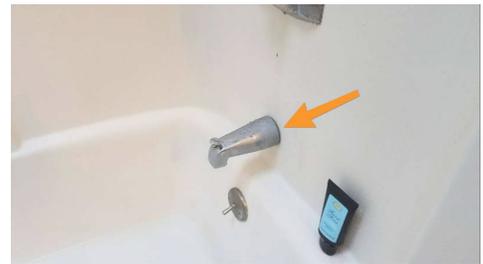
11.4.1 Tub-Shower

I recommend caulking or sealing around shower valves and faucets etc to help prevent moisture intrusion behind or into the walls.

Monitoring these areas is also recommended to help ensure an adequate seal is in place.

Contact a qualified handyman.

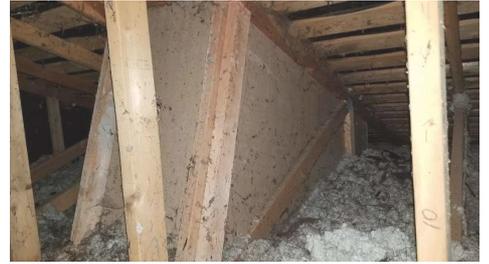
ATTIC SKYLIGHT WALLS ARE NOT FULLY INSULATED

The attic skylight walls are not insulated and should be to prevent cooling and heating loss. I recommend having a qualified contractor correct this situation.

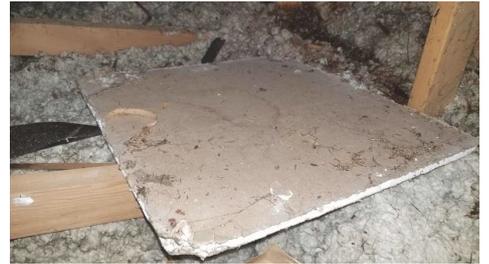
14.5.2 Insulation Notes

HATCH MISSING INSULATION

The attic access hatch was missing insulation. We recommend installing.

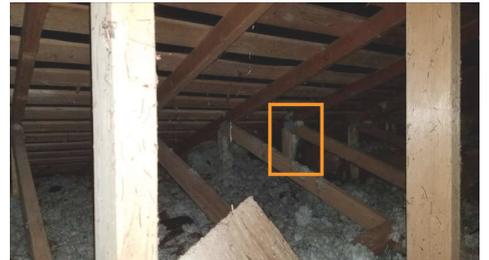
14.7.1 Exhaust Ducts

BATHROOM EXHAUST EXTEND TO EXTERIOR

The bathroom exhaust duct should be extended to an exterior vent port.

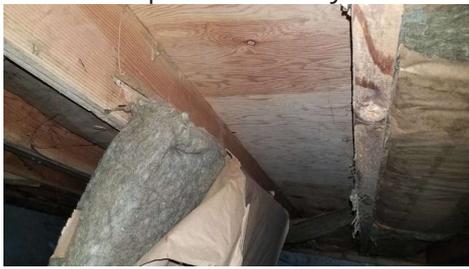
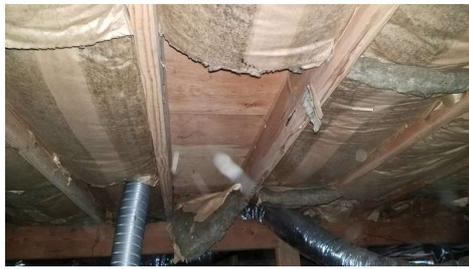
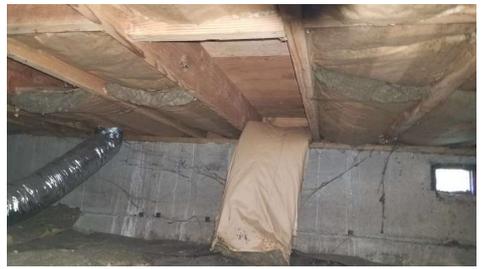
15.1.2 Crawlspace Notes

INSULATION FALLING DOWN

Contact a qualified handyman.

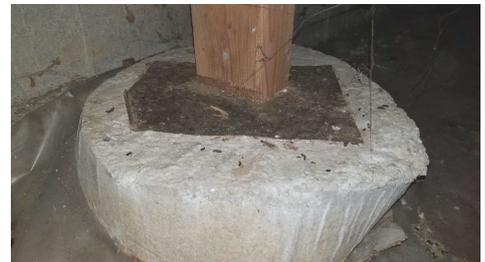
15.1.3 Crawlspace Notes

RODENT ACTIVITY

Contact a qualified pest control specialist.

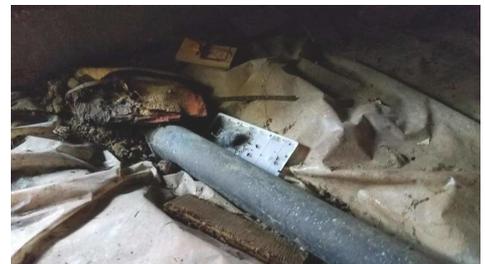
15.1.4 Crawlspace Notes

DEAD ANIMAL

Contact a qualified professional.

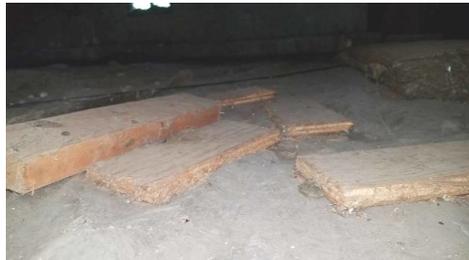
15.1.5 Crawlspace Notes

WOOD DEBRIS

Contact a qualified professional.
