RW WEST HOME INSPECTION REPORT

18548 43rd Ave NE
Lake Forest Park WA 98155

APRIL 29, 2021

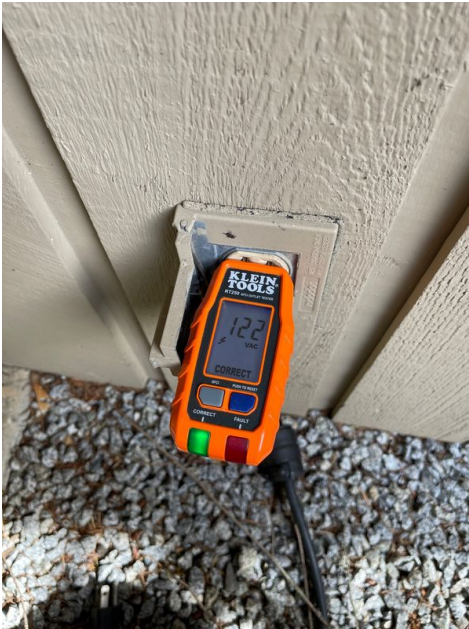
GFCI outlets have been required at exterior (since 1973) No GFCI protection present, strongly recommend GFCI outlets are installed as a safety precaution.

Contact a qualified electrical contractor.

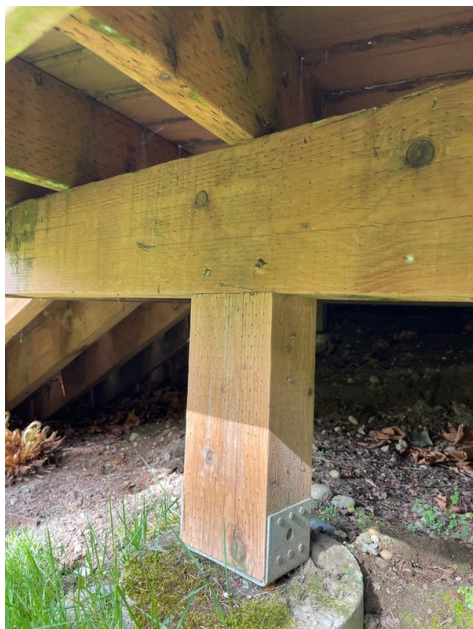
Beams nailed to posts. Typically bolts should be used for this application to prevent splitting

Recommendation
Contact a qualified professional.

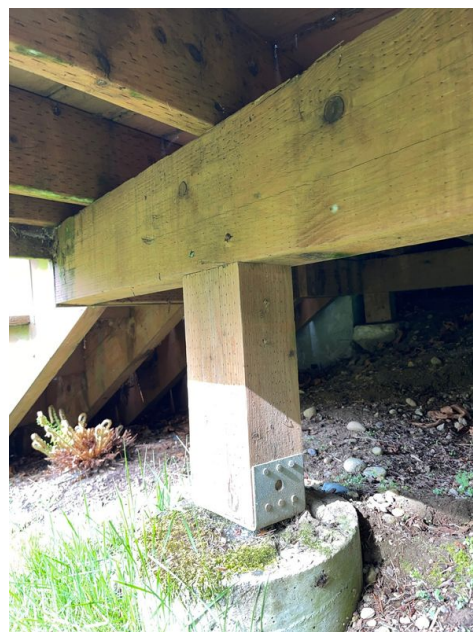
Deck post and beam connections are not gusseted or strapped, recommend conditions are corrected as a safety precaution

Contact a qualified professional.

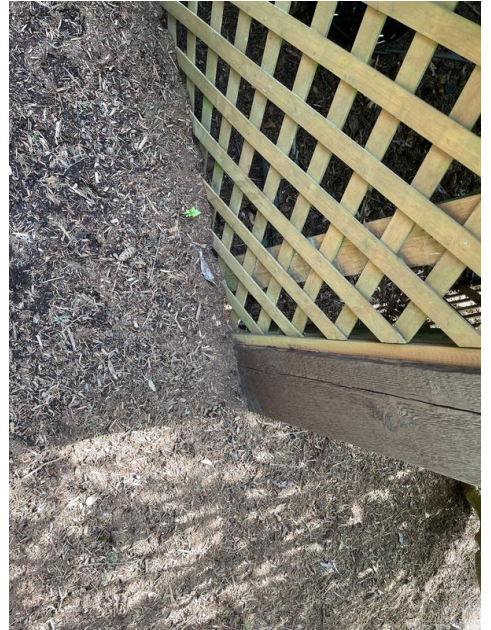
Cannot verify if cut ends were retreated, if not decay can result.
Recommend alleviating soil contact

Contact a qualified professional.

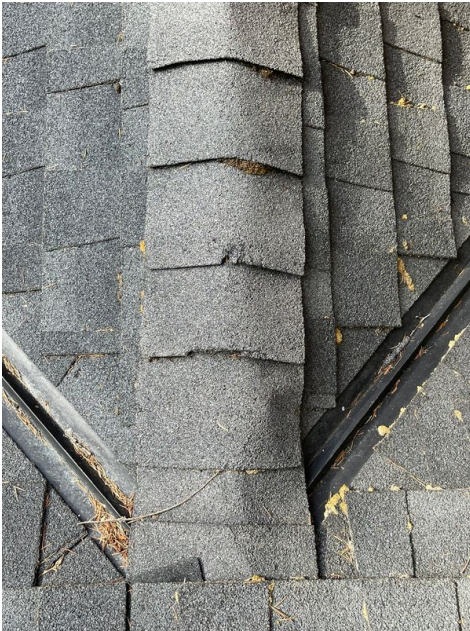
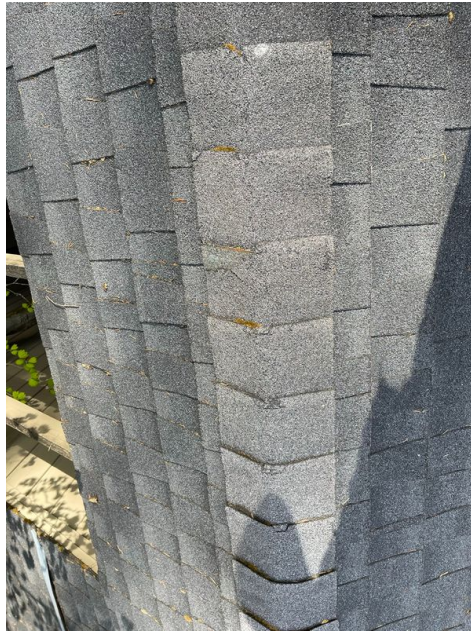
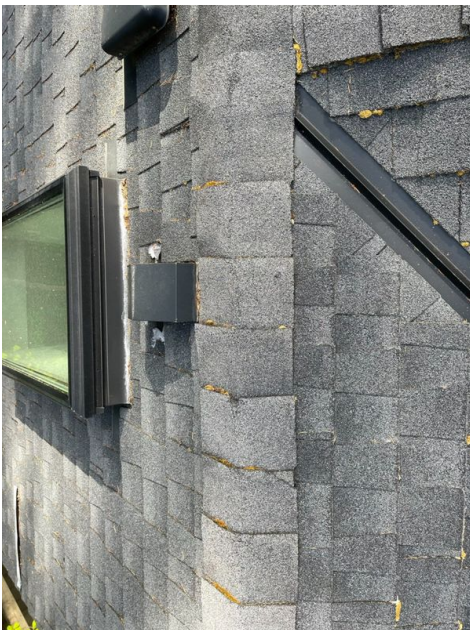
6.1.1 Roof Type

DAMAGED

Some shingles damaged, recommend extent of damage is investigated further and repaired as needed.

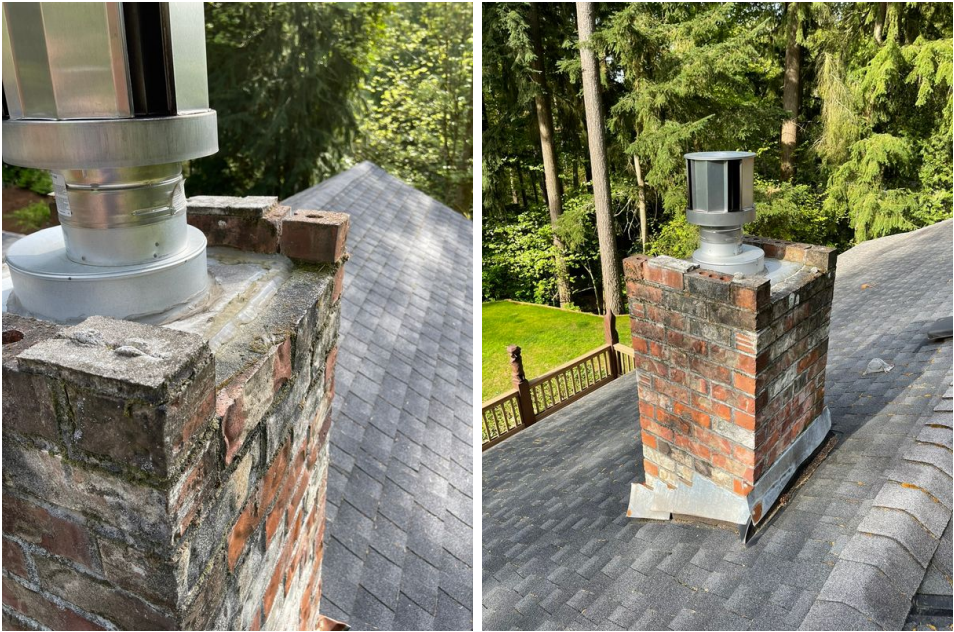
Moss on chimney recommend alleviating to prevent spalling

Recommendation
Contact a qualified professional.

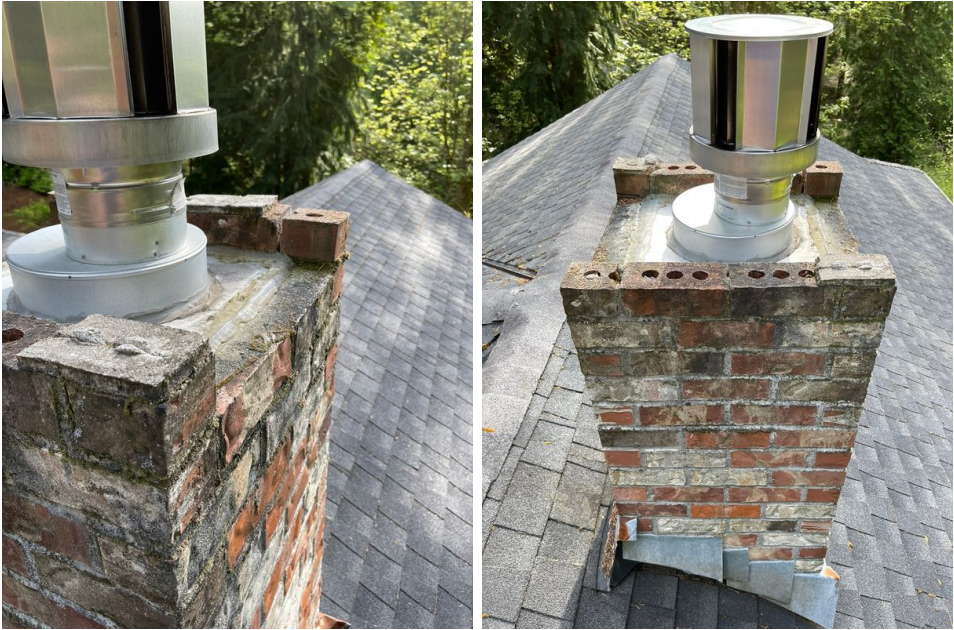
6.4.2 Chimney
DETERIORATION

Brick and mortar deterioration observed; recommend conditions are repaired by licensed chimney sweep or masonry contractor.

Recommendation
Contact a qualified masonry professional.

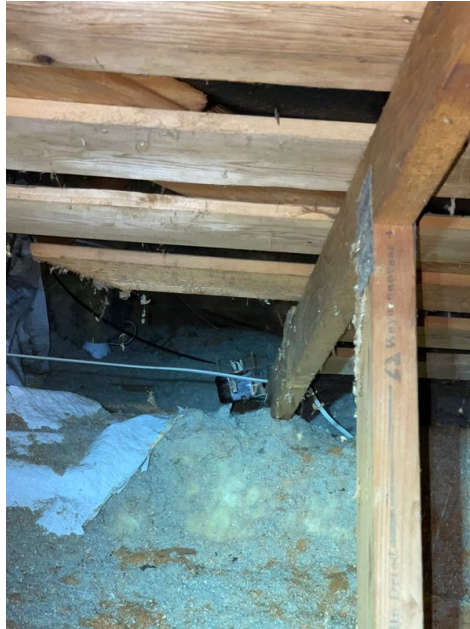
Electrical switch/Junction Box Covers missing or damaged, which is a potential shock is hazard, recommend cover plates are installed as a safety precaution. Easily correctable

Contact a handyman or DIY project

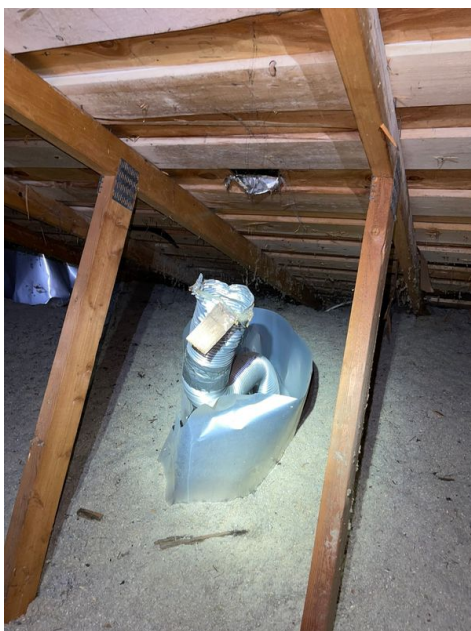
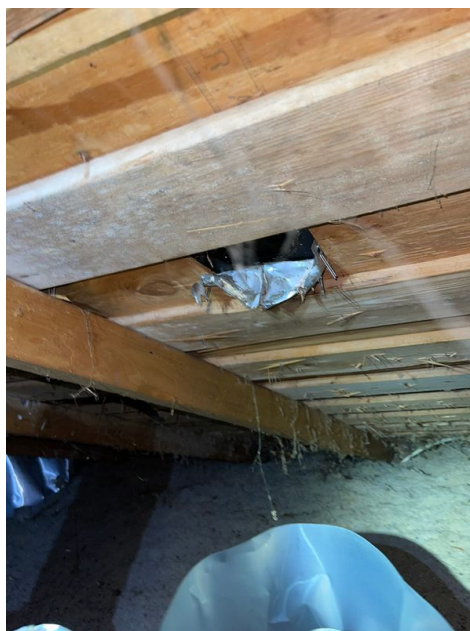
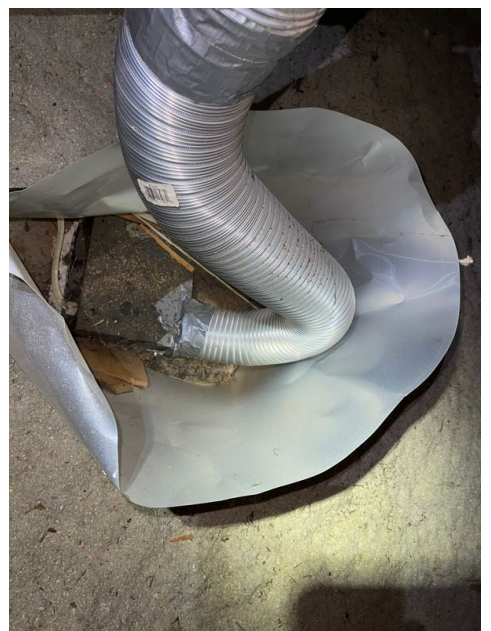
7.5.1 Fan/Duct

BATH FANS NOT EXHAUSTING OUT

Not All Bathroom fans exhaust completely to the exterior. Typically piping should actually connect to exterior vent, recommend correction. This condition can result in mold/fungal growth.

Contact a qualified professional.

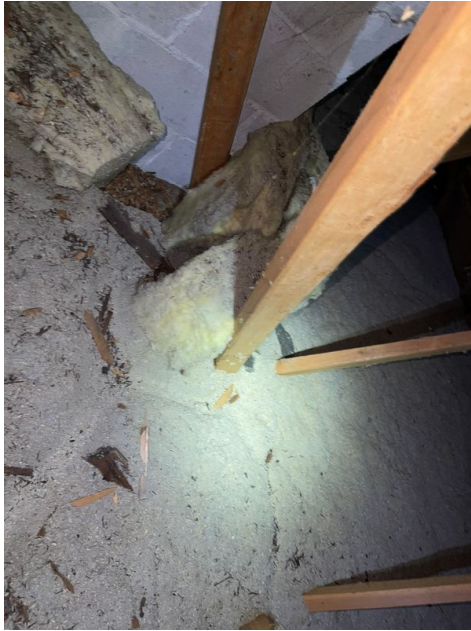
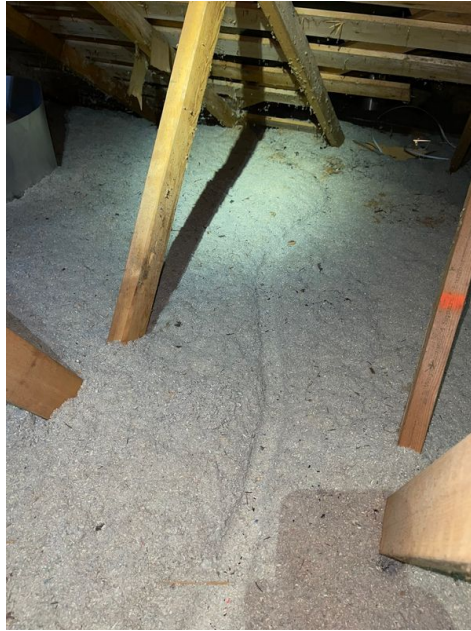
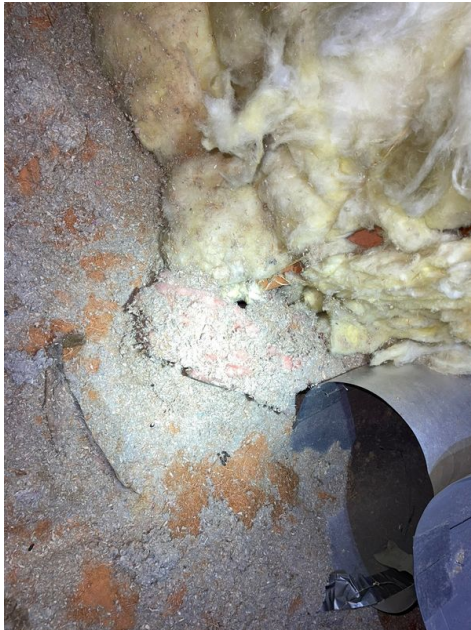
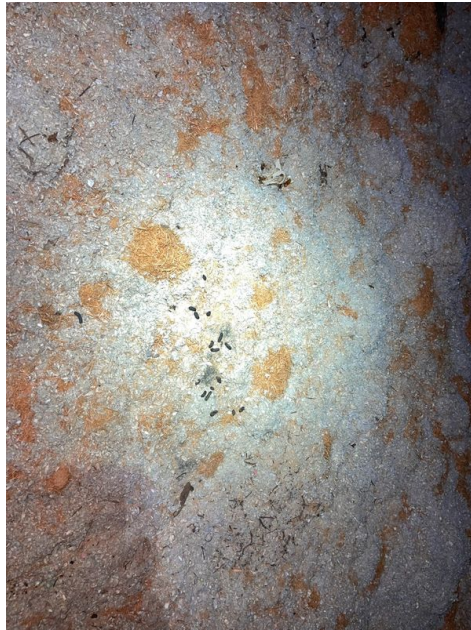
7.8.1 Rodents/Pests

RODENT ACTIVITY

Indications of Rodent activity. Droppings and/or Urine/Carcasses. Rodent droppings can carry disease. rodents can also cause damage to insulation. Recommend conditions are investigated further by licensed Pest Control Company.

Contact a qualified pest control specialist.

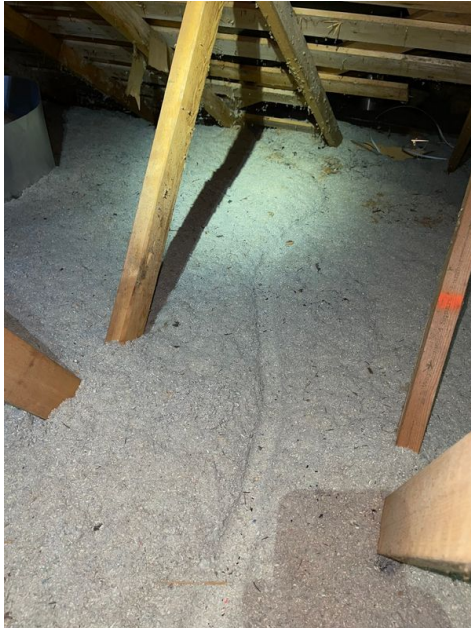
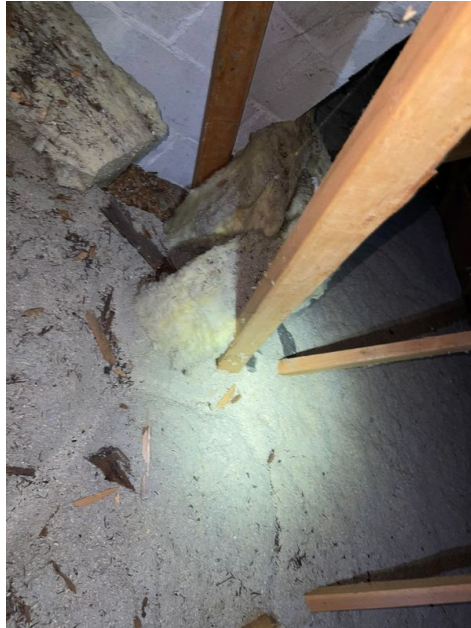
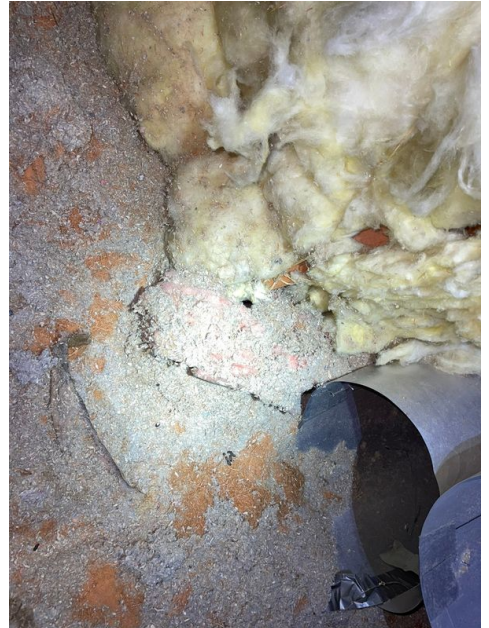
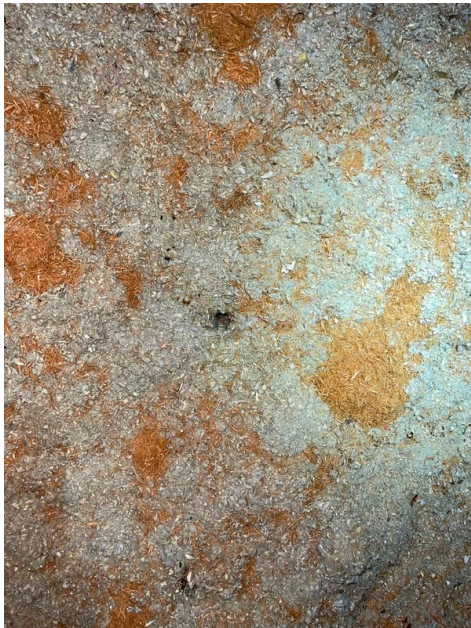
7.8.2 Rodents/Pests

BURROWING

Burrowing in the insulation indicating rodent activity. Recommend further investigation by licensed pest control company

Contact a qualified pest control specialist.

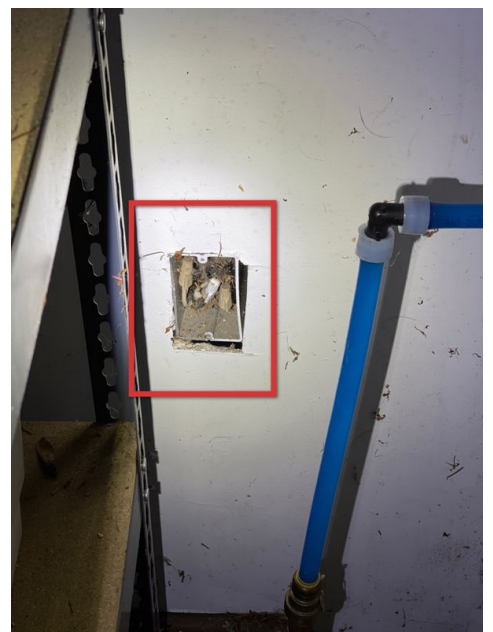
Open junction boxes were observed, which is a safety concern. Recommend installing proper covers as needed for safety. Easily correctable

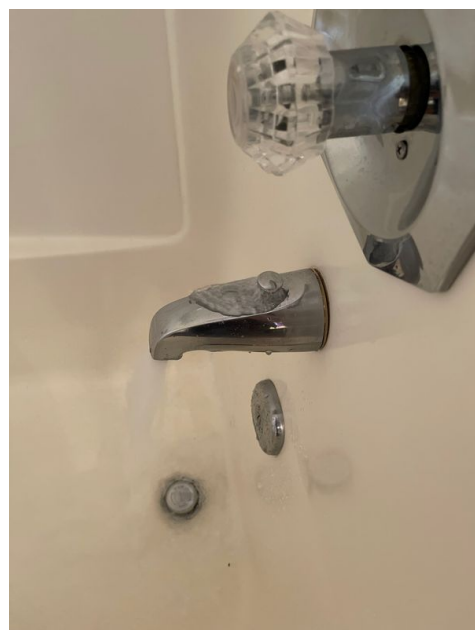
SPIGOT LEAK

Tub spigot leaks where it attaches to the wall, recommend conditions are investigated further and corrected. Sometimes tightening will remedy this condition.

Contact a qualified professional.

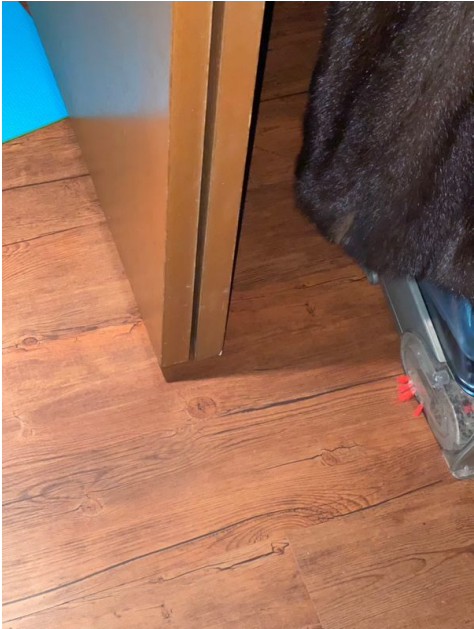
Guides missing at the base of closet door(s).

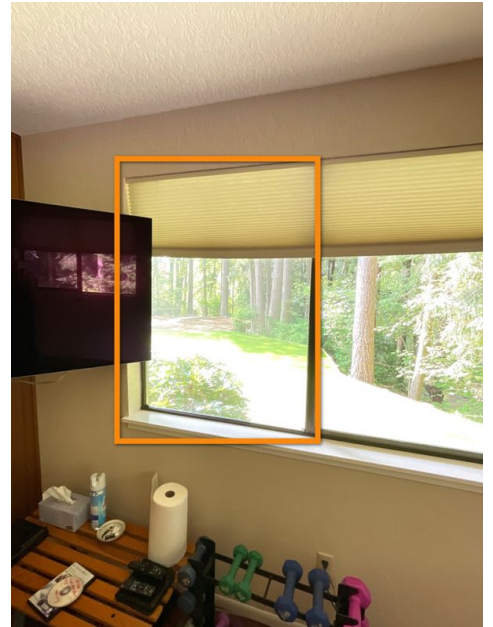
12.6.1 Window Deficiencies

FAILED SEAL

Discoloration/condensation between the panes. This is an indication of a failed seal. Recommend conditions are corrected by licensed glass company.

Contact a qualified window repair/installation contractor.

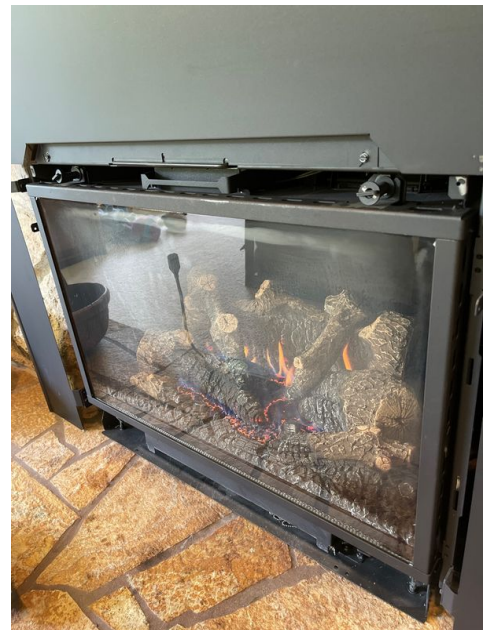
Recommend cleaning fireplace glass, if discoloration is left for long periods it can become etched in the glass. Recommend cleaning fireplace glass, if discoloration is left for long periods it can become etched in the glass. Products with ammonia or regular glass cleaners should not be used as they can cause the glass to shatter

Contact a qualified professional.

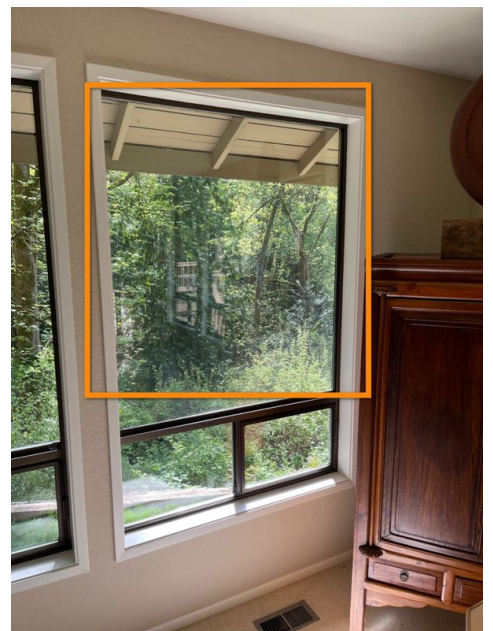
15.6.1 Window Deficiencies

FAILED SEAL

Discoloration/condensation between the panes. This is an indication of a failed seal. Recommend conditions are corrected by licensed glass company.

Contact a qualified window repair/installation contractor.

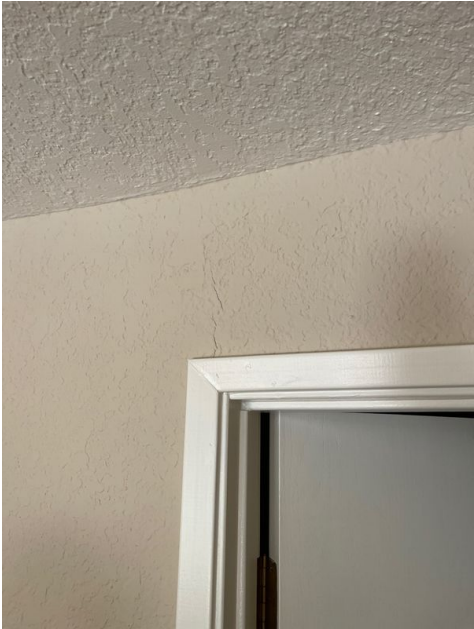
CRACKING NOT UNUSUAL

Cracking at the ceiling and or walls does not appear unusual.

Recommendation
Recommend monitoring.

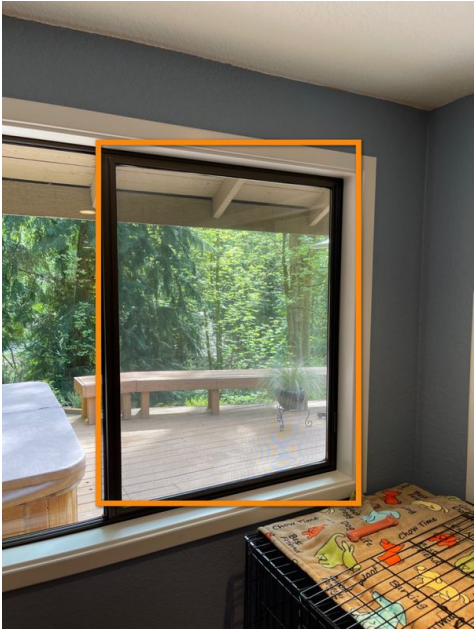
19.6.1 Window Deficiencies

FAILED SEAL

Discoloration/condensation between the panes. This is an indication of a failed seal. Recommend conditions are corrected by licensed glass company.

Contact a qualified window repair/installation contractor.

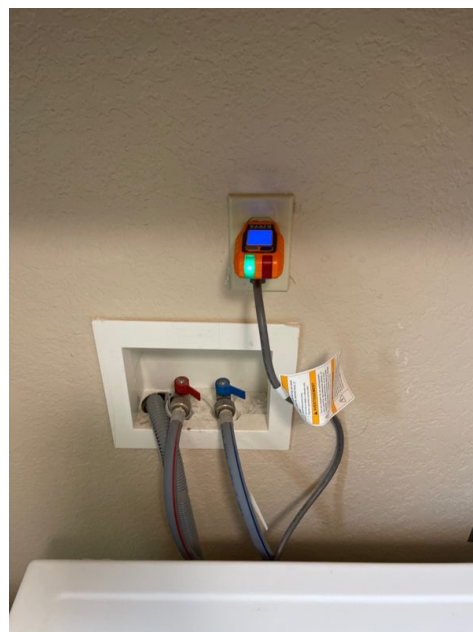
GFCI outlets have been required for Laundry and utility sinks (since 2005) No GFCI protection present,, strongly recommend GFCI outlets are installed as a safety precaution.

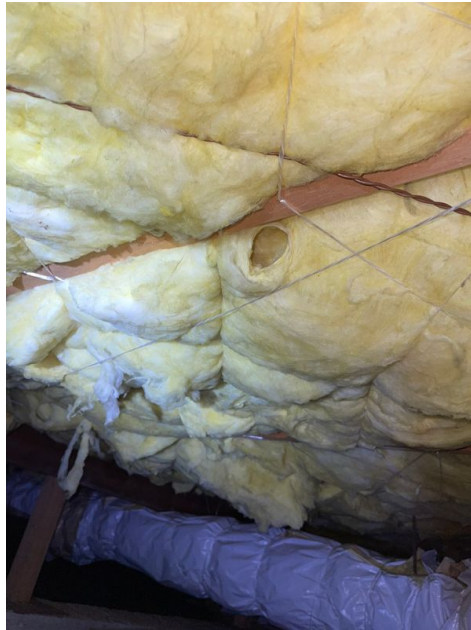
Burrowing in the insulation indicating rodent activity. Recommend further investigation by licensed pest control company

Contact a qualified pest control specialist.

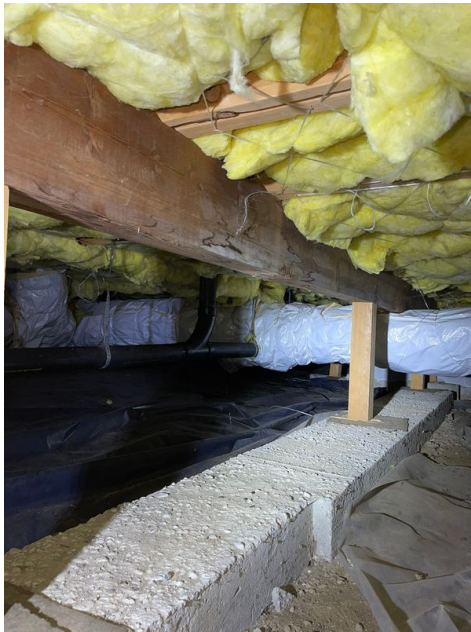
23.10.1 Insulation Condition

DAMAGED/MISSING

Insulation damaged/missing in areas of the crawlspace, recommend damaged/missing insulation be replaced

Contact a qualified professional.

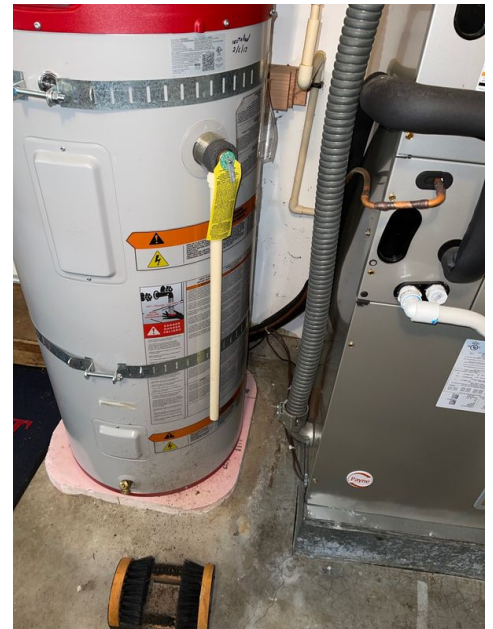
Observations**25.8.1 TPRV Condition****6 INCHES ABOVE**

Recommendation
Contact a qualified professional.
