BEST HOME INSPECTIONS

HOME INSPECTION REPORT

1234 Main St
Denver CO 80210

NOVEMBER 21, 2016

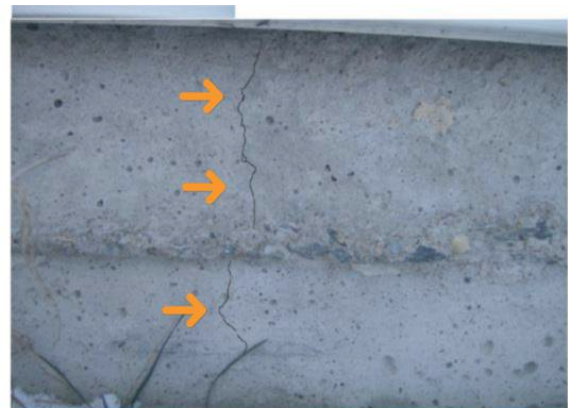
2.1.1 - FOUNDATION, BASEMENT & CRAWLSPACES: FOUNDATION CRACKS - MINOR

Minor cracking was noted at the foundation. This is common as concrete ages and shrinkage surface cracks are normal. Recommend monitoring for more serious shifting/displacement.

Recommendation

Contact a qualified professional.

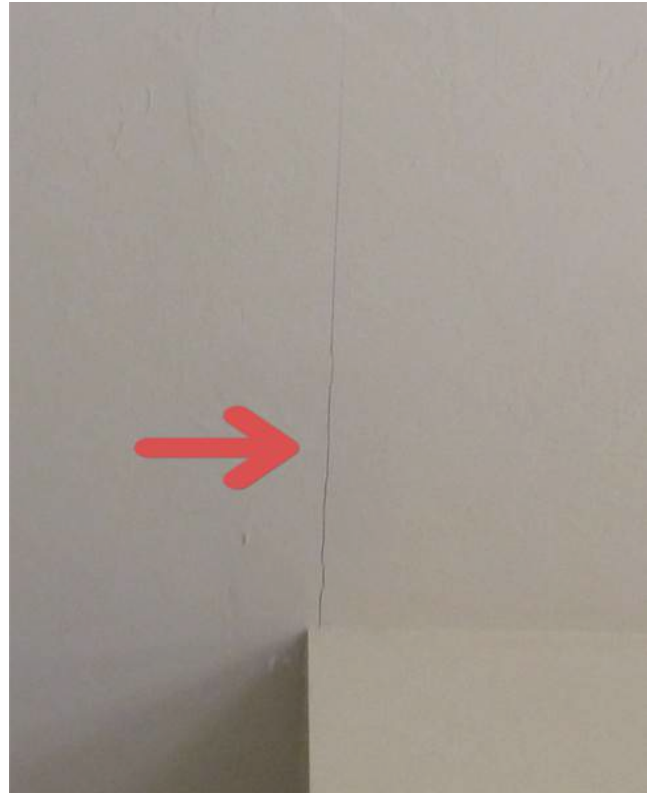
2.3.1 - WALL STRUCTURE: EVIDENCE OF STRUCTURAL DAMAGE

⚠ Safety Hazard and/or Requires Immediate Attention

Evidence of structural damage was found in the wall structure. Recommend a structural engineer evaluate and advise on how to repair.

Recommendation

Contact a qualified structural engineer.

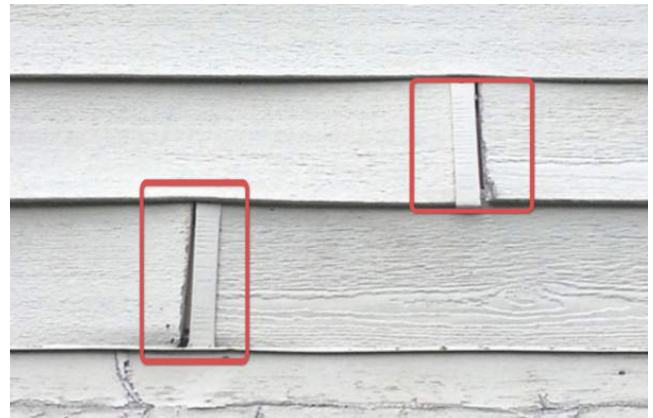
3.1.1 - SIDING, FLASHING & TRIM: WARPING/BUCKLING

Vinyl siding was warping or buckling in areas. This is often as a result of nailing siding boards to tight to the home, preventing expansion/contraction. Recommend a qualified siding contractor evaluate and repair.

Recommendation

Contact a qualified professional.

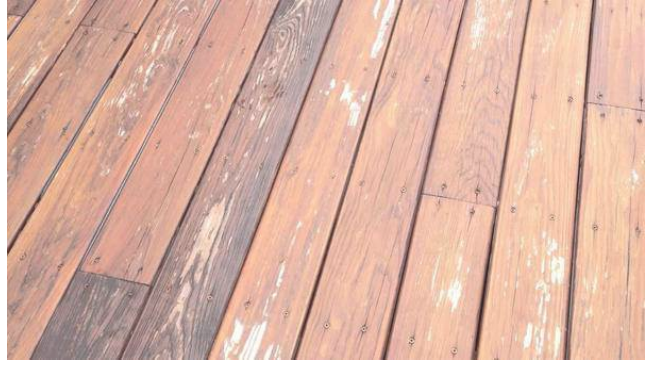
3.3.1 - DECKS, BALCONIES, PORCHES & STEPS: DECK - WATER SEALANT REQUIRED

Deck is showing signs of weathering and/or water damage. Recommend water sealant/weatherproofing be applied.

Recommendation

Recommended DIY Project

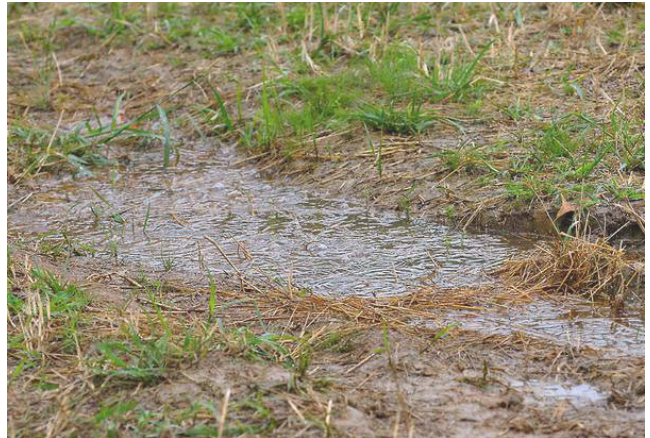
3.5.1 - VEGETATION, GRADING, DRAINAGE & RETAINING WALLS: STANDING WATER

Standing water observed, which could indicate poor drainage and/or grading. Recommend monitor and/or have landscaper correct.

Water pooling in yard; recommend drainage

Recommendation

Contact a qualified landscaper or gardener.

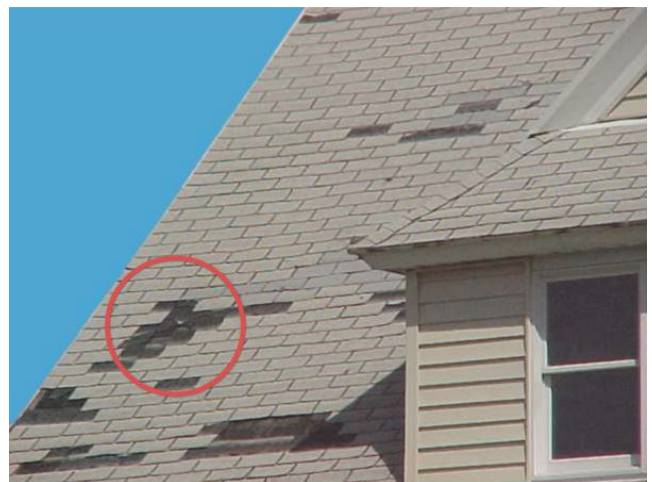
4.1.1 - COVERINGS: SHINGLES MISSING

Observed areas that appeared to be missing sufficient coverings. Recommend qualified roofing contractor evaluate & repair.

Recommendation

Contact a qualified roofing professional.

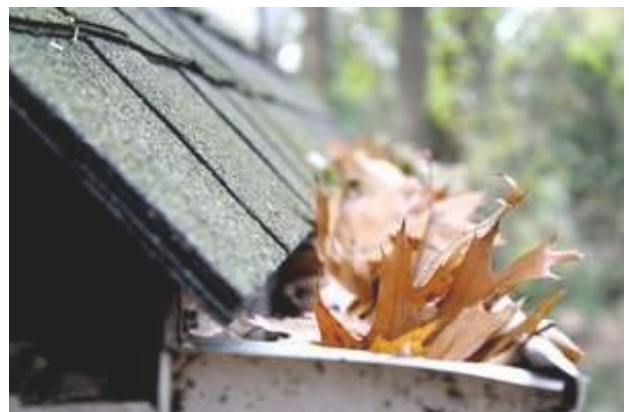
4.2.1 - ROOF DRAINAGE SYSTEMS: DEBRIS

Debris has accumulated in the gutters. Recommend cleaning to facilitate water flow.

Recommendation

Contact a qualified roofing professional.

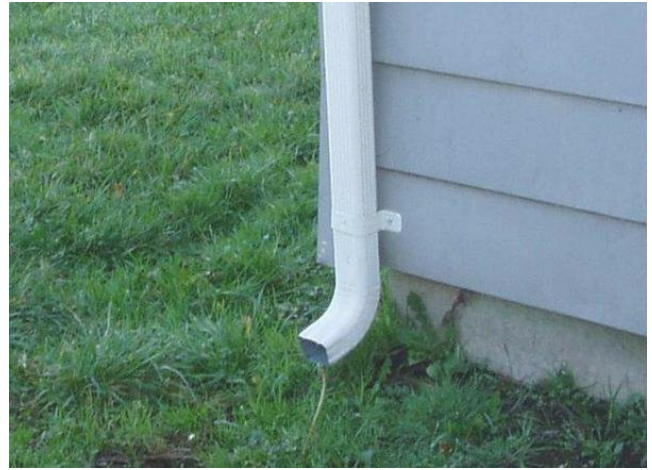
4.2.2 - ROOF DRAINAGE SYSTEMS: DOWNSPOUTS DRAIN NEAR HOUSE

One or more downspouts drain too close to the home's foundation. This can result in excessive moisture in the soil at the foundation, which can lead to foundation/structural movement.

Recommend a qualified contractor adjust downspout extensions to drain at least 6 feet from the foundation.

Recommendation

Contact a qualified roofing professional.

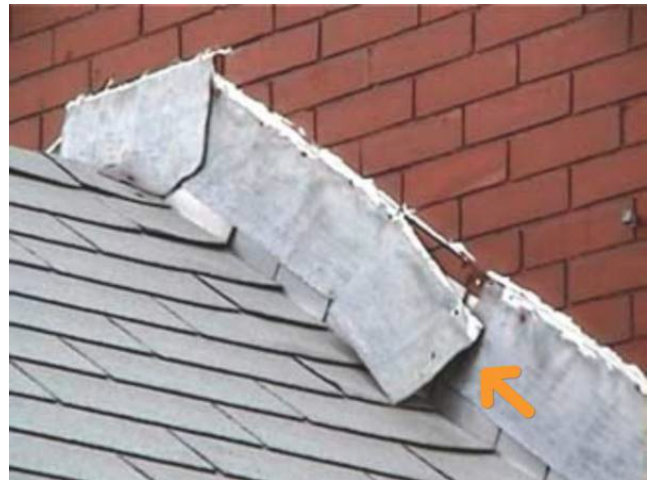
4.3.1 - FLASHINGS: LOOSE/SEPARATED

Flashings observed to be loose or separated, which can lead to water intrusion and/or mold. Recommend a qualified roofing contractor repair.

Recommendation

Contact a qualified roofing professional.

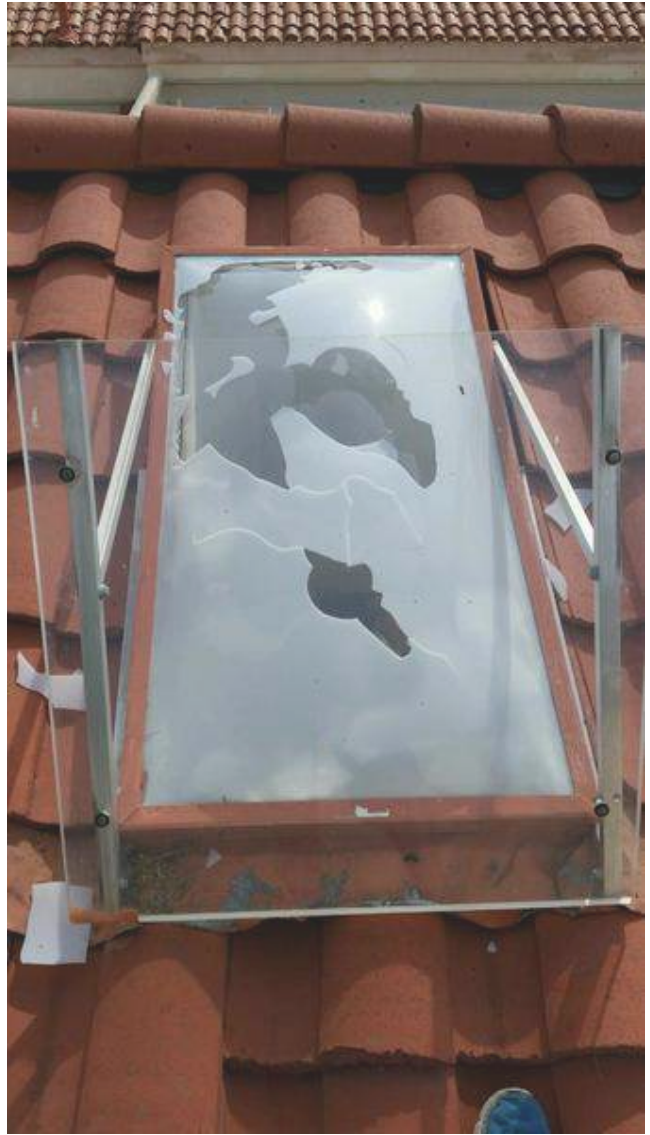
4.4.1 - SKYLIGHTS, CHIMNEYS & ROOF PENETRATIONS: SKYLIGHT CRACKED

⚠ Safety Hazard and/or Requires Immediate Attention

Skylight was cracked in one or more places. Recommend a qualified roofing contractor repair.

Broken skylight presents risk of water entry and glass shards entering house.

Recommendation

Contact a qualified roofing professional.

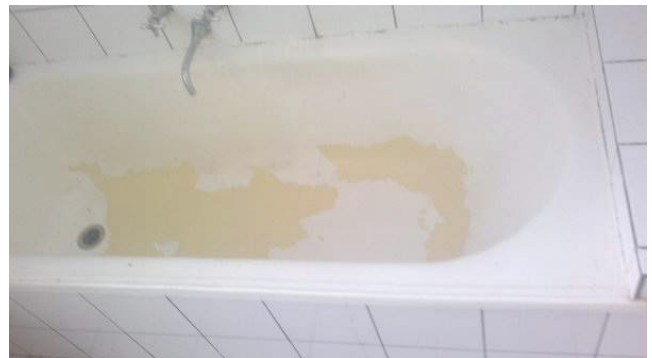
**5.1.1 - FIXTURES / FAUCETS:
BATHTUB PAINT PEELING**

Bathtub paint is peeling off. Recommend replacement or qualified repair.

Recommendation

Contact a qualified professional.

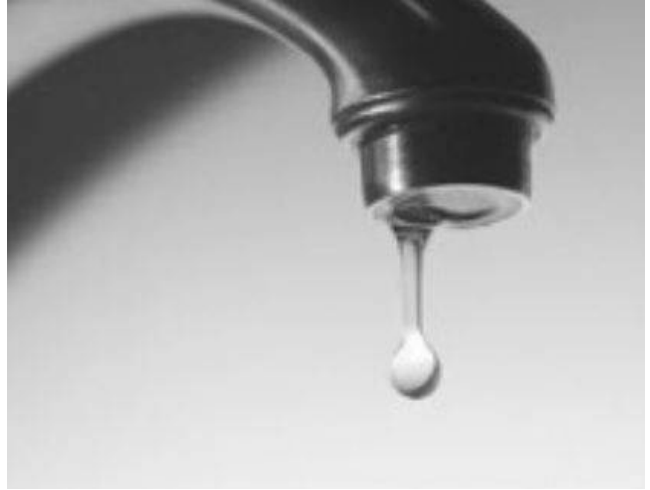
5.1.2 - FIXTURES / FAUCETS: FAUCET DRIP

A faucet is dripping. Recommend qualified handyman or plumber repair.

Recommendation

Contact a qualified plumber.

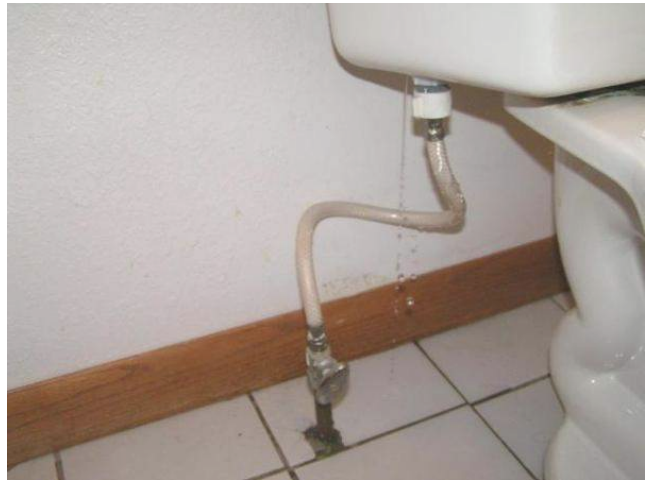
5.1.3 - FIXTURES / FAUCETS: TOILET LEAKING

Toilet is dripping near water supply. Recommend qualified handyman or plumber repair.

Recommendation

Contact a qualified plumber.

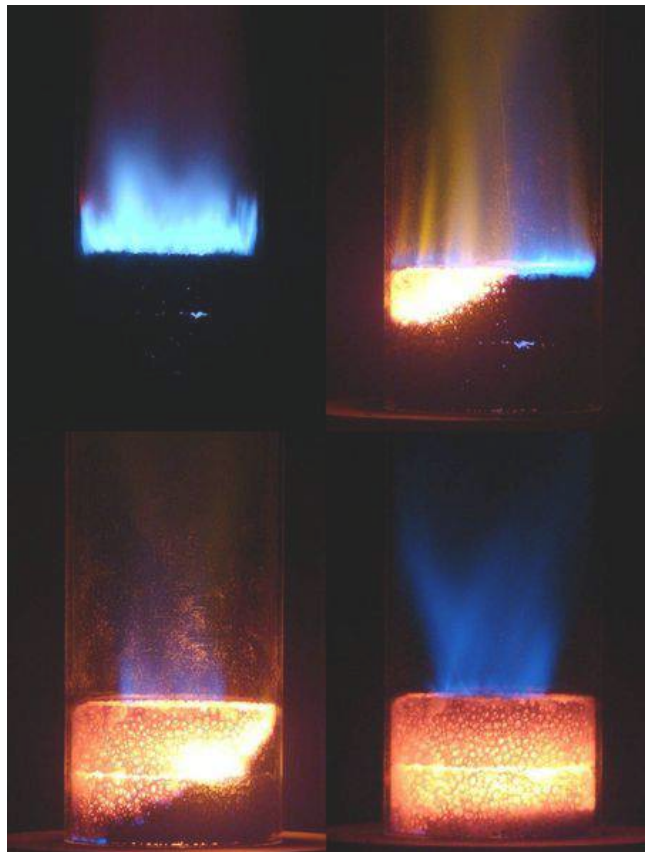
5.3.1 - WATER HEATER: IRREGULAR FLAME

Water heater flame is irregular. Recommend qualified plumber evaluate & repair.

Recommendation

Contact a qualified plumber.

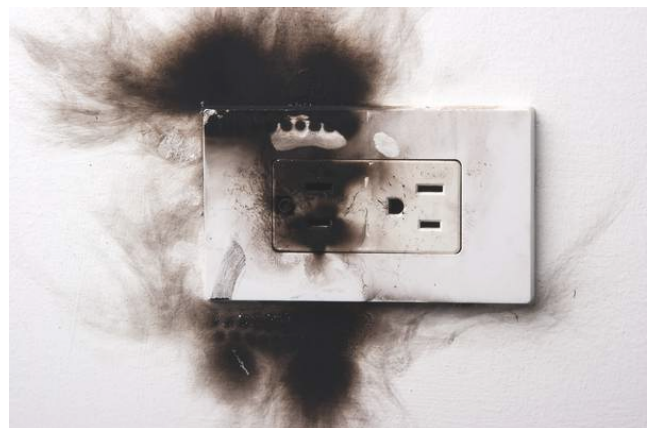
6.4.1 - CONNECTED DEVICES AND FIXTURES (REPRESENTATIVE NUMBER OF SWITCHES AND RECEPTACLES IN THE HOME, GARAGE & EXTERIOR): COVER PLATES DAMAGED

One or more receptacles have a damaged cover plate. Recommend replacement.

Scorch marks on cover plate

Recommendation

Contact a qualified electrician.

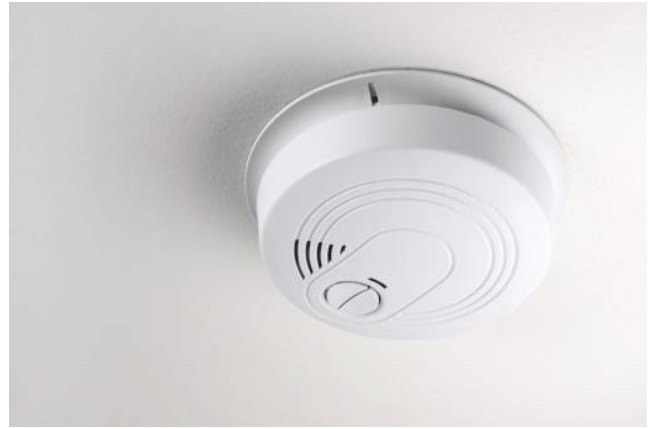
6.7.1 - SMOKE DETECTORS: DEFECTIVE

⚠ Safety Hazard and/or Requires Immediate Attention

Smoke detector is connected, but not functioning properly. Recommend replacement.

Recommendation

Recommended DIY Project

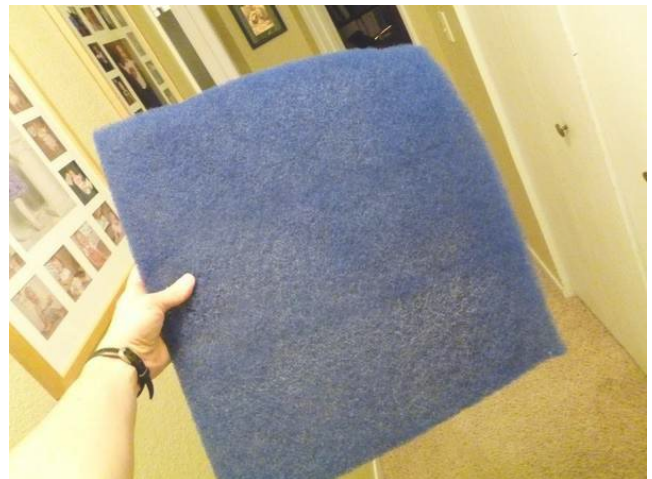
7.1.1 - HEATING EQUIPMENT: FILTER REQUIRES REPLACEMENT

The furnace filter appears to be beyond its expected lifespan. Recommend replacement.

Recommendation

Contact a qualified HVAC professional.

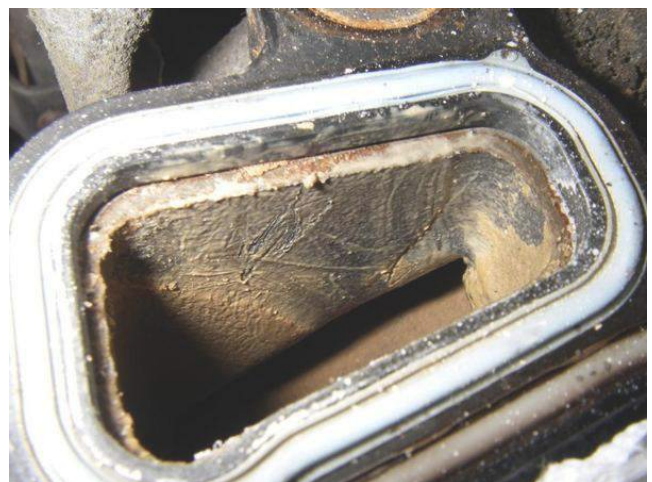
7.1.2 - HEATING EQUIPMENT: MANIFOLDS DIRTY

Cleaning manifolds will result in better air quality.

Recommendation

Contact a qualified HVAC professional.

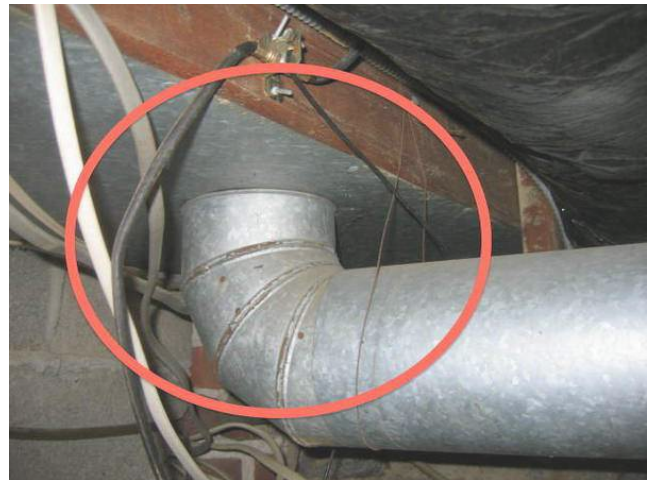
8.2.1 - DISTRIBUTION SYSTEM: LOOSE CONNECTION

There are loose connections on ducts, resulting in energy loss. Recommend licensed HVAC contractor resecure.

Loose connection; recommend sealing.

Recommendation

Contact a qualified HVAC professional.

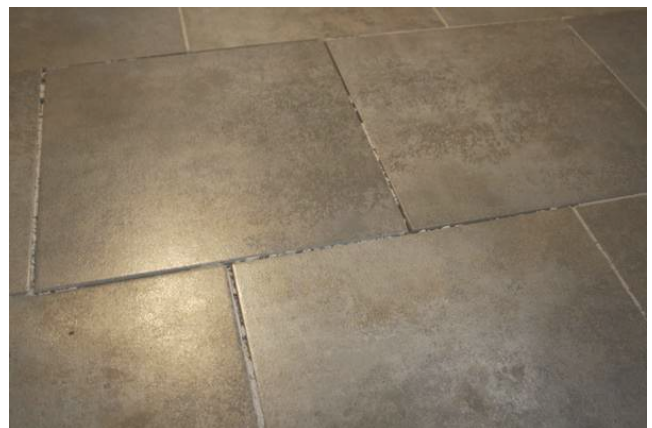
9.3.1 - FLOORS: TILES LOOSE

Loose tiles are present. Recommend re-attach and seal.

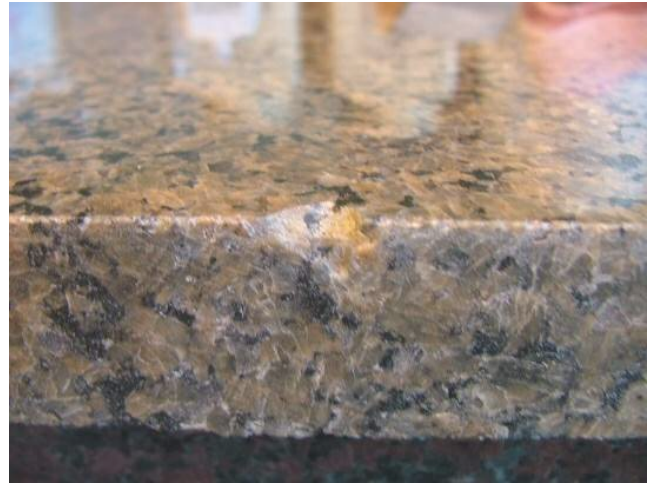
9.5.1 - COUNTERTOPS & CABINETS (REPRESENTATIVE NUMBER): COUNTERTOP CRACKED/CHIPPED

Countertop had one or more cracks or chips. Recommend qualified countertop contractor evaluate and repair.

Recommendation

Contact a qualified countertop contractor.

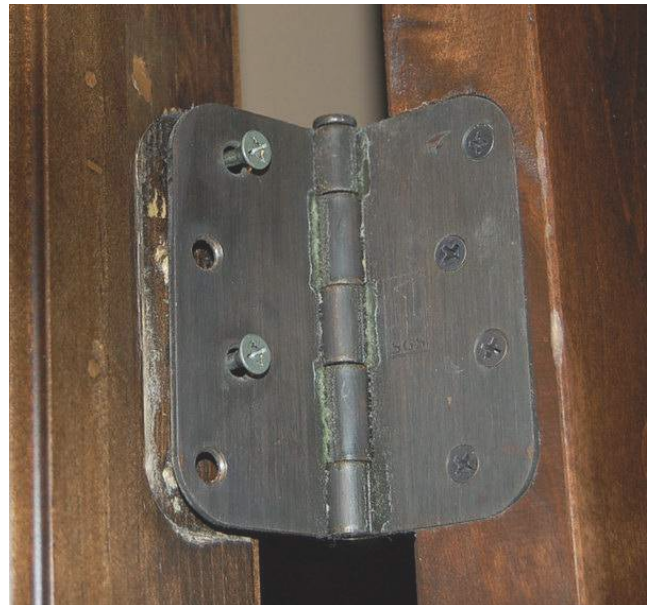
9.6.1 - DOORS (REPRESENTATIVE NUMBER): HINGES LOOSE

Loose hinges can cause door to stick or eventually fall out of place. Recommend handyman tighten hinges.

Recommendation

Contact a quality handyman.

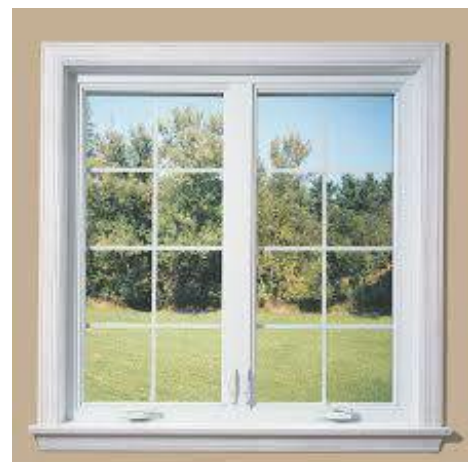
9.7.1 - WINDOWS (REPRESENTATIVE NUMBER): MISSING SCREEN

Window missing screen. Recommend replacement.

Recommendation

Contact a qualified window repair/installation contractor.

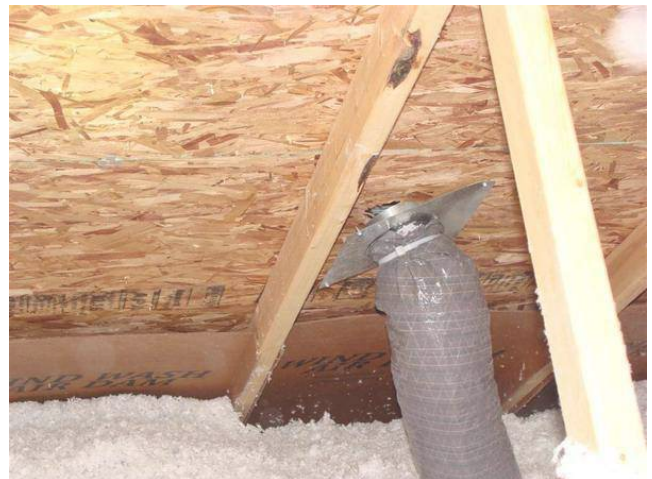
11.4.1 - EXHAUST SYSTEMS: DUCTS LOOSE

Ductwork in the attic is loose or disconnected. Recommend repair.

Recommendation

Contact a qualified HVAC professional.

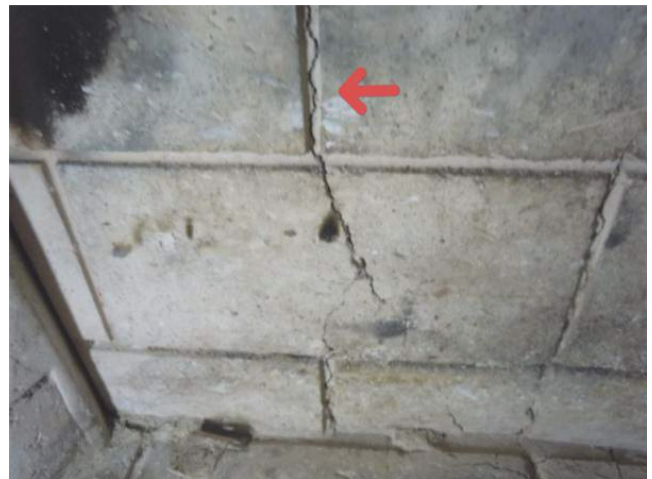
12.1.1 - FIREPLACES, STOVES & INSERTS: FIREWALL CRACKED

⚠ Safety Hazard and/or Requires Immediate Attention

The brick lining of the fireplace was cracked in one or more places, which could lead to chimney damage or toxic fumes entering the home. Recommend a qualified fireplace contractor evaluate and repair.

Recommendation

Contact a qualified fireplace contractor.
