REPAIR REQUEST LIST

422 W 1600 N
03/03/2020 10:21 am

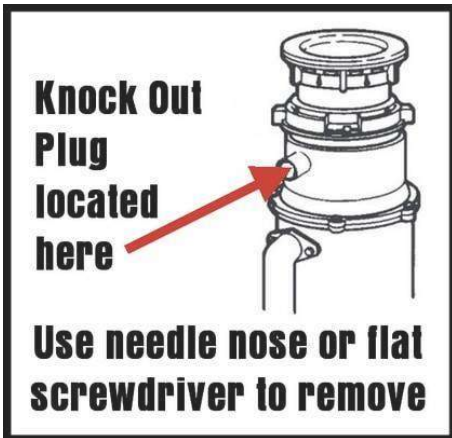
2.1.1 - Built-in Appliances: Dishwasher

DRAIN NOT CONNECTED

The drain from the dishwasher to the drain line or the garbage disposal was not connected.

The garbage disposal drain plug was not removed upon installation.

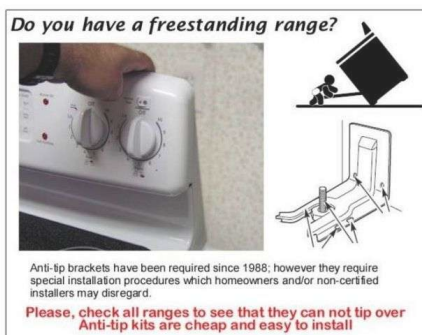
2.3.1 - Built-in Appliances: Range/Oven/Cooktop

ANTI-TIP DEVICE

There was no Anti-tip device installed. This poses a safety hazard to children. Recommend an Anti-tip be installed.

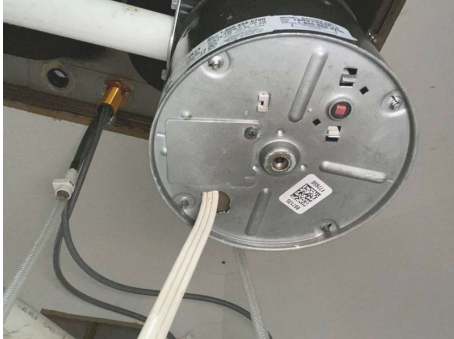
2.5.1 - Built-in Appliances: Garbage Disposal

WIRE CLAMP

The wire clamp on the bottom of the unit was either missing or not properly installed.
The wire clamp is used to prevent the cord from damage or being pulled out of the unit.

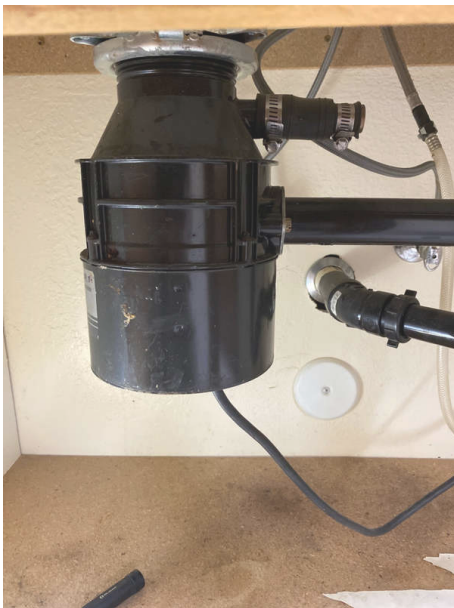
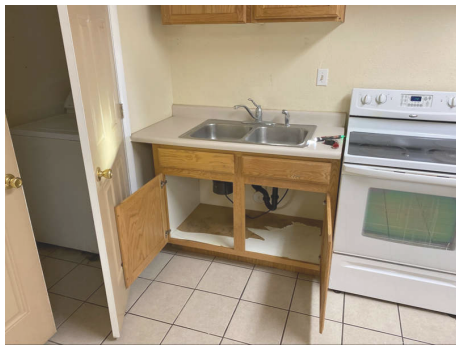
2.6.1 - Built-in Appliances: Garbage Disposal
INOPERABLE

Garbage disposal was inoperable at the time of inspection. Recommend qualified handyman repair.

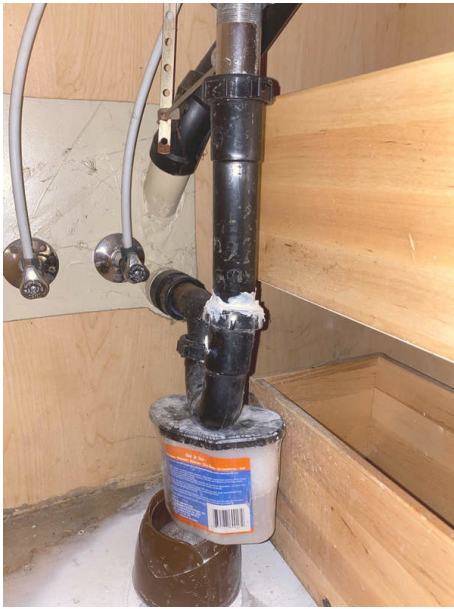
5.2.1 - Plumbing: Drain, Waste, & Vent Systems
LEAKING PIPE

A drain, waste and/or vent pipe showed signs of a leak. Recommend a qualified plumber evaluate and repair.

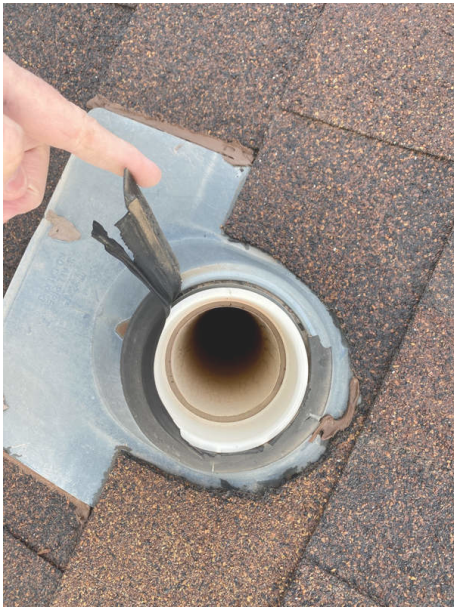
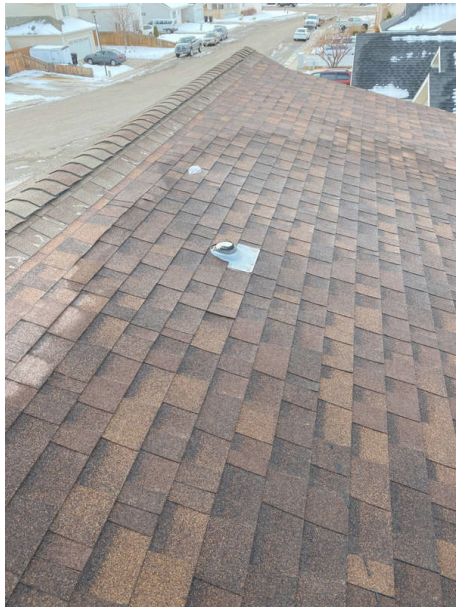
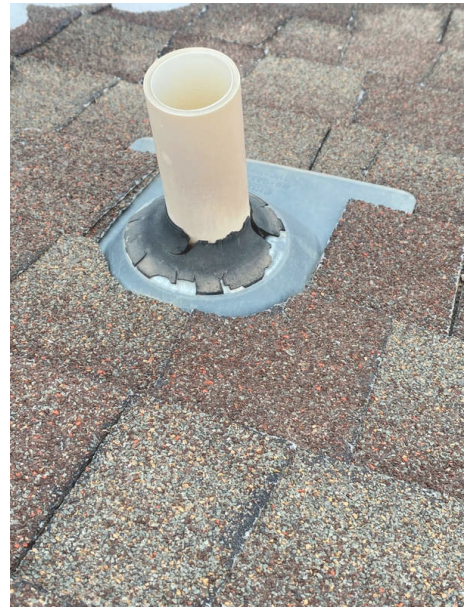
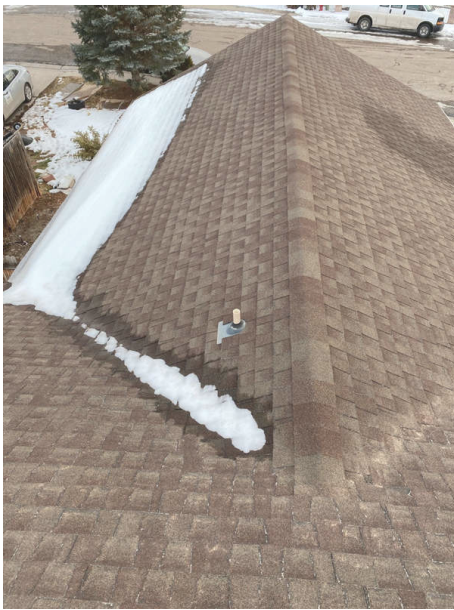
5.2.4 - Plumbing: Drain, Waste, & Vent Systems

VENT STACK BOOT

The vent stack boot was torn.

Contact a qualified professional.

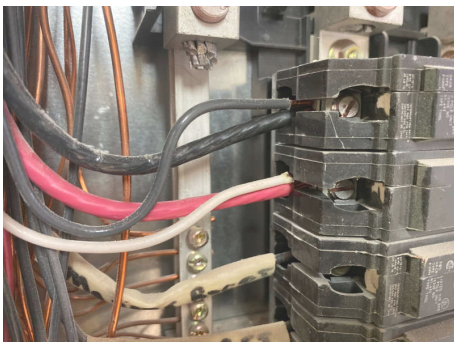
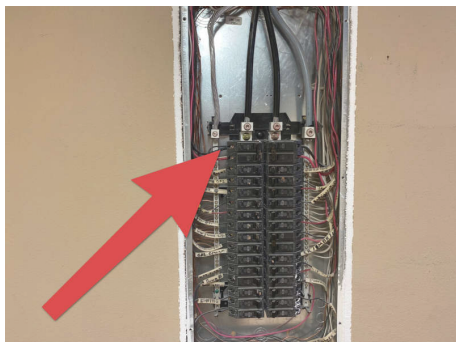
6.2.1 - Electrical: Main & Subpanels, Service & Grounding, Main Overcurrent Device

DOUBLE TAP

There were two wires connected to single breakers this is called a double tap and is not authorized in this brand of electrical panel.

Contact a qualified professional.
