# Uniform Mitigation Verification Inspection Form

| Address: <b>2753 Vista parkway</b> | | Home Phone: | |
| Year of Home: <b>1986</b> | # of Stories: <b>1</b> | Email: <b>contact@billingshomein...</b> | |

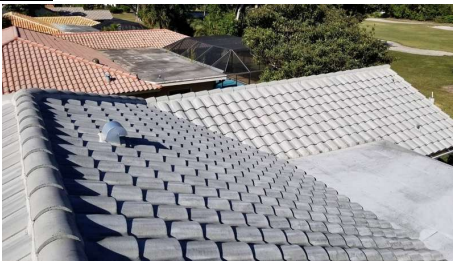
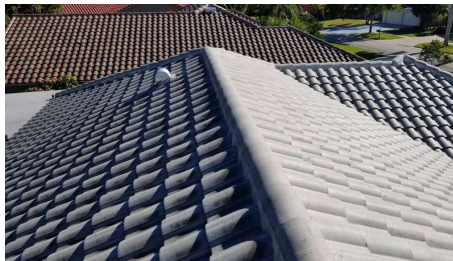
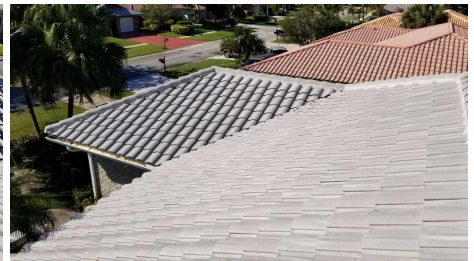
| 2.1 Roof Covering Type | Permit Application Date | FBC or MDC Product Approval # | Year of Original Installation or Replacement | No Information Provided for Compliance |
|---|---|---|--|--|
| <input checked="" type="checkbox"/> 2. Concrete/Clay Tile | <u>11/21/2016</u> | <u>B-2016-028633-0000</u> | <u>2016</u> | <input type="checkbox"/> |

- ☒ A. Hip Roof Hip roof with no other roof shapes greater than 10% of the total roof system perimeter. Total length of non-hip features: 21 feet; Total roof system perimeter: 286 feet
- ☐ B. Flat Roof Roof on a building with 5 or more units where at least 90% of the main roof area has a roof slope of less than 2:12. Roof area with slope less than 2:12 \_\_\_\_\_ sq ft; Total roof area \_\_\_\_\_ sq ft
- ☐ C. Other Roof Any roof that does not qualify as either (A) or (B) above.

Roof

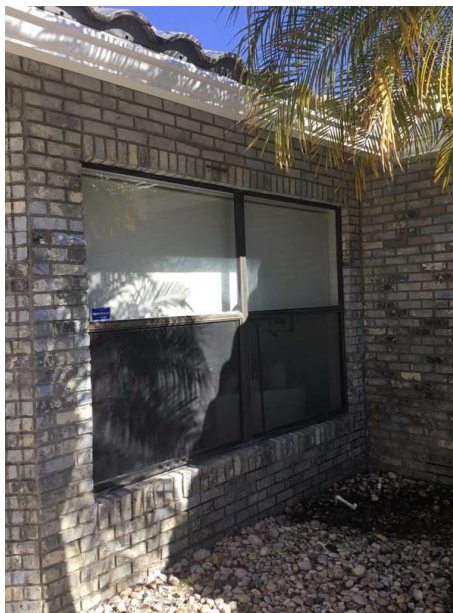
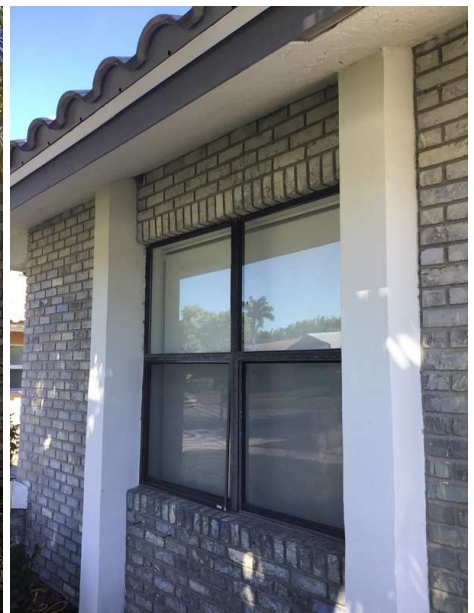
| Opening Protection Level Chart<br>Place an "X" in each row to identify all forms of protection in use for each opening type. Check only one answer below (A thru X), based on the weakest form of protection (lowest row) for any of the Glazed openings and indicate the weakest form of protection (lowest row) for Non-Glazed openings. | | Glazed Openings | | | | Non-Glazed Openings | |
|--|---|---|---|---|---|---|---|
| X | No Windborne Debris Protection | X | | | | X | X |

Unprotected openings

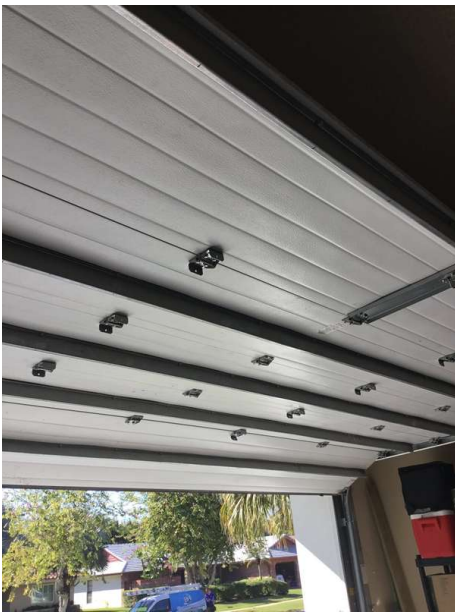
Garage door

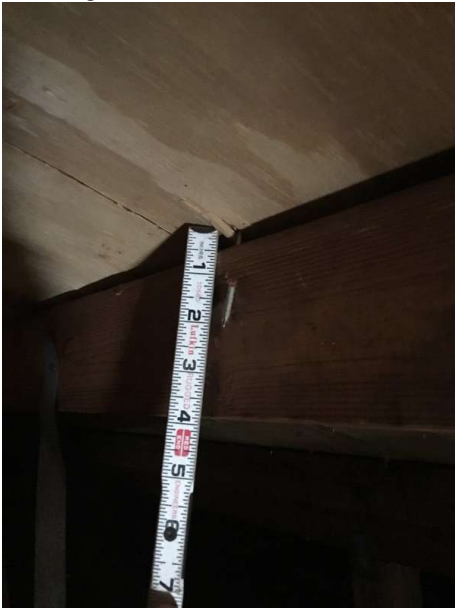
- ☒ C. Plywood/OSB roof sheathing with a minimum thickness of 7/16" inch attached to the roof truss/rafter (spaced a maximum of 24" inches o.c.) by 8d common nails spaced a maximum of 6" inches in the field. -OR- Dimensional lumber/Tongue & Groove decking with a minimum of 2 nails per board (or 1 nail per board if each board is equal to or less than 6 inches in width). -OR- Any system of screws, nails, adhesives, other deck fastening system or truss/rafter

Nail length

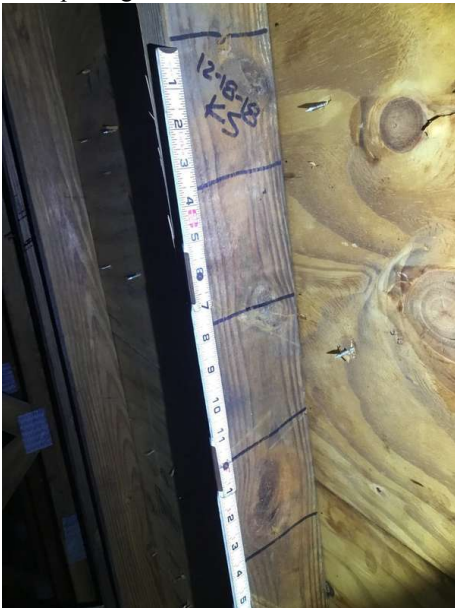
Nail spacing

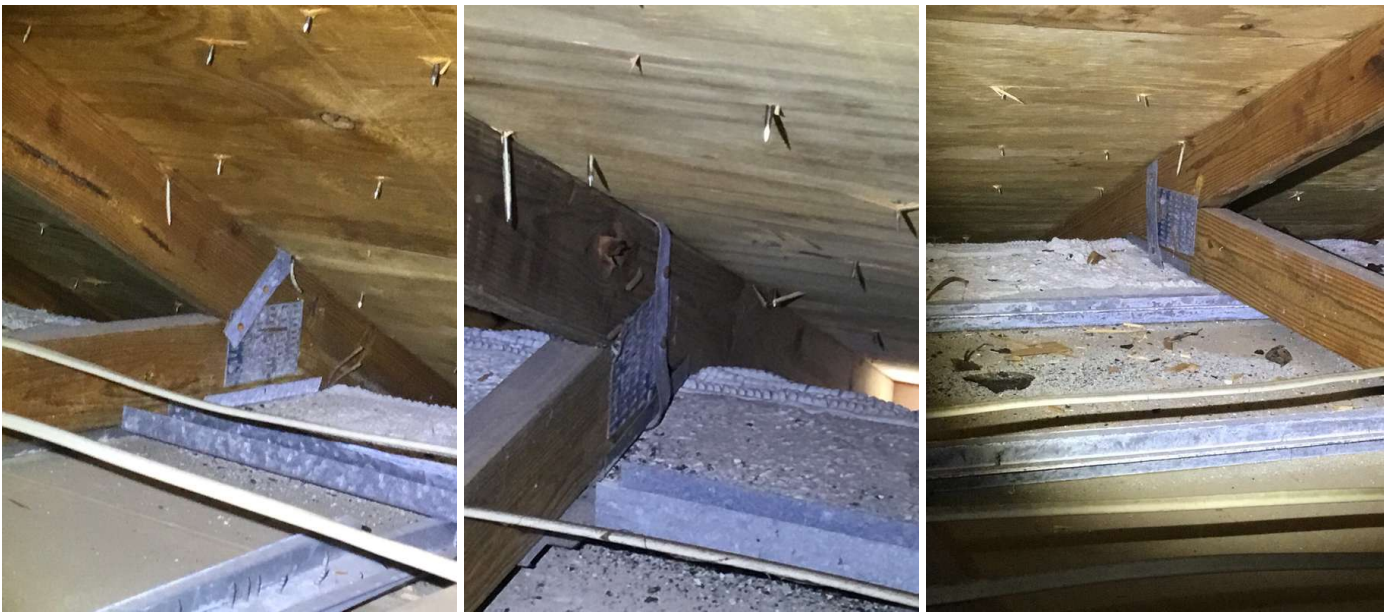
- ☒ Secured to truss/rafter with a minimum of three (3) nails, **and**
- ☒ Attached to the wall top plate of the wall framing, or embedded in the bond beam, with less than a 1/2" gap from the blocking or truss/rafter **and** blocked no more than 1.5" of the truss/rafter, **and** free of visible severe corrosion.

- ☒ C. Single Wraps
  - Metal connectors consisting of a single strap that wraps over the top of the truss/rafter and is secured with a minimum of 2 nails on the front side and a minimum of 1 nail on the opposing side.

Roof to wall attachments
