RESIDENTIAL REPORT

1234 sample st.
Mountain View, AR 72560

Samuel Snyder
OCTOBER 18, 2019

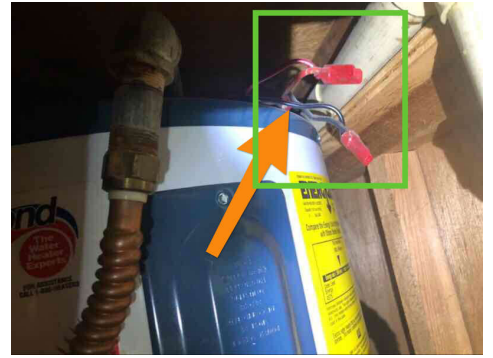
2.3.1 Water Heater

EXPOSED ELECTRICAL

UNDER KITCHEN SINK

Exposed electrical connection for hot water heater. Should be in an approved electrical enclosure. Recommend further evaluation by qualified electrician.

Contact a qualified professional.

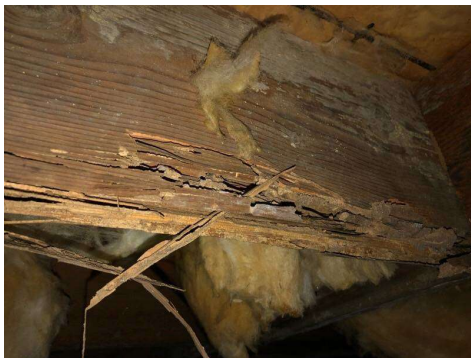
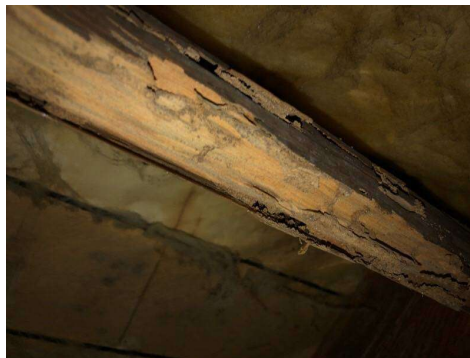
3.2.1 Floor Structure

EVIDENCE OF WOOD DESTROYING ORGANISM

Wood floor joist show evidence of wood destroying organisms. Recommend further evaluation by qualified/licensed pest control company.

Contact a qualified professional.

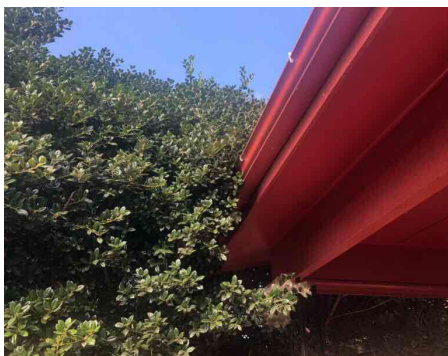
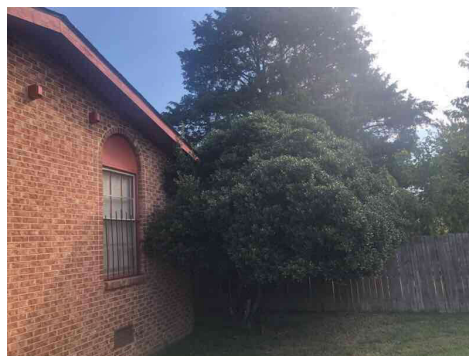
**Vegetation, Grading, Drainage & Retaining Walls: Vegetation**

Vegetation in contact with roof and siding allowing for moisture and pest intrusion. Recommend trees be trimmed at minimum 12" from house.

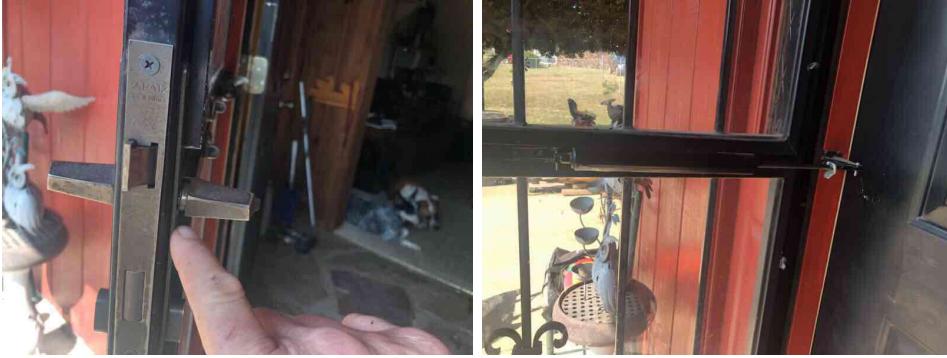
4.2.1 Exterior Doors

HARDWARE DAMAGED

FRONT DOOR

One or more pieces of door hardware are damaged. Recommend repair or replace.

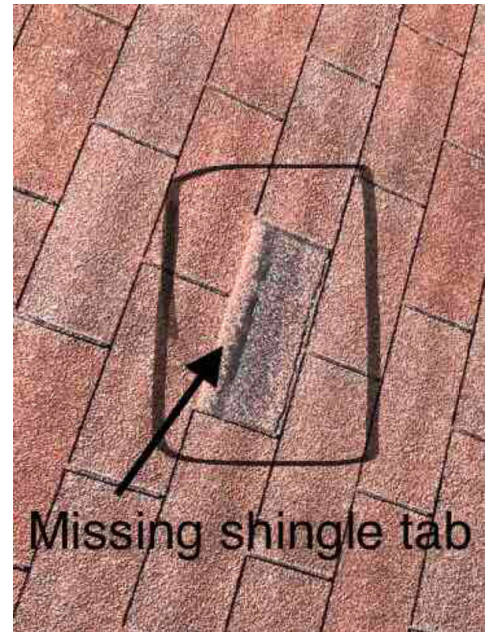
3 TAB SHINGLE

Roof shingle missing. Recommend further monitoring for damaged or missing shingles in the future.

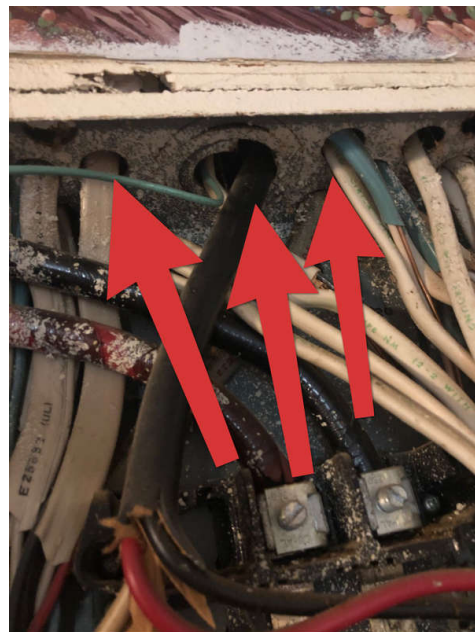
6.2.1 Service and Grounding Equipment, Main Overcurrent Device, Main and Distribution Panels

MISSING BUSHINGS

MASTER BEDROOM

Bushings were observed to be missing. May cause wires to be damaged.

missing bushings

Recommend further evaluation by licensed/qualified electrician.

Contact a qualified professional.

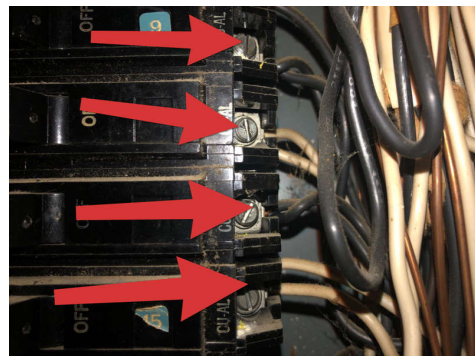
6.2.2 Service and Grounding Equipment, Main Overcurrent Device, Main and Distribution Panels

DOUBLE TAP

MASTER BEDROOM

Double tap wiring observed on circuit breakers.

double taps

Recommend further evaluation by licensed/qualified electrician.

Contact a qualified professional.

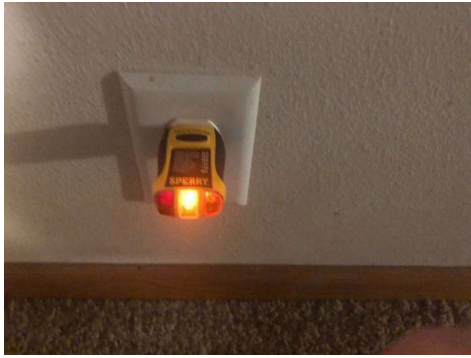
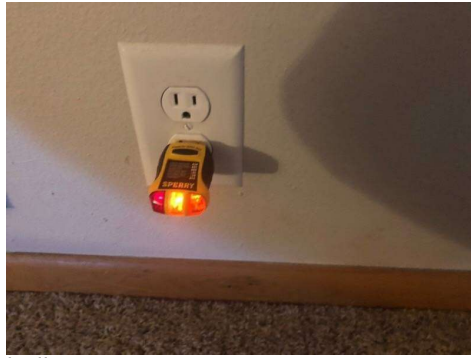
6.5.1 Polarity and Grounding of Receptacles

OPEN GROUND

LIVING ROOM AND HALLWAY

Open grounds were noted in multiple locations. Recommend further evaluation by qualified/licensed electrician.

Living Room

hallway

Contact a qualified professional.

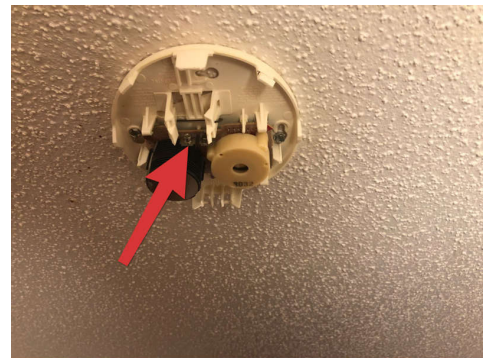
6.7.1 Smoke Detectors

SMOKE DETECTOR

HALLWAY

Battery was removed from smoke detector.

Hallway

Recommend installing battery for proper operation

Recommended DIY Project

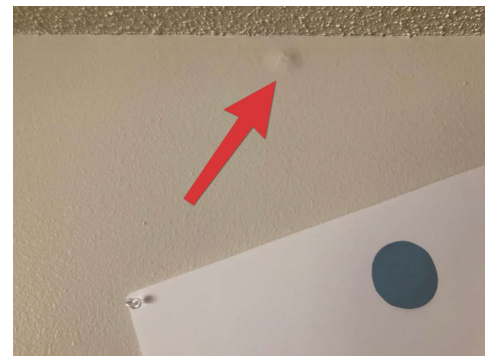
9.1.1 Walls

NAIL POPS

LIVING ROOM

Protruding nail heads visible at the time of the inspection. Protruding nails can be hammered back in and the drywall finished to match the existing wall surfaces.

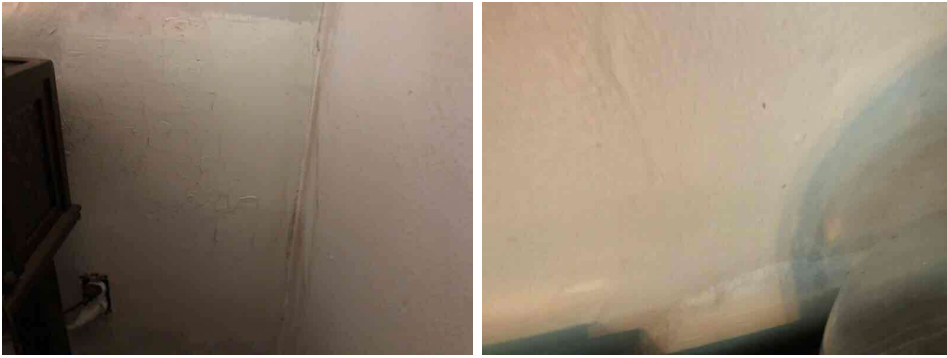
9.1.2 Walls

POOR PATCHING

LIVING ROOM

Sub-standard drywall patching observed at time of inspection. Recommend re-patching.

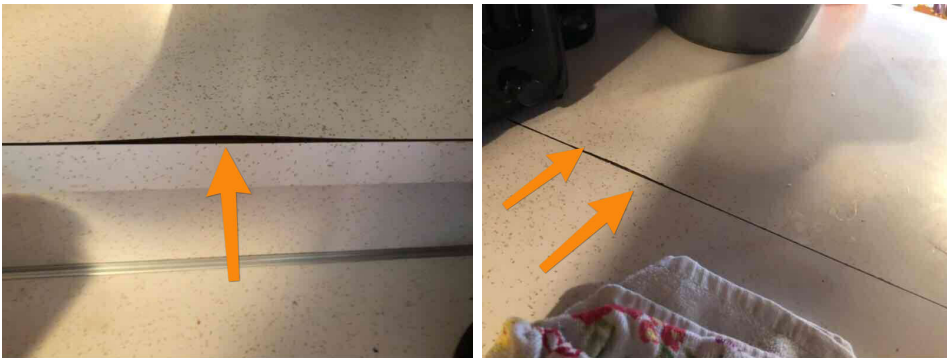
9.5.1 Countertops & Cabinets

COUNTERTOP CRACKED/CHIPPED

KITCHEN

Countertop had one or more cracks or chips. Recommend qualified countertop contractor evaluate and repair.

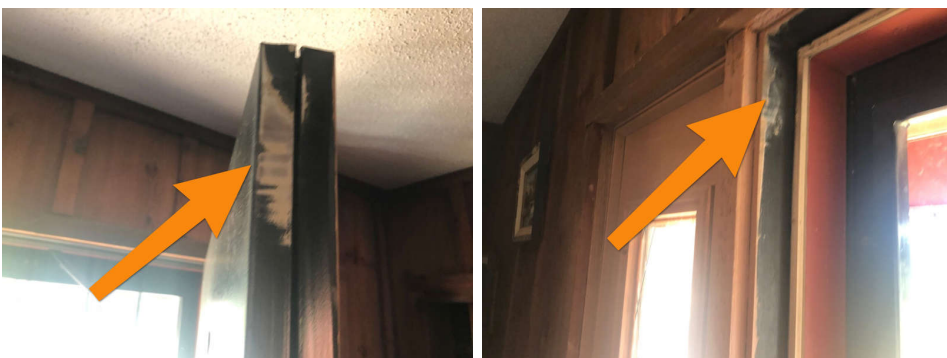
9.6.1 Doors

DOOR STICKS

Door sticks and is tough to open. Recommend sanding down offending sides.

Front door

Front door jam

Contact a qualified carpenter.

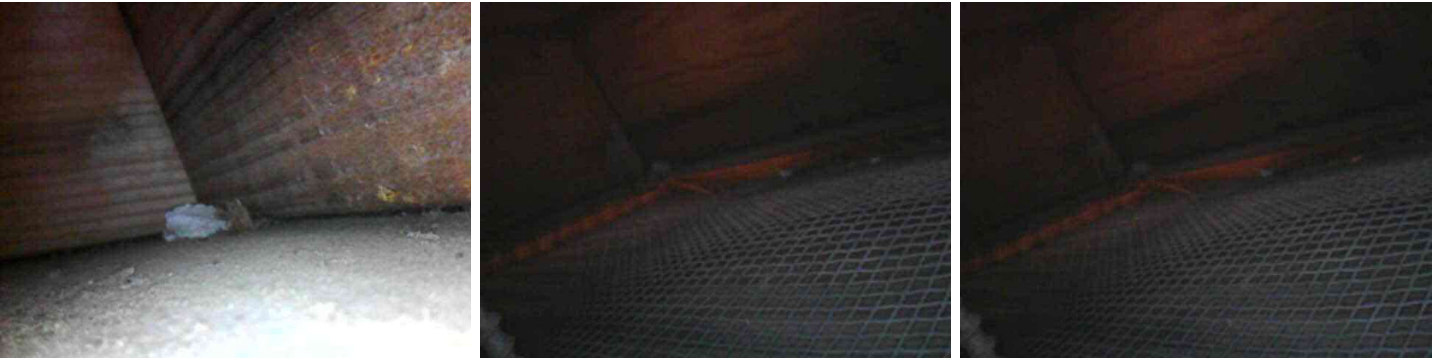
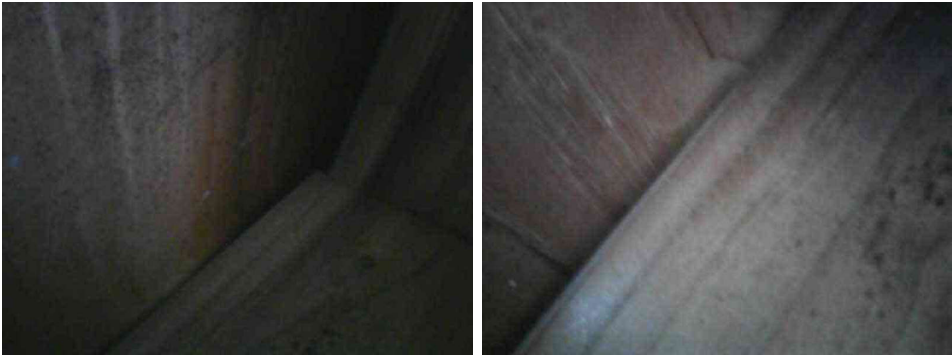
11.4.1 Exhaust Systems

BATHROOM VENTS INTO ATTIC

Bathroom fan vents into the attic, which can cause moisture and mold. Recommend a qualified attic contractor property install exhaust fan to terminate to the exterior.
