HOME INSPECTION REPORT

2431 30th PI NE
Issaquah WA 98029

Bao Phung
AUGUST 20, 2019

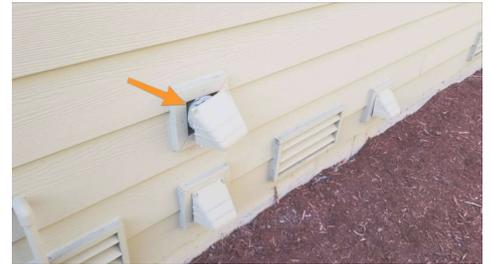
Gaps and/or holes were observed on one or more sides in the siding around plumbing, gas, cable, wiring and/or other penetrations. We advise that all the holes and the gaps be caulked and/or sealed to prevent moisture and/or pest intrusion.

Recommendation

Contact a qualified professional.

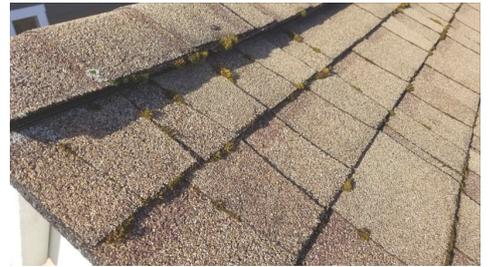
Parts of the roof needs to be cleaned of moss and/or debris. This can restrict drainage and lead to moisture intrusion and moisture damage if not corrected.

Recommendation

Contact a qualified professional.

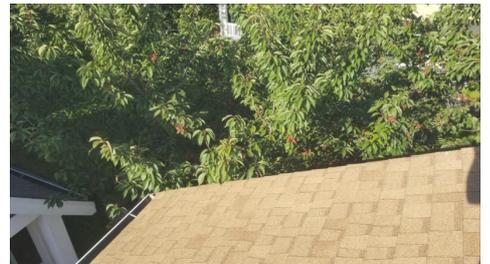
Trees near the dwelling have overhanging branches and/or branches in contact with the roof surface, which may cause damage to the roof surface. This condition may also cause the obstruction of roof water runoff and is a access for rodents, animals and carpenter ants. All overhanging or touching branches in contact of the roof surface should be trimmed to eliminate this condition.

Recommendation

Contact a qualified professional.

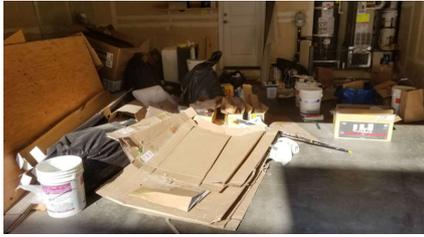
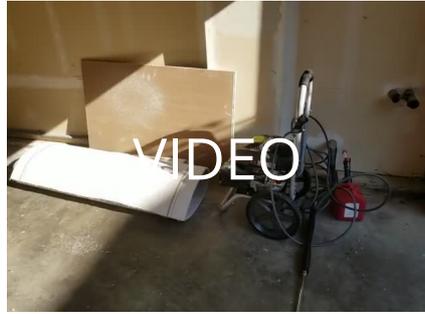
The garage is too full of storage to permit a clear view of the entire slab. I recommend evaluating the floor yourself once the storage is removed.

Recommendation

Recommended DIY Project

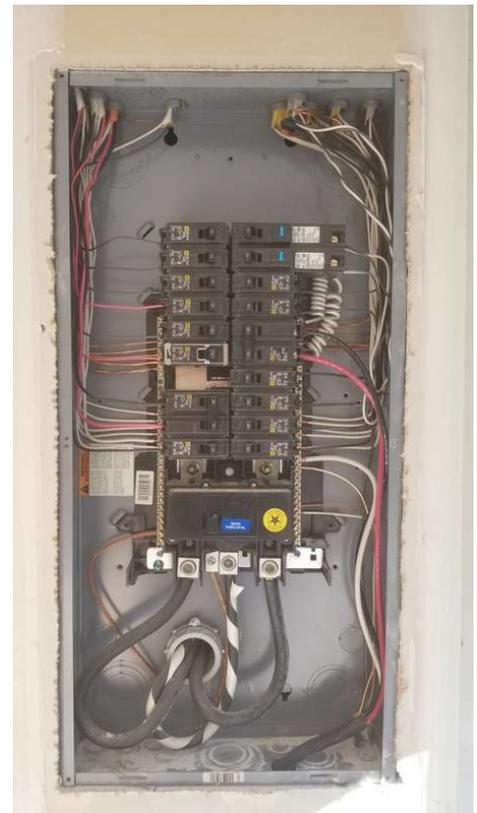
Panel Amps, Location and Picture

Garage, 200 AMP

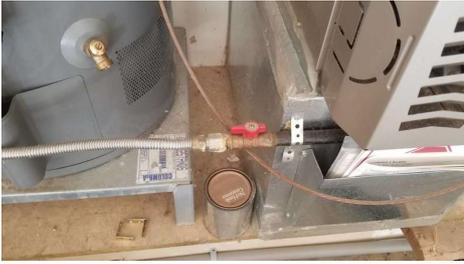
Water Heating System: Gas Shut-Off Valve & Connector

The gas control valve and its connector at the water heater were not moved but appear functional.

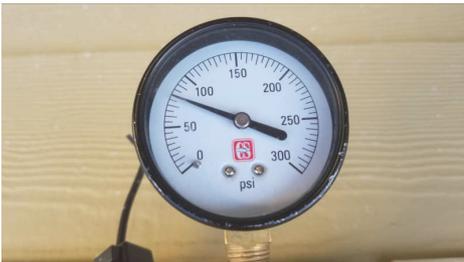
Main Water Shut-Off, Distribution & Supply: House Pressure PICTURE-Acceptable

The pressure at the street was within industry standards, between 40 and 80 and a regulator is not required on the plumbing system.

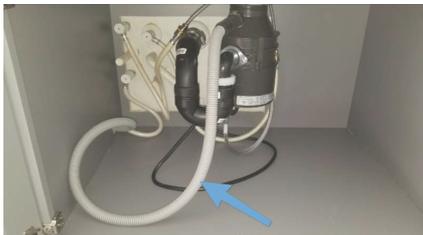
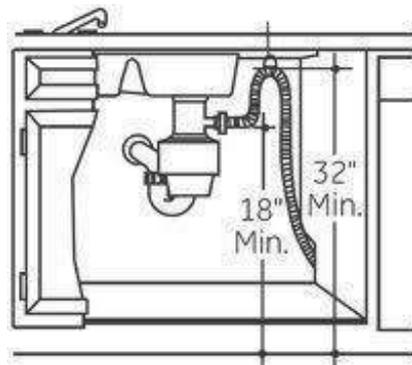
Dishwasher drain pipe was installed without an air gap/high loop to prevent cross contamination. Recommend a qualified licensed professional evaluate and or repair.

Recommendation

Recommended DIY Project

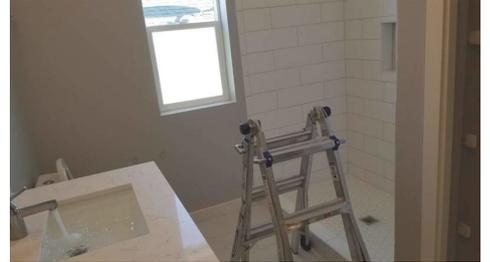
SHOWER DOOR MISSING

The shower door was not installed at the time of inspection.
Recommend further evaluation at a later time. (a shower door was noted in the garage)

Recommendation

Contact a qualified professional.

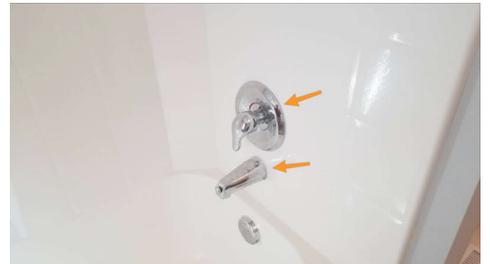
11.4.2 Tub-Shower

I recommend caulking or sealing around shower valves and faucets etc to help prevent moisture intrusion behind or into the walls.
Monitoring these areas is also recommended to help ensure an adequate seal is in place.

Recommendation

Contact a qualified handyman.

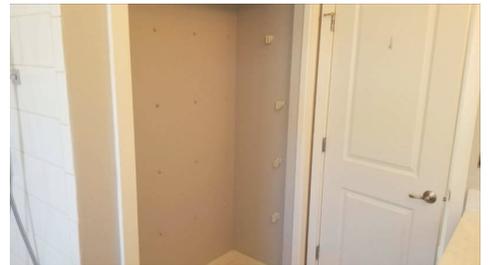
CLOSET DOORS MISSING

The closet doors were not installed at the time of inspection.
Recommend further evaluation at a later time. (closet doors were noted in the hallway)

Recommendation

Contact a qualified professional.

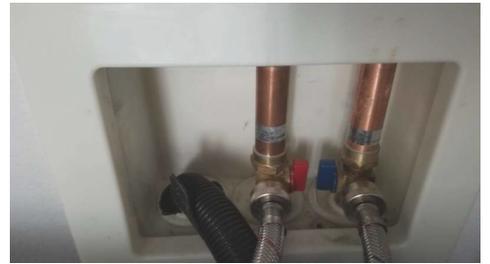
WATER OFF AT VALVES

The water was turned off at the valves behind the washing machine.
Recommend further testing at a later time

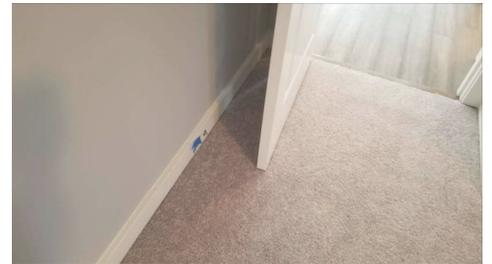
One or more door stops throughout the home should be repaired or installed as necessary.

Recommendation

Contact a qualified handyman.

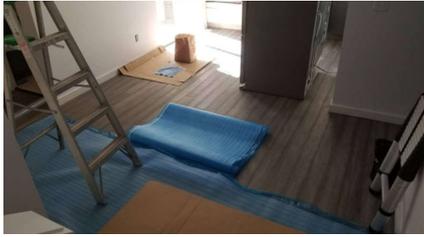
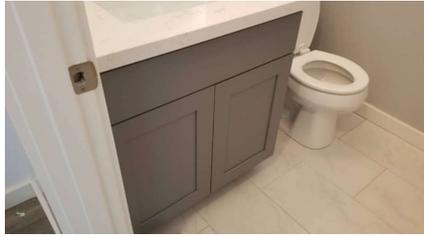
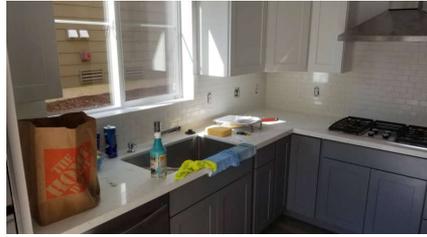
The home was in the process of being remodeled or renovated at the time of inspection. Noted the following:

- Missing cabinet hardware/handles in bathrooms and kitchen
- Restricted view of portions of flooring and walls
- Missing outlet and switch covers

Recommended that you check for these items during final walkthrough.

Recommendation

Contact a qualified professional.

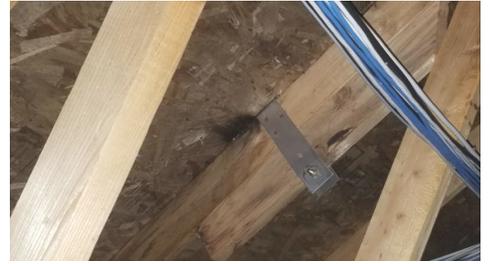
STAINING AT ROOF SAFETY BRACKET INSERTION

There was dark staining near or below the roof safety bracket insertion. This is fairly common, and we recommend monitoring or replacing as needed.

Recommendation

Contact a qualified professional.

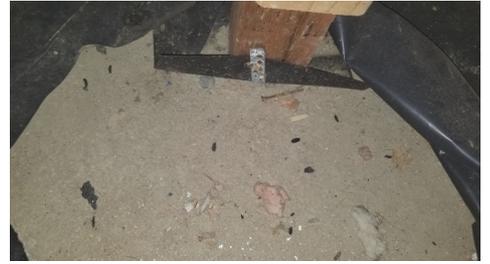
Evidence of rodent activity in the form of feces or urine stains was observed in the crawl space. We recommend sealing all access points and eliminating any active infestation.

Recommendation

Contact a qualified pest control specialist.
