HOME INSPECTION REPORT

11928 122nd St E
Puyallup WA 98374

Rick Wolslegel
JUNE 11, 2019

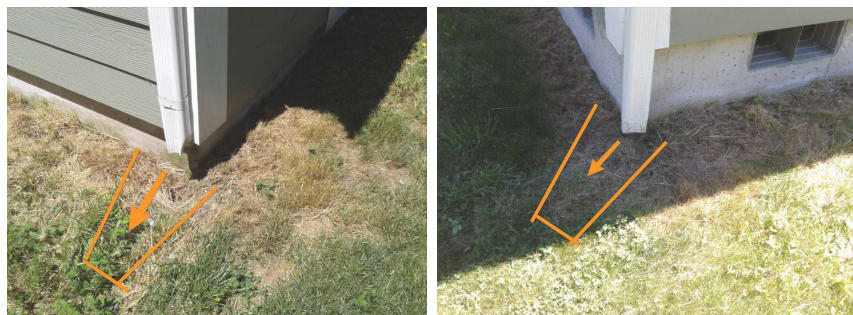
DOWNSPOUTS MISSING COMPONENTS

The downspout are missing parts. Recommend repairs to allow for proper drainage away from the structure.

Recommendation

Contact a qualified professional.

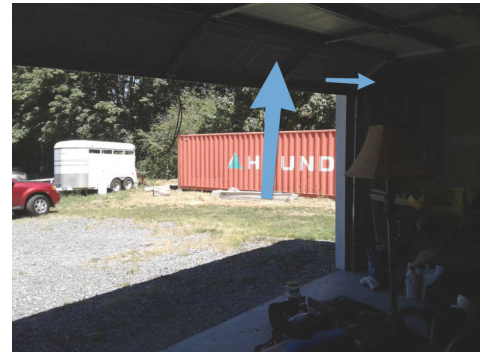
There was not a garage door opener present during the inspection.
Recommend installing as desired.

Recommendation

Contact a qualified garage door contractor.

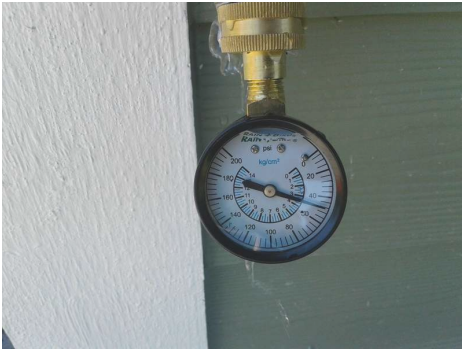
Main Water Shut-Off, Distribution & Supply: House Pressure PICTURE-Acceptable

The pressure at the street was within industry standards, between 40 and 80 and a regulator is not required on the plumbing system.

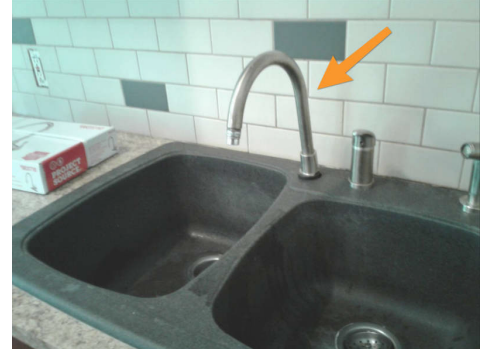
LOOSE FAUCET

The kitchen faucet is loose and should be secured or repaired as necessary.

Recommendation

Contact a qualified handyman.

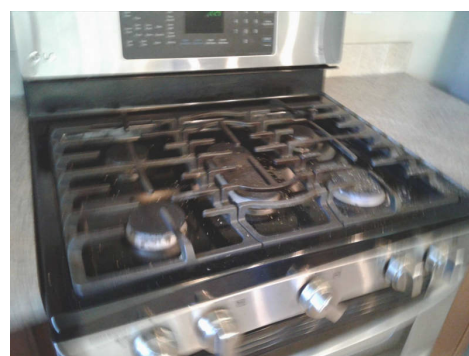
The range did not work on demand and repair or replacement is recommended. Further evaluation from a qualified appliance repair service is recommended or demonstrated

Recommendation

Contact a qualified appliance repair professional.

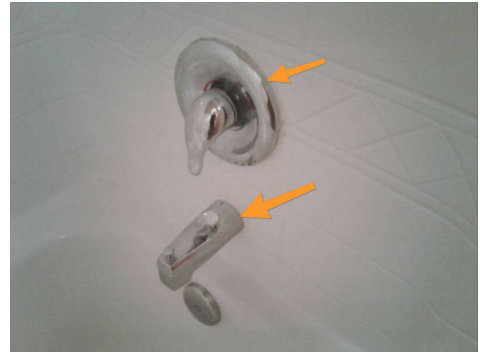
13.4.1 Tub-Shower

CAULKING OR SEALING

I recommend caulking or sealing around shower valves and faucets etc to help prevent moisture intrusion behind or into the walls.

Monitoring these areas is also recommended to help ensure an adequate seal is in place.

Recommendation

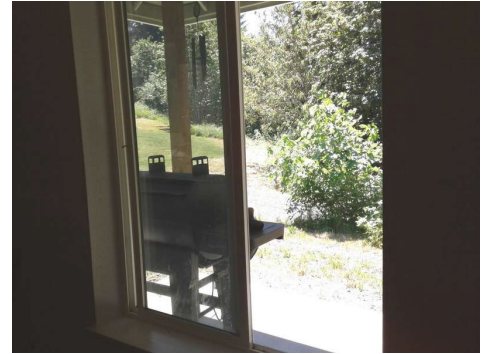
SCREENS DAMAGED/MISSING

Window screens were missing or damaged in one or more areas. We recommend repair or replacement as needed.

Recommendation

Contact a qualified professional.
