MOUNTAINS TO SOUND HOME INSPECTION LLC

HOME INSPECTION REPORT

1175 Harrington Pl NE #313
Renton WA 98056

Sheila Frericks
DECEMBER 4, 2019

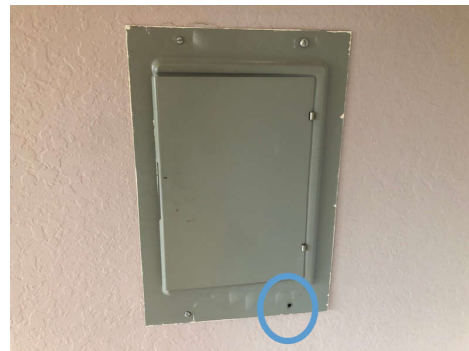
3.4.1 Panel Cover Condition

MISSING SCREWS

The main electrical exterior panel cover is missing screws, which should be replaced.

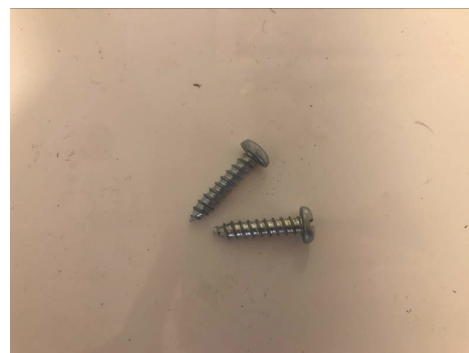
3.4.2 Panel Cover Condition

POINTED OR IMPROPER SCREWS

The main electrical main interior panel cover includes pointed or improper screws which should be replaced with ones appropriate for electrical use. This is important to help prevent damage to wiring within the panel.

Contact a qualified electrical contractor.

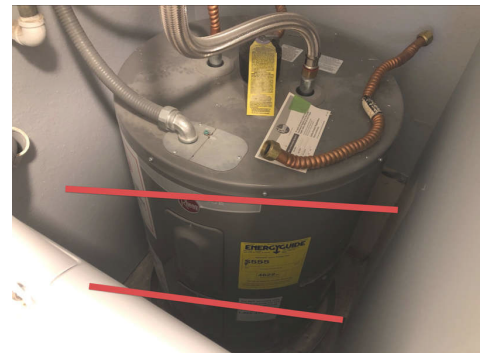
SEISMIC STRAPS - MISSING/INSUFFICIENT

The hot water heater was missing seismic straps or was insufficiently anchored. Recommend two straps to properly secure water heater in the case of an earthquake.

Contact a qualified professional.

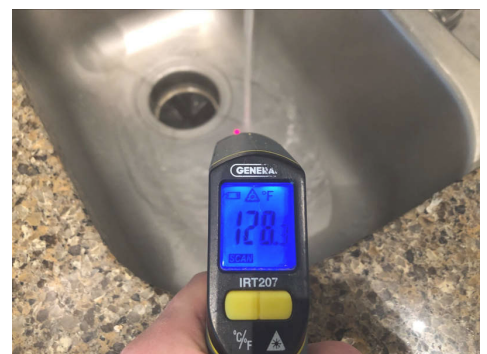
The water temperature is too high and is a potential hazard. Recommend water temperature be lowered not to exceed 120 degrees.

Recommended DIY Project

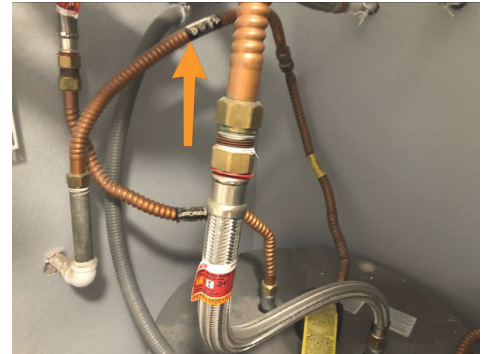
5.1.4 Water Heating System

DISCHARGE PIPE FLEXIBLE

The discharge pipe from the relief valve includes a flexible line and should be replaced with a solid copper discharge pipe. This is because flexible lines can become kinked and possibly prevent the relief valve from working properly in the event it needs to release temperature or pressure and may cause a dangerous situation.

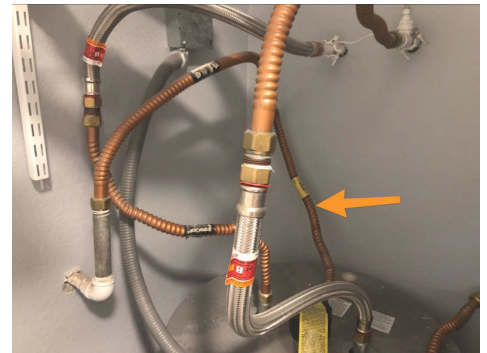
5.1.5 Water Heating System

DISCHARGE PIPE PLUMBED UPHILL

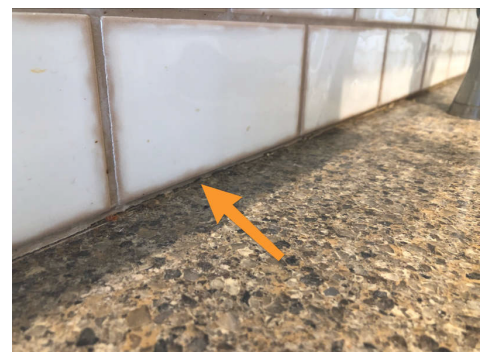
MISSING OR DETERIORATED CAULK/GROUT

The caulking or grout for the backsplash is missing, has gaps and/or not installed properly. We advise caulking/grout be installed and/or gaps filled to prevent possible water intrusion.

Recommended DIY Project

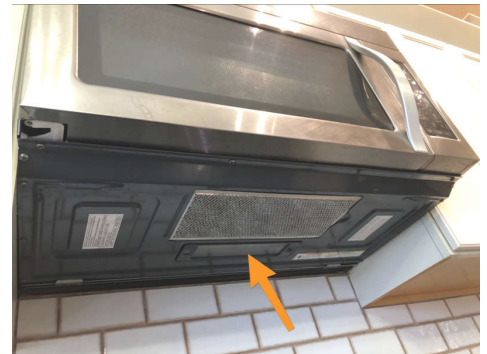
HOOD LIGHT

The exhaust hood has a burned out or missing light bulb. Recommend that it be replaced to confirm the proper operation of the light fixture.

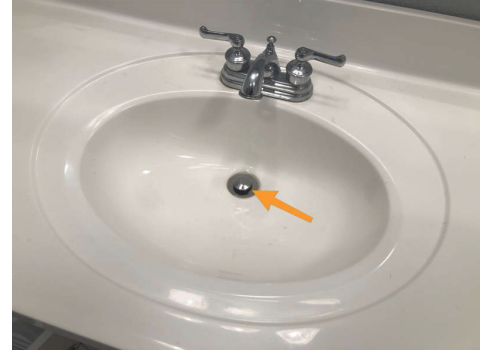
The sinkstopper does not work properly and repair is recommended.

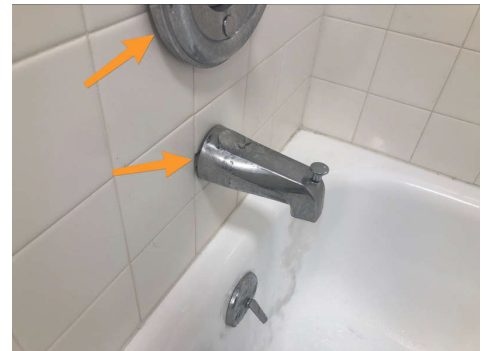
8.4.1 Tub-Shower

CAULKING OR SEALING

I recommend caulking or sealing around shower valves and faucets etc to help prevent moisture intrusion behind or into the walls.

Monitoring these areas is also recommended to help ensure an adequate seal is in place.

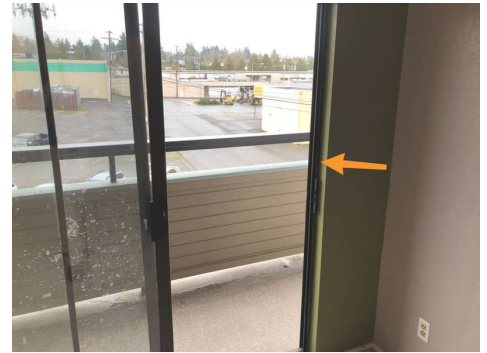
LOOSE TRIM

The trim around the sliding glass door was loose. Recommend securing.

Contact a qualified professional.

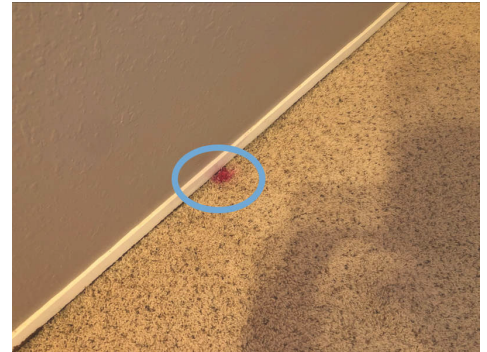
10.3.1 Flooring

CARPET IS STAINED.

The carpet is stained. Recommend a thorough cleaning or replacement as needed.

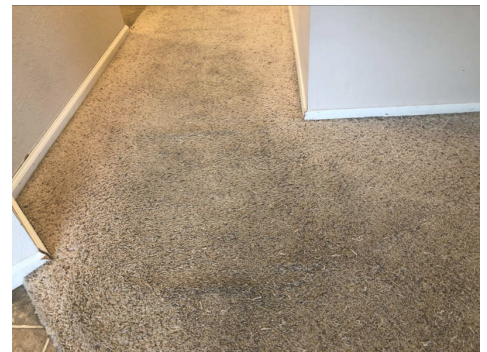
10.3.2 Flooring

CARPETS WORN OR DETERIORATED

Carpets in one or more areas were worn or deteriorated. Recommender repairs or replacement as needed.

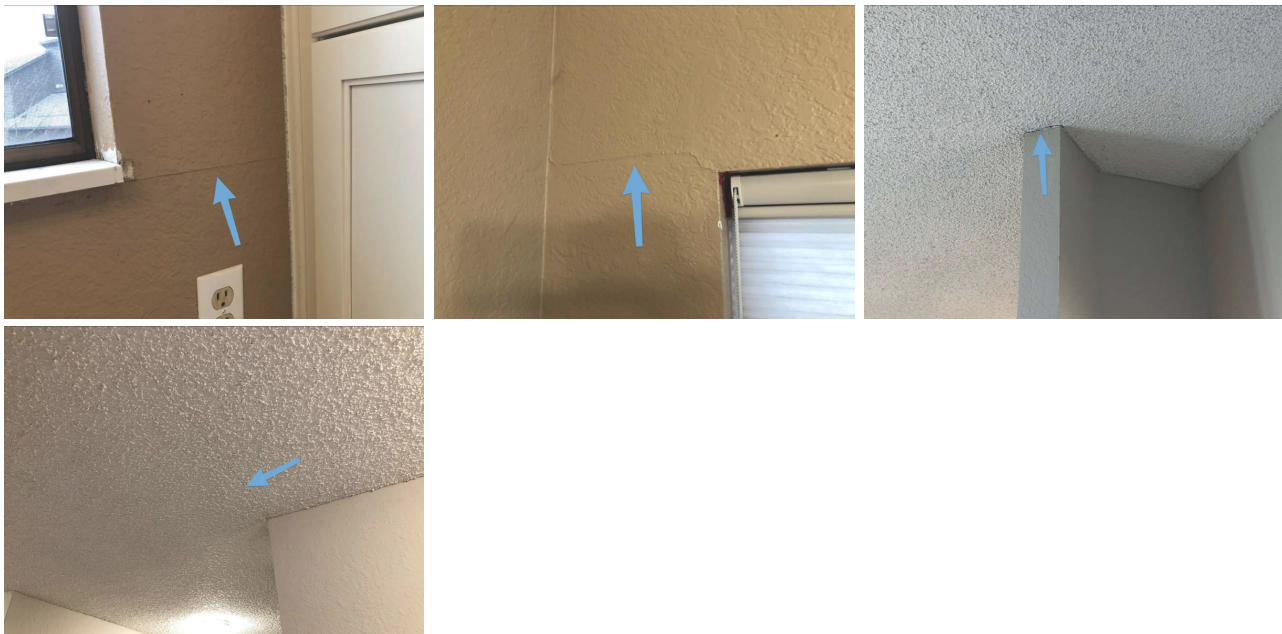
10.4.2 Walls and Ceiling

TYPICAL SETTLEMENT CRACKING/NAIL POPS

Observed typical settlement type cracking and nail pops on walls and ceilings. Recommend repairs as needed. Home owner to identify all areas for repair.

Recommend monitoring.

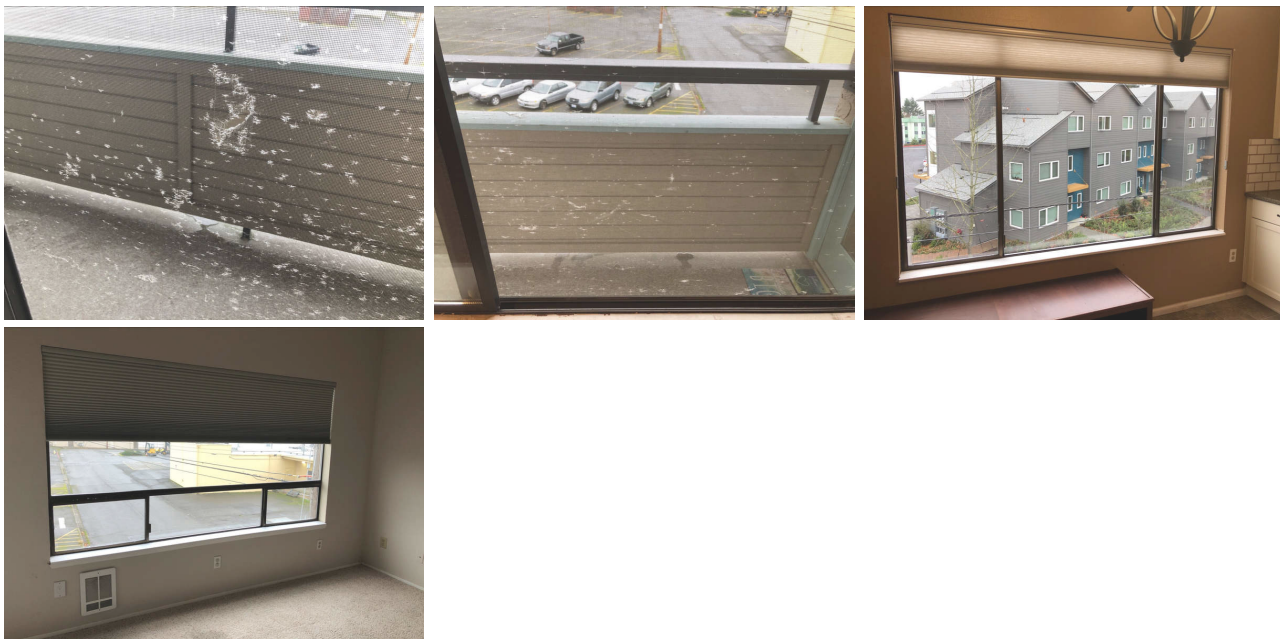
10.5.1 Windows

SCREENS DAMAGED/MISSING

Window screens were missing or damaged in one or more areas. We recommend repair or replacement as needed.

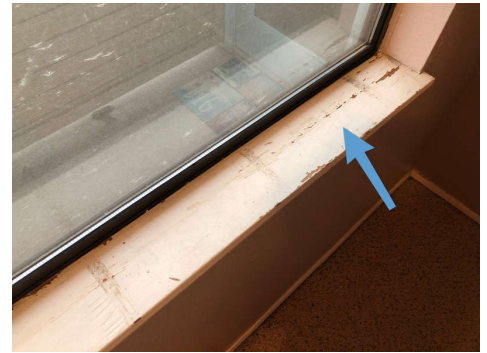
10.5.2 Windows

WINDOW SILL PAINT

The window sill has chipping paint. Recommend repair.

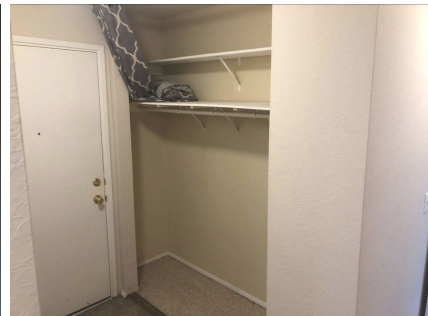
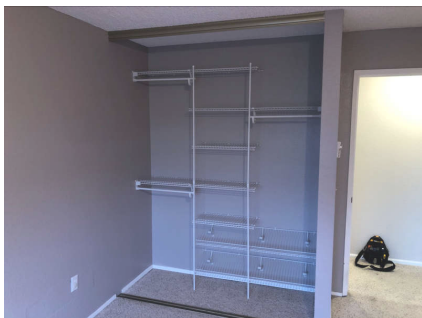
10.6.1 Closet

DOOR MISSING

The door is Missing. Recommend replacement as needed.

Contact a qualified professional.

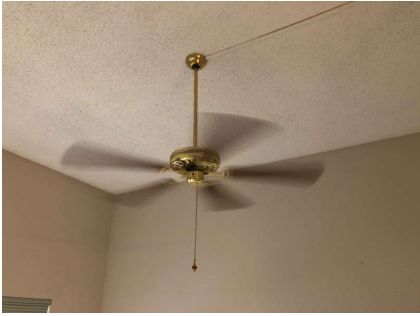
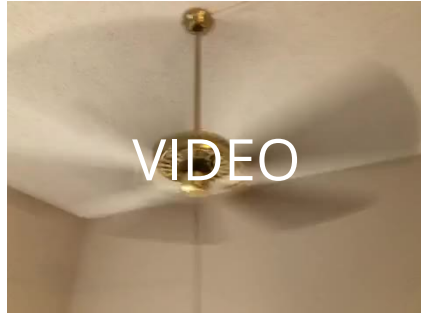
10.7.1 Ceiling Fan

FAN NOISE

An older bearing in the ceiling fans makes a rubbing noise while the fan is functioning. Recommend repairs.

Contact a qualified professional.

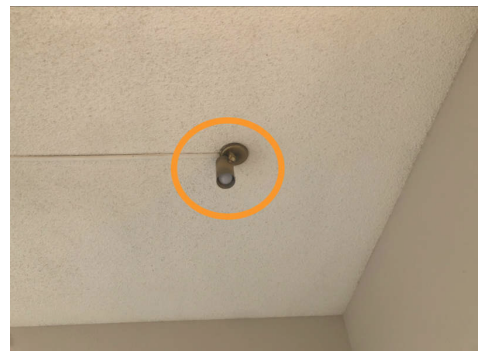
A light fixture did not have light bulbs or the bulbs were burnt out. Recommend replacing bulbs and testing.

Contact a qualified handyman.
