HOME INSPECTION REPORT

1463 Olsen Ave
Buckley WA 98321

John Koopman Jr
JULY 3, 2019

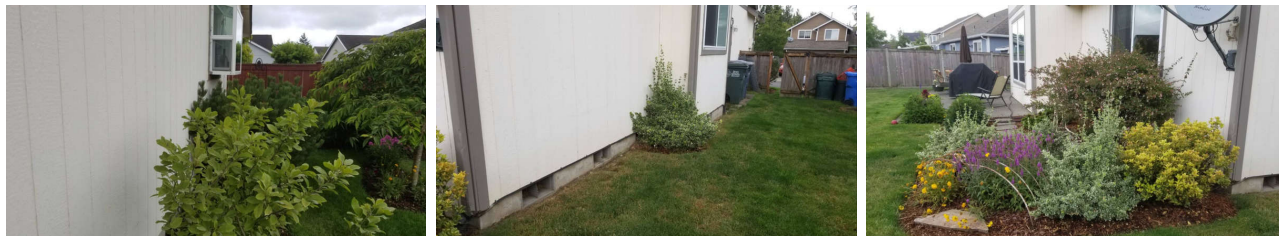
3.5.1 Exterior Siding Notes

VEGETATION IS ENCROACHING

Vegetation is encroaching on the structure, and should be kept a minimum of twelve inches away for the general welfare of the walls and foundation.

Recommendation

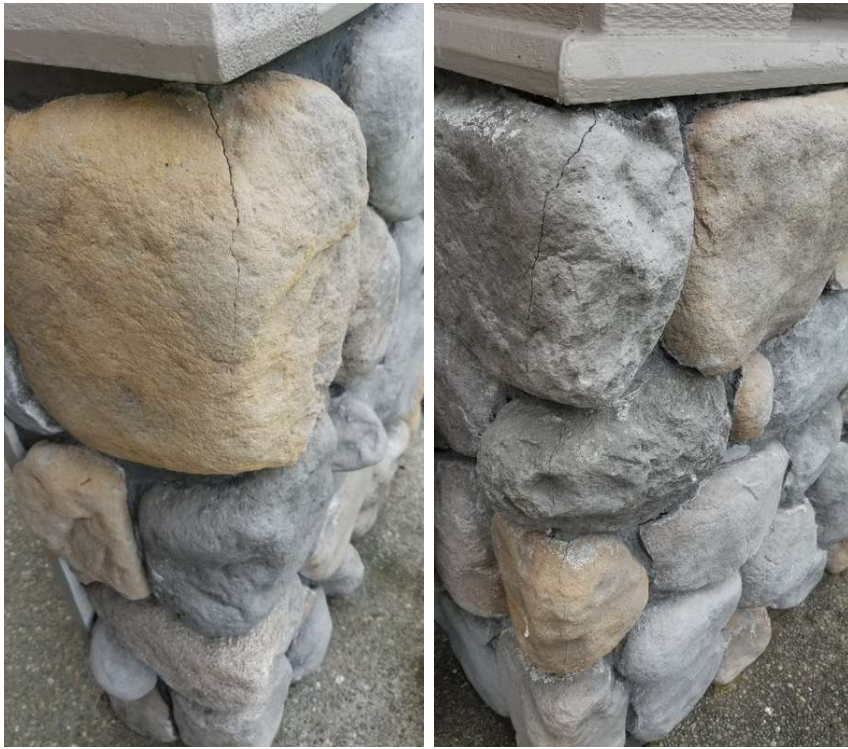
3.5.4 Exterior Siding Notes

HAIRLINE CRACKS IN STONE VENEER

Cracks were noted in the post veneer located near the front of the home. Veneer is not typically structural, though you may want to have it patched in places for cosmetic reasons.

Recommendation

Contact a qualified professional.

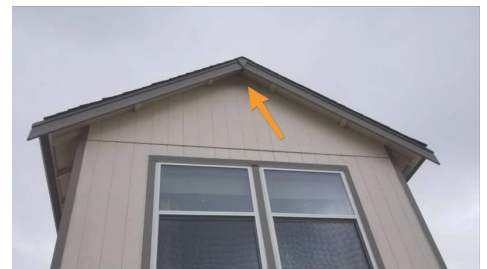
3.7.1 Fascia, Trim & Eaves

BEE/WASP NEST

A bee or wasp nest was observed at the exterior of the home. Recommend removal.

Recommendation

Contact a qualified pest control specialist.

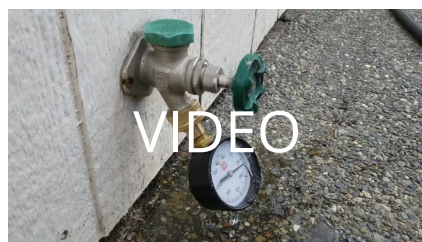
3.8.1 Exterior Plumbing

HOSE BIB LEAKS WHILE IN USE

The hose bib leaks at the handle while in use and you may want to have it repaired or replaced by a licensed professional. Sometimes they just need to be tightened.

Recommendation

Contact a qualified handyman.

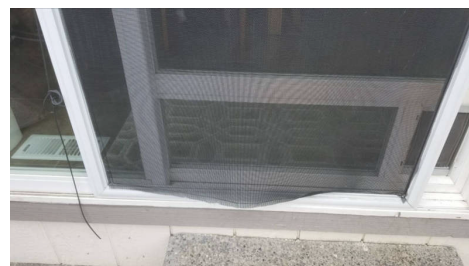
3.10.1 Exterior Doors

SLIDING DOOR SCREEN MISSING/DAMAGED

The rear sliding screen is missing or needs work. Have it repaired by a qualified contractor.

Recommendation

Contact a qualified handyman.

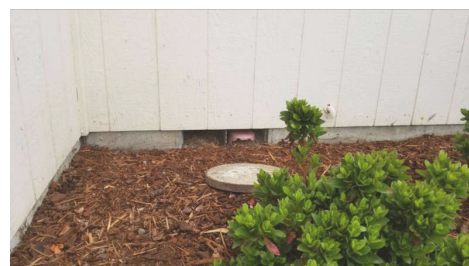
3.11.2 Crawlspace Vents

BLOCKED SCREENS

One or more crawlspace vent screens were blocked by vegetation, debris or otherwise obstructed. Recommend clearing to allow for proper ventilation.

Recommendation

Contact a handyman or DIY project

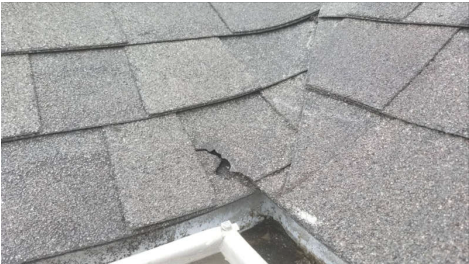
4.2.1 Composition Shingle Roof Notes

DAMAGED SHINGLES

There were one or more damaged shingles. Recommend repair.

Recommendation
Contact a qualified roofing professional.

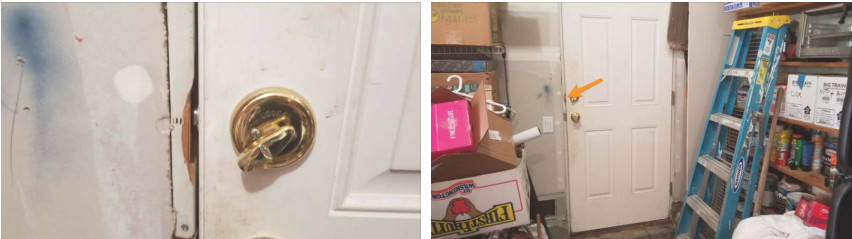
5.7.1 Garage Side Door

DOOR STRIKER PLATE

The entry door striker plate needs to be adjusted for the deadbolt pin to engage.

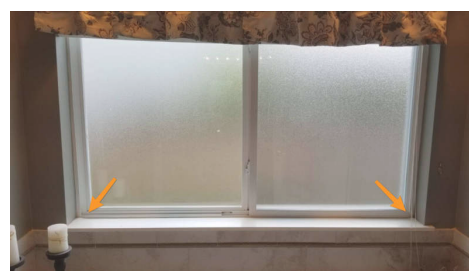
11.12.1 Windows

MOISTURE DAMAGE (LIGHT)

Window sill was starting to swell on the outside corners. Recommend repair and recaulk.

Recommendation

Contact a qualified professional.
