HOME INSPECTION REPORT

634 S 331st Pl
Federal Way WA 98003

Alexis Mackay
JULY 13, 2019

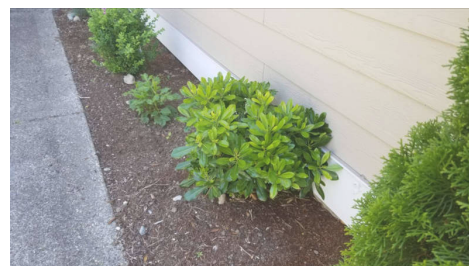
3.5.1 Exterior Siding Notes

FRONT

Vegetation is encroaching on the structure, and should be kept a minimum of twelve inches away for the general welfare of the walls and foundation.

Contact a qualified landscaping contractor

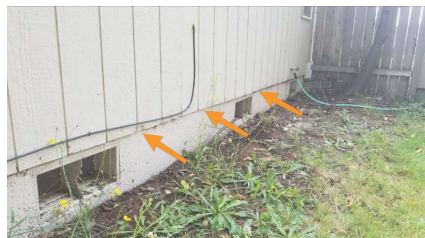
3.5.2 Exterior Siding Notes

MOISTURE DAMAGE

Portions of the lower edges of the fiberboard siding were previously moisture damaged and should be further evaluated by a contractor.

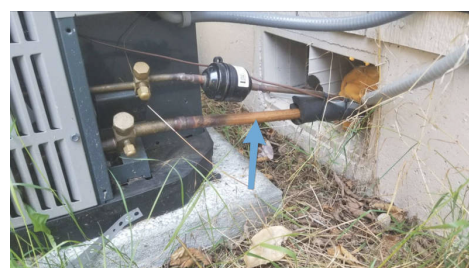
3.10.1 Air Conditioning/Heat Pump

INSULATION MISSING

Insulation is missing from the refrigerant lines at the condensing coil, which could help inhibit condensation to form and drip within the wall, hvac foam should be installed for that reason and for increased efficiency. These are easily found at the hardware store.

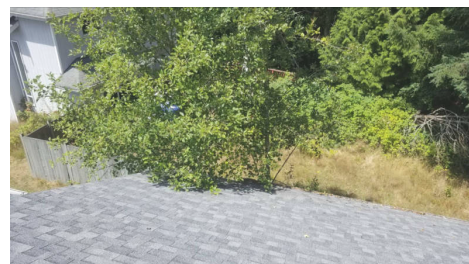
Trees near the dwelling have overhanging branches and/or branches in contact with the roof surface, which may cause damage to the roof surface. This condition may also cause the obstruction of roof water runoff and is a access for rodents, animals and carpenter ants. All overhanging or touching branches in contact of the roof surface should be trimmed to eliminate this condition.

Contact a qualified professional.

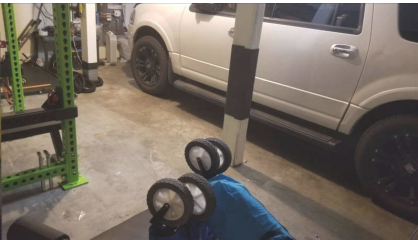
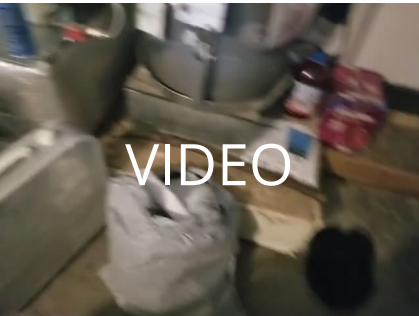
The garage is too full of storage to permit a clear view of the entire slab. I recommend evaluating the floor yourself once the storage is removed.

Recommended DIY Project

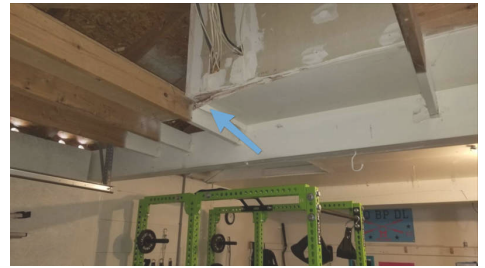
5.8.1 Walls and Ceiling

WALLS/CEILING HAVE DAMAGE

The walls/ceiling have some damage and repair is recommended.

Contact a qualified drywall contractor.

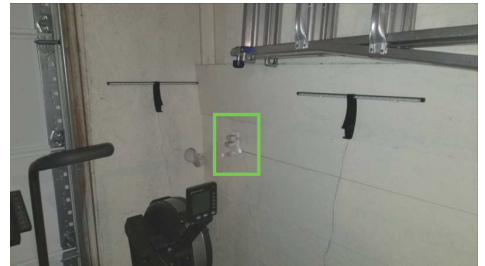
5.11.1 Outlets, Electrical Observations

OUTLET POWER CONTROLLED BY LIGHT SWITCH IN INTERIOR

Contact a qualified professional.

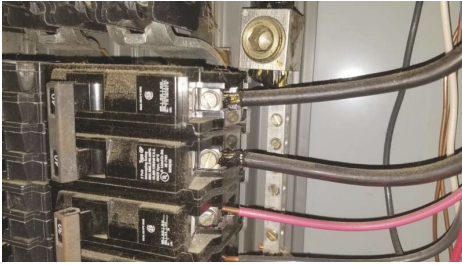
Wiring Notes: Aluminum but only on the larger circuits

There is modern aluminum wiring in the panel but only on the larger circuits such as: the range and a/c unit.

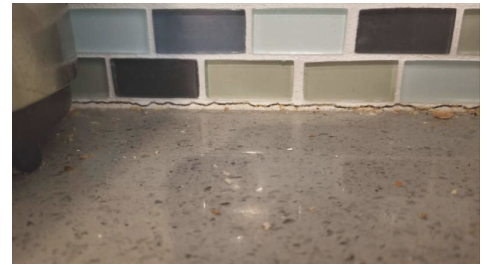
**MISSING OR DETERIORATED
CAULK/GROUT**

The caulking or grout for the backsplash is missing, has gaps and/or not installed properly. We advise caulking/grout be installed and/or gaps filled to prevent possible water intrusion.

Recommended DIY Project

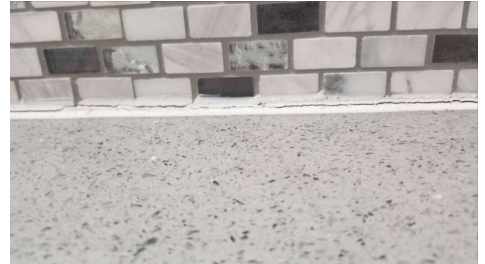
11.6.1 Countertop

**MISSING OR DETERIORATED
CAULK/GROUT**

The caulking or grout for the backsplash is missing, has gaps and/or not installed properly. We advise caulking/grout be installed and/or gaps filled to prevent possible water intrusion.

Recommended DIY Project

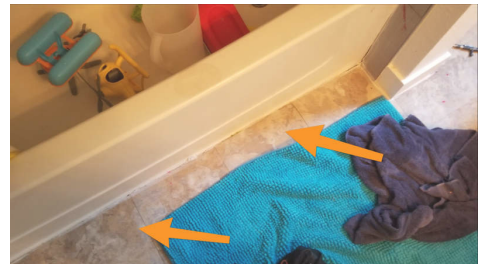
11.10.1 Flooring

LIFTING TILES ALONG BATHTUB EDGE

Slight lifting of tiles was noted along the bathtub edge. Recommend repair by a qualified professional.

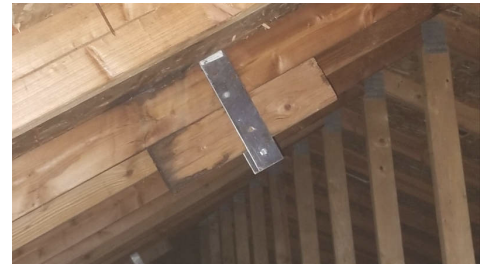
MOISTURE STAINS ON THE UNDERSIDE DECKING.

There are obvious moisture stains on the underside of where the safety roof hook is attached. This does not necessarily confirm an active roof leak. However, the possibility of an active leak could not be ruled out either. Therefore, you are recommended to have a qualified roof specialist evaluate further before the close of escrow.

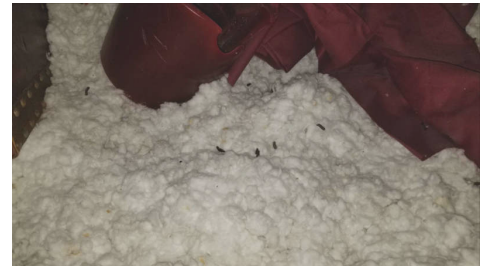
14.6.1 Common Observations

RODENT ACTIVITY

The attic has evidence of rodent activity. We recommend ceiling access points and eliminating any active rodent activity
