YOUR HOME INSPECTION

7483 Tiffany Meadows Ln  
Fort Worth TX 76140

# PROPERTY INSPECTION REPORT

Concerning: 7483 Tiffany Meadows Ln, Fort Worth TX 76140

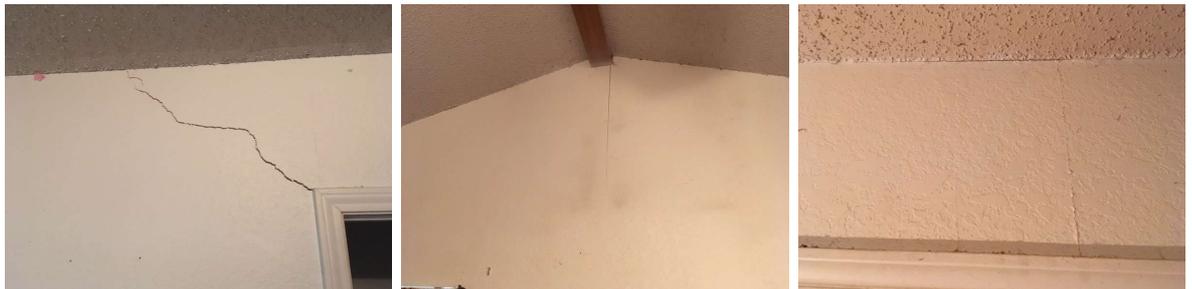
In **my opinion**, the slopes in the foundation are above acceptable tolerance for slope in a foundation and or the stress indicators (Cracks etc...) appear to be more than normal.. **Further evaluation is recommended.**

- Brick/Mortar cracks observed in the exterior veneer.
- Misalignment of interior doors.
- Interior door(s) stick and/or not closing.
- Separations of the exterior veneer and window / door frames.
- Frieze board separations.
- Cracks in the floor / foundation.
- Floor slopes and/or not level.
- Stress crack(s) in the exterior foundation perimeter beam.
- Interior drywall cracks or stress indicators.
- Other indicators as noted by Inspector.

- It is recommended that the foundation be **evaluated by a Licensed engineer** and repaired if necessary per the engineers recommendations by a qualified foundation contractor.
- It is recommended that a **sub-surface drain leak test** be performed by a **licensed plumbing contractor**. If a leak is found it is recommended that the leak be fixed.
- **Maintain a watering program** throughout the year to prevent the soil around the home from drying and cracking. If soaker hoses are used, place the soaker hoses 1' 2' away from the foundation and run for 30 60 minutes every other day as needed. Do not over water the foundation; this can be as detrimental as under watering.

Recommendation: Contact a qualified professional.

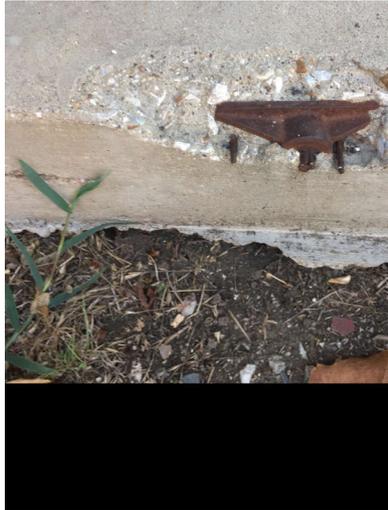
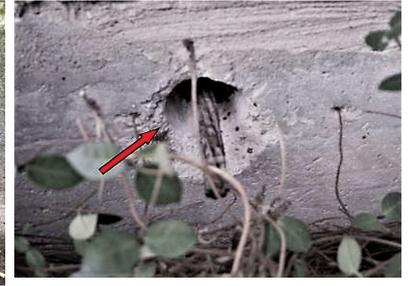
**2: Exposed Cable Ends**

- **Exposed post tension cable ends** were observed at the exterior of the home. It is recommended that the metal cables be painted (rust inhibiting paint) and then the slab should be patched. The slab patch / mortar should be used in conjunction with a bonding agent that helps it bond to the old concrete.

Example Picture of an Exposed Post Tension Cable (Live End)

Recommendation: Contact a qualified concrete contractor.

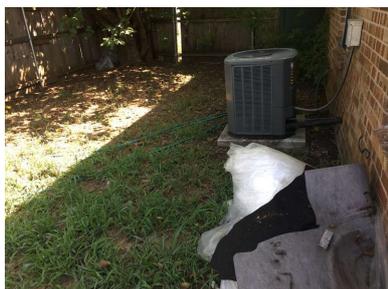
7483 back

- Marginal site drainage was observed. Proper drainage is needed to help prevent water from standing and/or ponding next to the foundation beam. Corrective measures may be needed if the water stands within 10-feet of the foundation perimeter beam for more than 24-hours.

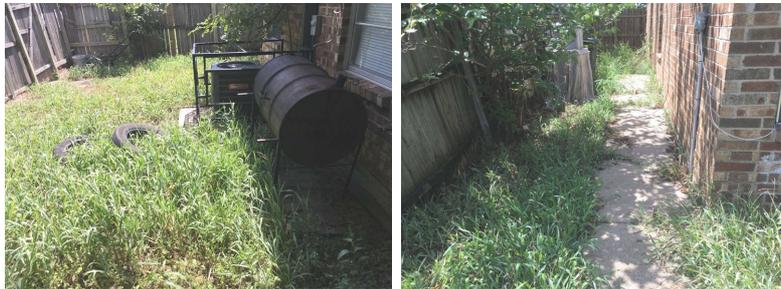
Grading is sloping towards the home in some areas. This could lead to water intrusion and foundation issues. Recommend qualified landscaper or foundation contractor regrade so water flows away from home.

Recommendation: Contact a qualified grading contractor.

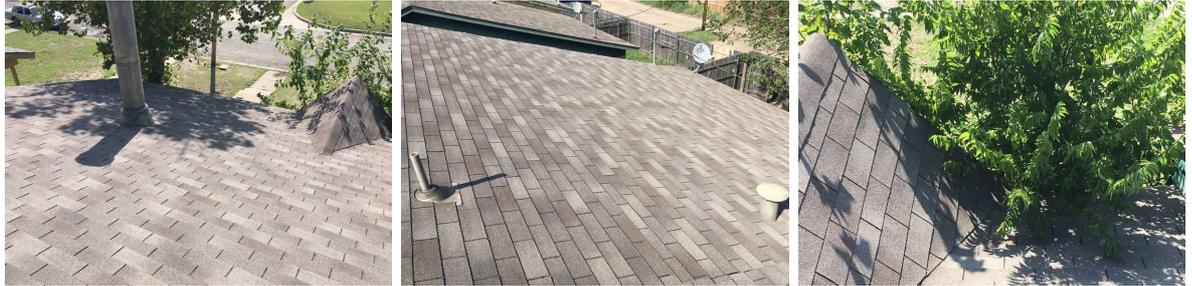
Pictures if the roof covering for reference.

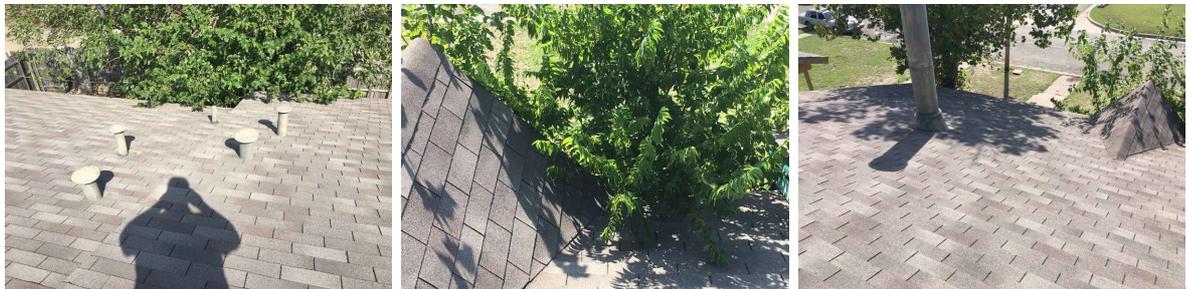
*Trim Trees (too close):*

- Tree and shrub branches need to be trimmed away from the roofing material at all times to help prevent damage to the roofing material. It is the opinion of this Inspector that there are some branches too close to the roofing material at this time and corrective measures are needed.

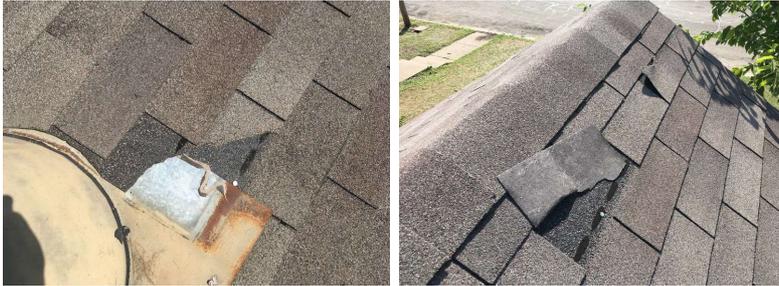
**1: Damaged shingles**

- Damaged shingles were observed at the time of inspection. All damaged shingles should be replaced.

Recommendation: Contact a qualified roofing professional.

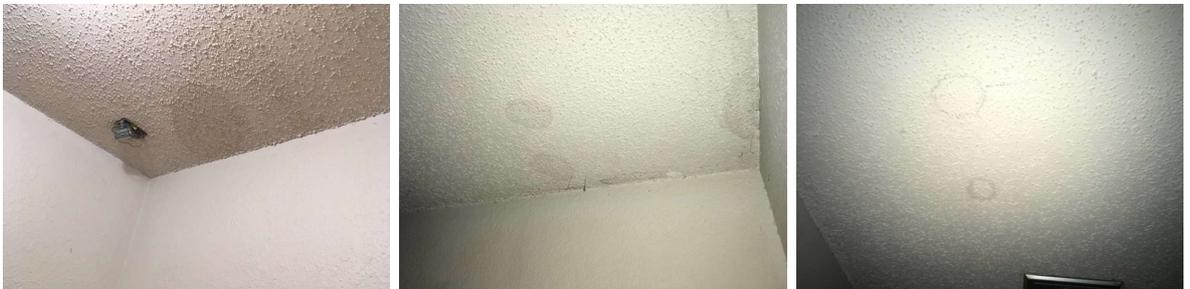
## 2: Evidence of leaks

- Visible evidence of leaks were observed. Recommend a qualified roofer evaluate and repair.

Recommendation: Contact a qualified roofing professional.

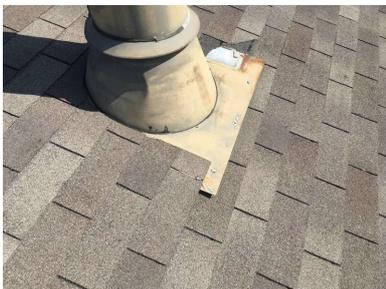
## 3: Lifted Shingles

The roofing material observed to have loose and/or lifting shingles in various locations. The damage may have been caused by a previous wind storm and should be further evaluated.

Recommendation: Contact a qualified roofing professional.

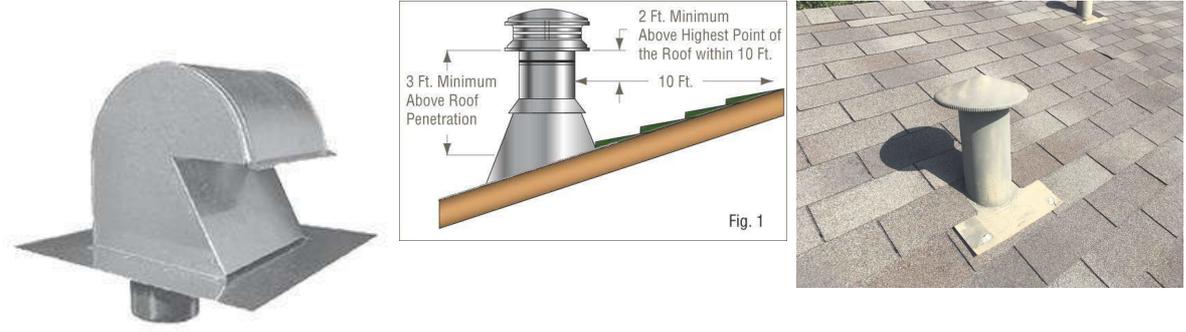
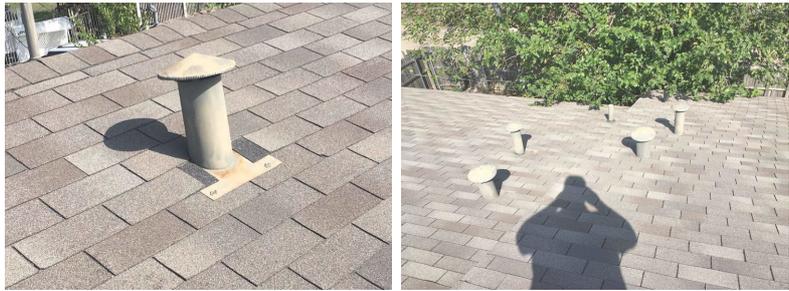
The roof caps for the dryer vents, water heaters or bathroom exhaust fans are no longer approved as vent caps the gaps around the cap are too large and could allow pests to enter the vent. This type of cap was allowed years ago but no longer. it is recommended that a approved cap be installed at all necessary vents.

Recommendation: Contact a qualified roofing professional.

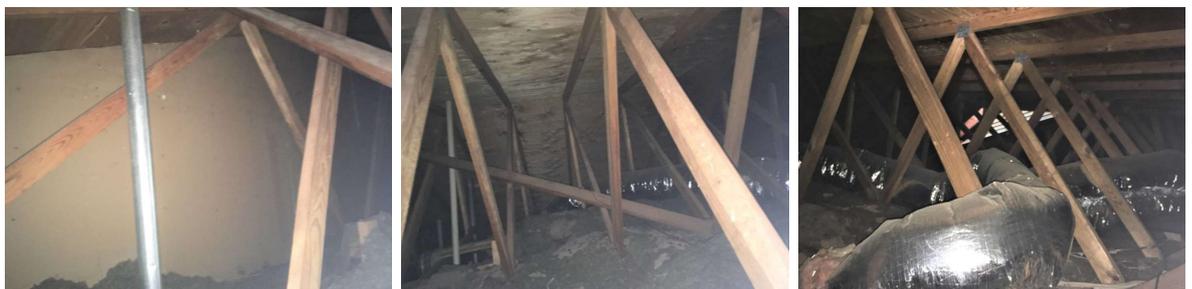
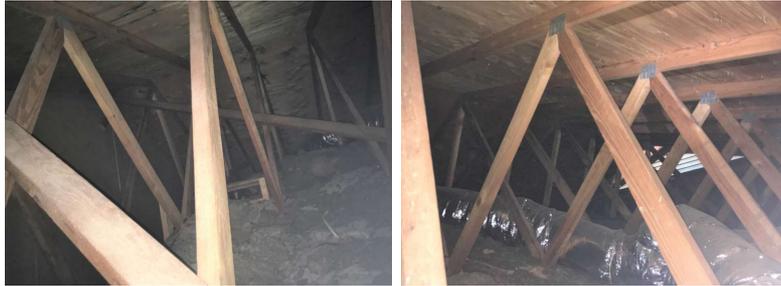
*Roof structure good.:*

- The roof structural components appeared to be in satisfactory condition at the time of this inspection. No corrective actions are recommended at this time.

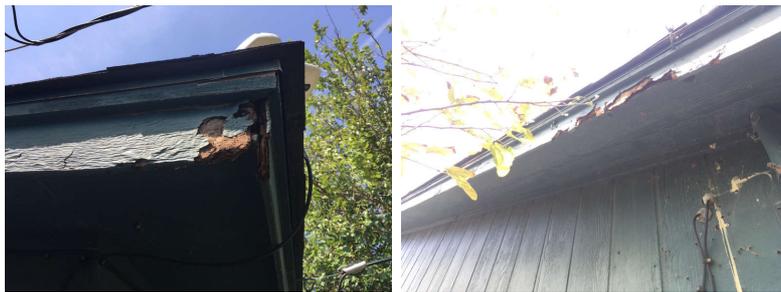
**1: Soffit damaged**

🟡 Minor or Cosmetic Deficiencies  
front, rear left side and right side

- Damage to the soffit or fascia of the home was observed at the time of this inspection. It is recommended that the damaged soffit / fascia board be replaced, resealed and properly painted.

Recommendation: Contact a qualified professional.

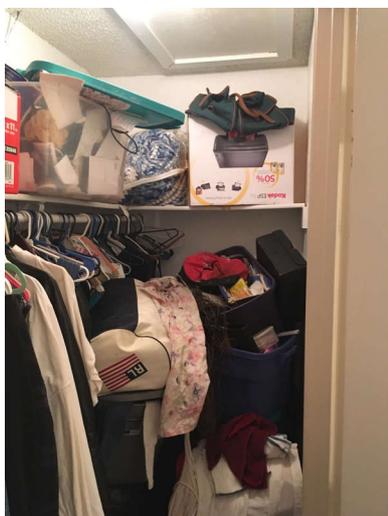
**2: No access**

🟡 Minor or Cosmetic Deficiencies  
Unit 7485

There was no access to the attic at the time of inspection. Belongings or storage were in the way.

Recommendation: Recommended DIY Project

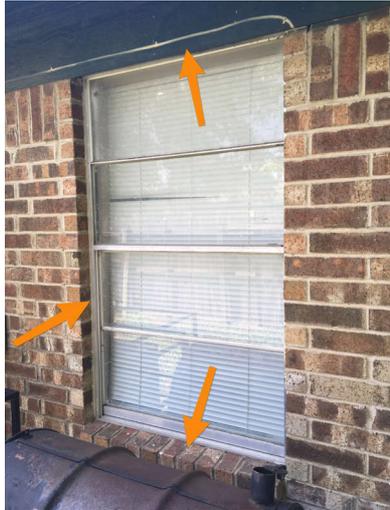
It is recommended to use elastomeric caulking.

Recommendation: Contact a handyman or DIY project

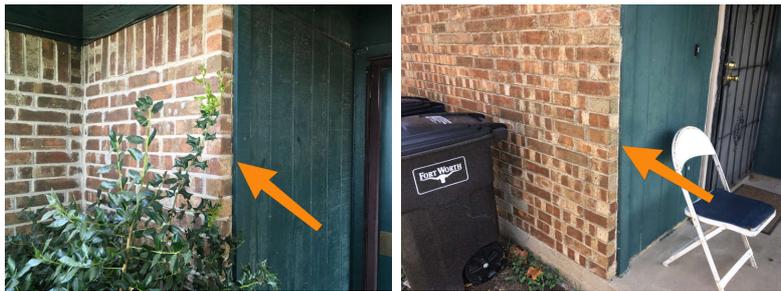
## 2: Seal Transition

The transition from wood veneer to brick veneer needs to be better sealed.

Recommendation: Contact a handyman or DIY project

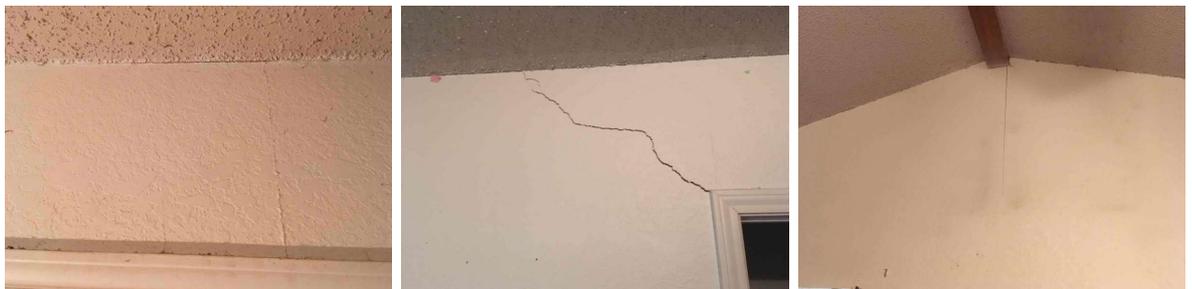
## 3: Drywall Cracks

There are a number of cracks in the interior walls that are considered to be cosmetic and average for the age of the home. . No attempt is made to discover or document an exhaustive list of every crack or anomaly in the interior. These deficiencies should be repaired the next time the interior is painted.

Recommendation: Contact a qualified painter.

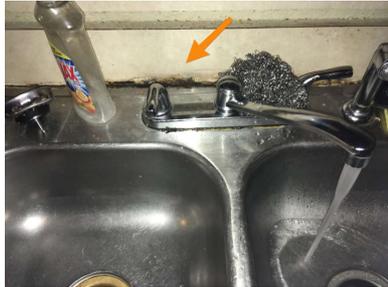
Water stains were observed on the walls. The cause and remedy should be further evaluated and corrected as necessary. All water damaged building materials should be replaced.

Recommendation: Contact a qualified drywall contractor.

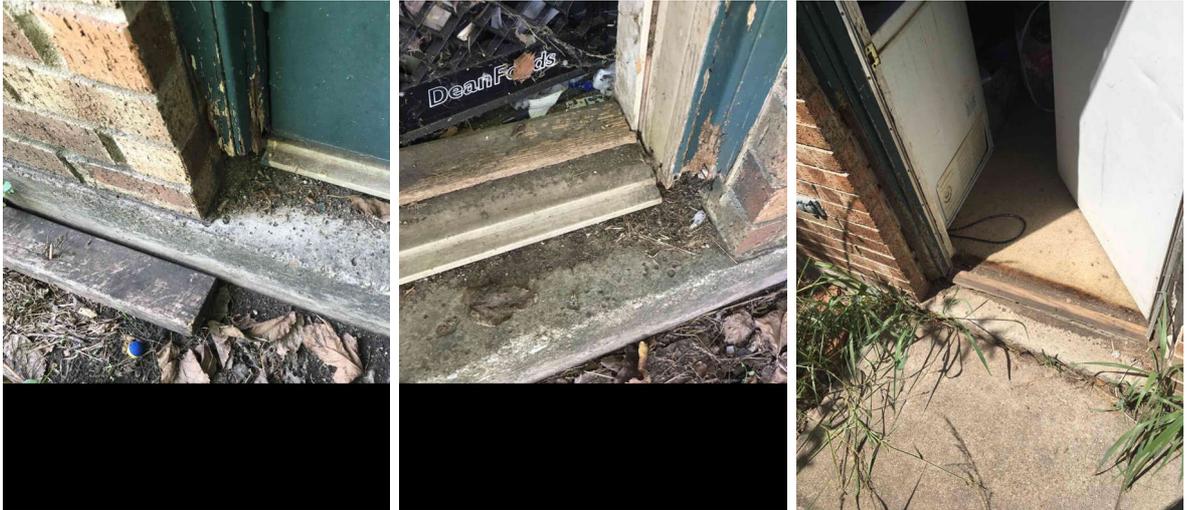
**6: Wood destroying insects damage**

🔴 **Essential Items (Licensed Professionals & Safety)**

Recommendation: Contact a qualified professional.

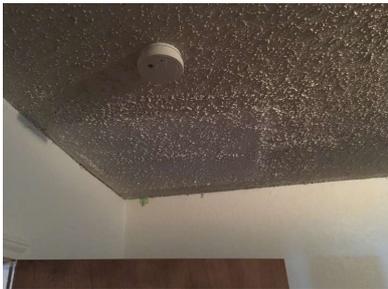
7483 front bedroom

Signs of previous paint or texture touch ups were observed on the ceilings.

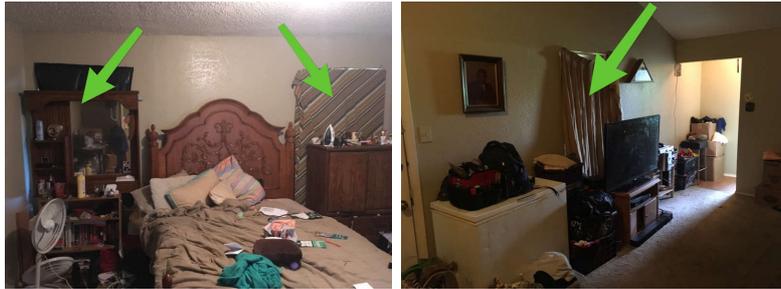
I was unable to inspect the operation of some of the windows due to window treatments, personal effects, large, heavy or fragile storage and/or furniture.

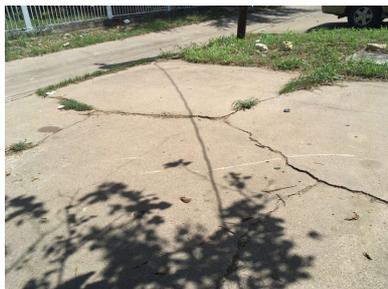
Larger than typical cracks and/or deficiencies were observed in the driveway. Any areas where the cracks present a trip hazard should be replaced sfor safety reasons.

Recommendation: Contact a qualified concrete contractor.

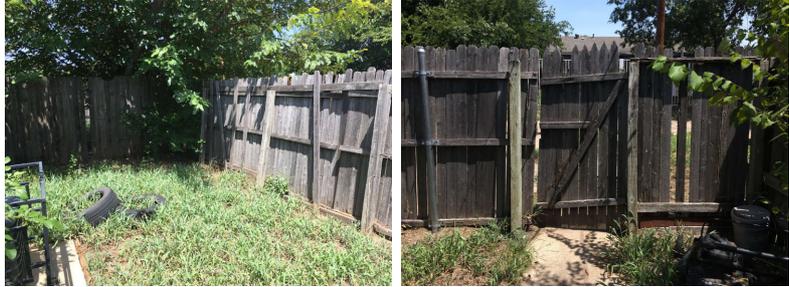
Some deterioration and/or damage was observed on the fence support posts.

Recommendation: Contact a qualified fencing contractor

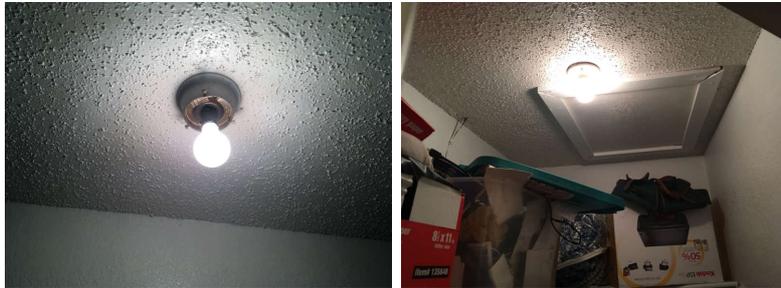
One or more of the closet light fixtures appear to be installed without globes and/or covers. Safety precautions should be taken around these light fixtures. This is an as built condition however we are required by TREC to note this as a deficiency.

Recommendation: Contact a handyman or DIY project

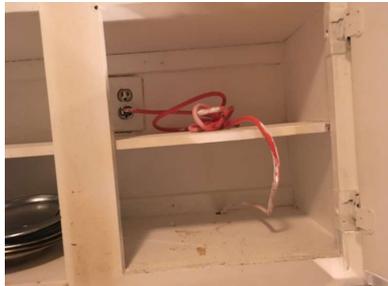
- Handyman wiring observed above hange hood.

Recommendation: Contact a qualified electrical contractor.

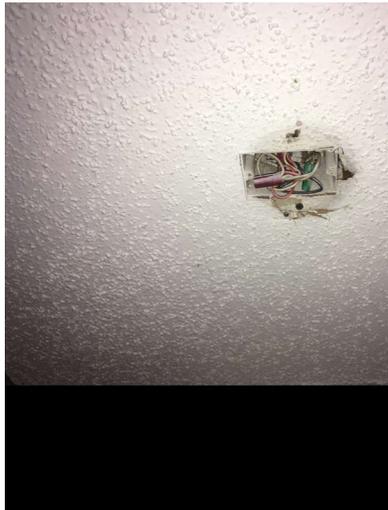
light fixture missing.

Recommendation: Contact a qualified electrical contractor.

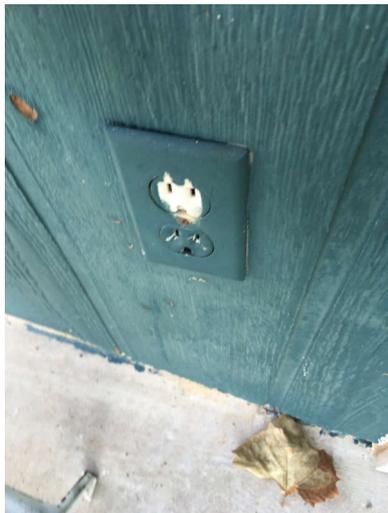
A weather resistant cover was missing or damaged at the time of inspection and should be replaced/installed.

Recommendation: Contact a qualified electrical contractor.

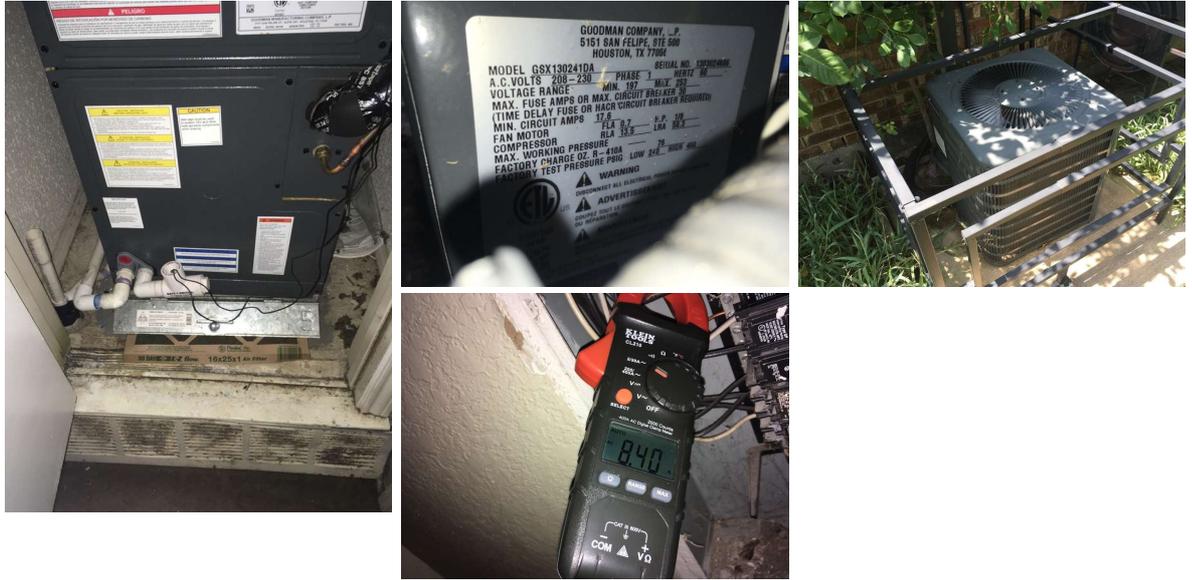
7485

- The RLA (Running Load Amps) The unit drew 8.4 **amps**. This rough check is within the normal operating range.
- Picture of the cooling equipment in the atticHVAC closet for your reference.
- Picture of the outside condensing unit for reference.

- The RLA (Running Load Amps) The unit drew 8.39 **amps**. This rough check is within the normal operating range.
- Picture of the cooling equipment in the atticHVAC closet for your reference.
- Picture of the outside condensing unit for reference.

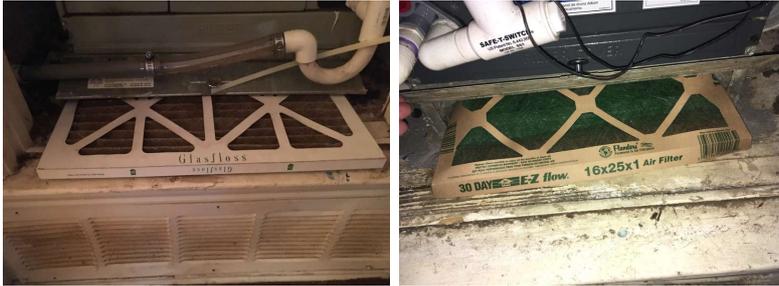
- Picture of the HVAC filter for reference. **FYI: 1 inch filters should be changed Every month and 4 inch filters should be changed every three months as part of regular home maintenance.**

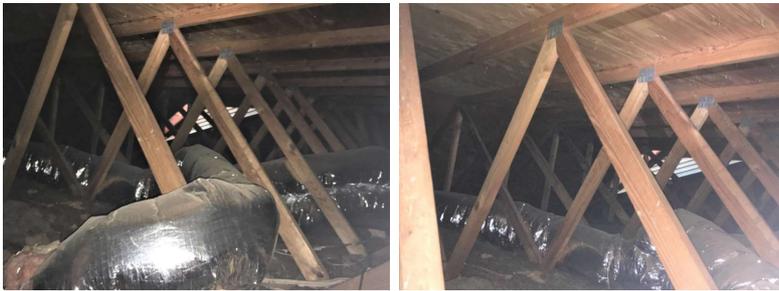
*Ductwork ok:*

- All visible ducts appeared to be in satisfactory condition at the time of this inspection. None of the ductwork was visible for unit 7485 because there was No attic access. The ductwork that was visible above unit 7483 appeared to be in satisfactory condition.

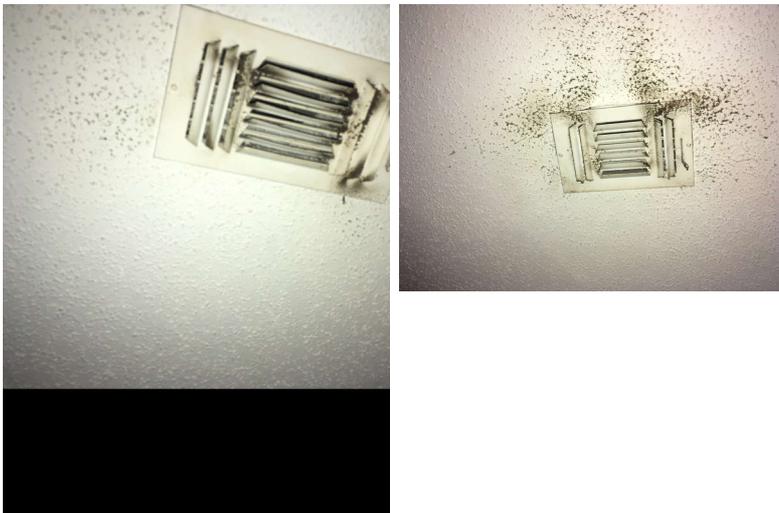
The air-registers for the HVAC system appear to be dirty and should be cleaned to help maintain good air quality. This is typically an indication of a dirty HVAC filter.

Recommendation: Contact a qualified professional.

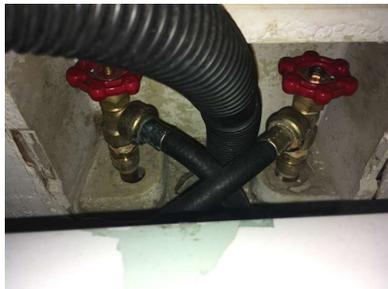
- Picture of the laundry room washer box connections. No rust or leaks were found at the time of this inspection.

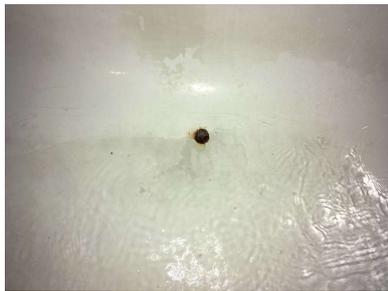
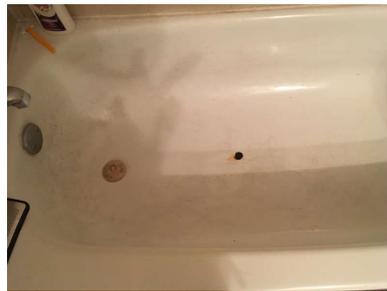
- Bathtub has some surface damage and should be repaired as necessary to prevent further damage/rusting.

Recommendation: Contact a qualified professional.

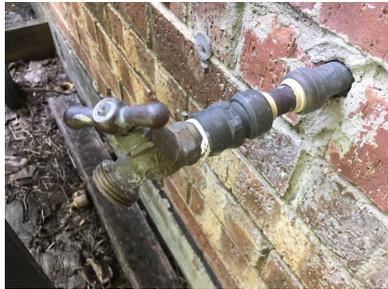
- The outside faucets were spigots and not hosebibs. Extra freeze protection is needed during winter months.

Recommendation: Contact a qualified professional.

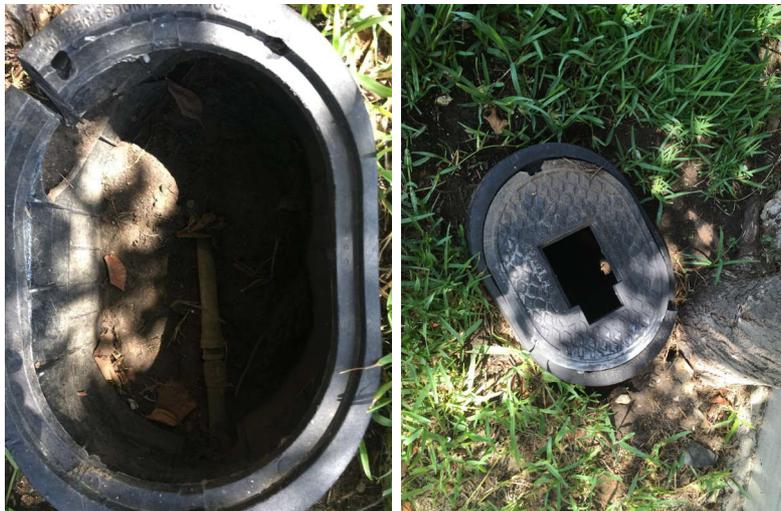
The cover was missing from the customer shutoff

Recommendation: Contact a qualified professional.

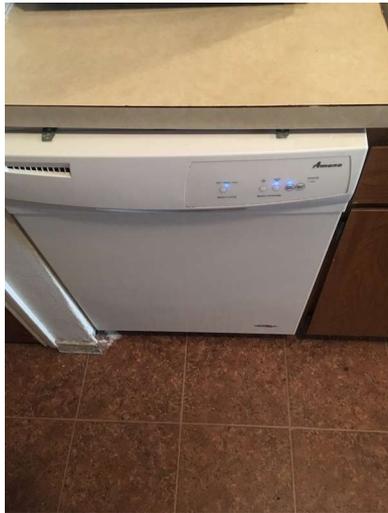
7483

Picture of the dishwasher for reference. The dishwasher appeared to be working properly at the time of inspection.

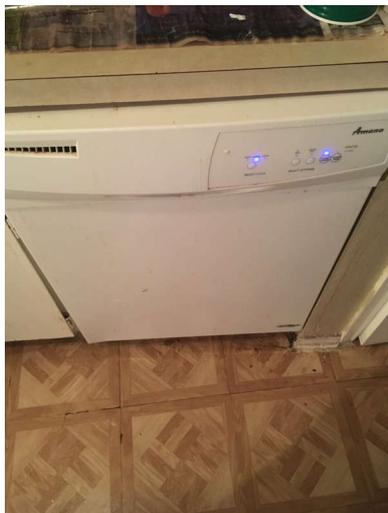
The dishwasher is loose at the cabinetry and should be better secured.

Recommendation: Contact a handyman or DIY project

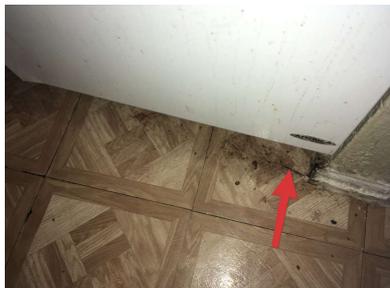
**2: Leaks on floor**

▲ Essential Items (Licensed Professionals & Safety)

Recommendation: Contact a qualified appliance repair professional.

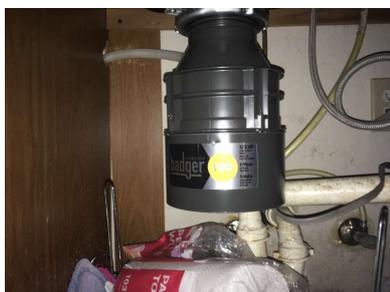
7483

The disposal was tested and appeared to be working properly at the time of this inspection.

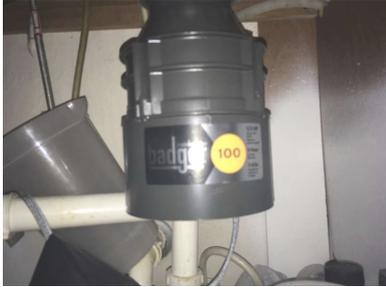
The disposal was noisy with debris inside and should be cleaned.

Recommendation: Contact a qualified professional.

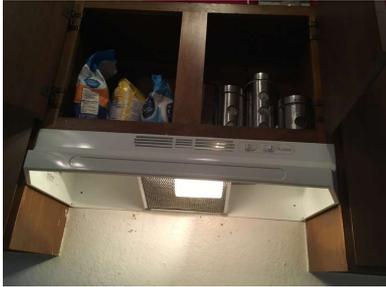
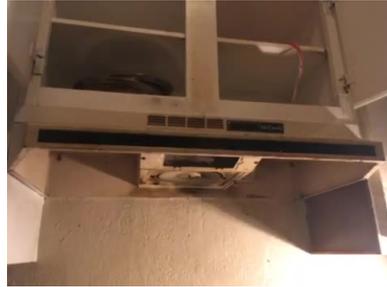
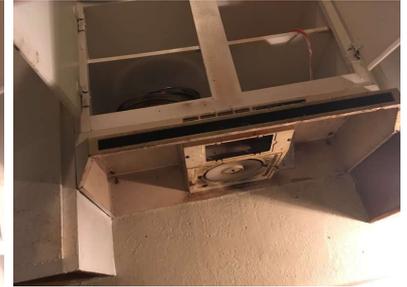
7483

The vent installed at the time of inspection was a recirculating type (Non Vented) It appeared to be working ok at the time of inspection

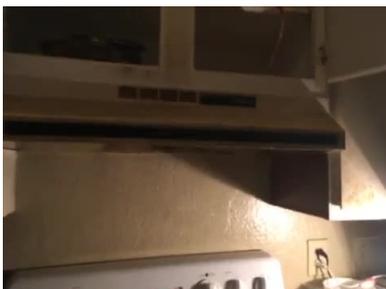
The range exhaust vent filter is missing.

Recommendation: Recommended DIY Project

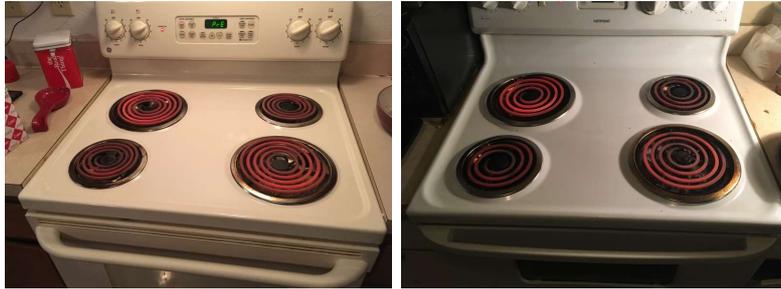
The cooktop burners appeared to be performing properly at the time of this inspection.

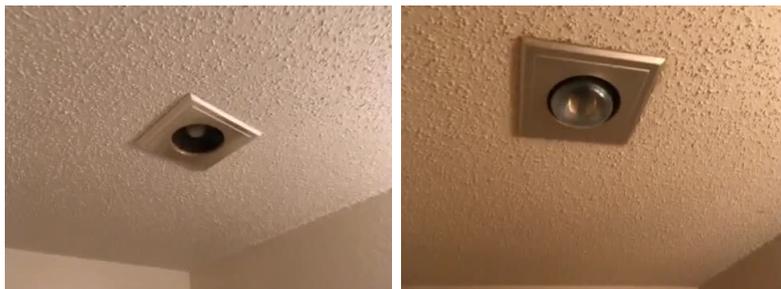
The vent fan light was inoperative.

Recommendation: Contact a qualified professional.

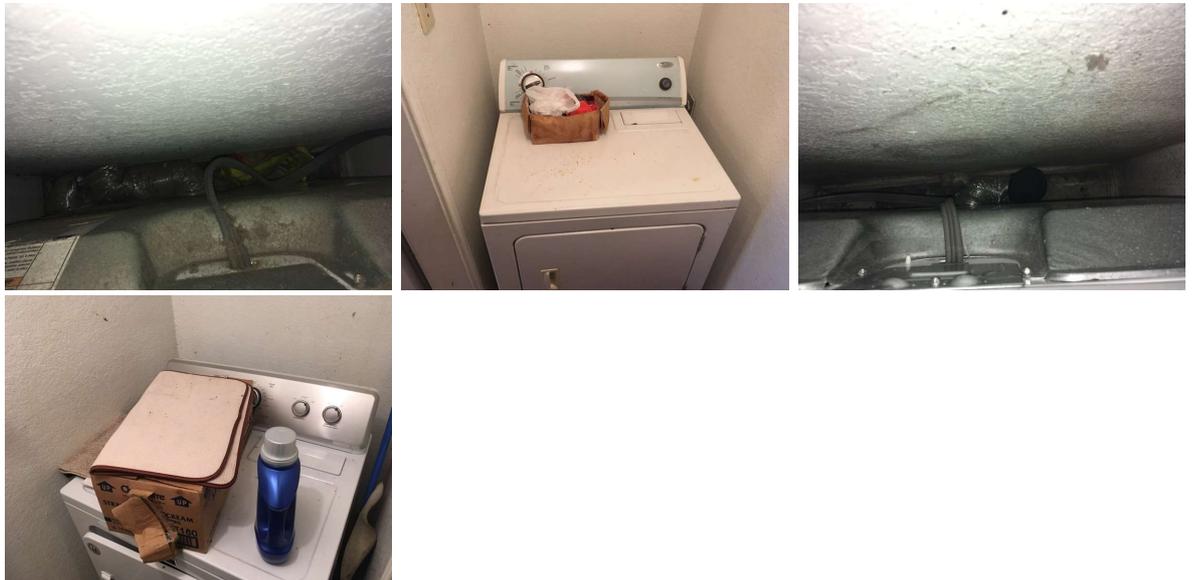
- The clothes dryer was in place on the day of inspection and the inside of the duct could not be seen. It is recommended that the condition of the duct be checked prior to connecting the clothes dryer to it. If it is dirty it should be cleaned for reasons of fire safety. Dryer vents should be cleaned regularly as part of normal home maintenance.

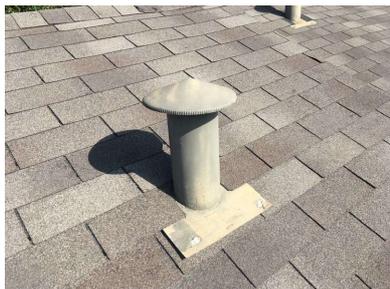
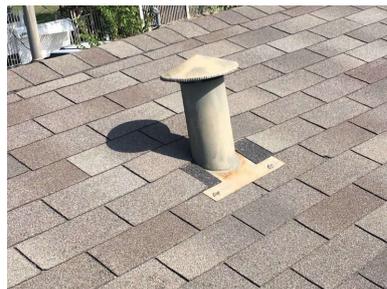
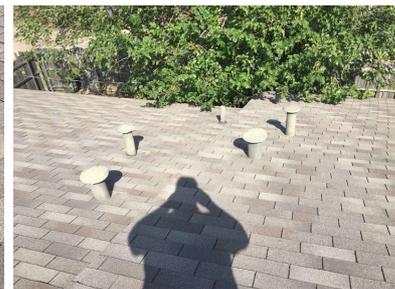
**1: Wrong type of termination**

Example wall termination

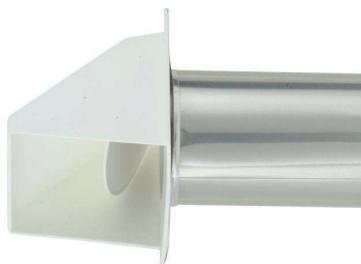
Example dryer vent wall termination

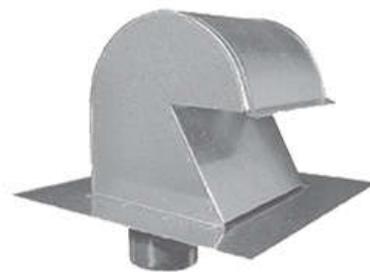
Example Dryer vent Roof cap
