HOME INSPECTION REPORT

2110 Ginkgo St SE
Auburn WA 98092

Tye Panzone
MAY 26, 2020

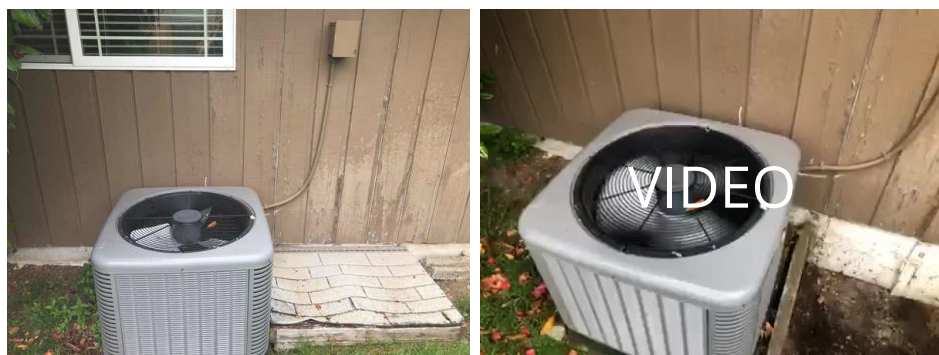
Air Conditioning/Heat Pump: Equipment Photo

**Air Conditioning/Heat Pump: Disconnect Acceptable**

The electrical disconnect(s) at the condensing coils are present and appear functional; however they were not activated or used at the time of inspection.

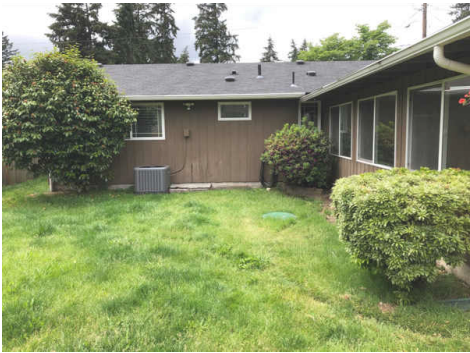
3.5.1 Exterior Siding Notes

Vegetation is encroaching on the structure, and should be kept a minimum of twelve inches away for the general welfare of the walls and foundation.

Recommendation
Contact a qualified landscaping contractor

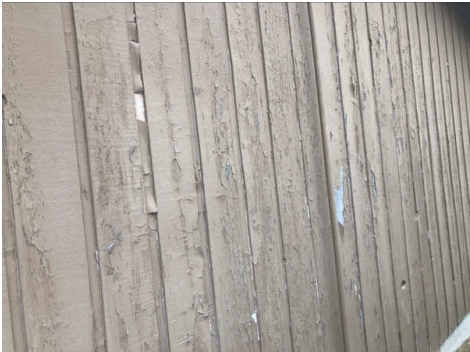
3.5.2 Exterior Siding Notes
DETERIORATED SIDING
RIGHT SIDE

Some of the exterior siding is deteriorated. It is weathered and curling. Maintenance, paint and repairs are recommended. Some replacement may be needed.

Recommendation
Contact a qualified professional.

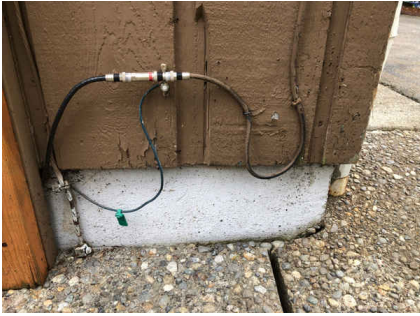
3.5.3 Exterior Siding Notes
SIDING NEEDS PAINT

The paint is peeling or deteriorated and we recommend it be repainted.

Recommendation
Contact a qualified professional.

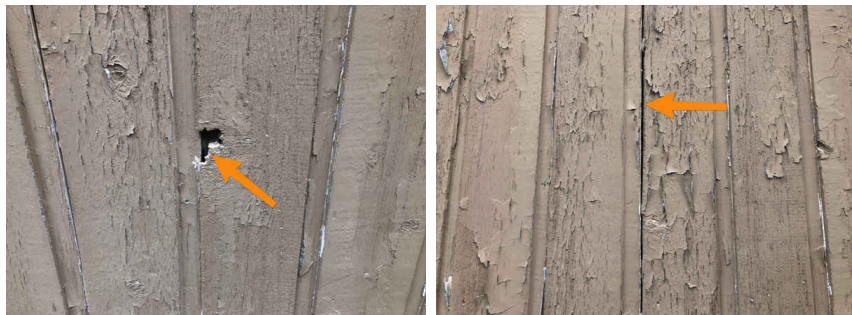
3.5.6 Exterior Siding Notes

Gaps and/or holes were observed on one or more sides in the siding around plumbing, gas, cable, wiring and/or other penetrations. We advise that all the holes and the gaps be caulked and/or sealed to prevent moisture and/or pest intrusion.

Contact a qualified professional.

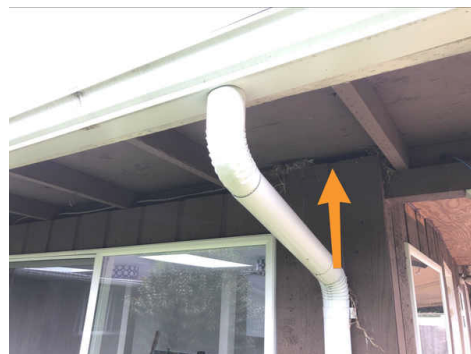
3.7.1 Fascia, Trim & Eaves

One or more gaps in the eaves were observed. Recommend sealing to prevent pest intrusion.

Contact a qualified professional.

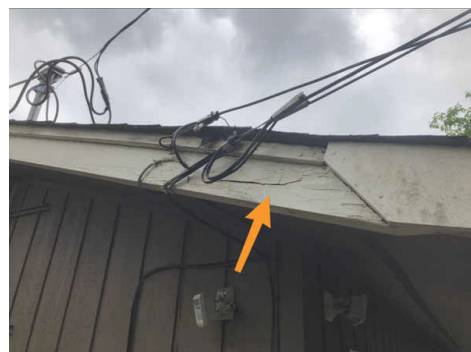
3.7.2 Fascia, Trim & Eaves

Sections of the fascia board or wood trim around the residence are slightly weathered, and should be serviced as necessary to prevent further deterioration. Service such as scraping, repainting and sealing.

Contact a qualified handyman.

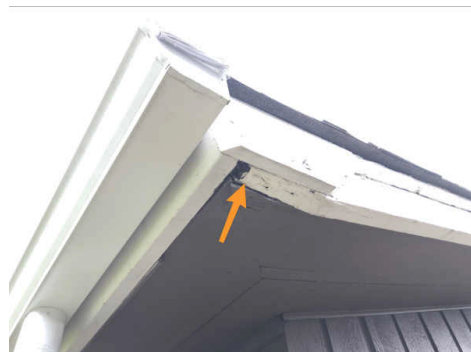
3.7.3 Fascia, Trim & Eaves

SECTIONS OF FASCIA & TRIM MOISTURE DAMAGED

Sections of the fascia board or wood trim are weathered, moisture damaged and should be serviced or replaced as necessary by a qualified professional contractor to help prevent further wear or deterioration.

Contact a qualified handyman.

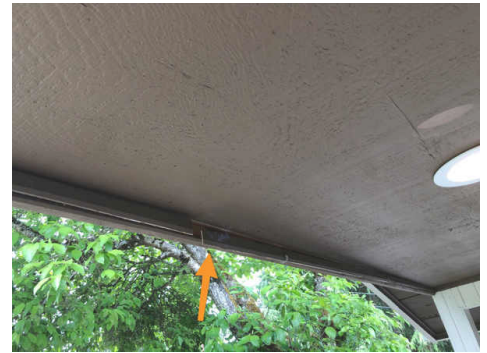
3.7.4 Fascia, Trim & Eaves

TRIM MISSING/DAMAGED

A piece of trim is damaged or missing. Recommend repairs.

Contact a qualified professional.

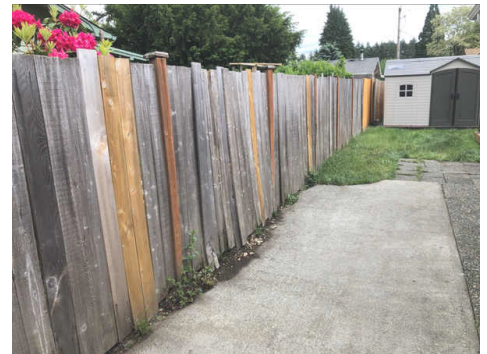
3.14.1 Fences & Gates

FENCES WEATHERED

The fences are weathered. Recommend maintenance and repairs.

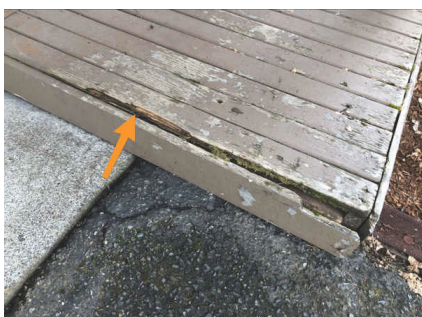
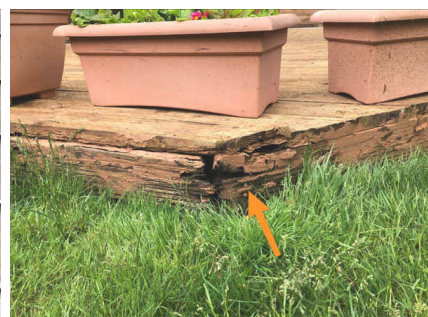
DECK IS DETERIORATED

One or more sections of the deck are damaged or deteriorated. Further evaluation and repair is recommended

Medium Priority

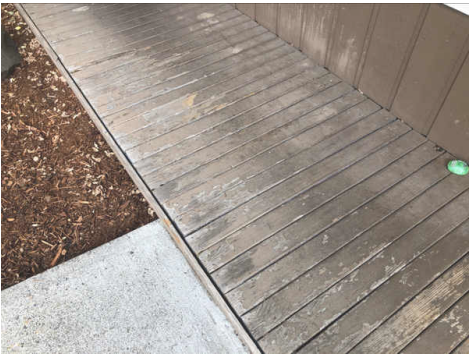
3.17.2 Deck

WEATHERED

Portions of the deck we're weathered and in need of minor repairs and maintenance.

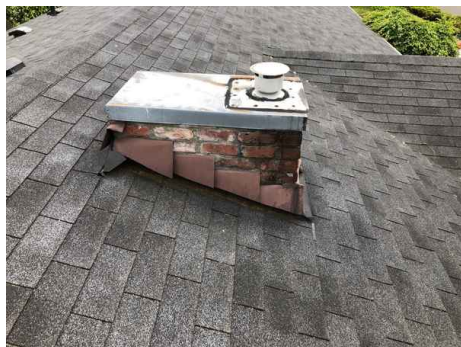
Chimney On Roof & Photo: Chimney Photo

Chimney On Roof & Photo: Rain Cap Acceptable

The chimney has a functional weather cap/spark arrestor.

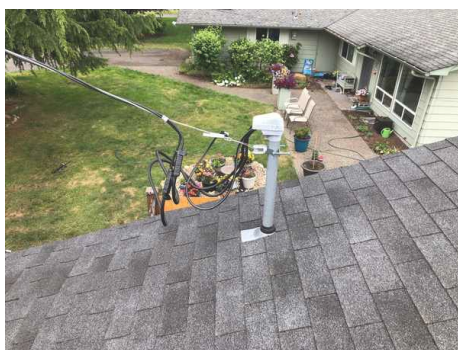
Roof Electrical : Electrical Strike Photo

The electrical strike and mast were in acceptable condition.

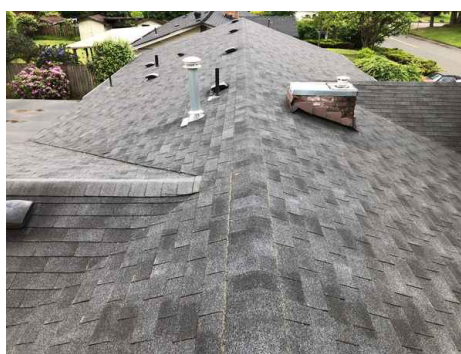
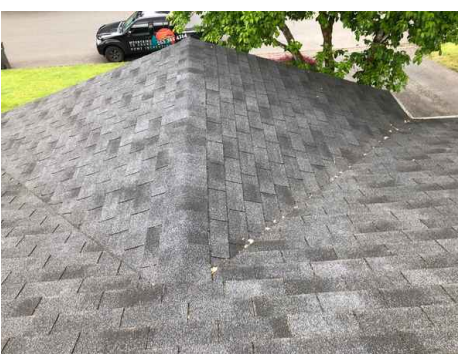
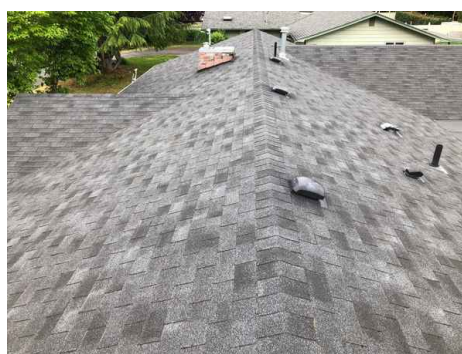
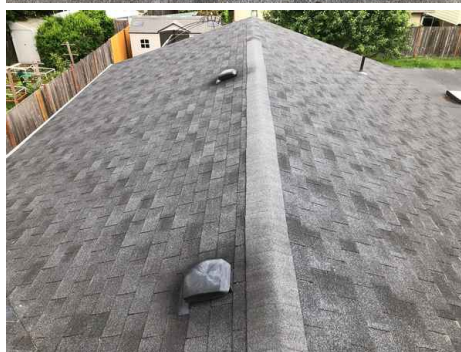
Method of Evaluation & Photos: Method of Evaluation & Photos

Walking on its surface

Composition Shingle Roof Notes: Acceptable

The roof is in generally acceptable condition. Any exceptions will be noted below. NOTE: This is not guarantee against leaks.

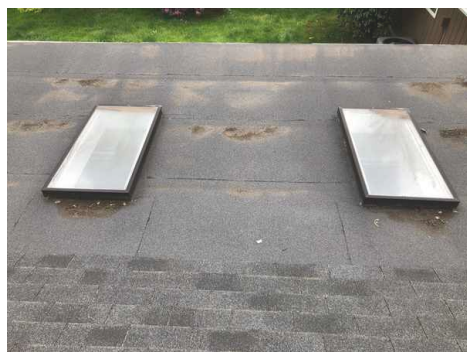
Flat Roof: Acceptable

The roof is in acceptable condition, but this is not a guarantee against leaks. For a guarantee, you would need to have a roofing company perform a water-test and issue a roof certification.

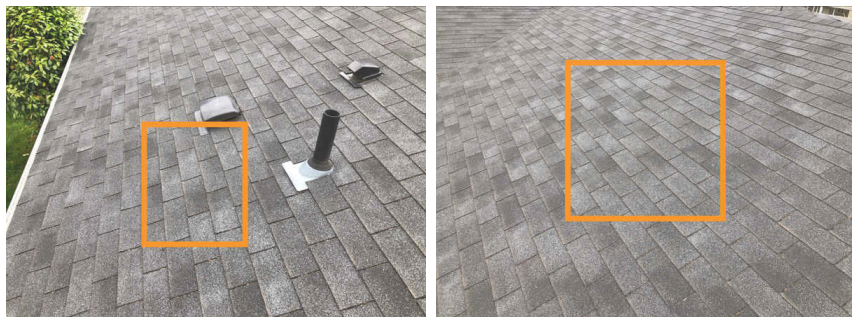
Medium Priority**SOFT SPOTS IN SHEATHING**

Soft spots in the sheathing was observed in one or more areas. For the revaluation and repairs are recommended as needed to.

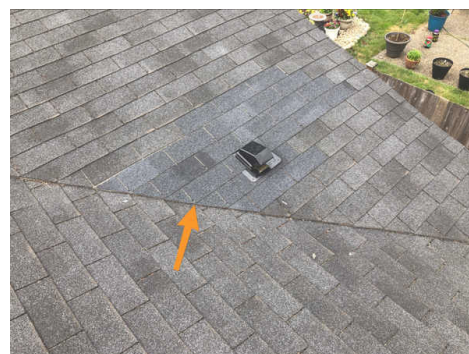
4.4.2 General Observations

Repairs and/or patches have been made to the roofing material in several areas. We cannot determine the reason or condition of the repairs. Monitoring is advised for future issues or conditions. An additional evaluation of the roof would be appropriate.

Contact a qualified professional.

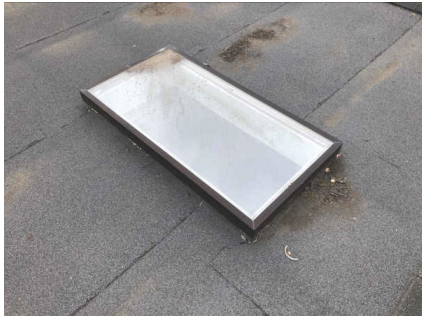
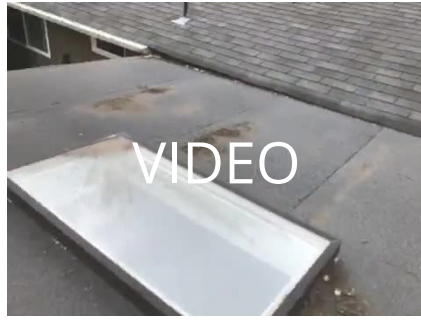
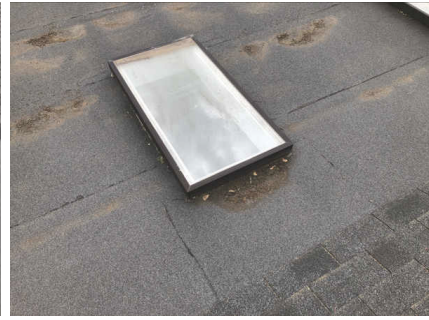
4.7.1 Skylights

Medium Priority**LOOSE SKYLIGHT**

The skylight is loose. We recommend securing.

Contact a qualified professional.

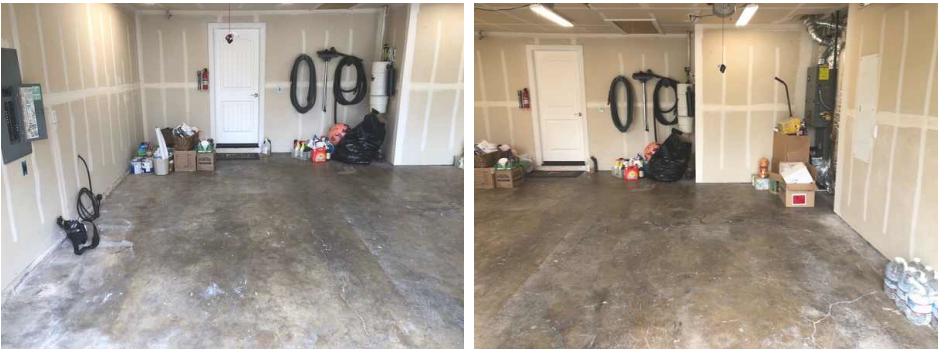
Automatic Opener: Acceptable The automatic garage door opener is acceptable.	Automatic Opener: Safety lights - Acceptable The garage door safety lights open the door when obstructed.	Garage Door & Hardware: Acceptable The sectional garage door and its hardware are functional.
Firewall Separation: Acceptable The firewall separating the garage from the residence is functional.	Walls and Ceiling: Acceptable The visible walls and ceiling are in acceptable condition.	Lights, Wall Switches: Acceptable The ceiling lights are functional.
Lights, Wall Switches: Acceptable The wall switches are functional.	Outlets, Electrical Observations: Acceptable The outlets were in acceptable condition.	
Picture and size of garage: Picture and size of garage Double Car Garage The garage and its components were evaluated.

Entry Door Into the House: Acceptable The house entry door is solid core, or fire-rated, and self-closes in conformance with fire-safety regulations.
Slab Floor: Acceptable The visable garage slab floor is in acceptable condition. Small cracks are common and result as a consequence of the curing process, seismic activity, common settling, or the presence expansive soils, but are not structurally threatening.
Parking Space: Check parking space to accommodate your vehicles It would be prudent for you to see that the parking space is adequate to accommodate your vehicles.

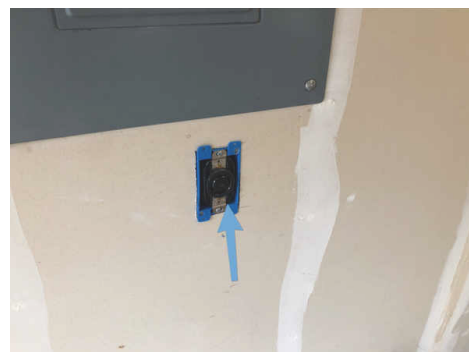
5.10.1 Outlets, Electrical Observations
COVERPLATE MISSING

Coverplates were missing on outlets, switches or junction boxes.
Recommend installing cover plates.

Contact a qualified handyman.

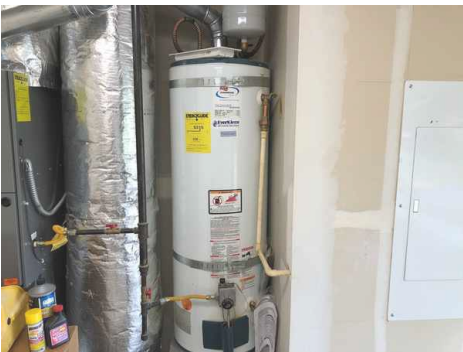
Water Heating System: Water Shut-Off Valve & Connectors

The shut-off valve and water connectors appear functional, but was not tested.

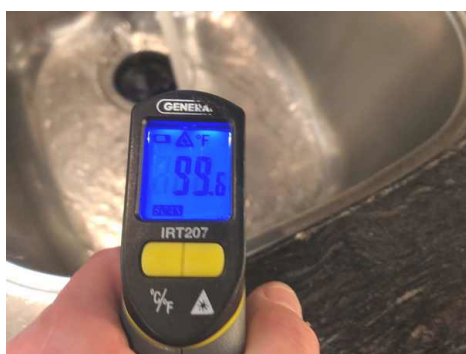
Sink and Faucet: Water temp

The Water temp at the Kitchen Faucet is Currently noted in the photo below. The U.S. Consumer Product Safety Commission (CPSC) urges all users to keep their water heater temps at 120 degrees Fahrenheit to prevent scalding and bacteria prevention reasons.

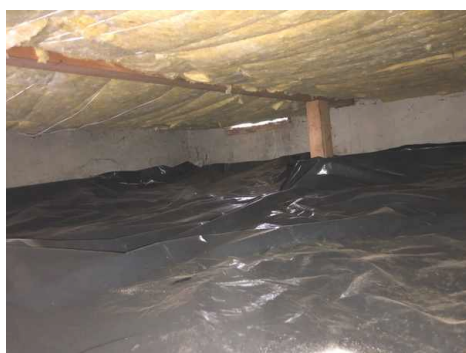
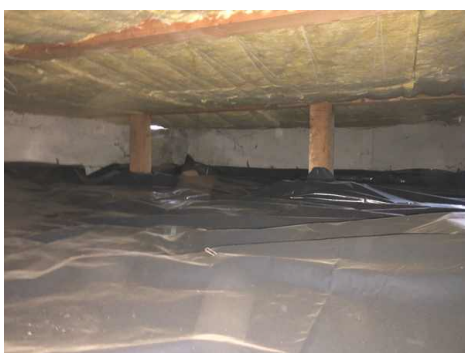
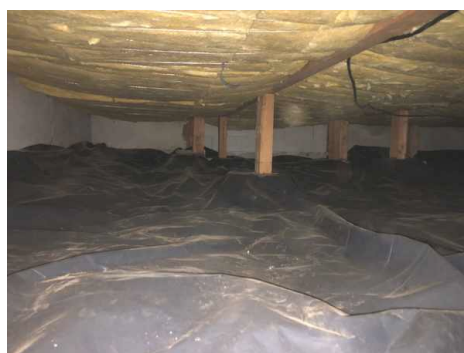
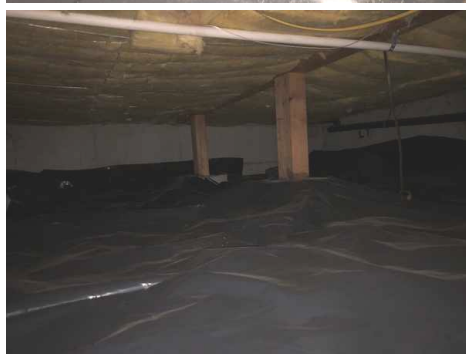
Crawlspace Notes: Crawlspace Photos

At the time of the inspection, the vapor barriers were in good condition with only minor visible defects normal to the age of the home.

The foundation showed only the normal signs of weathering and or cracking at the time of the inspection.

The foundation was found to be in acceptable condition. Any exceptions will be noted below.

The visible Beams, posts and piers and other sub-floor components were in acceptable condition at the time of the inspections. Any exceptions will be noted below.

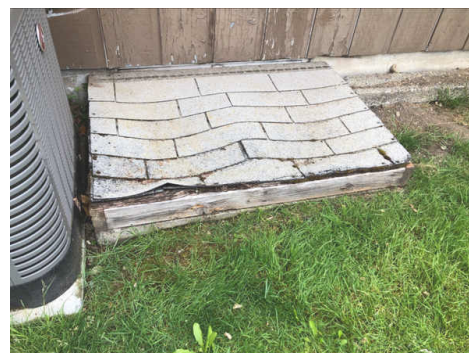
ACCESS HATCH DAMAGED

The crawlspace hatch is damaged or deteriorated. We recommend repair or replacement of the hatch to prevent rodent access.

Contact a qualified professional.
