PRO SPEX HOME & COMMERCIAL INSPECTION SERVICES

PRO SPEX RESIDENTIAL INSPECTION

15503 Sample Report Rd
LAUREL MD 20707

Inspection Report ID: 1806GB6884	Inspection Date: 06/25/2018	Inspection Start/End Time: 9.15- 4.30
Style Of Building Colonial	# Bedrooms/Bathrooms 4 Br, 4 Bath, 2 -1/2 Bath	Building Size (SF) 7500 SF
Weather Conditions Sunny, Light Winds, Hot	Approximate Temp. 80 F	In Attendance Client, Buyer Agent, Family Members
Occupancy Vacant

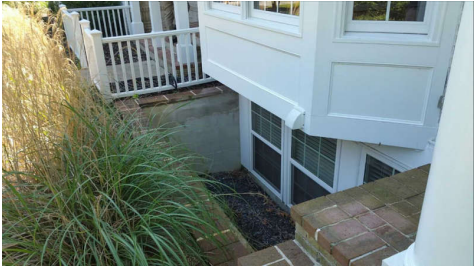
MISSING GUARDRAIL

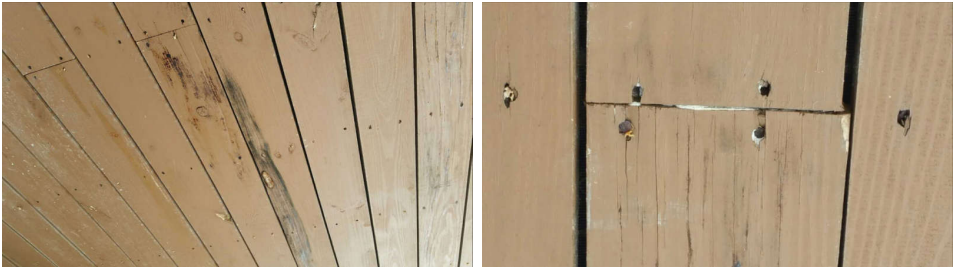
2.3.1 STOOPS, STEPS, AREAWAYS, AND APPLICABLE RAILINGS

General Repair/Replacement Item

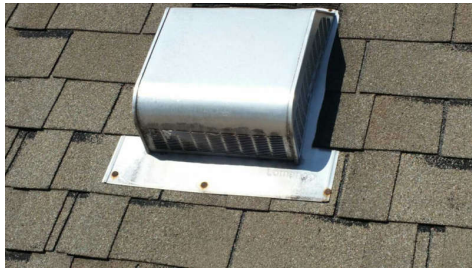
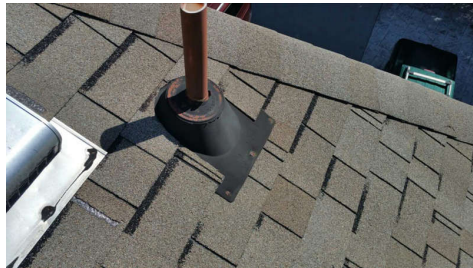
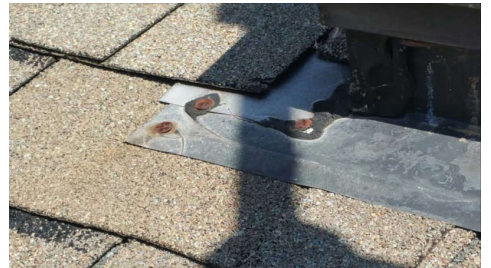
3.3.1 SKYLIGHTS, AND ROOF PENETRATIONS

SEAL EXPOSED NAILS

Seal exposed nails to prevent nail corrosion and leaks.

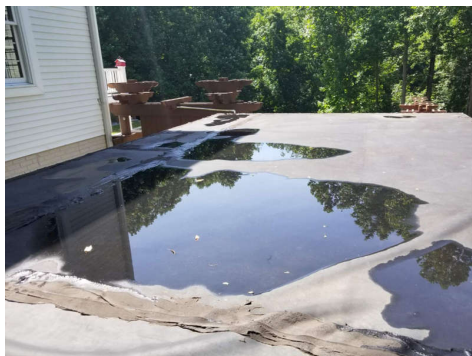
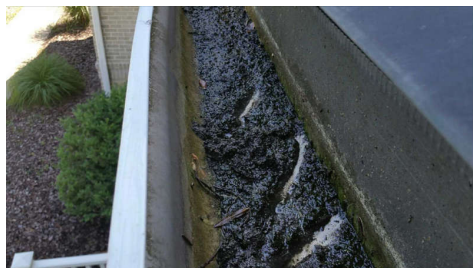
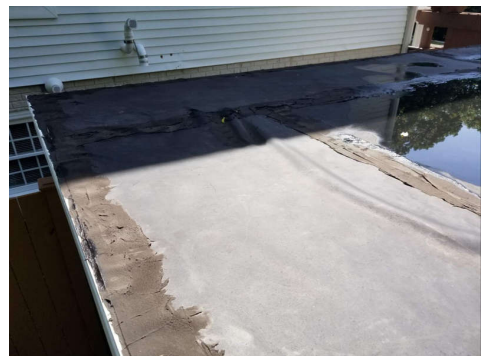
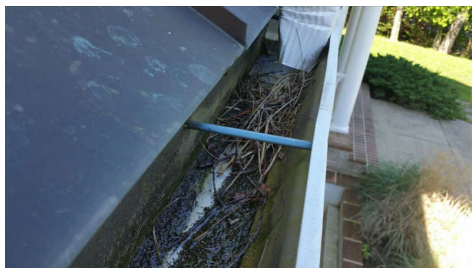
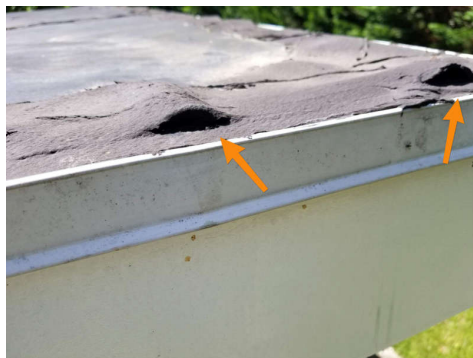
3.4.1 ROOF DRAINAGE SYSTEMS

CLOGGED GUTTERS

The gutters are full of debris in areas and need to be cleaned. The debris in gutters causes the gutter to overflow, resulting in rotting of the fascia board. As the fascia board weakens the gutters come loose and further deterioration occurs. Leaks in the gutters are often not visible until cleaned; damage to fascia boards and rafter ends can remain hidden from view. Client advised to keep gutters and downspouts clear and check fascia boards for possible damage.

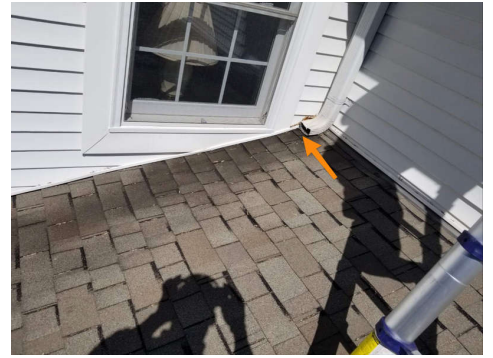
3.4.2 ROOF DRAINAGE SYSTEMS

EXTENSIONS

The downspout needs an extension/drain line to carry water away from the foundation at the front, rear and sides of home. Long term saturation of the foundation wall often leads to water penetration and high humidity in basements, which in turn can cause other problems. Recommend extensions that extend at least 8ft long beyond the foundation or into buried drain lines that terminate on the downhill side of the home.

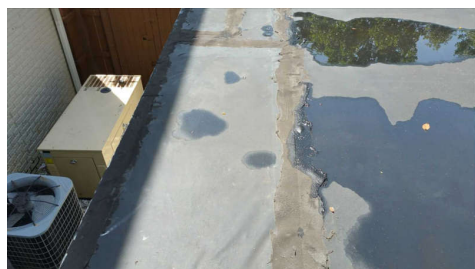
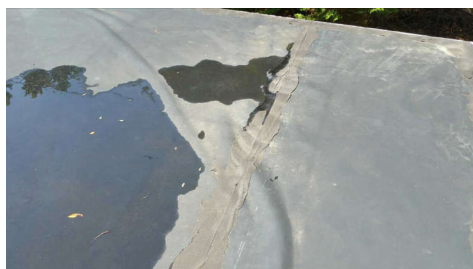
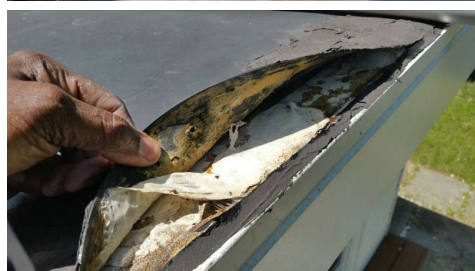
4.1.1 ROOF COVERINGS

Recommendation

Contact a qualified professional.

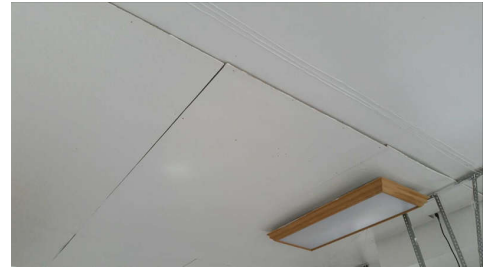
5.1.1 GARAGE/CARPORT CEILINGS

Recommendation

Contact a qualified professional.

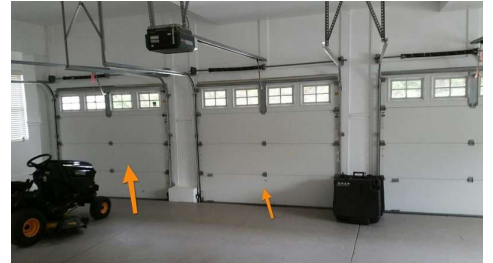
5.4.1 GARAGE OVERHEAD/ROLL UP DOOR (S)

GARAGE DOOR OPERATION FAULTY

In order to open or close 2 of the doors, the control must be depressed continuously.

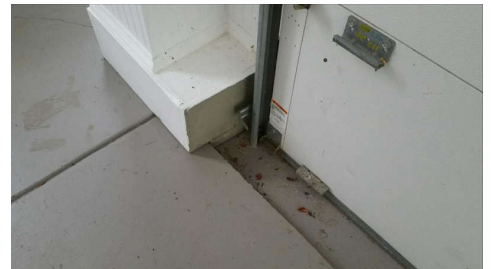
NO SENSORS

The left garage door is missing the motion sensors. Motion sensors are important for child safety and should be installed as soon as possible.

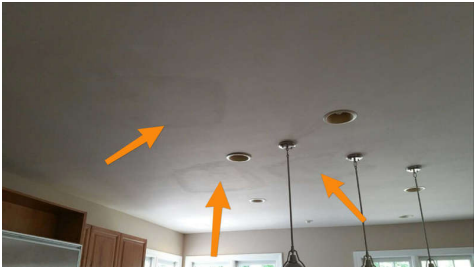
Kitchen

Signs of prior repairs visible in the kitchen ceiling below the master bathroom. We did not detect the presence of moisture which suggests this is not a recent occurrence. Recommend you contact the owner for more information.

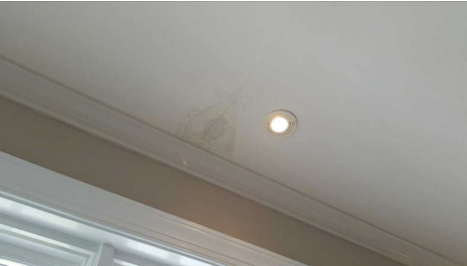
Sunroom

CEILING WATER STAIN-ROOF LEAK

Signs of water stains are present on ceiling in the sunroom and family room. We did not detect the presence of moisture which suggests this is not a recent occurrence. The underlying cause is moisture or dampness related a possible roof leak and or a leak around the chimney flashing.

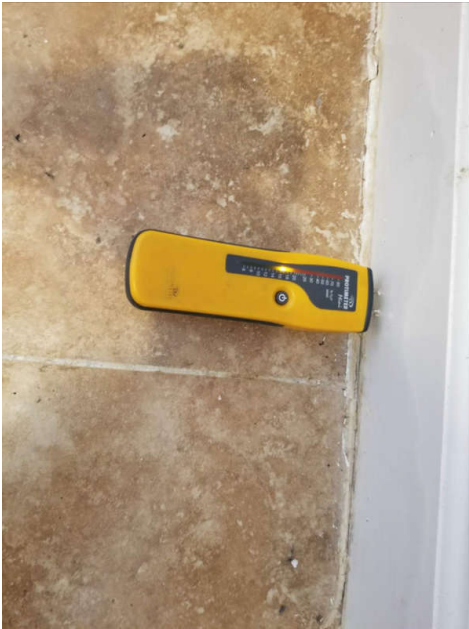
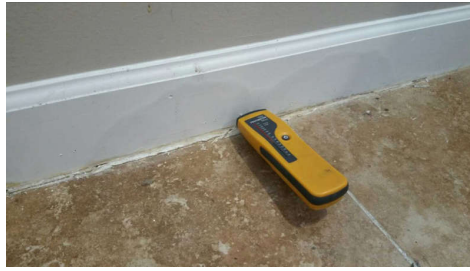
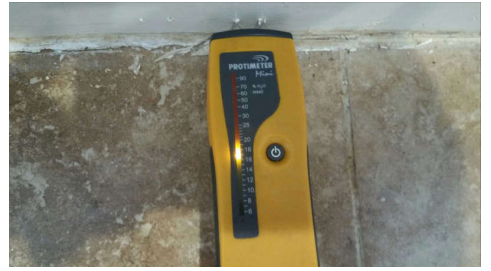
6.2.1 WALLS

BASEMENT WALL MOISTURE

Elevated moisture reading detected in several areas throughout the basement. The source of the water penetration (believed to be related to the site drainage) should be corrected so as to prevent further damage.

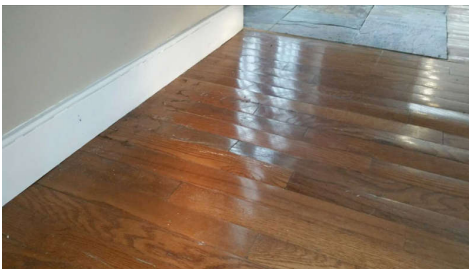
6.3.1 FLOORS

FLOOR DAMAGE

The floor at the base of the exterior door moves when weight is applied, an indication of possible hidden damage. This is often caused by water penetration around the door frame or sill, resulting in hidden damage.

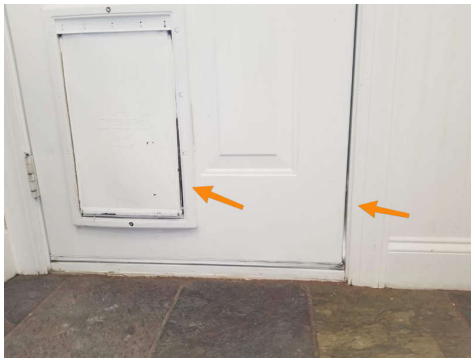
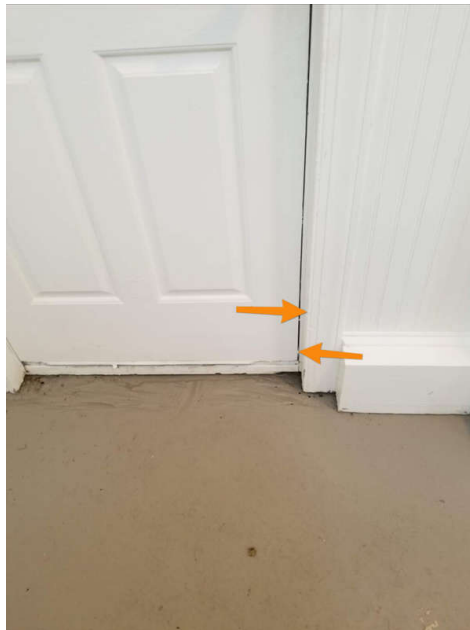
ADJUST DOOR-RUB

Some of the interior doors rub when opening and closing. Over time, either the hinges work loose or the locks will not align. Have contractor adjust door as needed. (see photo for location)

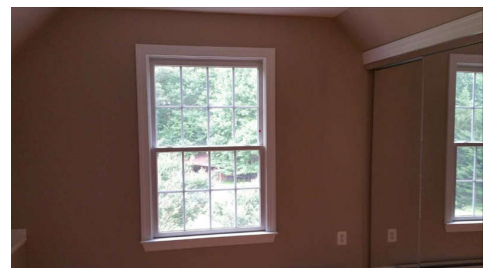
6.7.1 WINDOWS (Excluding Storm Windows)

FALLING WINDOWS

The four double hung windows at the 2nd floor do not stay up when opened. This is a safety hazard that should be repaired by a qualified window contractor.

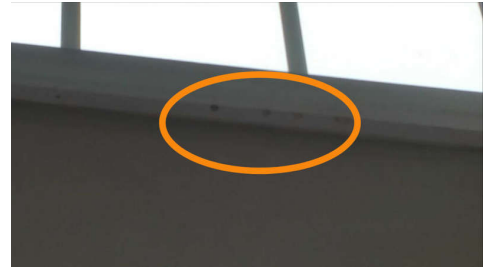
Water stain visible on interior window trim to the upper right of the stone fireplace. Reason unknown.

Contact a qualified professional.

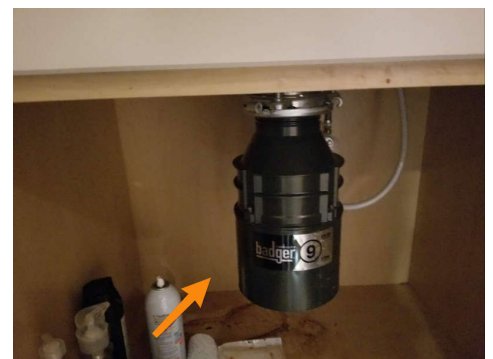
CLOGGED SINK

There are restrictions in the drainage system at the (basement, kitchen, bathroom) sink. This appears to be isolated to just this location, suggesting there is a blockage in the 'P' trap at the sink. Consult a qualified plumber (person) to clear the drainage system.

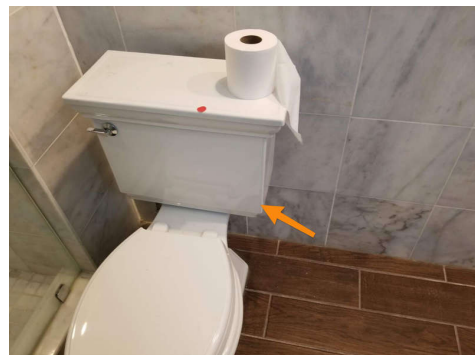
7.3.3 PLUMBING FIXTURES

LOOSE TOILETS

The toilet (is are) loose at the floor. Repairs may involve re-setting the toilet on a new wax seal. I recommend a qualified licensed plumber repair as needed. Failure to repair loose toilets can lead to significant floor damage caused by leaks and rotted wood. Consult a qualified plumber to correct as needed.

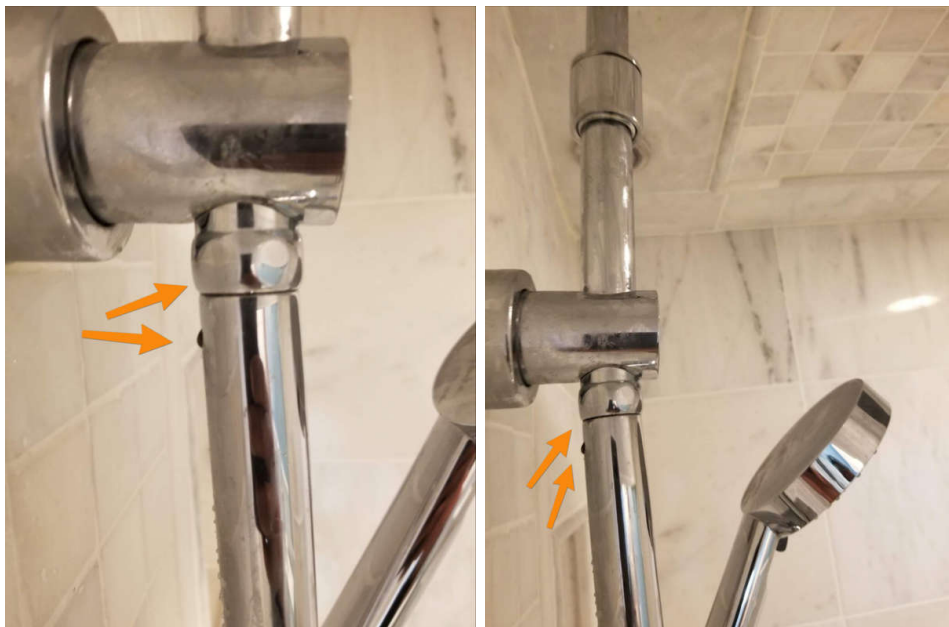
SHOWER HEAD LEAK

The shower head leaks where it connects to the stem.

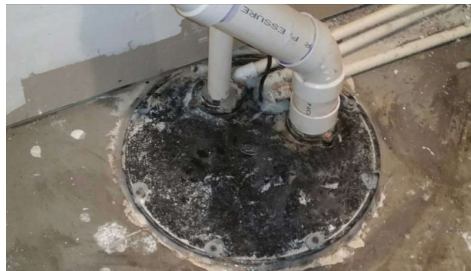
SUMP INOPERABLE

The sump pump is inoperable. Consult qualified plumbing contractor for replacement options.

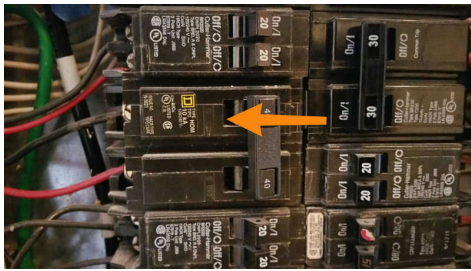
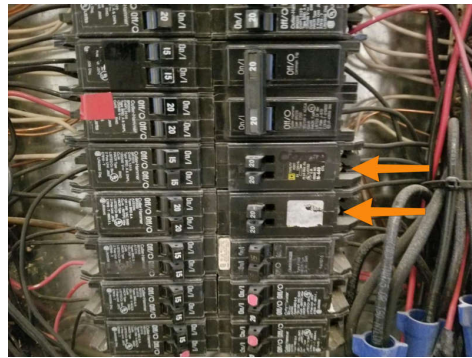
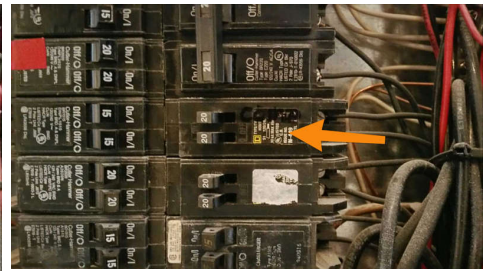
The problem(s) discovered in the panel such as breaker(s) are different brands, and any other problems that an electrician may discover while performing repairs need correcting. Unlike most electrical devices like switches and outlets, circuit breakers are brand specific. The manufacturer typically requires that you to only replace or add breakers specifically designed for that panel. Because of different mounting techniques, buss bar thicknesses, breaker contact tension specifications, and overall construction differences, breakers are typically not interchangeable. Placing another brand of breaker in a breaker panel could cause an electrical malfunction.

I recommend a licensed electrician inspect further to determine if these breakers are compatible and correct as needed.

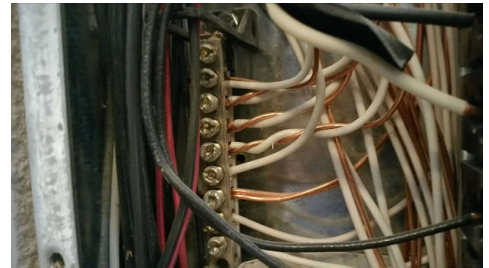
9.2.2 SERVICE AND GROUNDING EQUIPMENT, MAIN OVERCURRENT DEVICE, MAIN AND DISTRIBUTION PANELS

NEUTRAL.GRND SAME LUG

Neutral (white) wires and ground (bare copper) wires cannot share the same lug (screw) in a panel unless they are on the same circuit. Doing so could create a shock hazard.

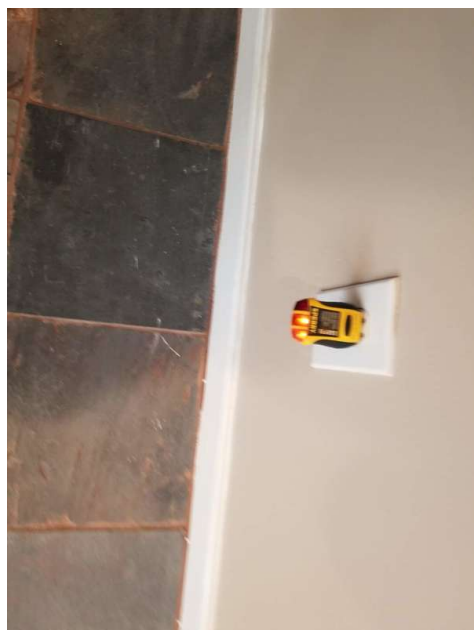
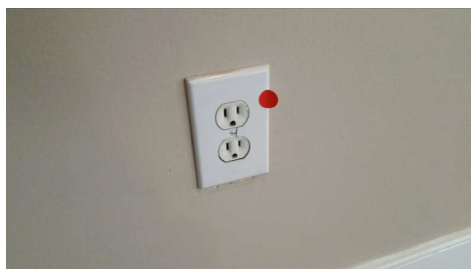
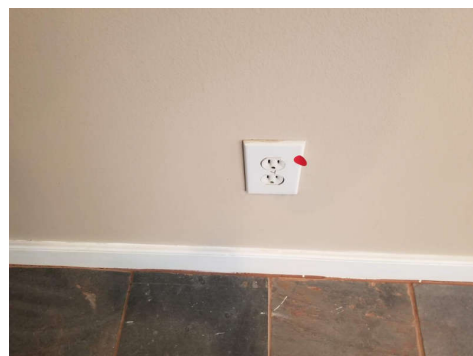
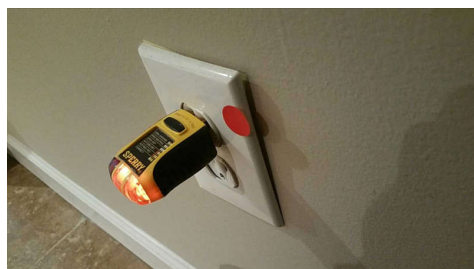
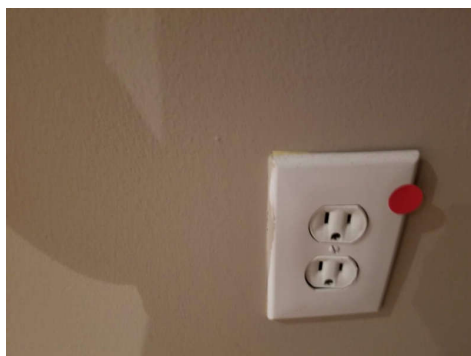
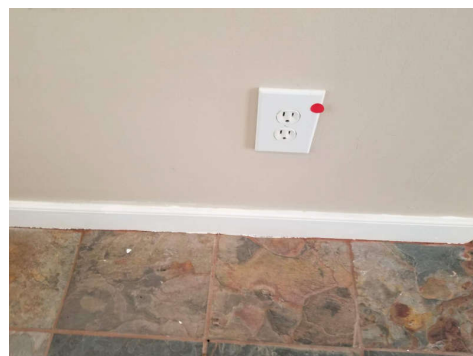
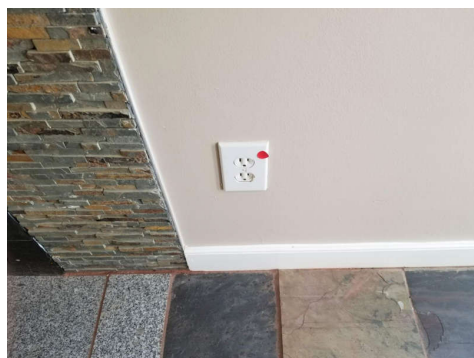
LOOSE OUTLETS

Several "three-prong" outlets (see outlets with green dots for location) are loose in the property. Loose outlets can result in an electrical short inside the wall. Electrical issues are considered a hazard until repaired. All outlets should be properly secured, and should not move when inserting or removing a device.

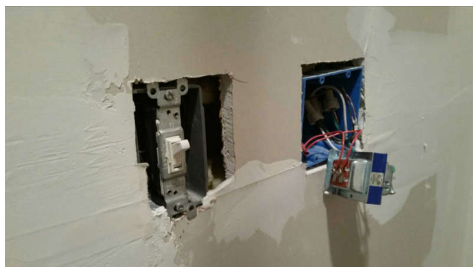
9.4.3 CONNECTED DEVICES AND FIXTURES (Readily Accessible permanently installed devices, fixtures, switches, outlets etc.)

MISSING COVERS

Outlets, junction boxes and switches with missing covers are a safety hazard, particularly for small children who may come in contact with the outlets, or adults reaching for the switch in the dark. Recommend all open junction boxes, switch boxes etc. be covered with an appropriate cover plate.

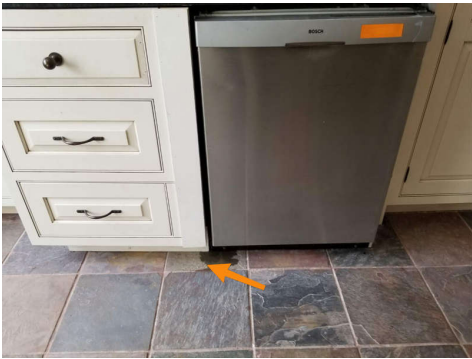
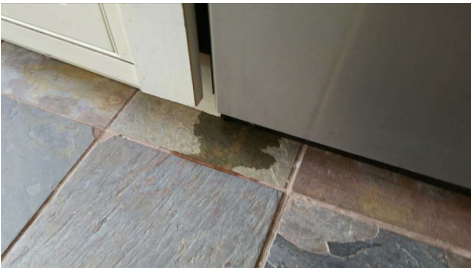
The dishwasher leaks when operated (door seal has failed). Consult a qualified appliance contractor to repair as needed.

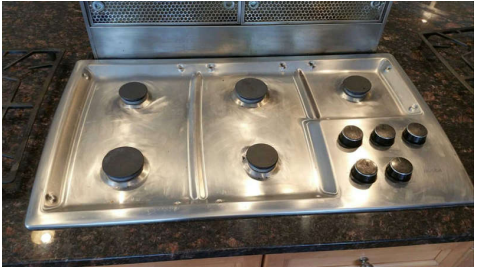
10.2.1 RANGES and COOKTOPS

The front/rear right/left coil/burner element (on range/cooktop) did not work when tested. Recommend repair or replacement by a qualified appliance contractor.

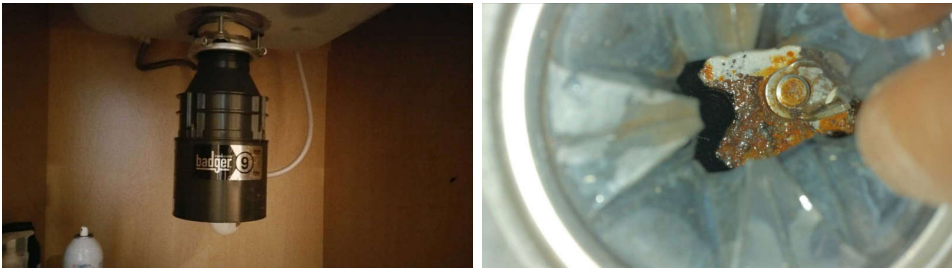
10.6.1 FOOD WASTE DISPOSER

CORRODED INTERIOR

The interior is heavily corroded and the unit is jammed.

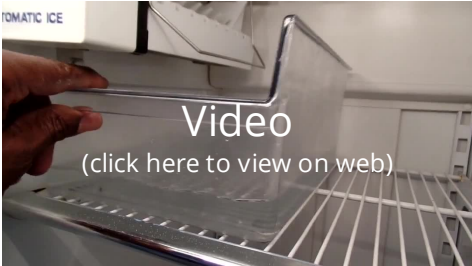
The freezer is not freezing and is making an unusual noise, reason unknown. Repairs to refrigerators of this type are often costly.

Contact a qualified professional.

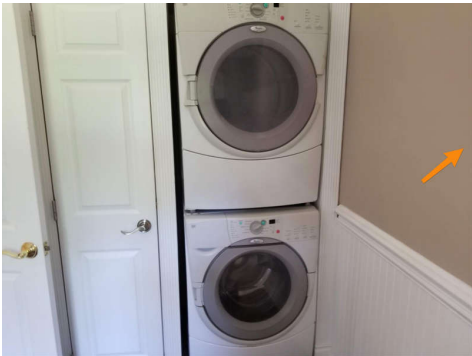
WASHER/DRYER LI

The washer dryer appears to be operational. A short limited test did not reveal any concerns. (This check is performed as a courtesy only, and is only performed if the unit is empty) For a detailed inspection, consult a qualified appliance contractor.
