PRO SPEX COMMERCIAL INSPECTION REPORT COPY

15503 Sample Report Rd
LAUREL MD 20707

Boo Bah Loo
JULY 10, 2018

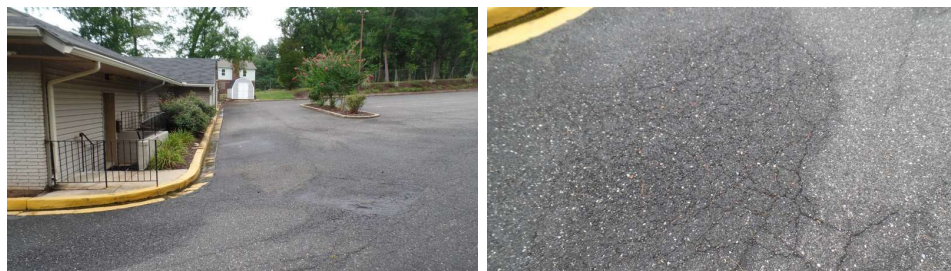
1.4.1 Paving, Curbing and Parking

PAVING GOOD

The * appears to be in satisfactory condition. With some minor exceptions of cracks in some surface areas typical of its age. Sealing the surface would extend its life.

Contact a qualified professional.

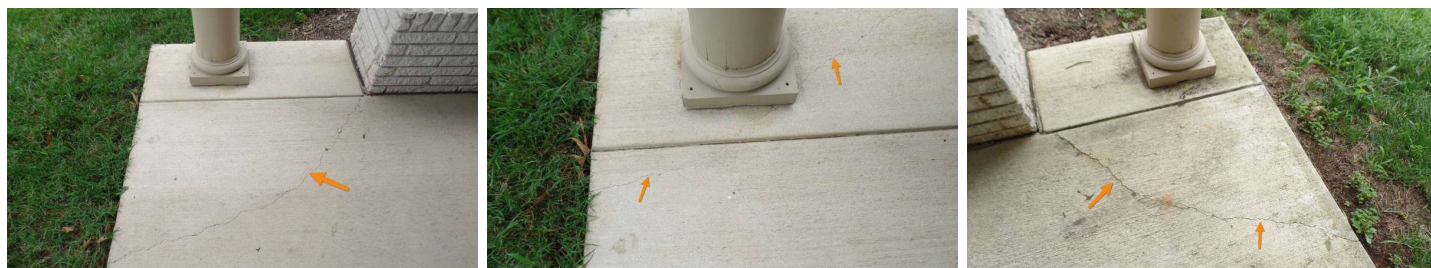
1.5.1 Flatwork (sidewalks, plazas, patios)

CRACKED, AND IS FAILING

Cracks have developed at the corners around the front columns.

Contact a qualified professional.

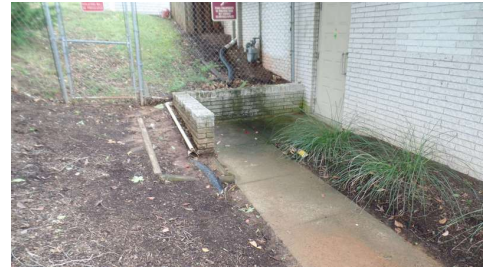
1.5.2 Flatwork (sidewalks, plazas, patios)

SHOWS SIGNS OF EROSION AND PROBLEM NEEDS TO BE ADDRESSED

Soil erosion towards the side emergency exit caused by excessive water discharging from the roof. This can result in icy conditions in winter.

Contact a qualified professional.

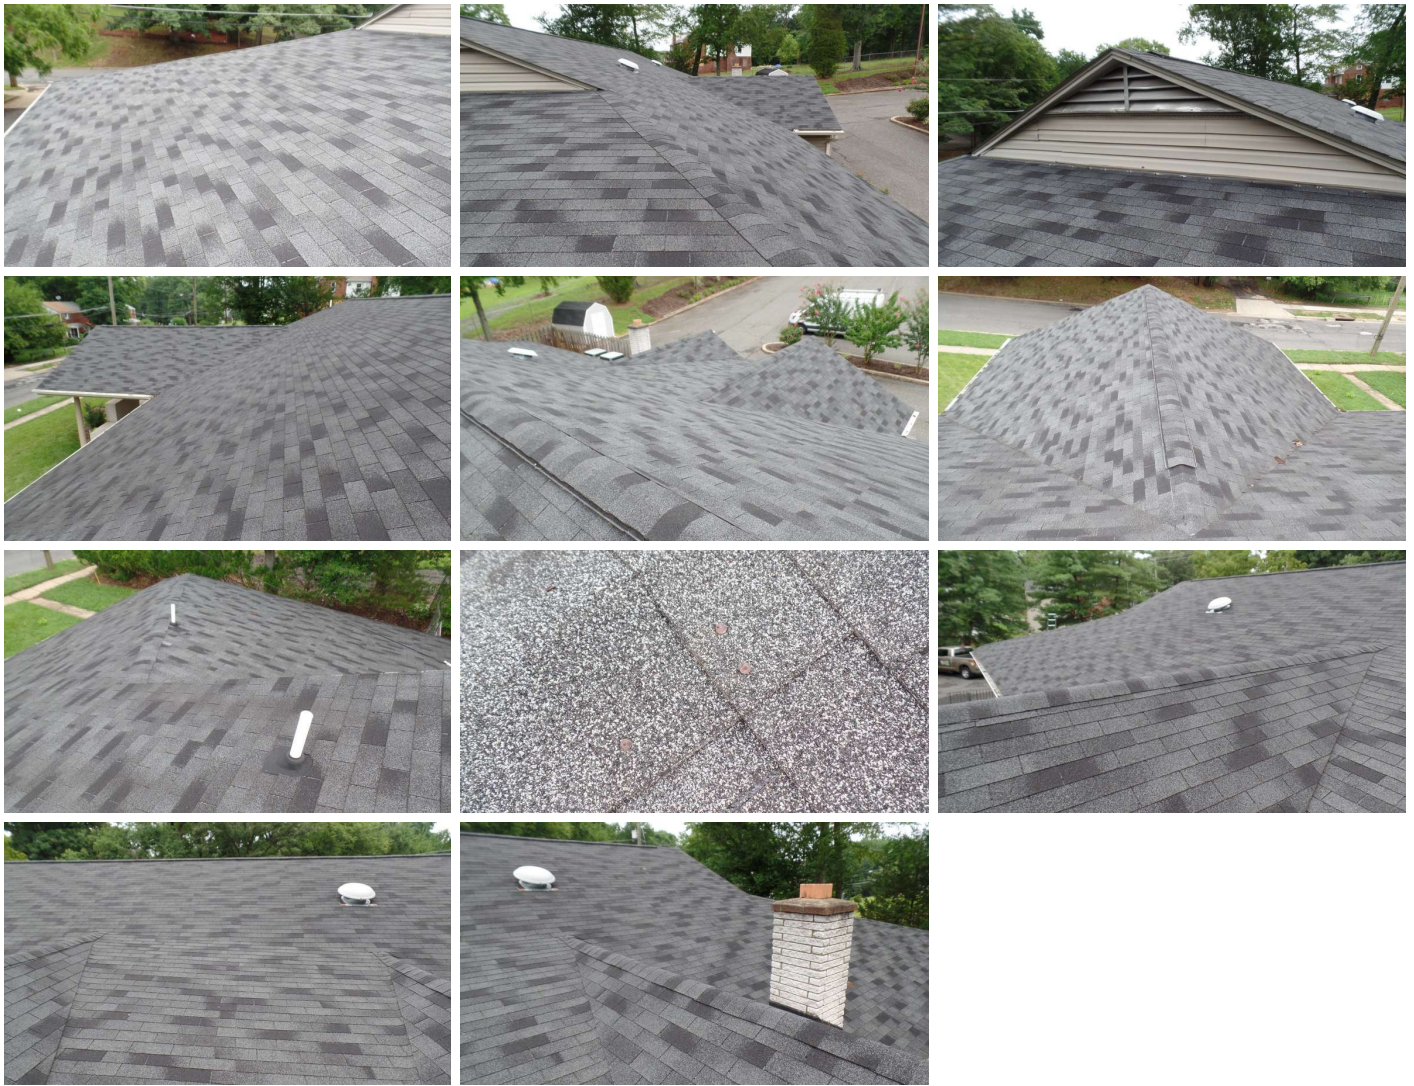
Roofing: Roof Photos

3.4.1 Roofing

LEAKING ROOF/FLASHING

There is a leak over the storage closet that hold the interior sump pump to the right of the emergency exit door. There were no visible signs of damage to the roof. Suspect the leak is related to the left gable vent flashing.

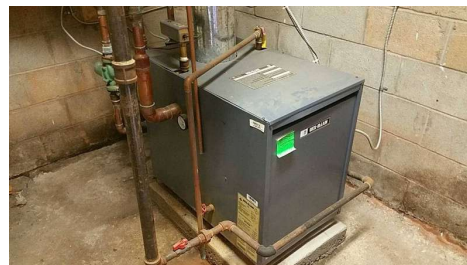
BOILER

The subject property has 3 air handlers, 3 compressors and one boiler. The 3 compressors are cooling only, dated 1992 and 1993. These systems are old and could fail at any time. The three air handlers are newer (2003). Heating is provided by a central boiler that feeds hot water to 3 external coils that sit on the supply line at the air handlers.

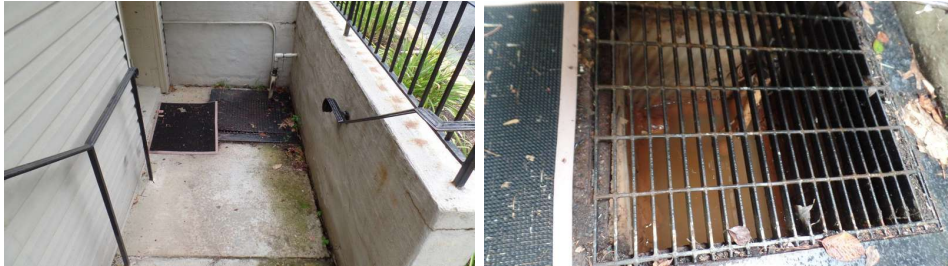
4.1.1 Plumbing water supply and Distribution and Fixtures

SUMP PUMP

There is a sump pump in the exterior stairwell. At the time of inspection, the pump was fully submerged, does not appear to be working.

Contact a qualified professional.

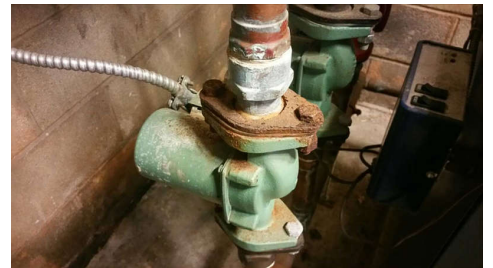
4.3.1 Heating Equipment

DETERIORATED

Is deteriorated

Contact a qualified professional.

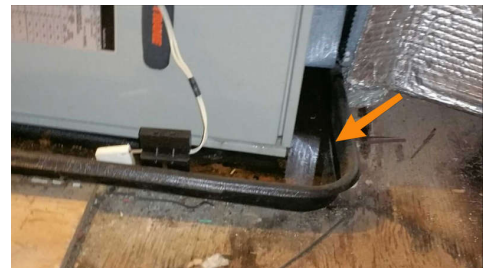
4.4.1 Air conditioning and Ventilation

LEAKING AT CONDENSATION LINE

Is leaking at condensation line

Contact a qualified professional.

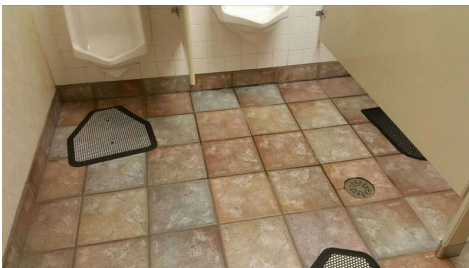
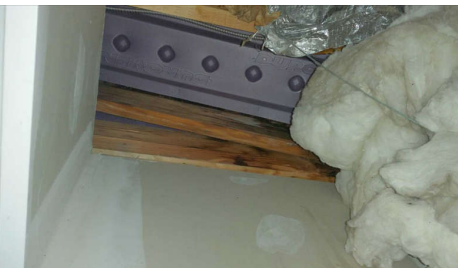
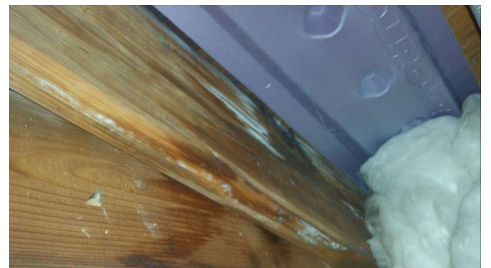
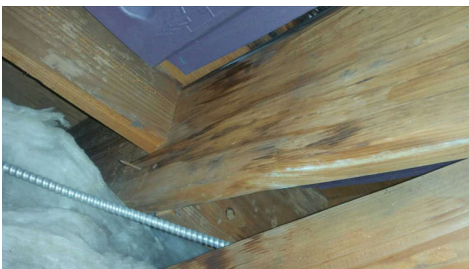
6.2.1 Ceiling, Walls, Floors

WATER IS ENTERING BEHIND COVERING AND NEEDS CORRECTING

Water is entering behind covering and needs correcting

Contact a qualified professional.
