HOME INSPECTION REPORT

3507 SW Alaska St #44
Seattle WA 98126

JANUARY 29, 2020

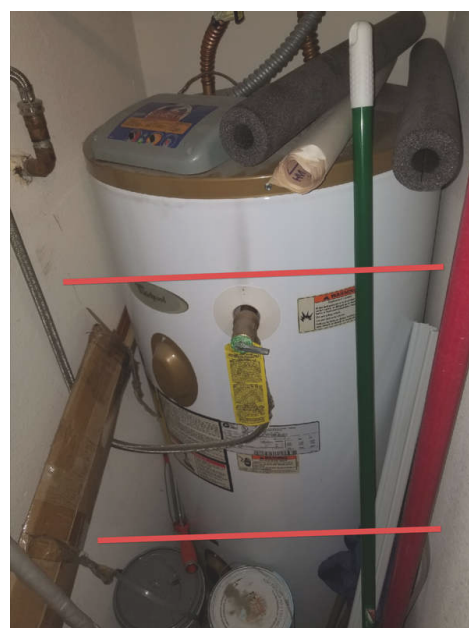
SEISMIC STRAPS - MISSING/INSUFFICIENT

The hot water heater was missing seismic straps or was insufficiently anchored. Recommend two straps to properly secure water heater in the case of an earthquake.

Contact a qualified professional.

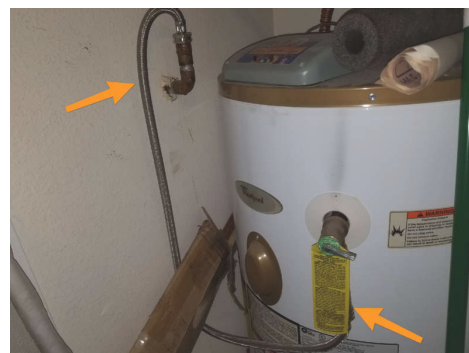
4.1.4 Water Heating System

DISCHARGE PIPE PLUMBED UPHILL

Contact a qualified plumbing contractor.

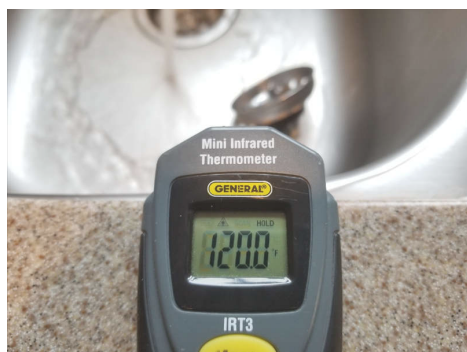
Sink and Faucet: Water temp

The Water temp at the Kitchen Faucet is Currently noted in the photo below. The U.S. Consumer Product Safety Commission (CPSC) urges all users to keep their water heater temps at 120 degrees Fahrenheit to prevent scalding and bacteria prevention reasons.

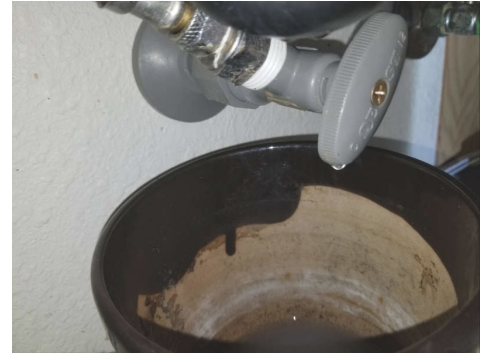
DRIP LEAK ON THE HOT WATER SHUT-OFF

There is a leak on the hot water shut-off valve below the kitchen sink, which should be evaluated and repaired as necessary by a qualified plumber.

Contact a qualified plumbing contractor.

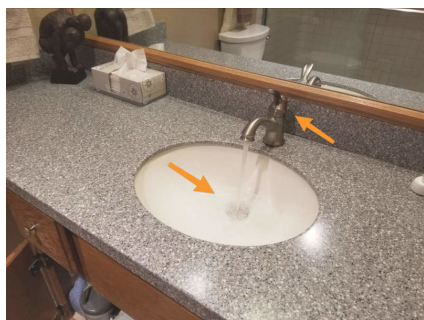
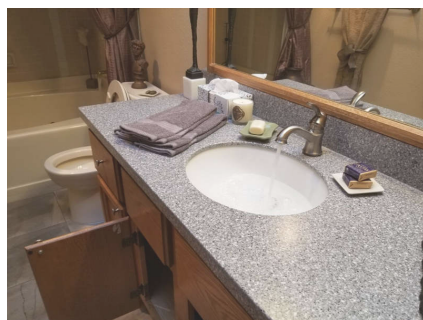
The sinkstopper does not work properly and repair is recommended.

Contact a qualified handyman.

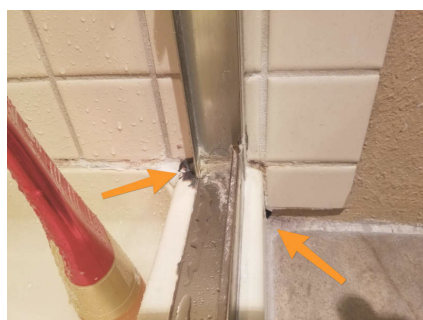
7.4.1 Tub-Shower

MISSING OR DETERIORATED CAULK/GROUT

The tub surround is has missing or deteriorated caulk/grout. Recommend caulking or sealing to prevent moisture intrusion.

Contact a qualified professional.

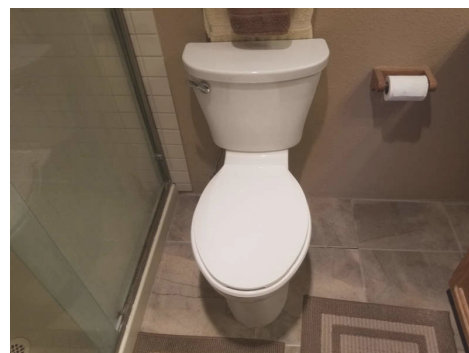
7.5.1 Toilet

FREE FLOWING/RUNS CONTINUOUSLY

The flush valve in the toilet tank does not seal closed, which causes the toilet to free-flow or run continuously, and should be further evaluated and serviced or replaced as necessary.

Contact a qualified handyman.

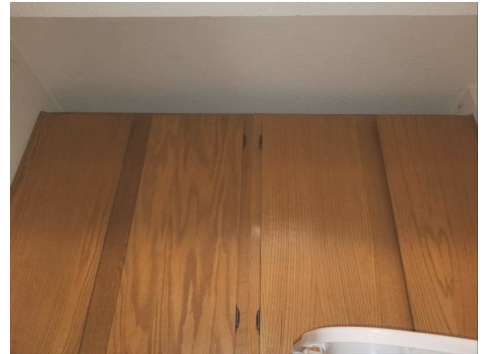
NO EXHAUST FAN OR OPENABLE WINDOW

There is not a laundry exhaust fan or openable window installed within this laundry room. Adding one is recommended and typically required to help disperse excessive moisture from the laundry room.

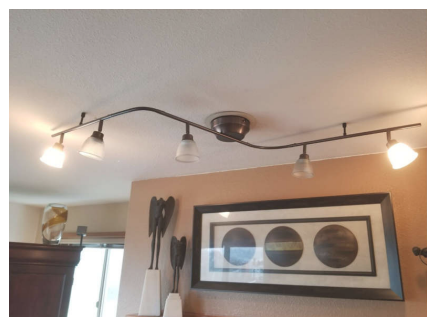
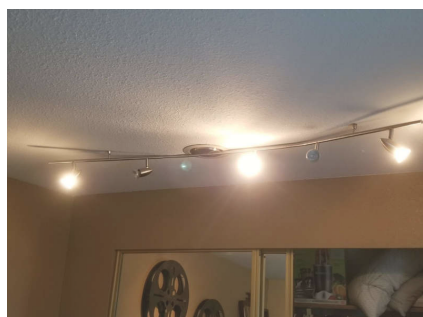
9.11.1 Lights, Wall Switches

LIGHT NOT WORKING

A light fixture did not have light bulbs or the bulbs were burnt out. Recommend replacing bulbs and testing.

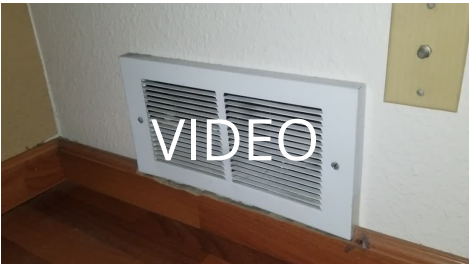
The heating unit was noisy. Recommend servicing for replacing as needed.

Recommendation
Contact a qualified professional.
