INTEGRITY HOME EVALUATION REPORT

174 Golden Cove Ln
Sparta TN 38583

Octavia Peete
FEBRUARY 26, 2021

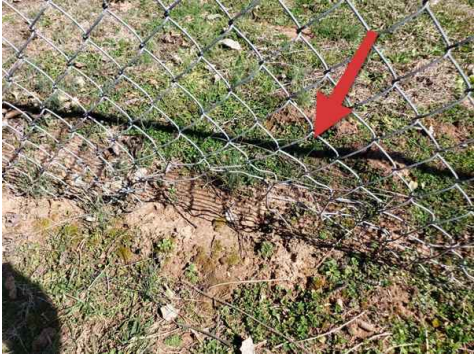
2.1.1 Gate/Fence

FENCE SECTIONS DAMAGED OR MISSING

BACK RIGHT

Some sections of the fence are damaged. I recommend further evaluation by a qualified fence installer

Contact a qualified fencing contractor

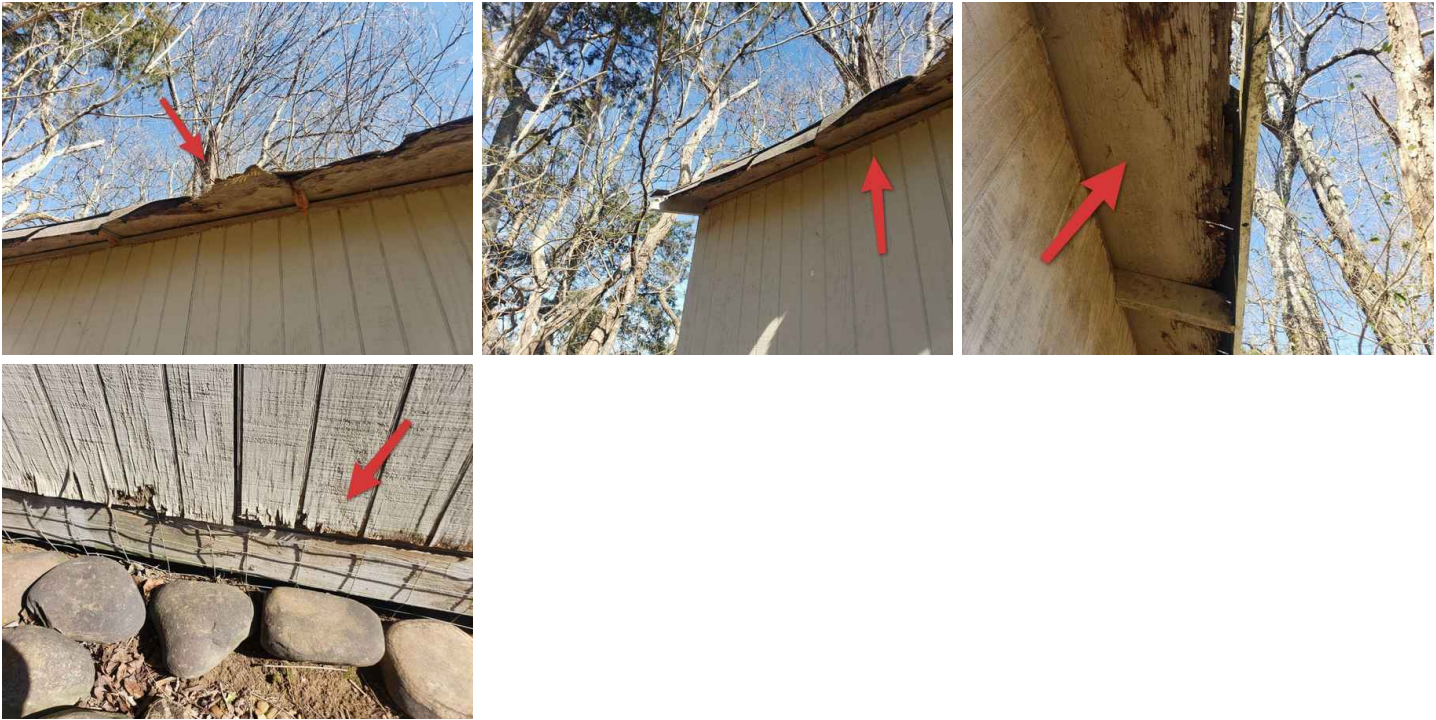
2.3.1 Shed/Outbuildings

ROTTING WOOD

BACK YARD

Rotting wood was noted at several locations around the outbuilding. I recommend further evaluation by a qualified carpenter or handyman.

Recommendation
Contact a handyman or DIY project

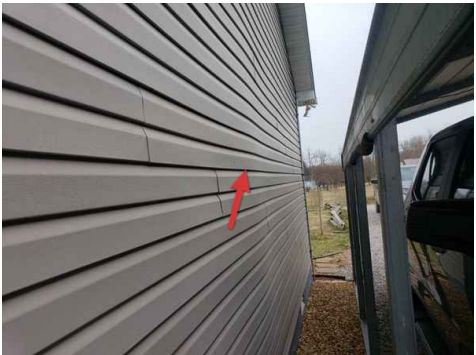
2.4.1 Siding, Flashing & Trim
WARPING/BUCKLING
NEAR CARPORT

Vinyl siding was warping or buckling in areas. This is often as a result of nailing siding boards too tight to the home, preventing expansion/contraction. I recommend a qualified siding contractor evaluate and repair.

Recommendation
Contact a qualified siding specialist.

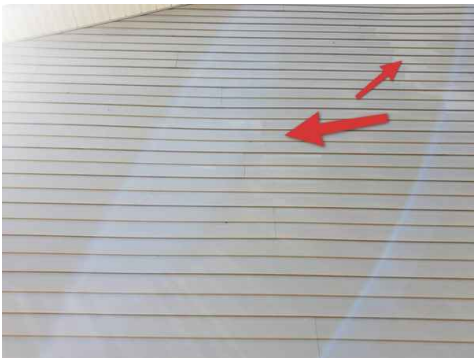
2.4.2 Siding, Flashing & Trim
DISCOLORATION
VARIOUS LOCATIONS

The siding appeared to be discolored in a few areas. This is likely due to UV rays and pressure washing.

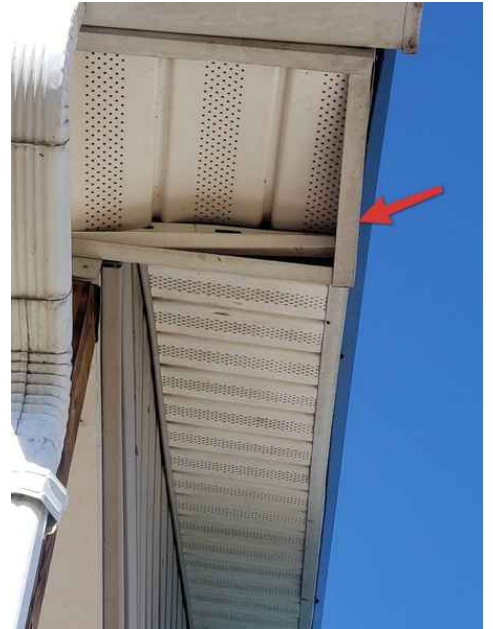
2.5.1 Eaves, Soffits & Fascia
GAP
FRONT PORCH AREA

There is opening, gap or hole in fascia / soffit which should be repaired. This can allow water intrusion and rodent infestation as well as deterioration of the surrounding material.

Contact a qualified siding specialist.

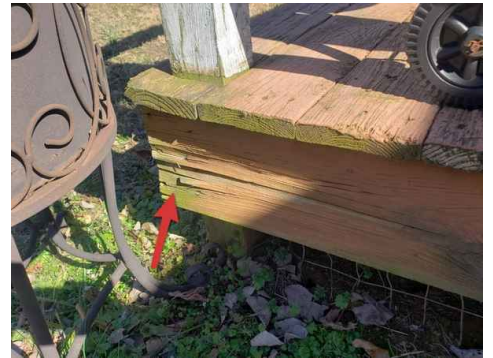
2.6.1 Decks, Balconies, Porches & Steps

DECK - ROTTED BOARDS

BACK DECK

One or more deck boards are showing signs of rot. I recommend a qualified deck contractor do repairs.

Contact a qualified deck contractor.

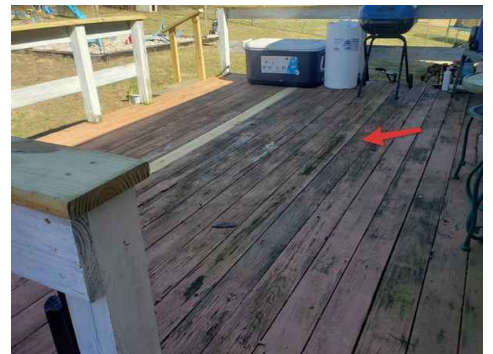
2.6.2 Decks, Balconies, Porches & Steps

DECK - WATER SEALANT REQUIRED

BACK DECK

Deck is showing signs of weathering and/or water damage. Recommend water sealant/weatherproofing be applied.

Recommended DIY Project

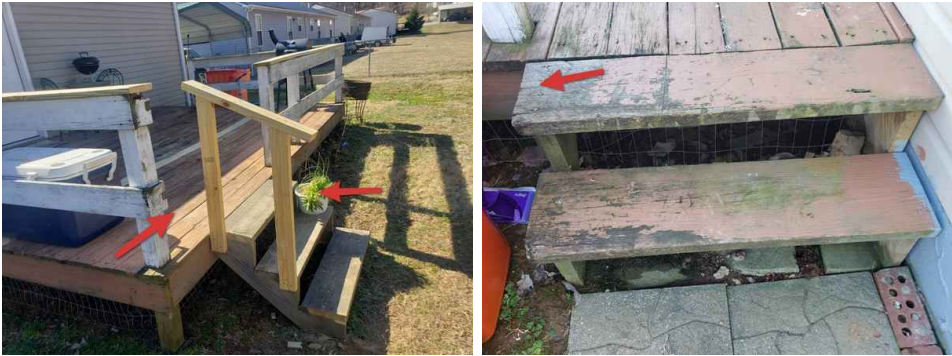
2.6.3 Decks, Balconies, Porches & Steps

RAILING UNSAFE

BACK DECK

The step railing on the back deck is unsafe or missing. I recommend a qualified deck contractor repair or replace.

Contact a qualified deck contractor.

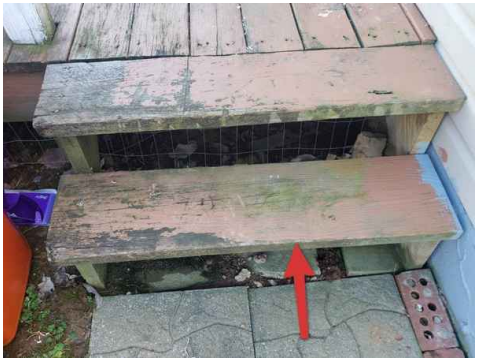
2.6.4 Decks, Balconies, Porches & Steps

TALL STEPS

BACK DECK

The steps on the back deck are very tall, which creates a serious trip hazard. I recommend repair or replacement by a qualified deck contractor.

Contact a qualified deck contractor.

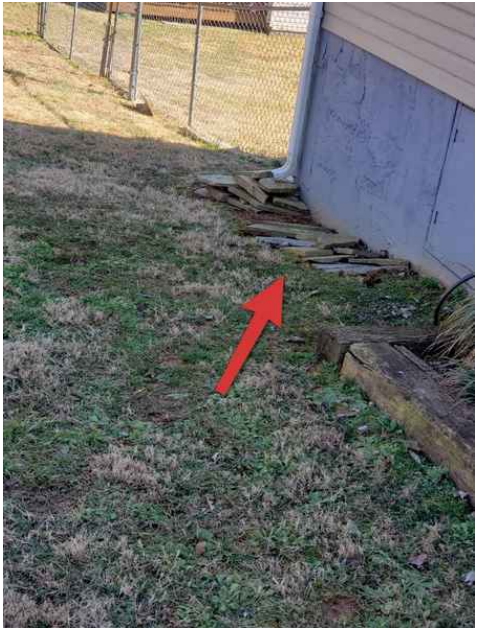
2.7.1 Vegetation, Grading, Drainage & Retaining Walls

NEGATIVE GRADING

BACK YARD

Grading is sloping towards the home in some areas. This could lead to water intrusion and foundation issues. Recommend qualified landscaper or foundation contractor regrade so water flows away from home.

Contact a qualified landscaping contractor

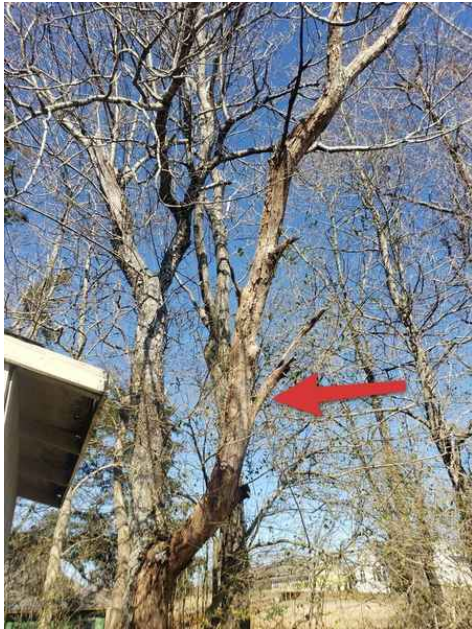
2.7.2 Vegetation, Grading, Drainage & Retaining Walls

TREE OVERHANG

BACK YARD

Damaged Trees were observed overhanging the roof of the shed. This can cause damage to the roof or personal injury if they fall. I recommend immediate removal.

Contact a qualified tree service company.

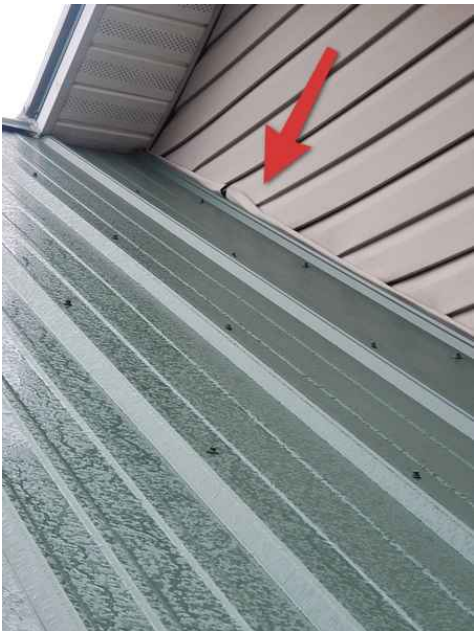
3.1.2 Coverings

QUESTIONABLE FLASHING

FRONT OF HOUSE

The metal roof does not appear to be flashed correctly along the walls. I recommend further evaluation by a qualified roofer.

Recommendation
Contact a qualified roofing professional.

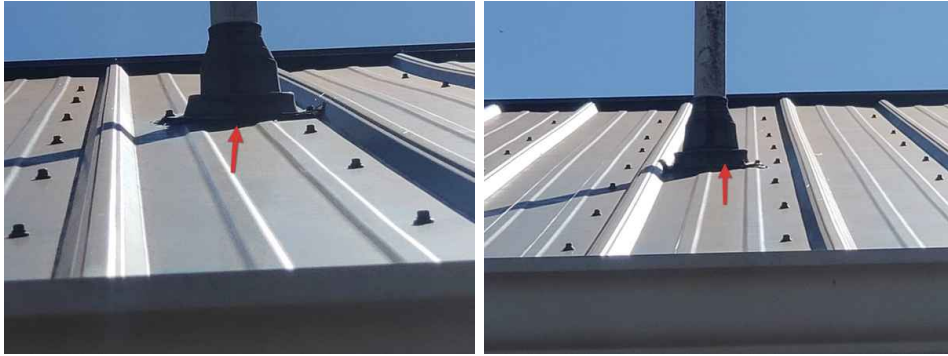
3.2.1 Flashings

SEALANT DETERIORATED

BACK OF HOUSE

The sealant around the vent flashings appears to be deteriorated. I recommend further evaluation by a qualified roofer.

Contact a qualified roofing professional.

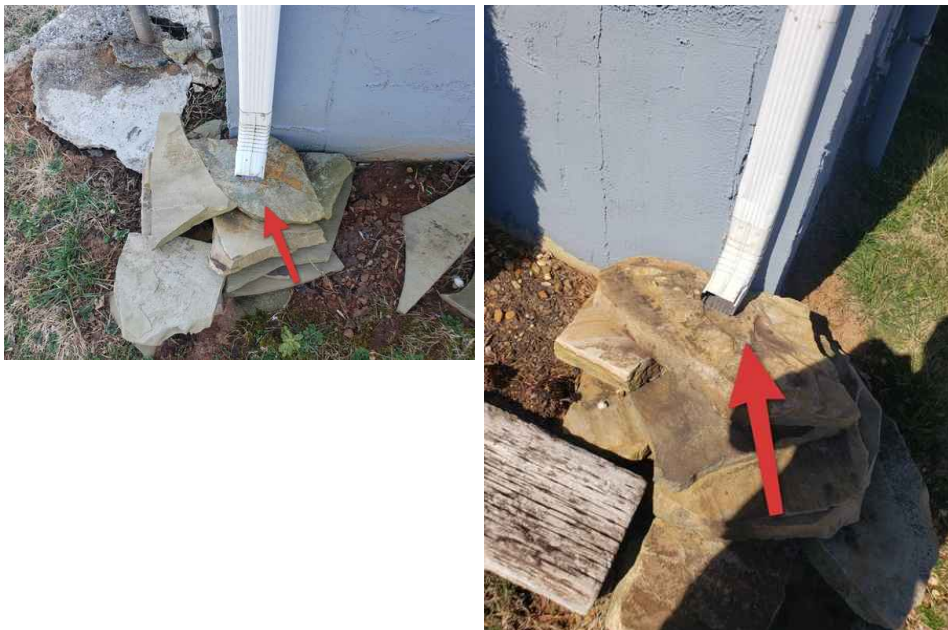
3.3.1 Roof Drainage Systems

DOWNSPOUTS DRAIN NEAR HOUSE

CORNERS OF HOUSE

One or more downspouts drain too close to the home's foundation. This can result in excessive moisture in the soil at the foundation, which can lead to foundation/structural movement. I recommend a qualified contractor adjust downspout extensions to drain at least 6 feet from the foundation.

Contact a qualified gutter contractor

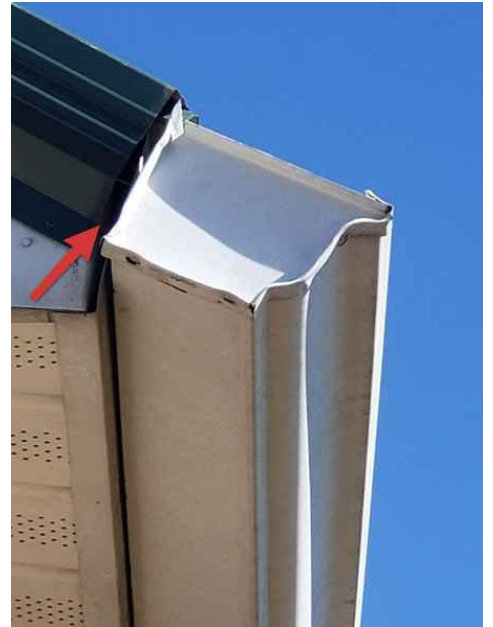
3.3.2 Roof Drainage Systems

GUTTER LOOSE

FRONT OF HOUSE

The gutter appears to be loose and needs to be re-fastened to fascia and pitched properly.

Contact a qualified handyman.

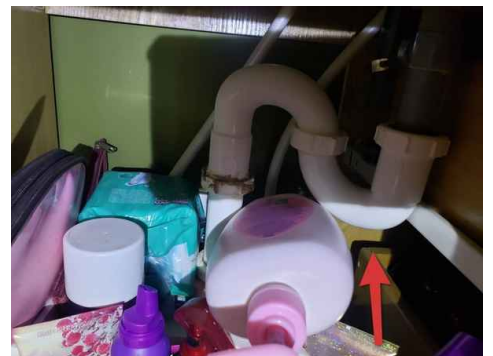
5.4.1 Sink

S TRAP

UNDER SINK

There is an S-trap under the sink. It is possible that an S-trap can siphon the water seal out, allowing odors and gas into the bathroom.

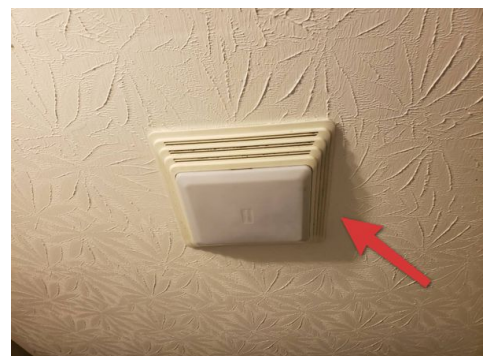
5.9.1 Lighting Fixtures, Switches & Receptacles

VENT FAN

BATHROOM CEILING

The bathroom vent fan appears to terminate in the attic. This can lead to moisture issues in the attic space. I recommend venting it to the outside of the house.

Contact a qualified handyman.

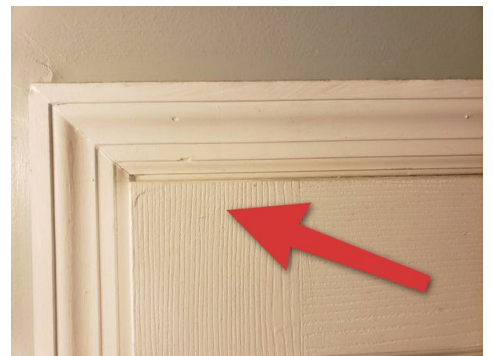
6.2.1 Doors

DOOR STICKS

BATHROOM DOOR

The door is sticking and is difficult to close. I recommend further evaluation by a qualified carpenter.

Contact a qualified handyman.

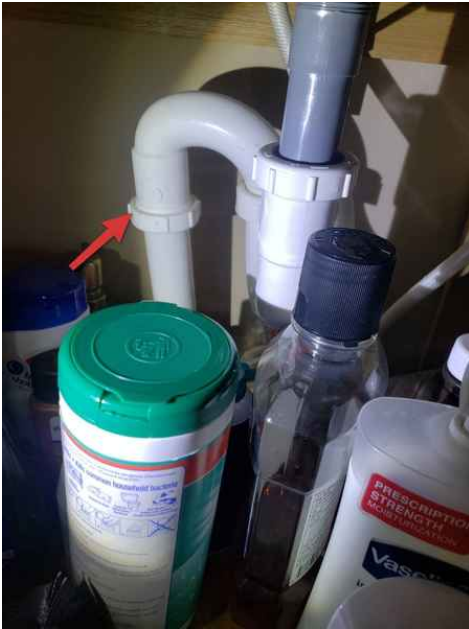
6.4.1 Sink

P TRAP INSTALLED

UNDER SINK

There is an S-trap under the sink. It is possible that an S-trap can siphon the water seal out, allowing odors and gas into the bathroom.

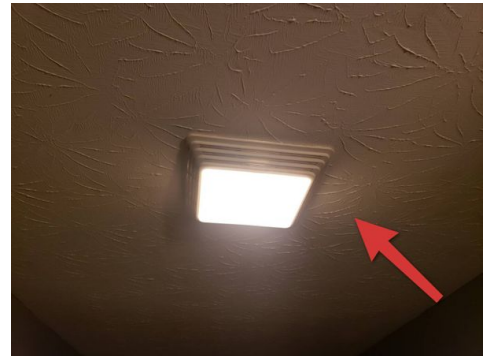
6.9.1 Lighting Fixtures, Switches & Receptacles

FAN

BATHROOM CEILING

The bathroom vent fan appears to terminate in the attic. This can lead to moisture issues in the attic space. I recommend venting it to the outside of the house.

Contact a qualified handyman.

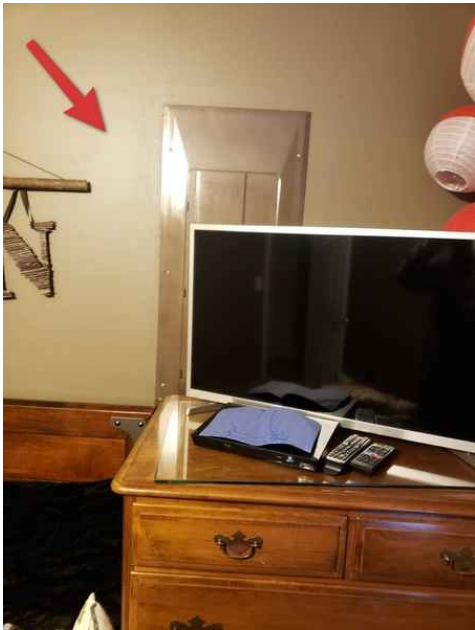
GFCI & AFCI
ELECTRICAL PANEL INACCESSIBLE
FRONT RIGHT BEDROOM
The electrical panel blocked by furniture and inaccessible.

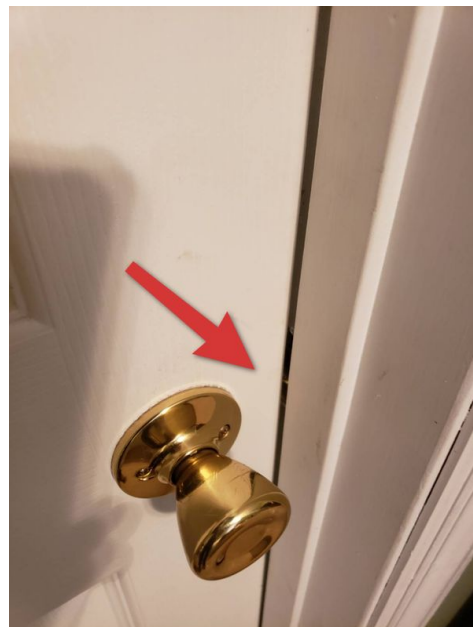
7.1.1 Doors

DOOR DOESN'T LATCH

CLOSET DOOR

Door doesn't latch properly. I recommend handyman repair latch and/or strike plate.

Contact a qualified handyman.

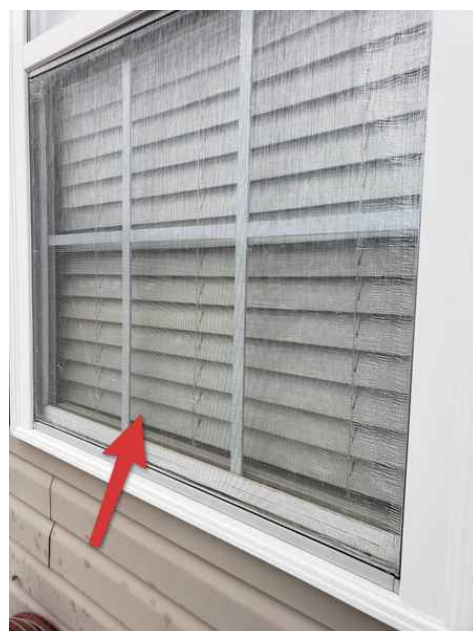
7.2.1 Windows

SCREEN DETERIORATED

ALL WINDOWS

The window screens are deteriorated. I recommend replacement.

Contact a handyman or DIY project

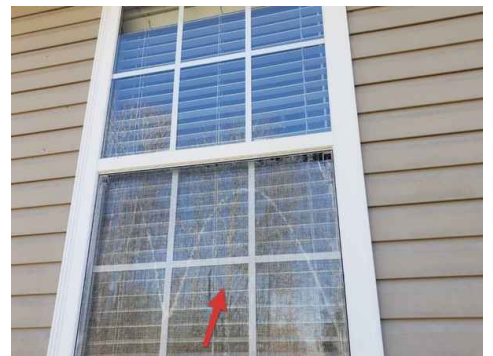
8.2.1 Windows

SCREEN DETERIORATED

RIGHT REAR

The window screens are deteriorated. I recommend replacement.

Contact a qualified handyman.

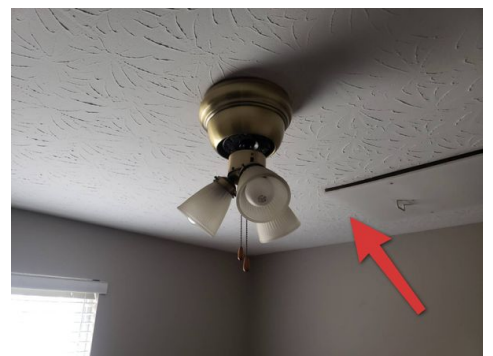
8.6.1 Lighting Fixtures, Switches & Receptacles

CEILING FAN BLADES MISSING

BEDROOM CEILING

There were no blades on the ceiling fan. I recommend replacement.

Contact a qualified handyman.

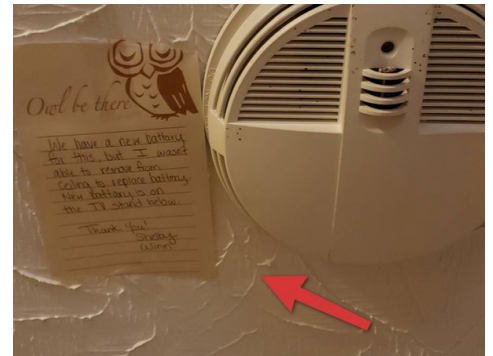
8.8.1 Smoke Detectors

LOW BATTERY

Smoke detector failed to respond when tested. Recommend battery be replaced.

Recommended DIY Project

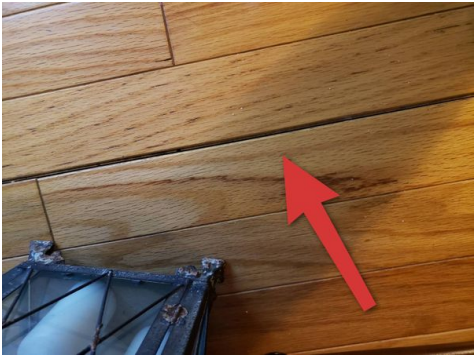
The hardwood is separated near the kitchen/hallway area. I recommend further evaluation by a qualified flooring installer.

Recommendation
Contact a qualified professional.

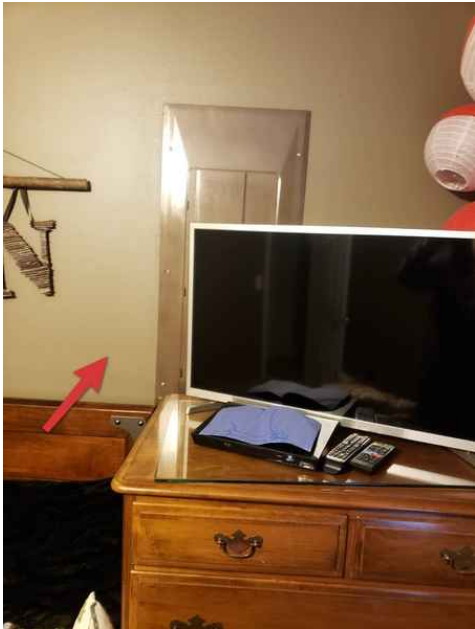
RIGHT FRONT BEDROOM

The electrical panel was blocked by furniture. I was not able to access it.

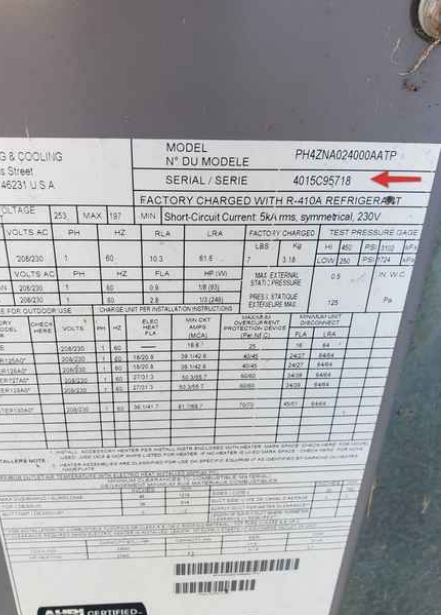
The date code on the heat pump indicates that it was manufactured in 2015.

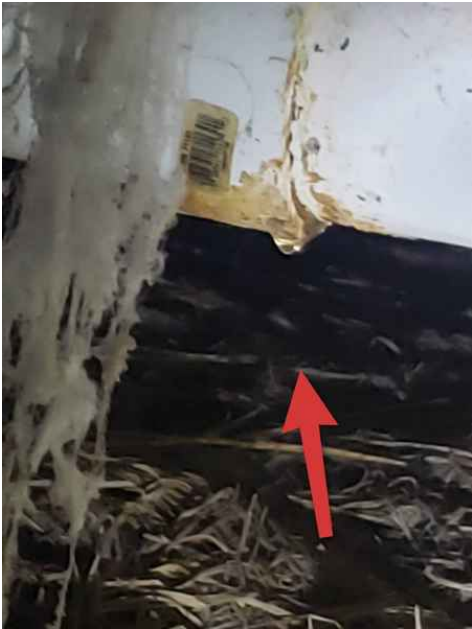
LEAKING PIPE

A drain, waste and/or vent pipe showed signs of a leak. I recommend a qualified plumber evaluate and repair.

Contact a qualified plumbing contractor.

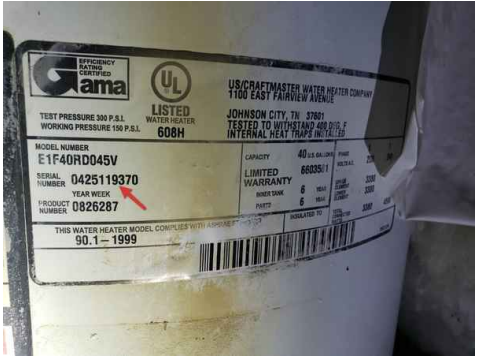
14.7.1 Hot Water Systems, Controls, Flues & Vents

Water heater showed normal signs of wear and tear. It is 17 years old. I recommend monitoring it's effectiveness and replacing in the near future.

Contact a qualified plumbing contractor.

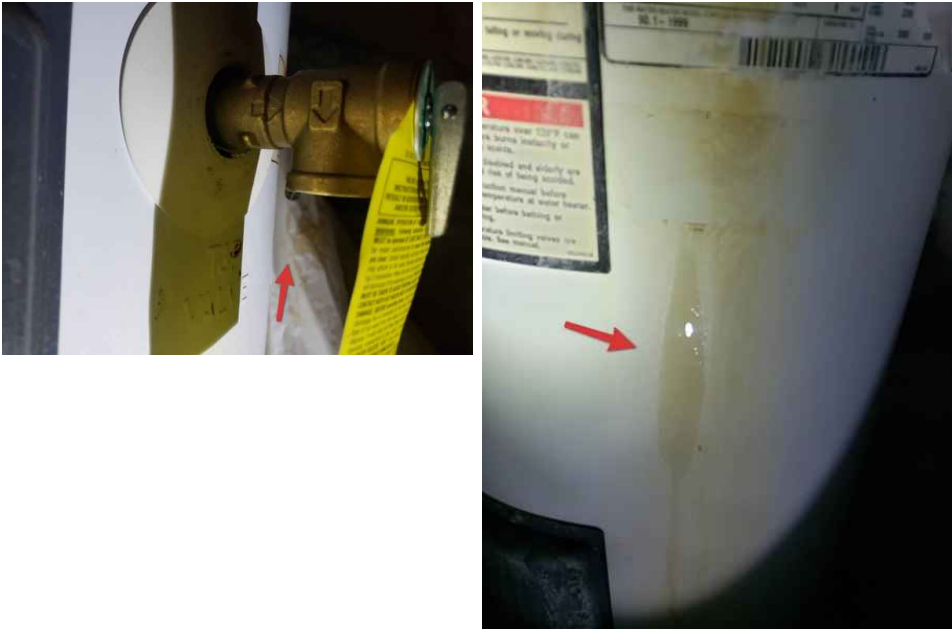
14.7.2 Hot Water Systems, Controls, Flues & Vents

TPR VALVE LEAKING

The TPR valve is leaking and there is no TPR valve piping installed. I recommend immediate replacement by a qualified plumber.

Contact a qualified professional.

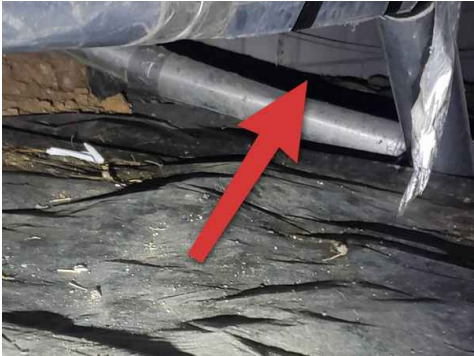
14.8.1 Dryer Vent
DISCONNECTED
UNDER LAUNDRY AREA

The dryer vent is disconnected under the house. There is a large amount of lint collected under the house. I recommend immediate repair by a qualified handyman.

Recommendation
Contact a qualified handyman.

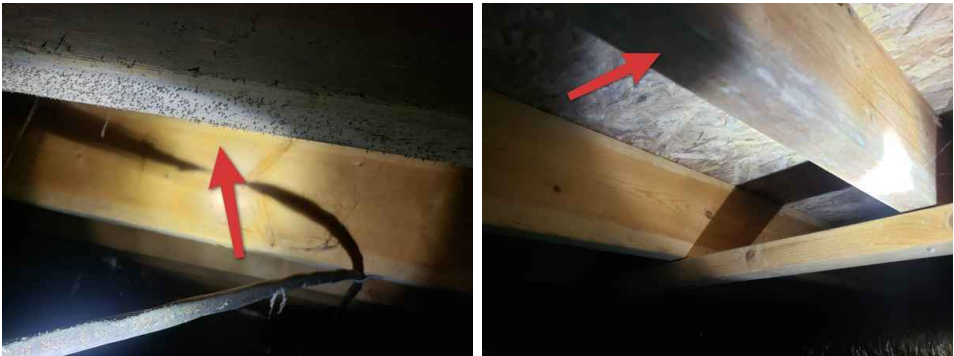
There is a moderate amount of mold in the crawlspace. I recommend further evaluation by a qualified mold expert.

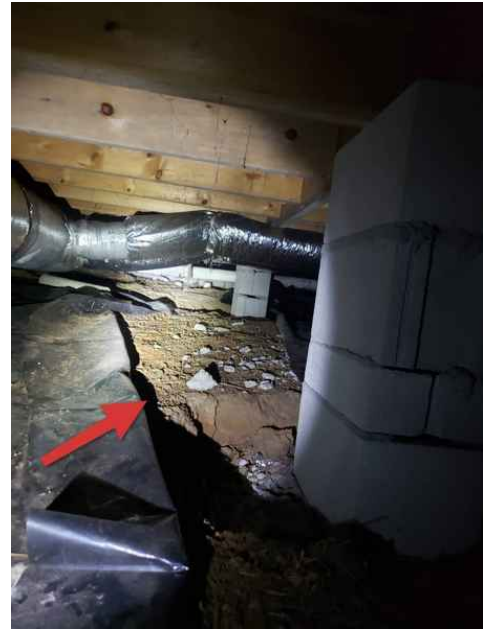
15.2.1 Vapor Retarders (Crawlspace or Basement)

VAPOR BARRIER DAMAGED

Vapor barrier is damaged in one or more areas. I recommend insulation contractor repair or replace.

Contact a qualified insulation contractor.

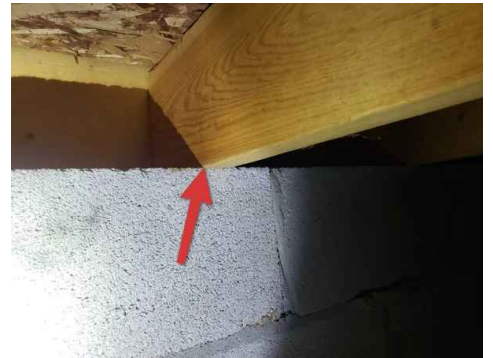
15.3.1 Floor Structure

NO SILL PLATE

The floor joists are resting directly on the cinderblock foundation. There is no sill plate. I recommend further evaluation by a qualified foundation expert.

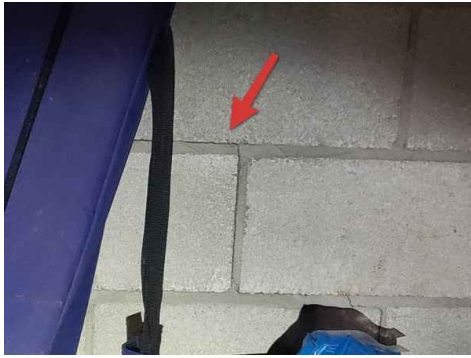
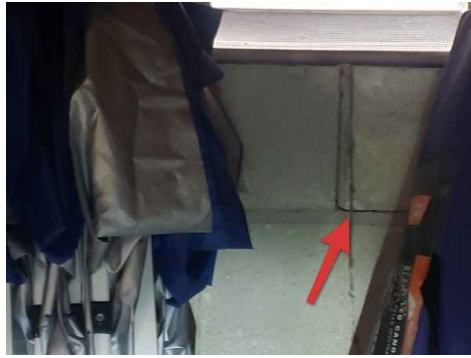
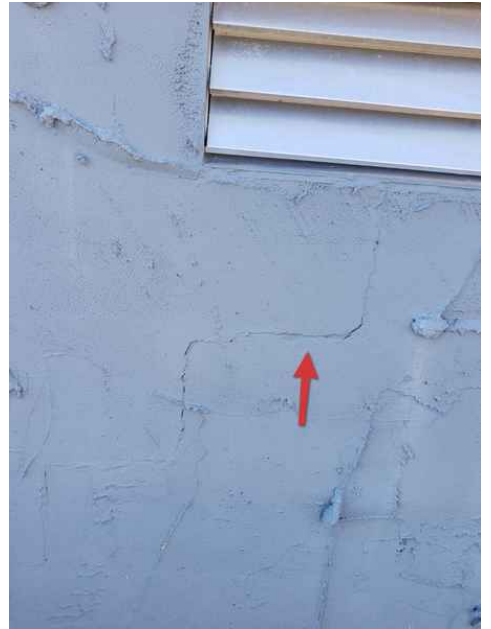
15.4.1 Foundation

FOUNDATION CRACKS - MINOR

Minor cracking was noted at the foundation. This is common as concrete ages and shrinkage surface cracks are normal. Recommend monitoring for more serious shifting/displacement.
