TAYLORED INSPECTION

## RESIDENTIAL REPORT

1755 N 200 E  
Logan UT 84341

MARCH 13, 2019

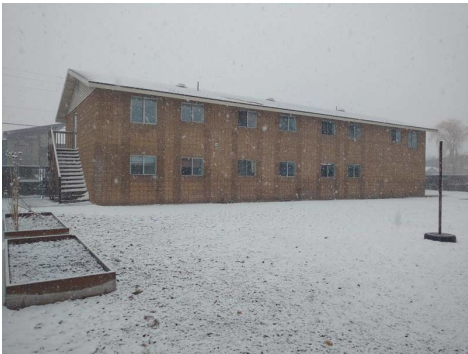
**SNOW ON ROOF**

Snow on the roof prevented the roof from being walked on.

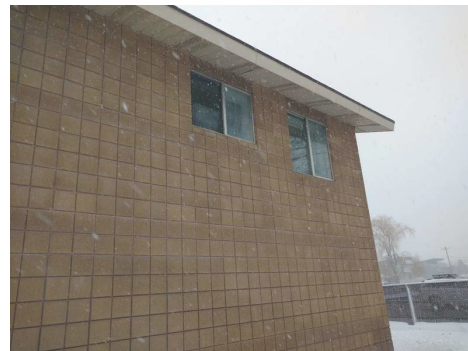
2.2.1 Roof Drainage Systems

**DOWNSPOUTS MISSING**

The building was missing downspouts in one or more areas. This can result in excessive moisture in the soil at the foundation, which can lead to foundation/structural movement. Recommend a qualified contractor install downspout extensions that drain at least 6 feet from the foundation.

Contact a qualified professional.

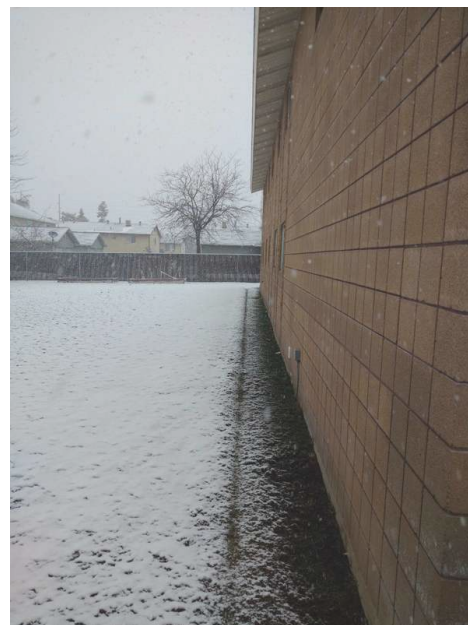
### 2.2.2 Roof Drainage Systems

#### **GUTTERS MISSING**

There are no gutters present on the structure. Gutters are recommended because they collect rain water from the roof and direct it away from the building.

Contact a qualified professional.

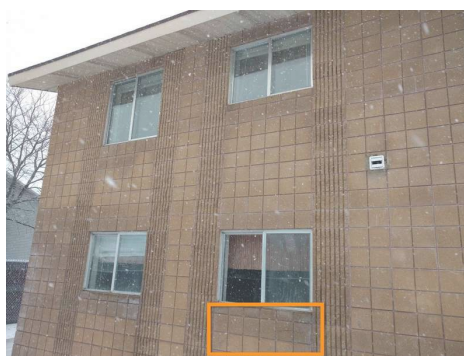
### 3.1.1 Siding, Flashing & Trim

#### CRACKING - MINOR

Siding showed cracking in one or more places. This is a result of temperature changes and freezing water that enters the masonry, and typical as structures age. Recommend monitoring.

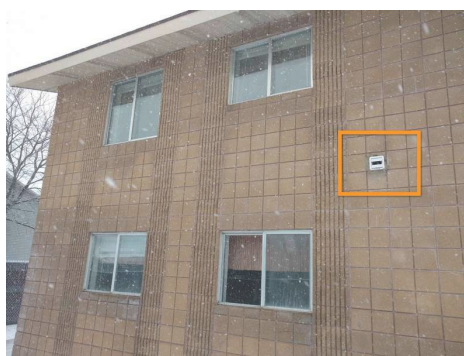
### 3.1.2 Siding, Flashing & Trim

#### VENT DAMAGE

Vent cover damage was observed. Vent covers should be replaced to help limit moisture intrusion, unwanted airflow and pest entry.

Contact a qualified professional.

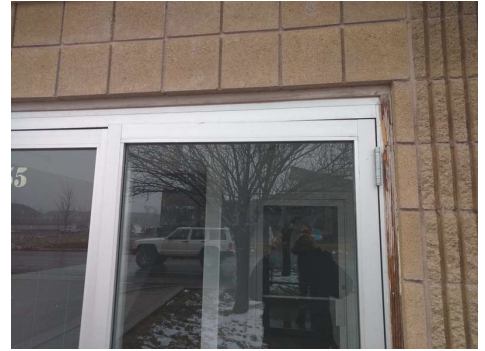
### 3.2.1 Exterior Doors

#### DOOR DOES NOT CLOSE OR LATCH

On the main entrance, the north door does not close properly. Recommend qualified handyman adjust door to close properly.

Contact a qualified professional.

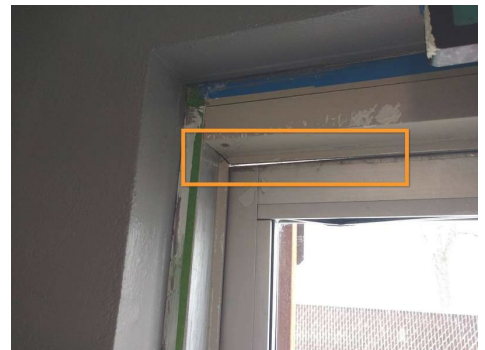
### 3.2.3 Exterior Doors

#### WEATHERSTRIPPING NOT PRESENT

Door is missing standard weatherstripping. This can result in significant energy loss and moisture intrusion. Recommend installation of standard weatherstripping.

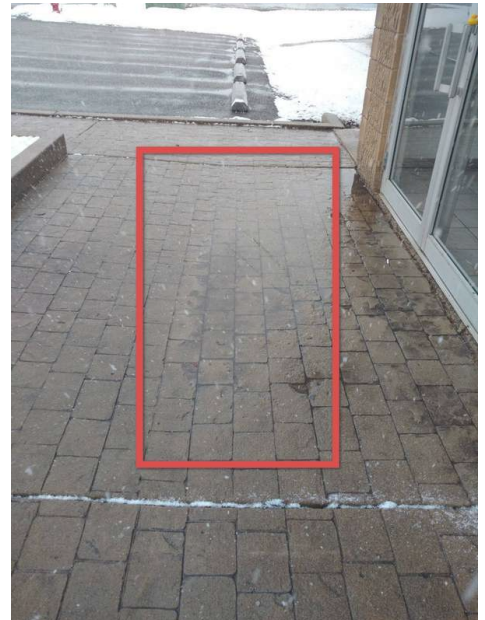
### 3.3.1 Walkways, Patios & Driveways

#### PONDING ON WALKWAY

Ponding (puddle formation) was observed in front of the main entrance. Accumulated water that freezes could pose a safety hazard.

Contact a qualified professional.

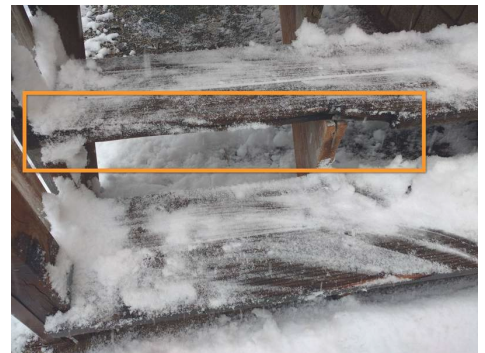
## 3.4.1 Decks, Balconies, Porches &amp; Steps

**STAIRS - DETERIORATED**

One sections of the exterior stairs is deteriorated. Second stair from the bottom. Recommend qualified contractor evaluate & repair.

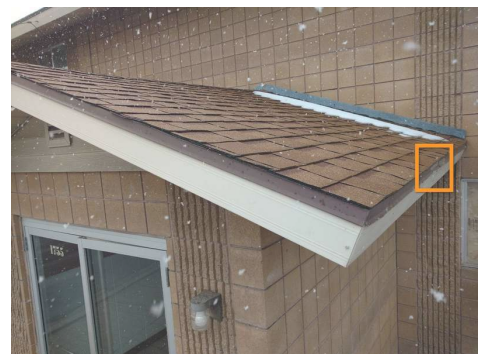
## 3.5.1 Eaves, Soffits &amp; Fascia

**PAINT/FINISH FAILING**

The paint or finish is failing. This can lead to deterioration and rot of the material. Recommend that the areas be properly prepared and painted / finished.

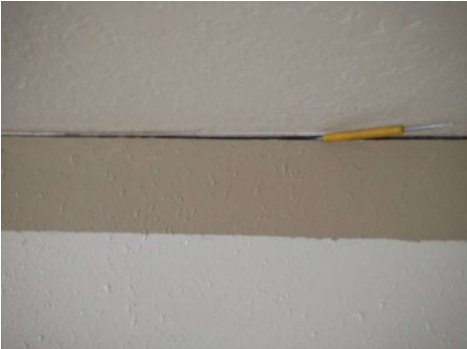
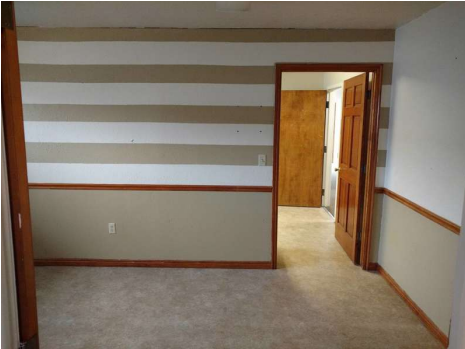
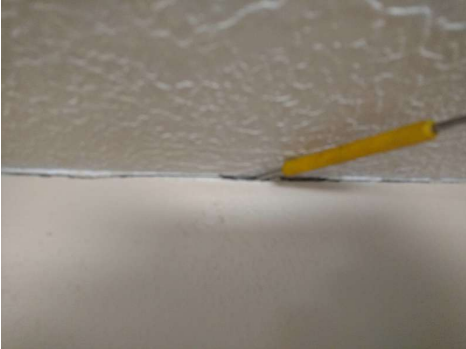
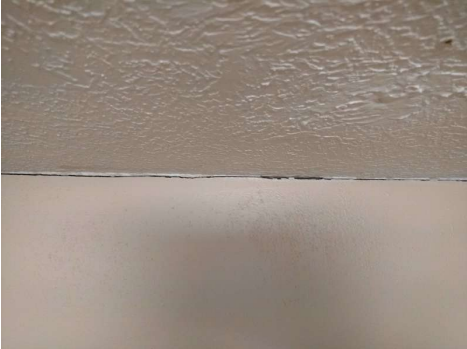
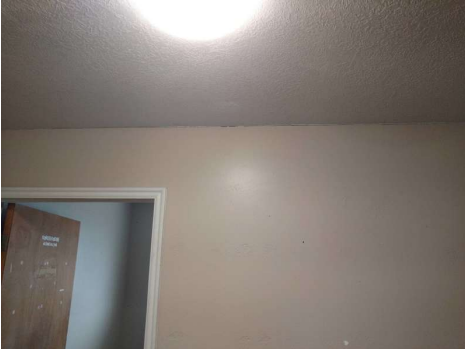
4.5.1 Ceiling Structure

### TRUSS UPLIFT

Due to temperature and humidity changes in the winter, trusses expand and contract which can cause the bottom of the truss (ceiling) to bow up in the middle and lift off of the top of the interior walls. This is not a structural issue, just a cosmetic issue.

Contact a qualified professional.

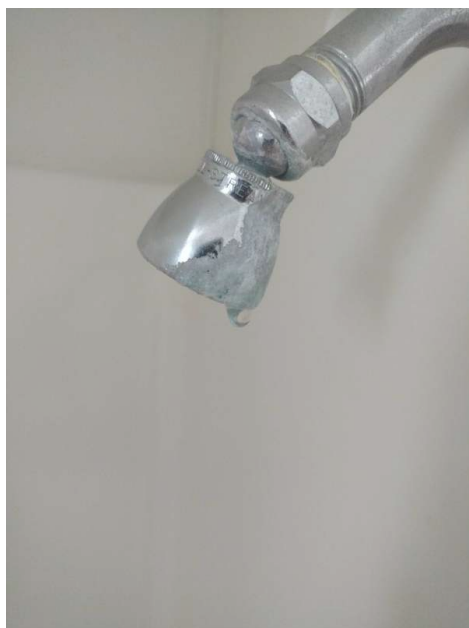
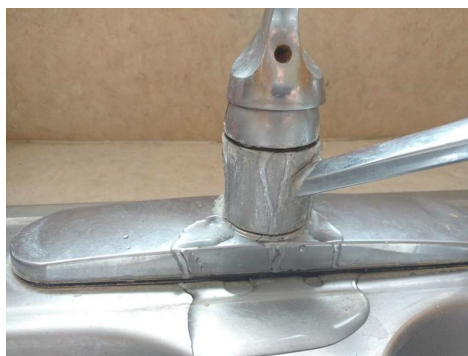
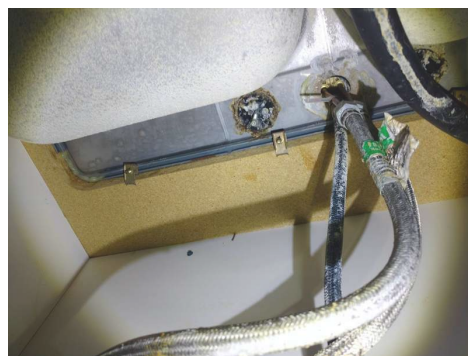
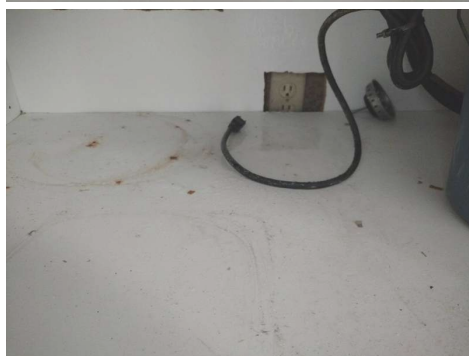
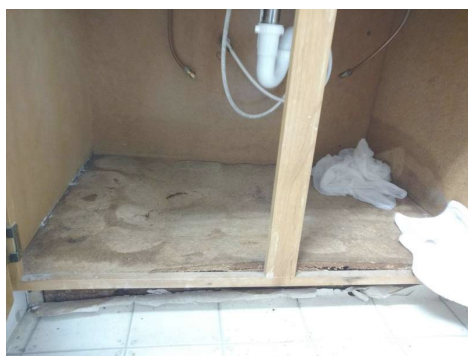
Leaking fixtures were observed. The shower in the north bathroom on the first floor is leaking and is missing the handle to turn on the water. The first floor kitchen faucet leaks when turned on and drips in the cabinet underneath the sink.

North bathroom on the second floor shows signs of water damage. No leaks were observed during the inspection.

Contact a qualified professional.

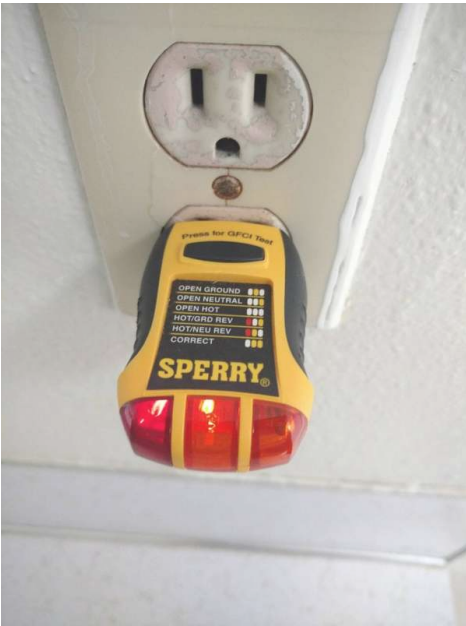
**REVERSE POLARITY**

One or more receptacles have been wired with reverse polarity. This can create a shock hazard. Recommend licensed electrician evaluate & repair.

First Floor North Bathroom

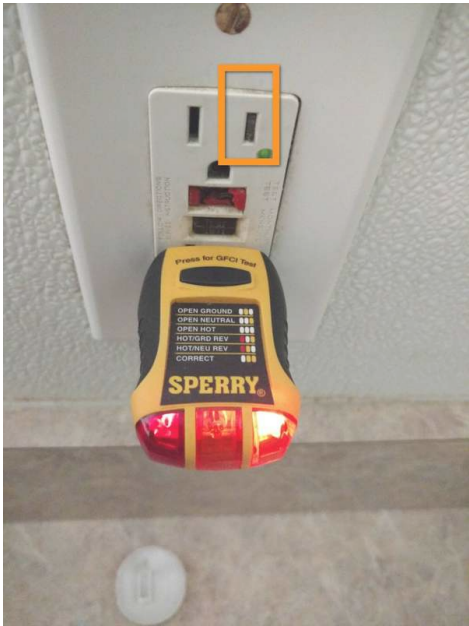
First Floor South Bathroom Top right outlet slot is blocked by a piece of an outlet protector that broke off inside. GFCI Test/Reset button broken.

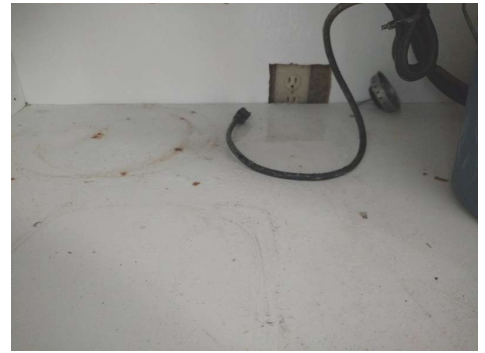
**UNSAFE RECEPTACLE LOCATION**

FIRST FLOOR KITCHEN, UNDER THE SINK

In the first floor kitchen, under the sink is an outlet that is at the level of the cabinet floor. Water leaking from the sink could pour into the receptacle creating a potentially dangerous situation.

Contact a qualified electrical contractor.

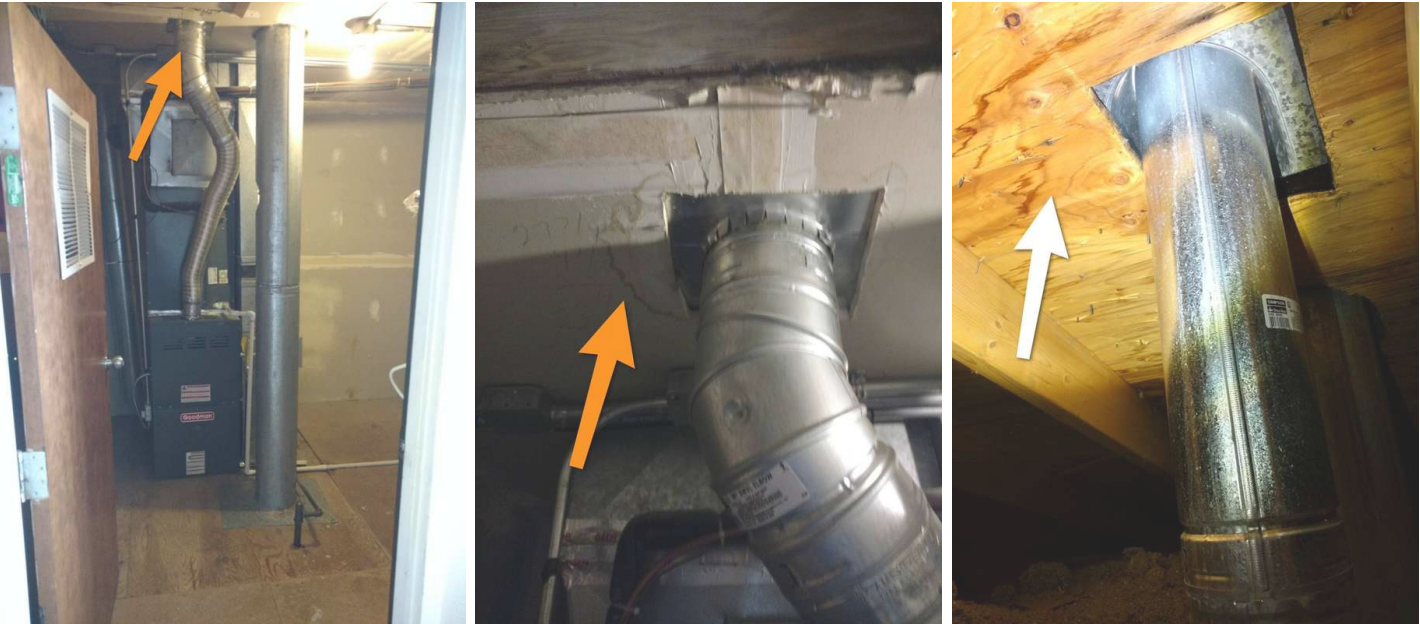
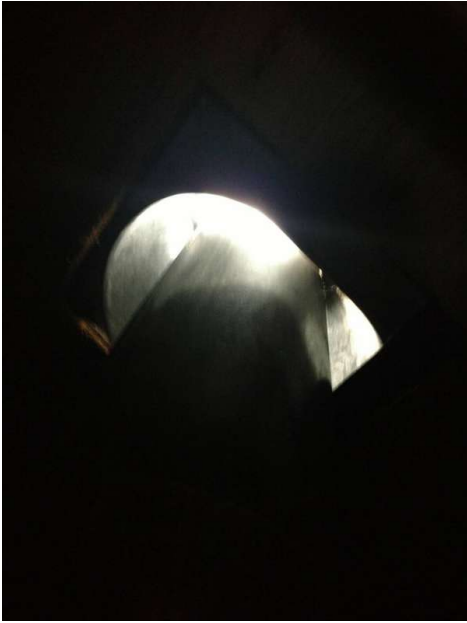
SIGNS OF WATER ON FURNACE EXHAUST VENT

Signs of moisture intrusion were observed on the furnace exhaust vent. Snow was falling and melting on the roof at the time of inspection and not moisture was detected.

Daylight coming in from around vent pipe.

Recommendation  
Contact a qualified professional.

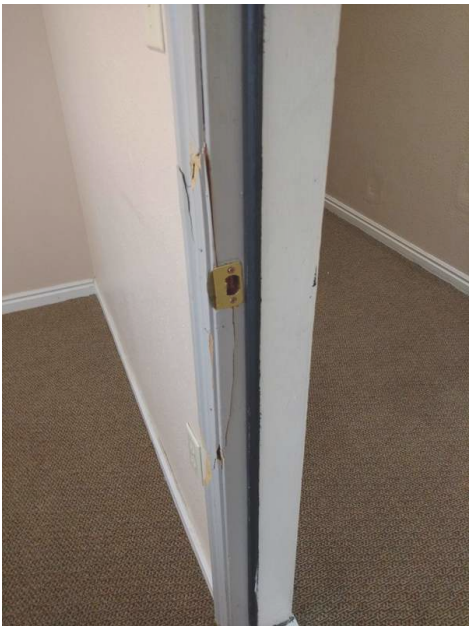
Signs of forced entry were observed on door frame in north east office on second floor.

Recommendation  
Contact a qualified professional.

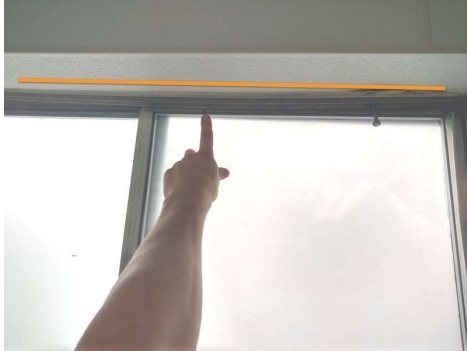
Top of window frame has bowed down in the first floor south bathroom.

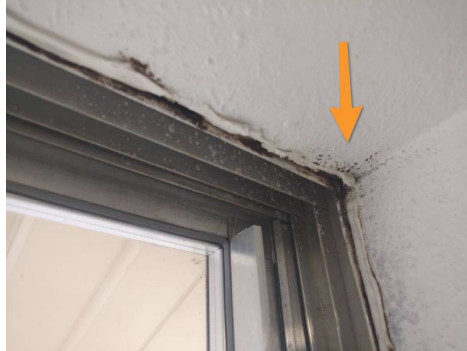
Mold observed around the window in the south bathroom on the second floor. Installing ventilation fans helps mitigate the risk of mold growth in bathrooms.

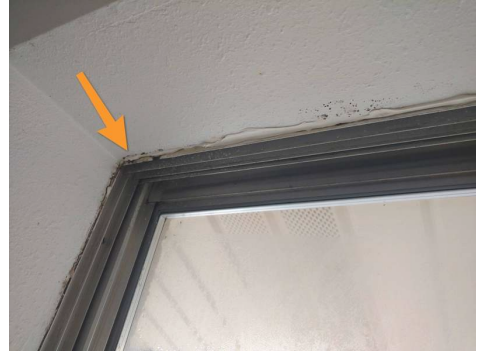
Mold observed around the window in the south bathroom on the second floor. Installing ventilation fans helps mitigate the risk of mold growth in bathrooms.

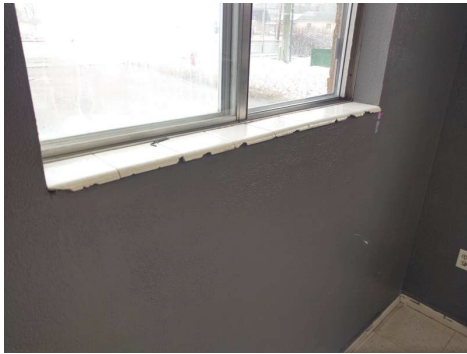
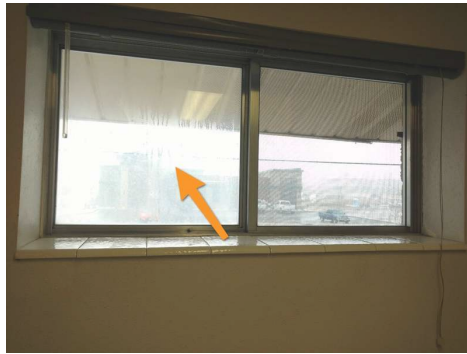
Moisture inside of the window.

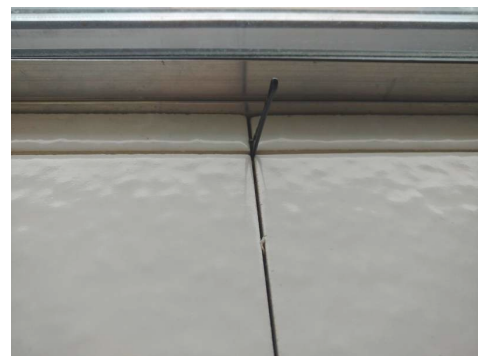
##### IMPROPER INSTALLATION

No grout was observed in a window sill in the north dorm room on the second floor.

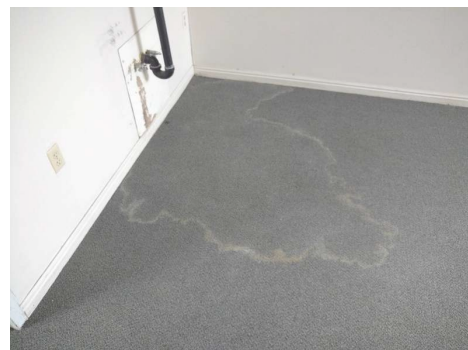
**CARPET STAINS**

Carpet had areas of staining or discoloration. Recommend a thorough steam clean by a qualified carpet cleaning company. No moisture was detected through visual or infrared imaging.

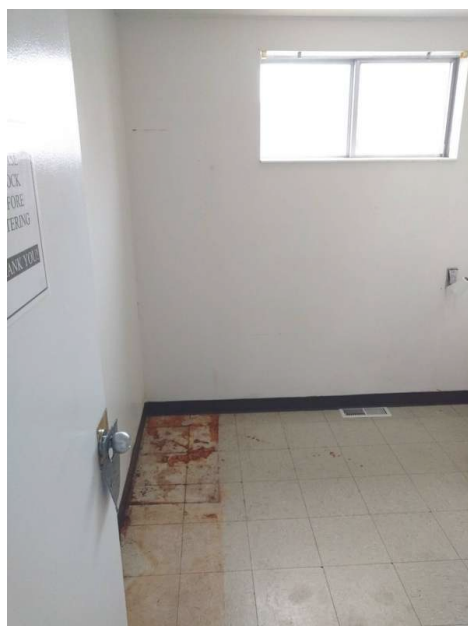
First floor north bathroom

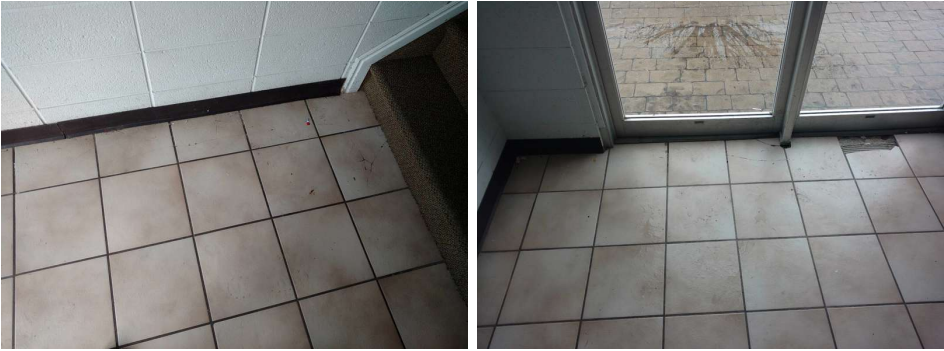
**TILES MISSING**

One or more floor tiles were missing or cracked. Recommend installing/replacing missing tiles in main entryway.

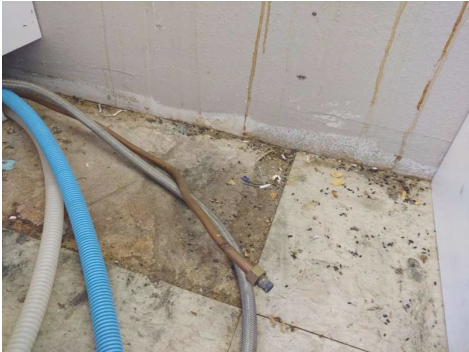
RODENT DROPPINGS

Rodent droppings were observed in the first floor kitchen where the dishwasher goes.

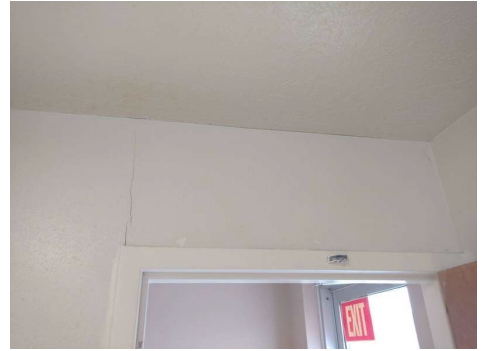
**MINOR CORNER CRACKS**

Minor cracks at the corners of doors and windows in walls. Appeared to be the result of long-term settling. Some settling is not unusual in a home of this age and these cracks are not a structural concern.

Second floor north bathroom

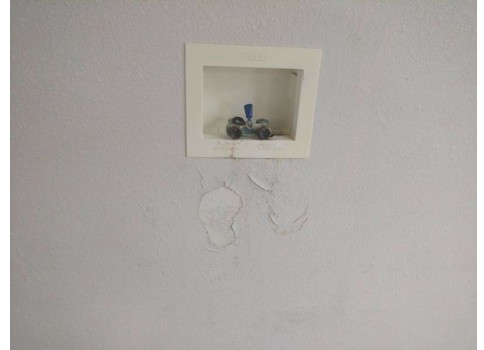
**MOISTURE DAMAGE**

Stains on the walls visible at the time of the inspection appeared to be the result of moisture.

Second floor north dorm.

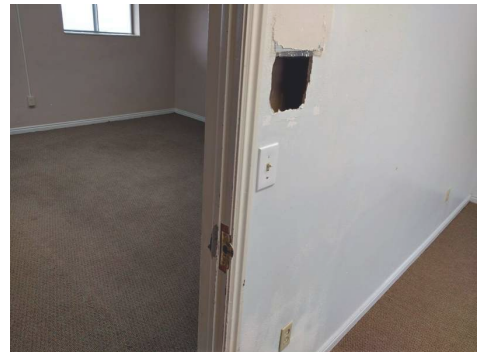
**POOR PATCHING**

Sub-standard drywall patching observed at time of inspection. Recommend re-patching.

Second floor south dorm.

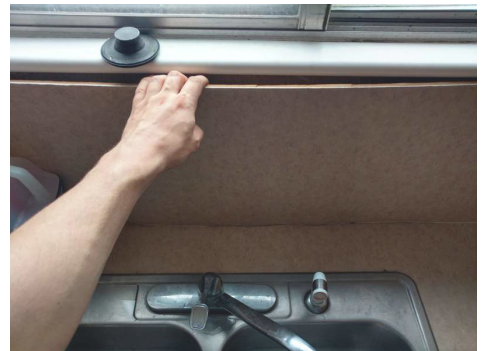
**LOOSE BACK SPLASH**

The back splash in the first floor kitchen is coming loose from the wall.

Contact a qualified professional.

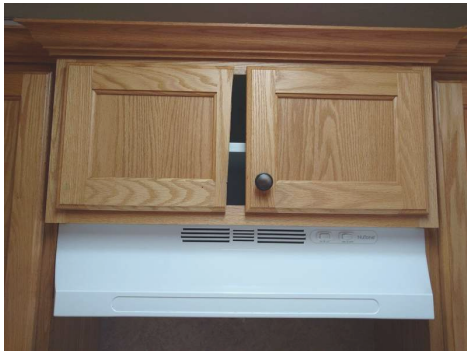
Cabinets had visible damage at time of inspection. Recommend a qualified cabinets contractor evaluate and repair.

Second floor kitchen.

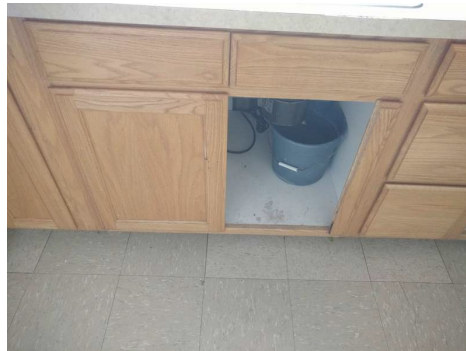
First floor kitchen
