HOMESIGHT INC  
414-321-1070  
[dave@myhsight.com](mailto:dave@myhsight.com)  
<http://homesightinc.com>

## RESIDENTIAL REPORT COPY

1234 test street  
Milwaukee WI 53227

Joe Blow & [jack@myhsight.com](mailto:jack@myhsight.com)  
SEPTEMBER 23, 2019

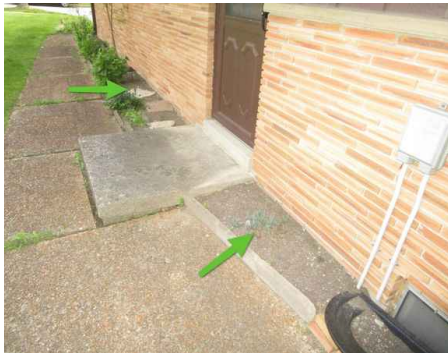
#### Landscaping: Improvements May Be Difficult to Correct

Some grading improvements may be difficult to pitch properly due to having little room to work with (concrete close to the structure) and/or because the grading is already touching or being close to siding. This may ultimately affect foundation drainage evaluate/repair as needed per professional.

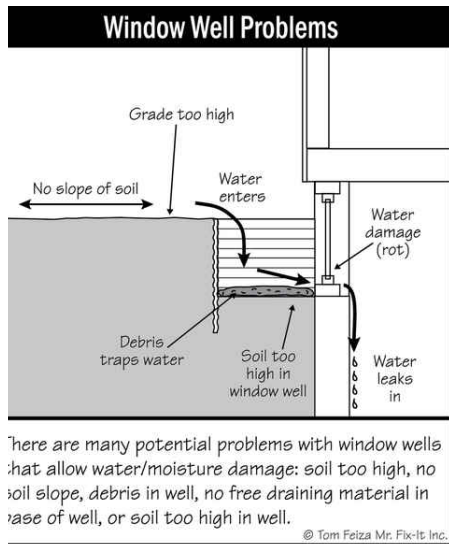
#### Landscaping: Window Well Drainage

Recommend reducing grade/stone/debris/leaves in window well(s) and install proper drainage so that water will not seep into the basement via the basement window. Consult professional and repair as needed

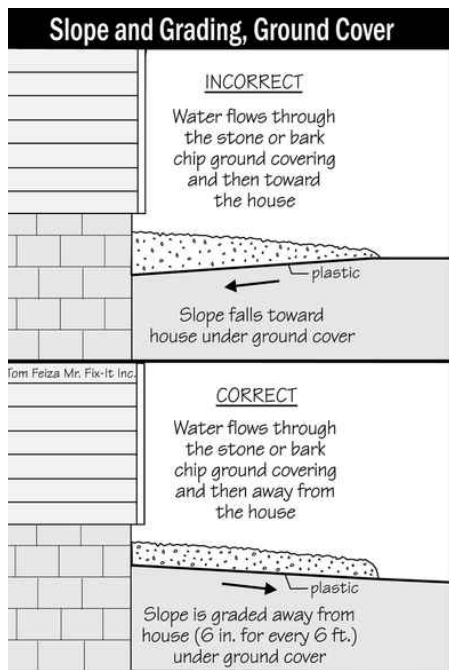
### Landscaping: Not Grading Material

Stone/Rock/Mulch landscaping material around the house is not grading material and will not flow water properly away from the home unless the grading underneath is positive evaluate/repair as needed per professional.

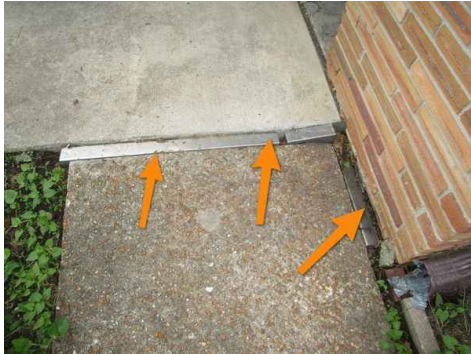
Purpose of metal is unknown

Flat surfaces appear to need repair to create a satisfactory surface. Consult professional for evaluation and corrective action.

Contact a qualified concrete contractor.

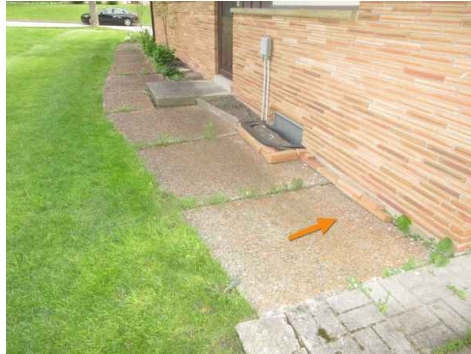
Settled towards the home

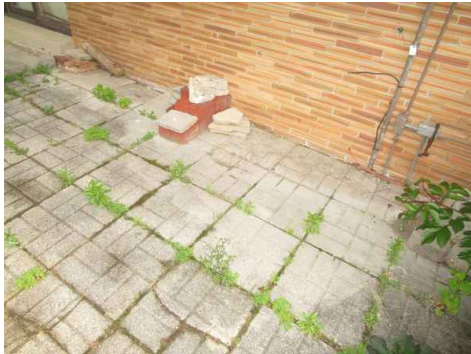
Settled towards the house

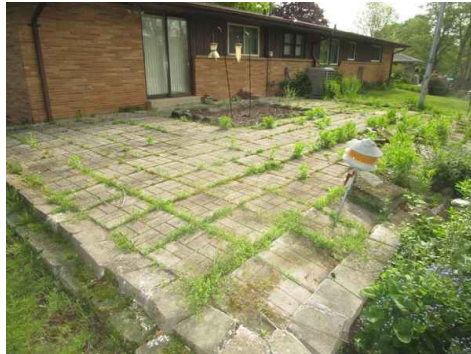
PATIO - settled, trip hazards and damage

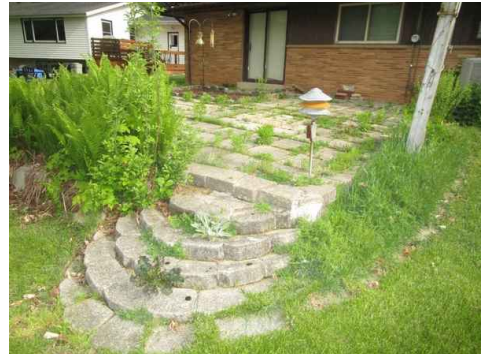
Improper and damaged steps and no handrail

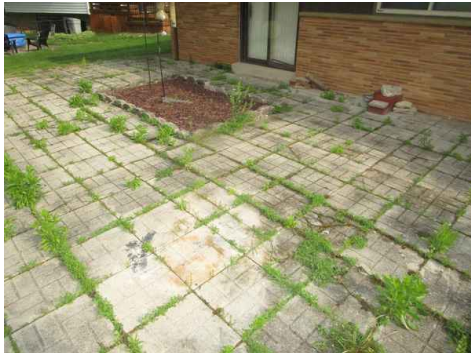
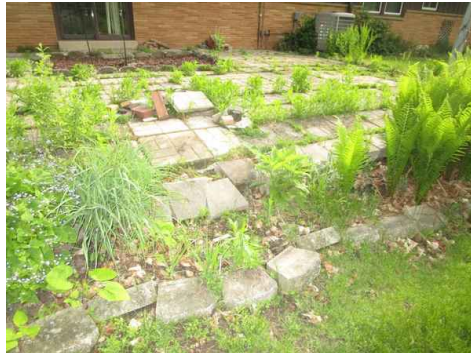
PATIO - settled, trip hazards and damage

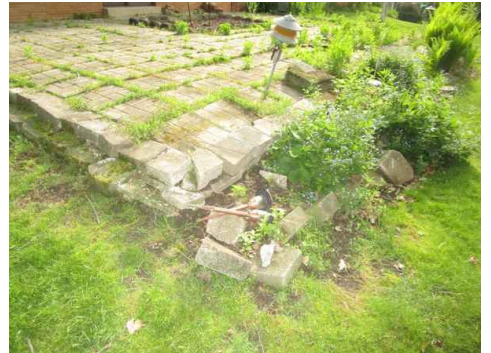
PATIO - settled, trip hazards and damage

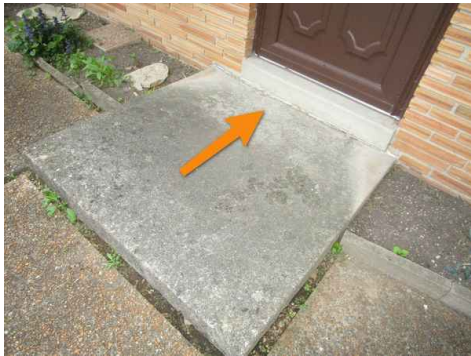
Settling towards the structure is observed today. If not corrected water may be directed towards the structure resulting in seepage/damage - recommend repair per professional.

West stoop - Appears to be settled towards the home

Contact a qualified professional.

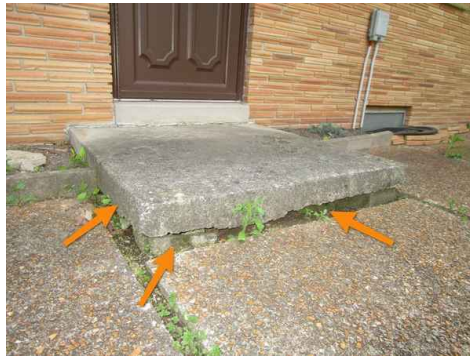
West stoop - Gaps and deterioration

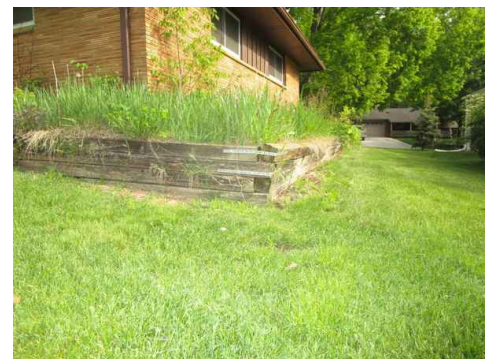
Retaining wall shows substandard repairs and is leaning today. If not corrected additional damage may occur - recommend evaluation/repair per professional.

Contact a qualified professional.

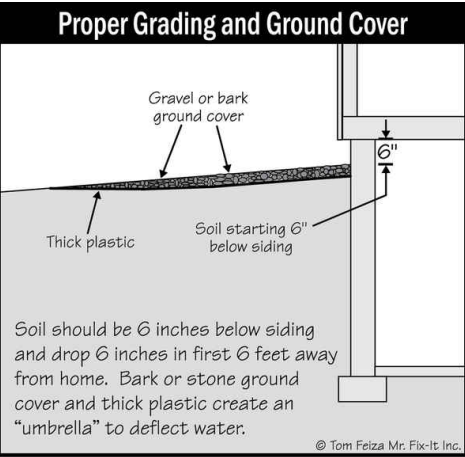
Grading is pitched/settled towards the structure which can direct water towards the structure resulting in potential moisture seepage/damage. In general - grading should have a pitch of 1" drop per foot extended for 6' away from the structure with no siding-to-dirt contact. Recommend evaluate/repair per professional.

Contact a qualified landscaping contractor

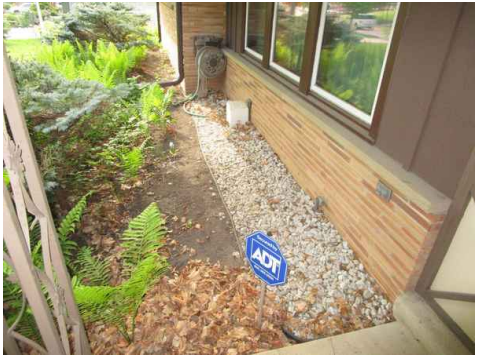
Flat grading with stone

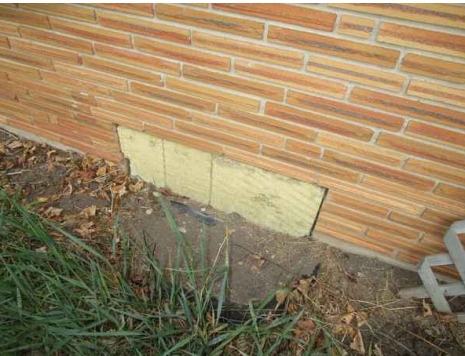
Add window well(s)

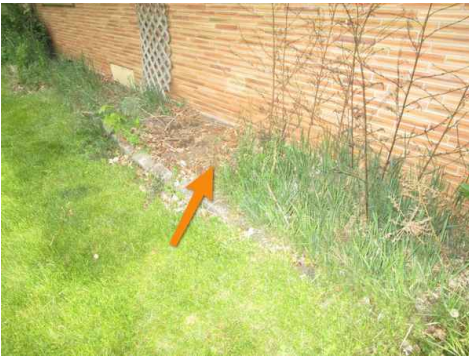
Flat grading

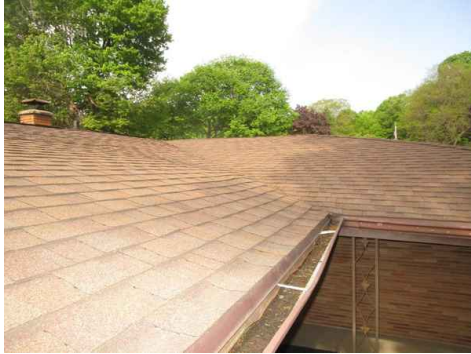
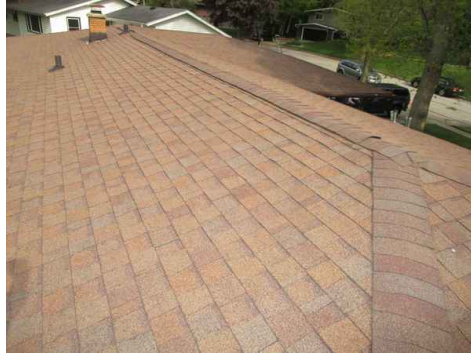
Roof system is nearing it's average life expectancy - consider budgeting for repairs and/or replacement.

Granular loss

Contact a qualified roofing professional.

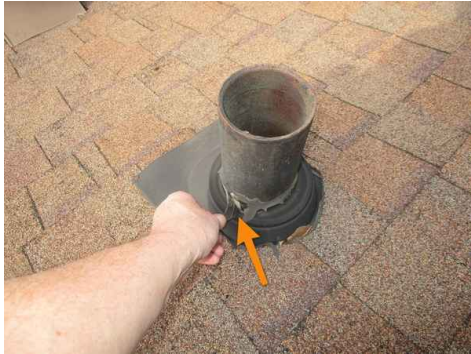
Damaged boot

Contact a qualified roofing professional.

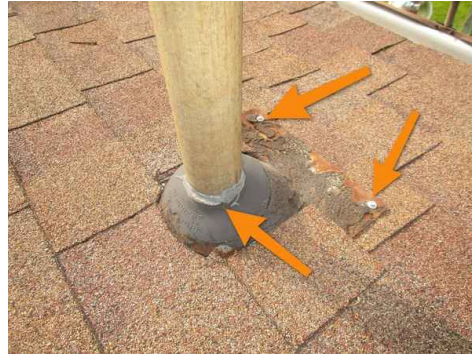
Rusted flashing, exposed fasteners and damaged boot

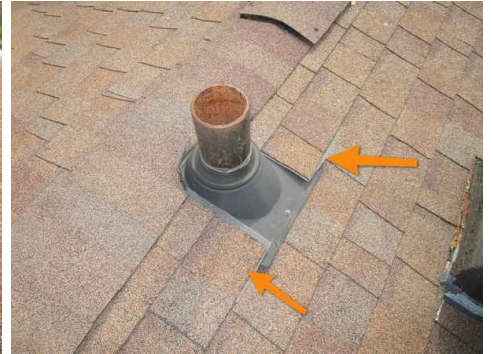
The roof flashings appear to need repair today. If not corrected leaks/damage ay result. Consult professional for corrective action.

Sub-Standard installation/repair

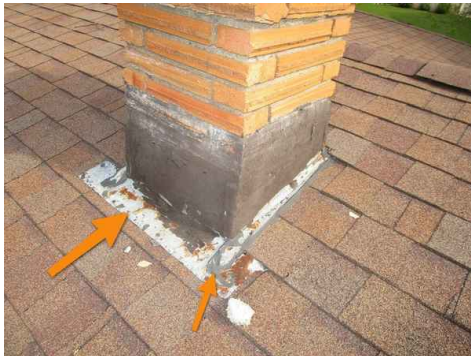
Rust, tarred and improper fasteners

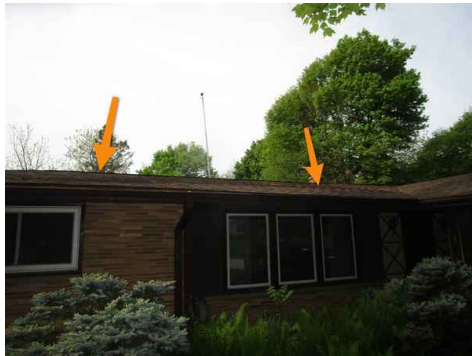
Roof appears wavy

Contact a qualified professional engineer

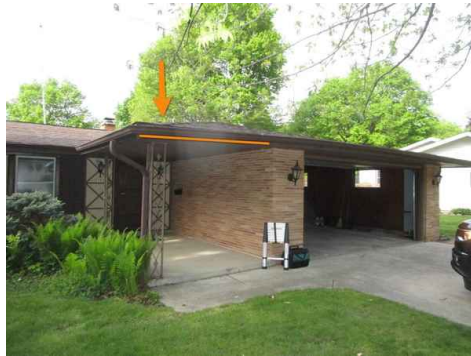
Stoop overhang appears to have settled

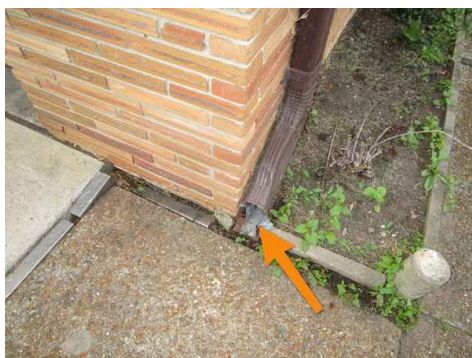
The gutters appear to have issues. If not corrected the gutter system may not operate as intended. Recommend professional evaluate the gutter system and repair as needed.

Downspouts need extensions

Contact a qualified gutter contractor

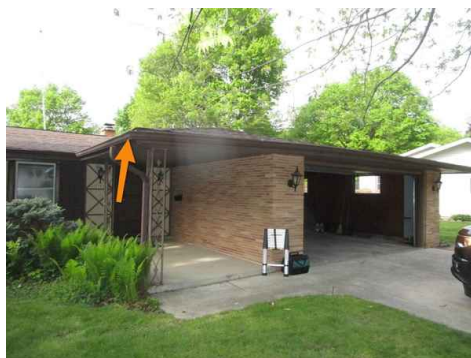
Improper pitch and ponding

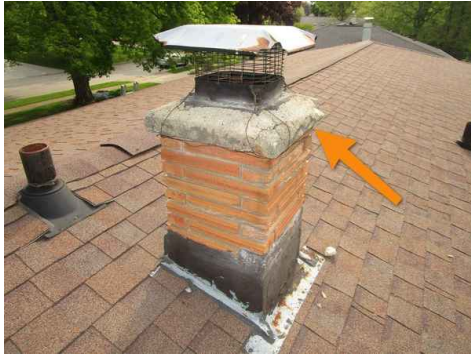
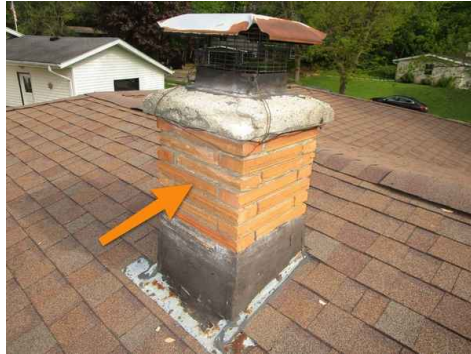
Limited view from attic

Contact a qualified professional.

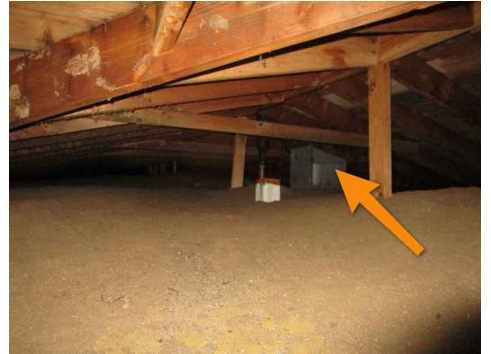
The chimney appears to need work - if not corrected additional damage may result. Recommend professional evaluate chimney components and repair as needed.

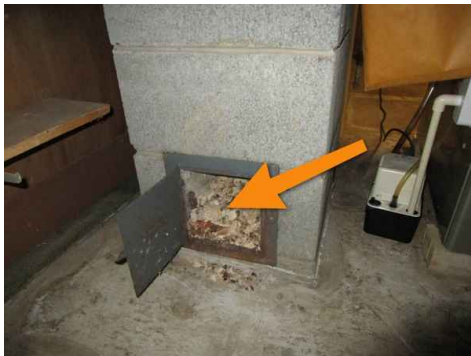
Clean-out in basement is full

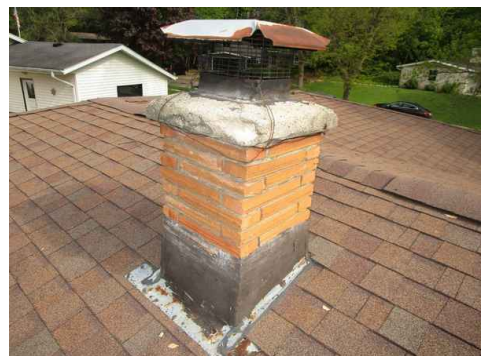
Water heaters chimney may be too large for just water heater alone (furnace was once using the same chimney too). Consult professional for additional information or evaluation/repair as needed.

Contact a qualified heating and cooling contractor

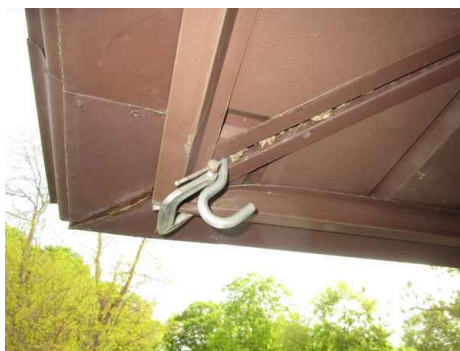
DIY repair - NW

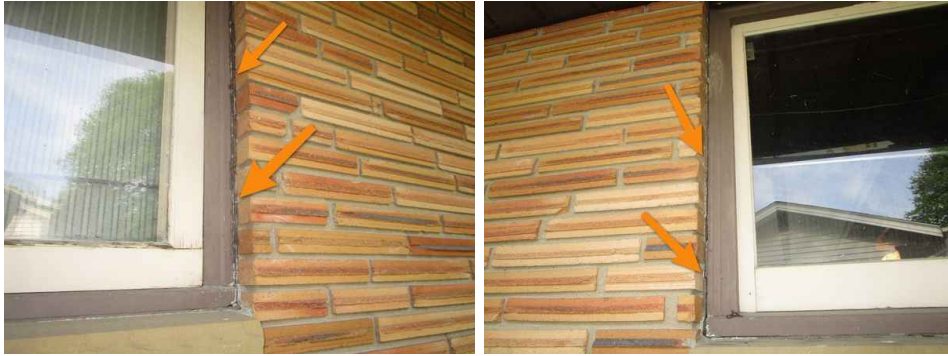
There area(s) of cracked/deteriorated and/or missing caulk. If not corrected water penetration may occur. Contact the qualified professional for repair.

Contact a qualified professional.

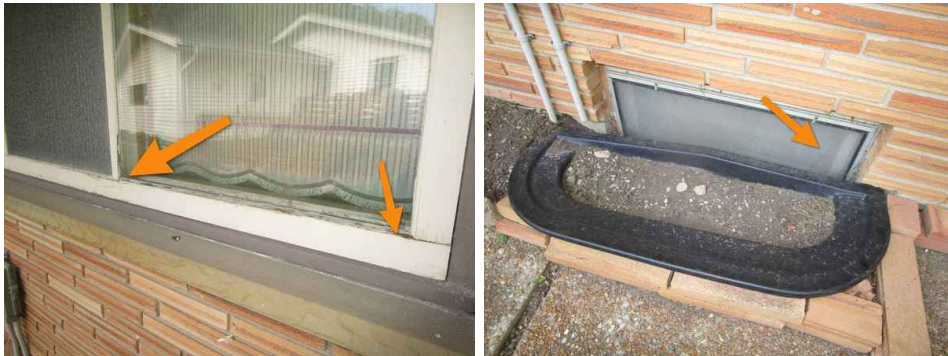
Storms windows appear to need maintenance. If not maintained damaged may result. Consult professional for corrective action.

Peeling/Deteriorated paint

Cracked glass - basement

Contact a qualified professional.

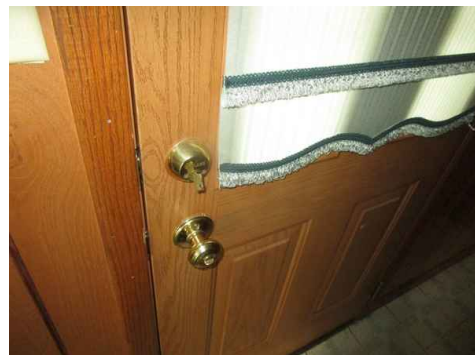
Entrance door(s) is double keyed. This means that a key is required to open the door from the outside and inside of the home. Modern fire safety standards do not allow double keyed locks on doors. In the event of an emergency exit from the home, a key is required to unlock the door. This is a safety issue if no key is readily available. Recommend replacing any double keyed locks on entrance doors.

Contact a qualified professional.

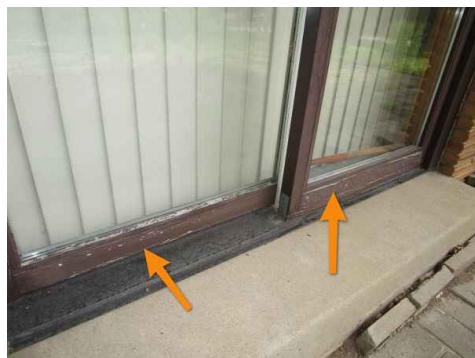
Door(s) appear to need maintenance. If not maintained damaged may result. Consult professional for corrective action.

Deteriorated treatment

Contact a qualified professional.

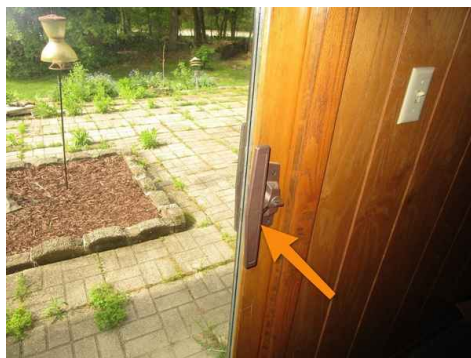
Loose hardware

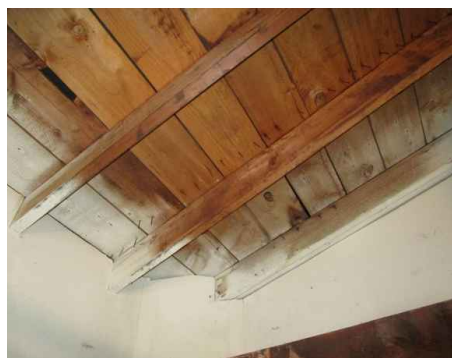
In general - moisture stain(s) noted at roof sheathing appear old and randomly read dry today with meter possible past/active leak (source not confirmed). Consult owner/professional as needed.

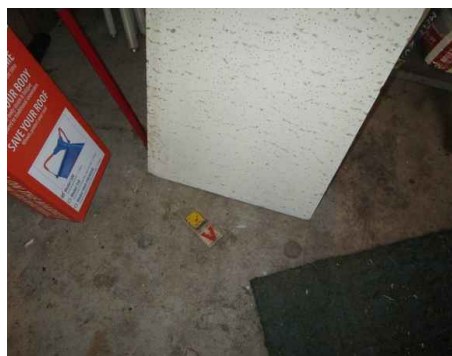
Evidence of past/active pests in structure - recommend consulting owner/pest professional as needed.

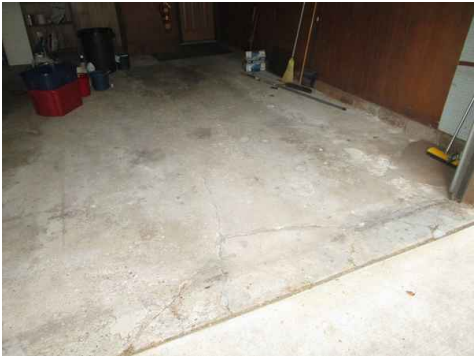
6.2.1 Floor  
**GENERAL OBSERVATIONS**  
MONITOR  
Trip hazard(s), Cracks, Settling, Past repairs  
Monitor for additional settling of floor. Additional movement may compromise the integrity of the structure consult professional as needed.  
Recommendation  
Contact a qualified professional.

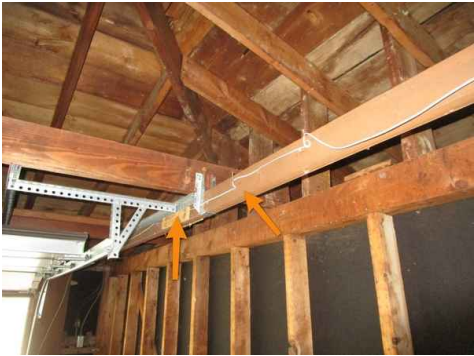
6.3.1 Overhead Door(s)  
**SUB-STANDARD INSTALLATIONS**  
RECOMMEND FURTHER EVALUATION  
Evidence of sub-standard installation. Consult professional to ensure installation is proper and safe.  
Recommendation  
Contact a qualified garage door contractor.

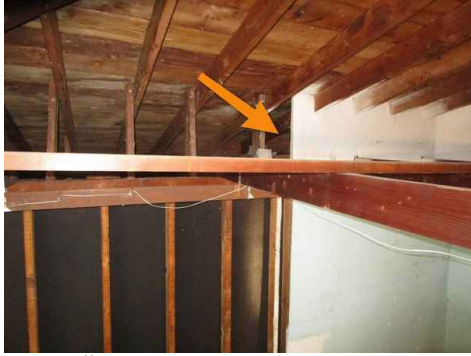
Firewall missing

Contact a qualified professional.

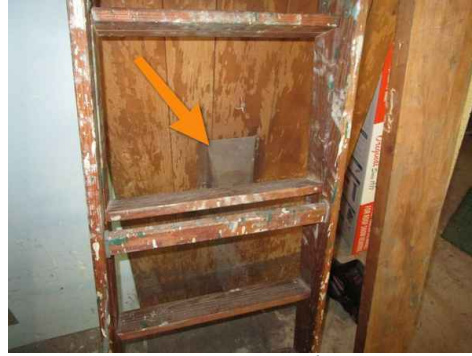
Dryer vent terminates in the garage

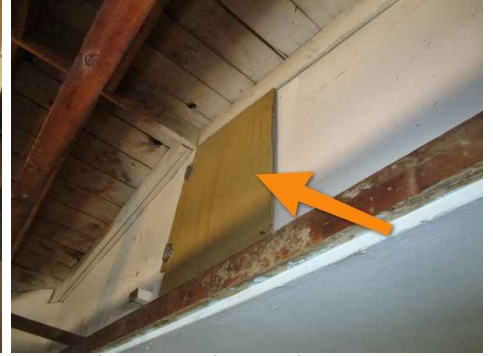
Cover does not close tight

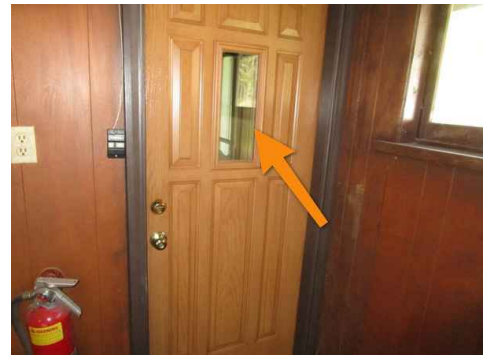
Improper fire door observed at door to interior. If not corrected a hazard exists in the event of a garage fire. Recommend repair per professional.

Glass not recommended

Contact a qualified professional.

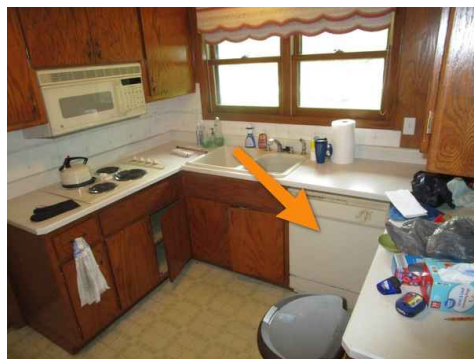
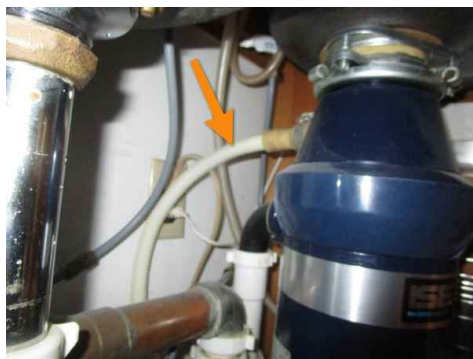
No air gap device

Contact a qualified professional.

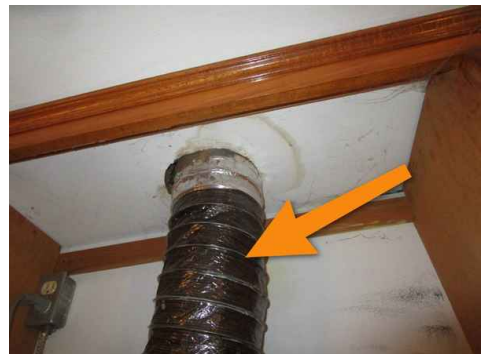
## 7.6.1 Exhaust fan

**RECOMMEND RIDGED DUCTWORK**

## NEEDS REPAIR

Recommend ridged ductwork in cabinetry. if not corrected damage may result. Consult professional for corrective action.

## Recommendation

Contact a qualified professional.

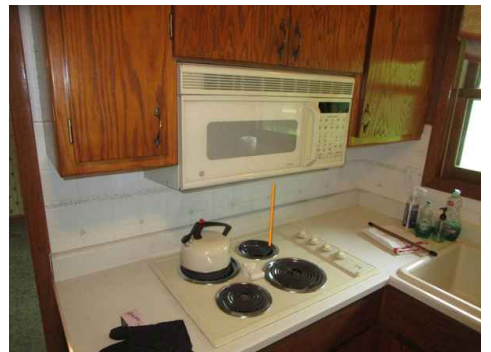
## 7.7.1 Microwave

**TOO LOW**

## SAFETY HAZARD

Microwave appear to be too low over the range. If not corrected a safety hazard exists. Consult professional for corrective action.

## Recommendation

Contact a qualified professional.

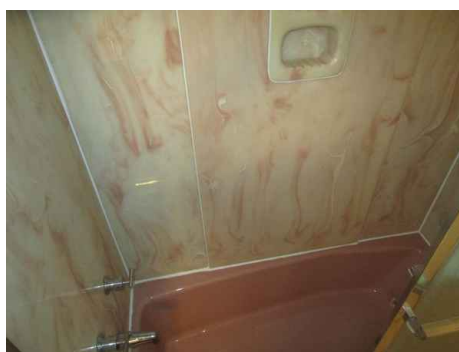
DIY caulking

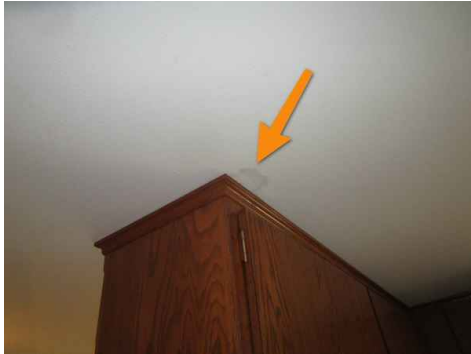
Kitchen

**MOISTURE STAINS AND PATCHING - DRY**

Moisture stain(s) and patching appear old (though not confirmed) and read dry today with meter possible past/active leak. Consult owner/professional and repair as needed.

## Recommendation

Recommend monitoring.

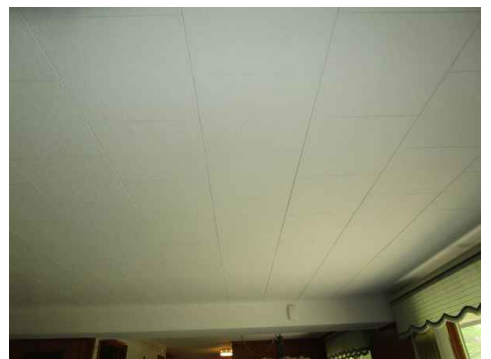
## 9.1.2 Walls and Ceilings

## SAFETY HAZARD

Some ceiling tiles and adhesives have been known to contain asbestos - commonly found. Recommend removing/testing as needed per professional.

## Recommendation

Contact a qualified professional.

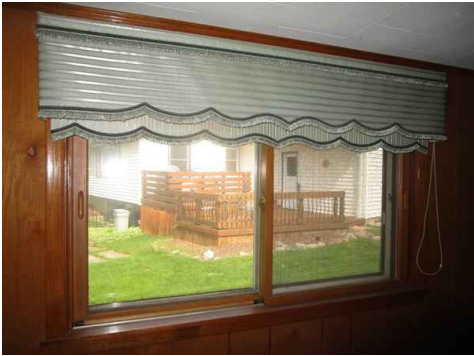
Family room

9.2.1 Windows (representative number)

**DIFFICULT TO OPERATE**

NEEDS REPAIR

Recommendation

Contact a qualified professional.

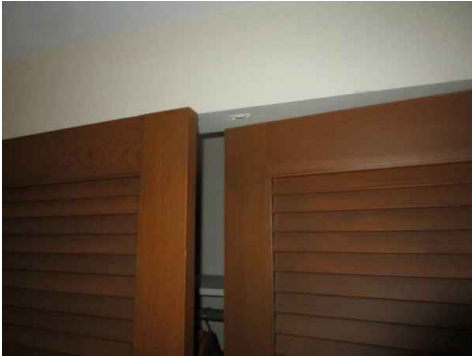
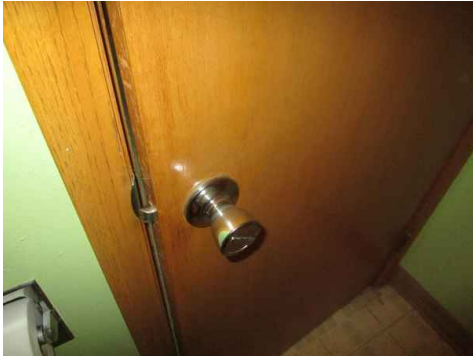
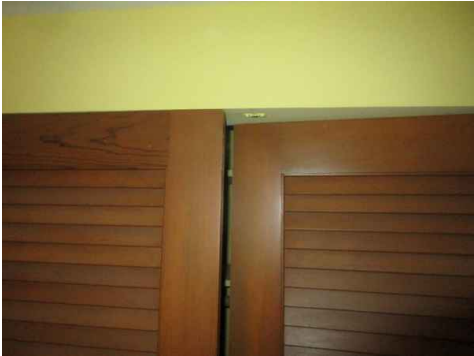
9.3.1 Interior Doors (representative number)

**LOOSE/DAMAGED/MISSING HARDWARE**

NEEDS REPAIR

Door(s) showed loose/damaged/missing or improperly installed hardware in areas. Recommend professional evaluating repair as needed.

Recommendation

Contact a qualified door repair/installation contractor.

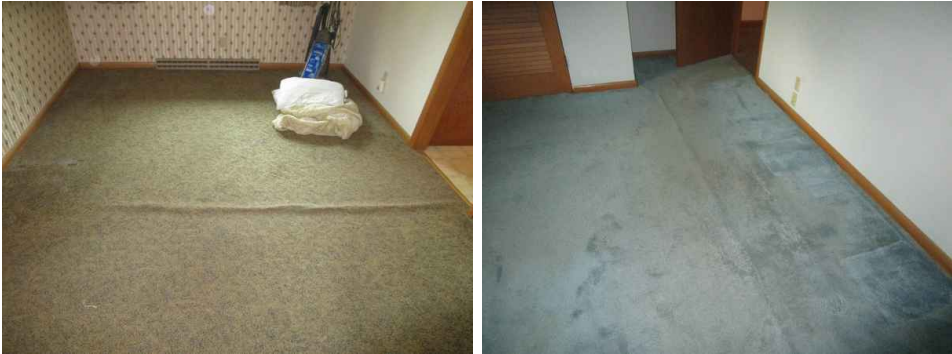
9.4.1 Floors

CARPET NEEDS STRETCHING

SAFETY HAZARD

The interior carpet needs stretching. If not corrected a trip hazard exists. Consult professional for corrective action.

Recommendation

Contact a qualified professional.

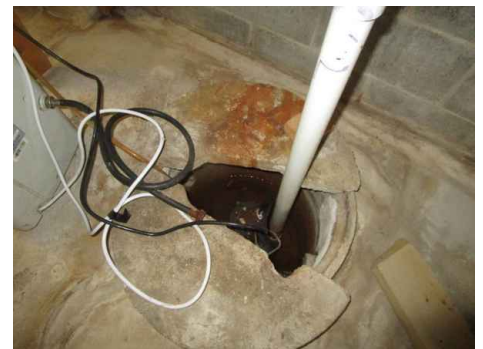
Sump pumps have an approximate life expectancy of 5-10 years, Recommend check-valve in discharge tube, Older pump - consider replacing, Recommend extra support, Corroded

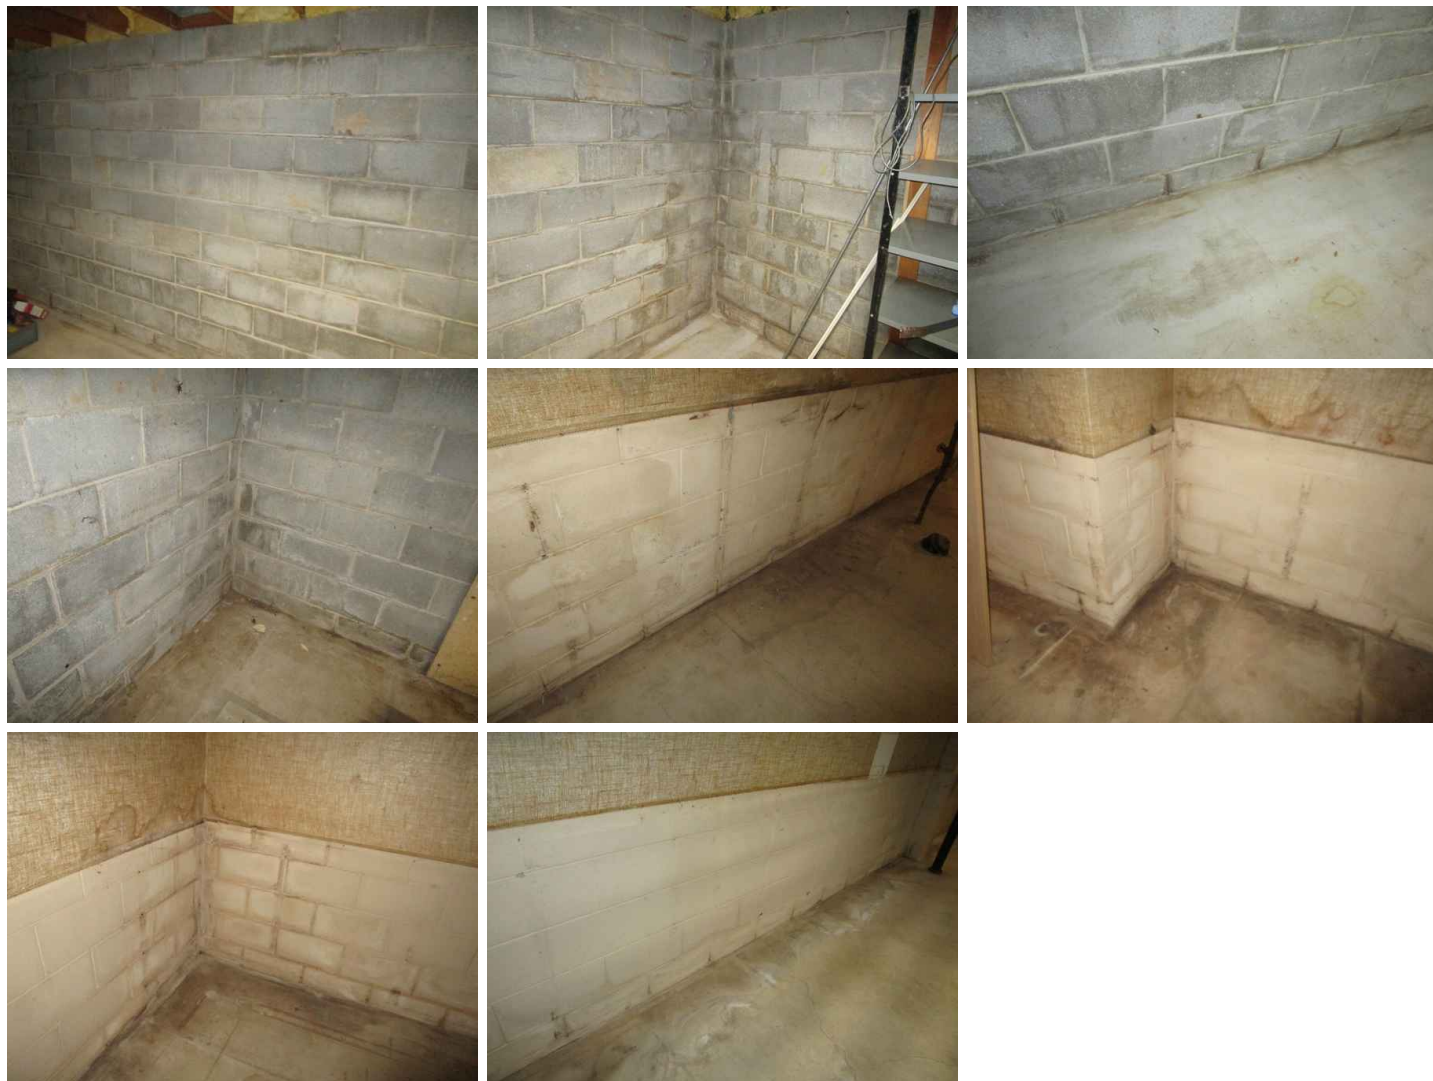
## 10.4.1 General Moisture Observations

**EVIDENCE OF PAST MOISTURE INTRUSION**

## RECOMMEND FURTHER EVALUATION

Evidence today of past water seepage in basement. Recommend all exterior grading be pitch away from the home (1 per foot extended for 6 feet). Also ensure all gutters and downspouts are clean and extended 6 feet away from the house. Also evidence of possible drain tile issues. Recommend professional evaluate further.

## Recommendation

Contact a foundation contractor.

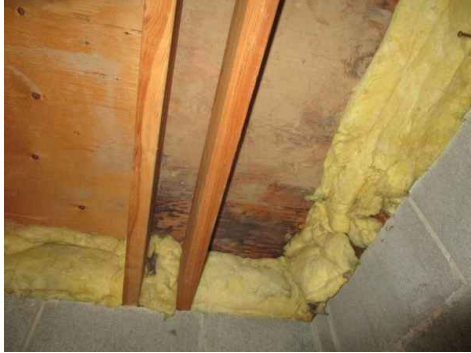
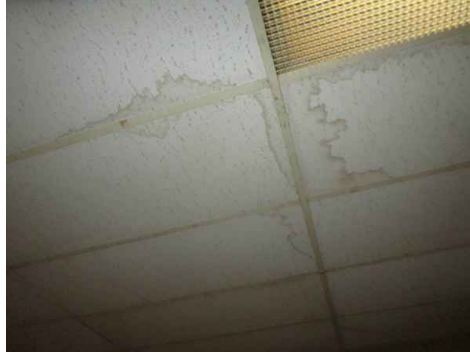
## 10.6.1 Structure

**GENERAL OBSERVATIONS**

Indication of moisture stains/damage, Finishings stained/damaged in areas – consult owner on history

## Recommendation

Contact a qualified professional.

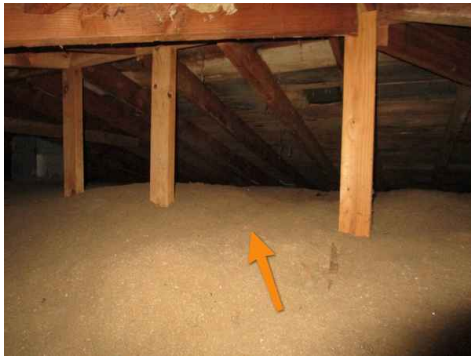
**INSPECTION LIMITED BY:**

Minimal Access, Insulation, Undisturbed insulation

Undisturbed insulation and minimal access

Recommend areas of the attic that could not be inspected today be inspected before closing.

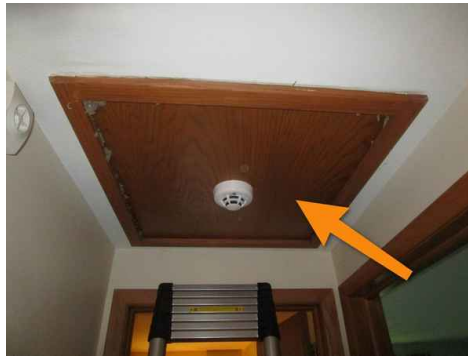
Too much insulation over access scuttle

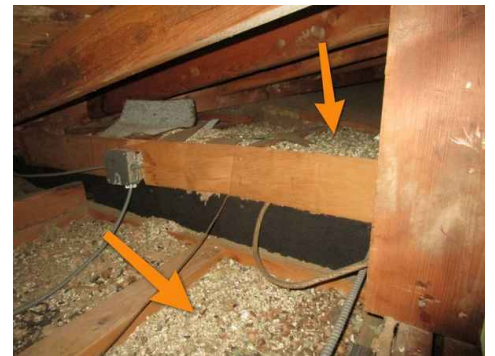
## SAFETY HAZARD

Some vermiculite insulations have been known to contain asbestos - commonly found. Recommend testing/removing as needed per professional.

## Recommendation

Contact a qualified professional.

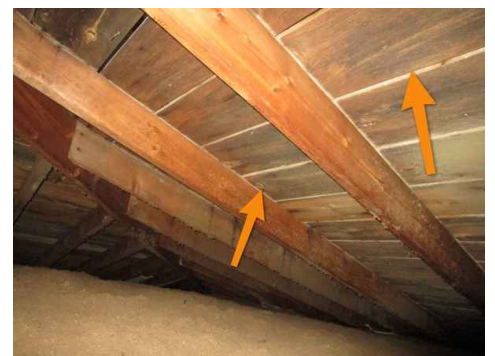
## 11.4.1 Roof Structure / Sheathing

**POTENTIAL MICROBIAL GROWTH**

## SAFETY HAZARD

## Recommendation

Contact a qualified mold remediation contractor

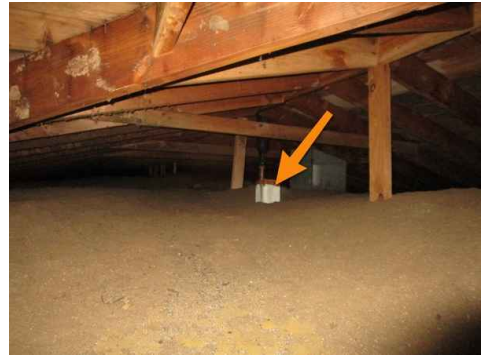
## 11.5.1 Exhaust Fan(s)

**VENT(S) TERMINATE TO THE ATTIC**

## DEFECT

Vent fan(s) terminates to the attic - not recommended. All exhaust fans should have their own exit out of the home/attic or moisture can develop. Consult professional for corrective action.

## Recommendation

Contact a qualified professional.

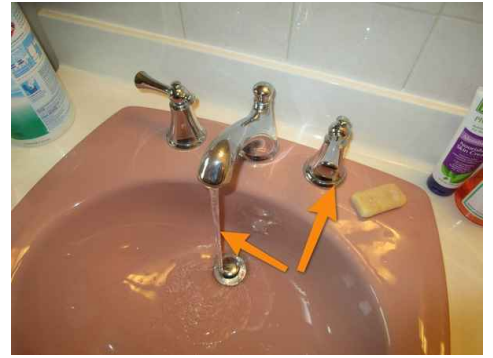
## 12.2.2 Sink(s)

**LOW WATER FLOW/PRESSURE**

## Recommendation

Contact a qualified plumbing contractor.

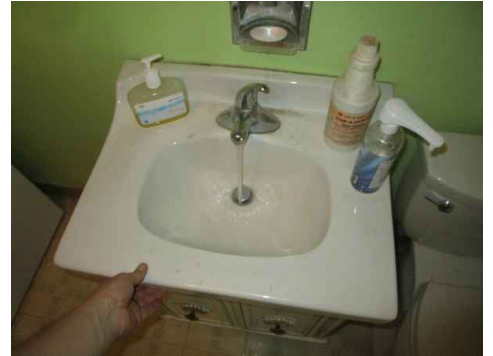
## 12.2.3 Sink(s)

**SINK LOOSE AT VANITY**

## Recommendation

Contact a qualified professional.

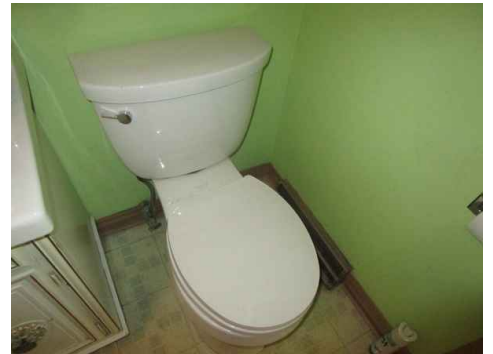
Half bath

## 12.4.1 Toilet(s)

**LOOSE AT FLOOR**

## Recommendation

Contact a qualified plumbing contractor.

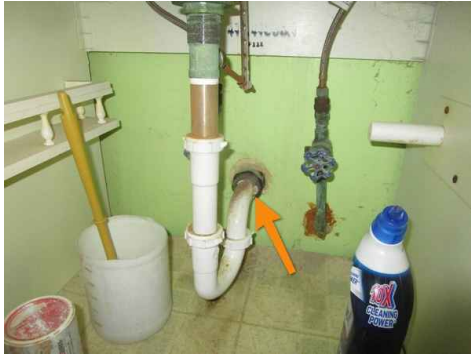
Half bath

## 12.6.1 Drain Pipes

## Recommendation

Contact a qualified plumbing contractor.

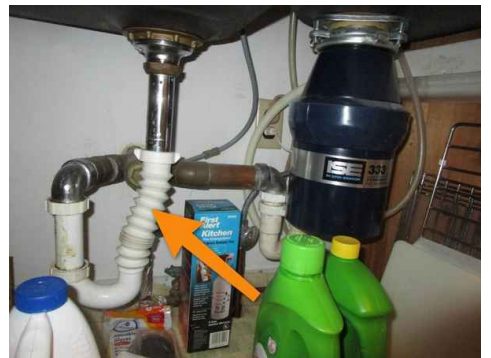
Kitchen

## 12.6.2 Drain Pipes

## Recommendation

Contact a qualified plumbing contractor.

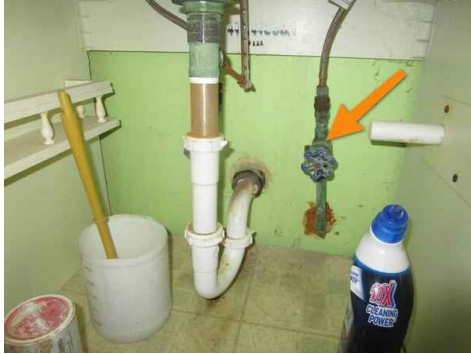
Half bath

## 12.7.1 Water Supply Lines

## Recommendation

Contact a qualified plumbing contractor.

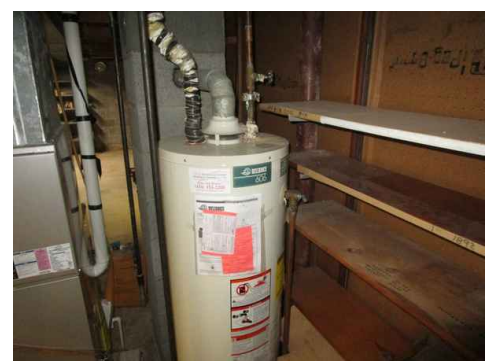
## 12.10.1 Water Heater(s)

**WATER TOO HOT**

## Recommendation

Recommended DIY Project

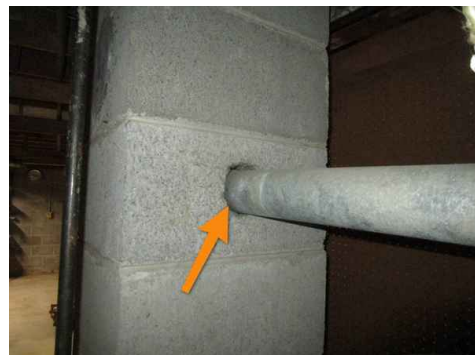
## 12.10.2 Water Heater(s)

**NOT SEALED AT CHIMNEY**

## Recommendation

Contact a qualified professional.

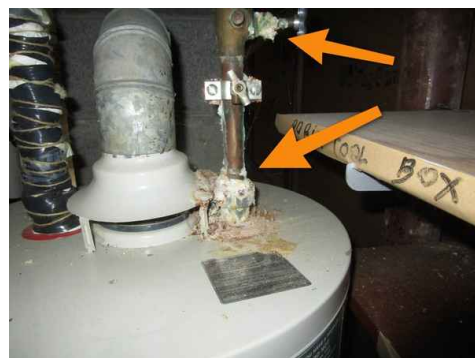
## 12.10.3 Water Heater(s)

**CORRODED WATER SUPPLY LINES**

## Recommendation

Contact a qualified plumbing contractor.

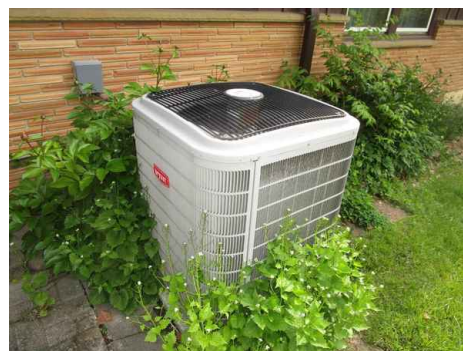
Keep foliage clear of unit,  
Furnace exhaust close to a/c unit  
- not recommended (may corrode  
unit over time)

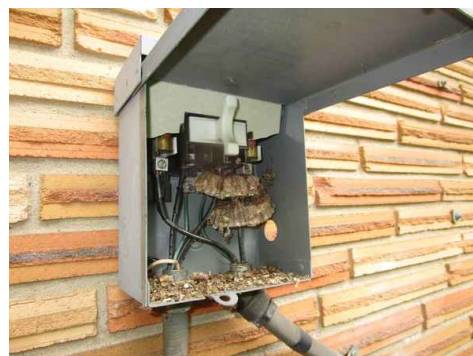
#### **COVER PLATE LOOSE/DAMAGED**

Cover plate in A/C shut-off is loose/damaged with open knock-outs and evidence of pests. If not corrected a safety hazard exists. Recommend repair per professional.

Contact a qualified professional.

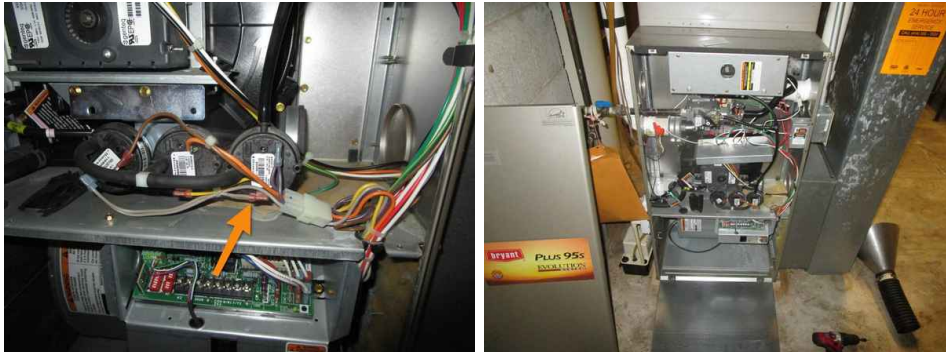
**EVIDENCE OF PAST LEAKS**

Evidence of past leaks - monitor. If leaks develop over time recommend professional evaluate at that time.

Contact a qualified heating and cooling contractor

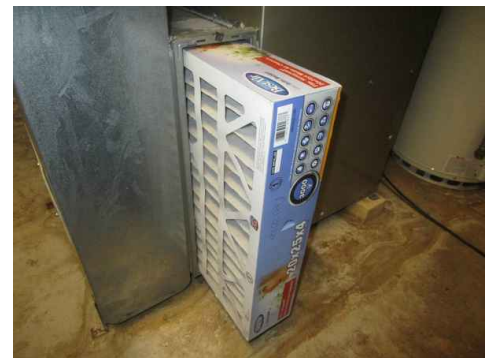
**DIRTY FILTER**

Filter appears dirty at furnace - recommend replacing.

Recommended DIY Project

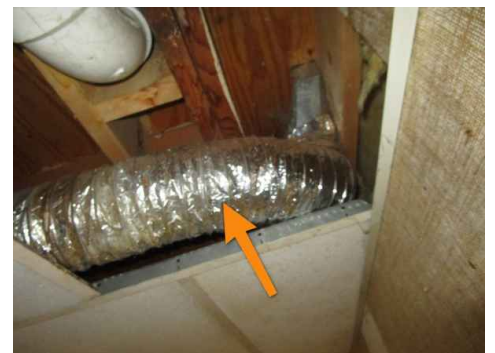
**SUB-STANDARD INSTALLATIONS**

Distribution duct worked appears to have been modified (showing sub-standard installation) which may affect proper air distribution. Recommend professional evaluate/repair as needed.

Contact a qualified heating and cooling contractor

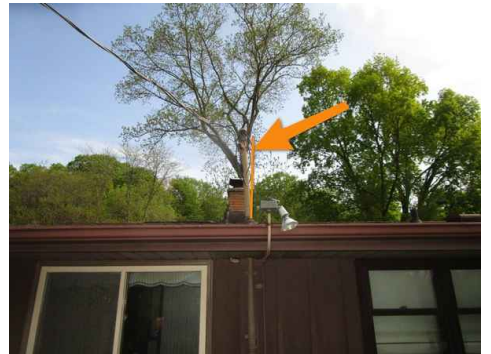
**MAST PULLING AT HOUSE**

Electrical mast appears to be pulling from the house. If not corrected a safety hazard exists. Consult professional for corrective action.

Contact a qualified electrical contractor.

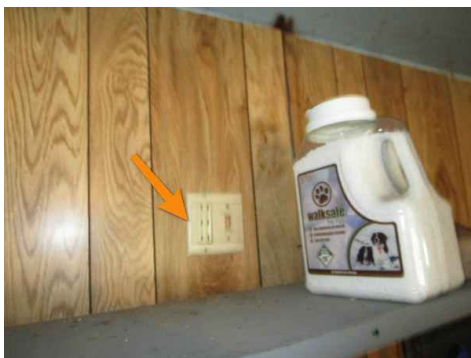
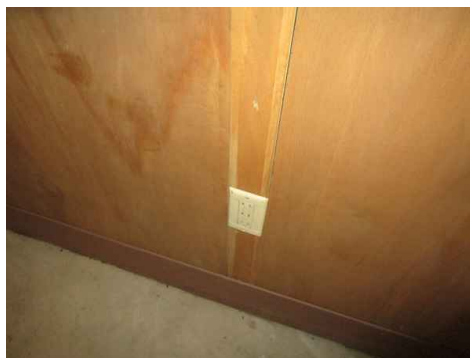
It is recommended that any 2-prong outlets be updated. Consult professional and repair as needed

Contact a qualified professional.

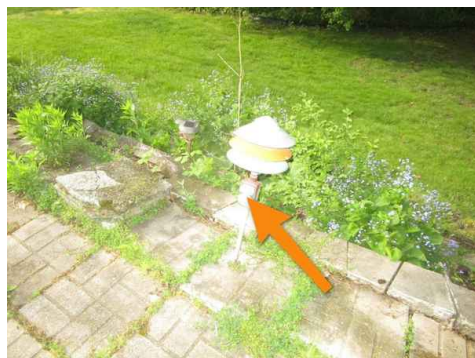
Outlets at patio

Not all exterior outlets and/or switches operated today (reason unknown). Consult owner/professional to confirm proper operation and/or repair.

Contact a qualified professional.

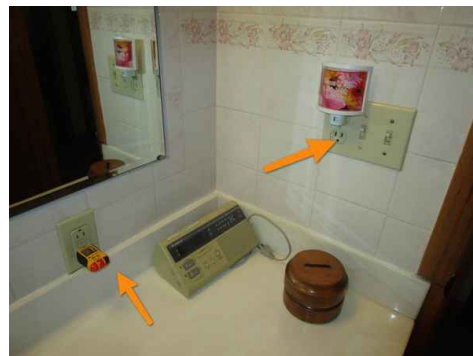
Full bath

GFCI(s) did not trip when tested (commonly found). This may be from a defective GFCI or a miss-wired outlet. Recommend repair per professional.

Contact a qualified electrical contractor.

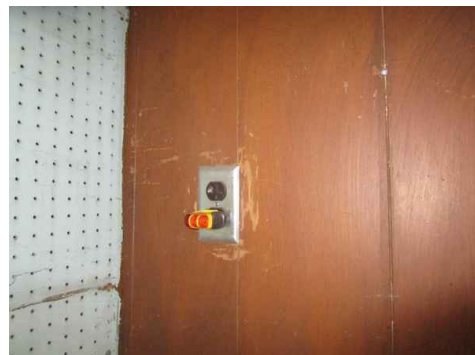
Garage

Not all outlets appeared to operate - recommend professional evaluate/repair.

Contact a qualified electrical contractor.

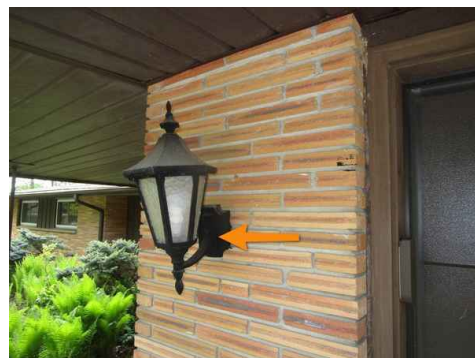
**LOOSE FIXTURE(S)**

Exterior fixture loose at the house (north) - recommend repair per professional.

Contact a qualified professional.

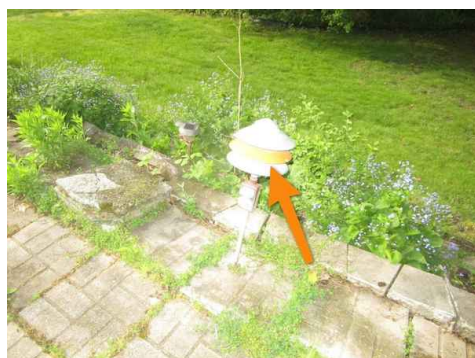
Patio

Not all exterior light fixtures operated (reason unknown). Consult owner/professional to ensure proper operation and/or repair as needed.

Contact a qualified professional.

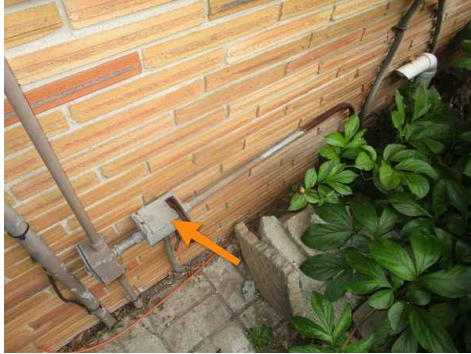
In general there appears to be areas of sub-standard wiring (commonly found) which may present common safety hazards. Recommend professional evaluate and repair as needed.

Outlet installed face up and closed with clamp - north

Contact a qualified electrical contractor.

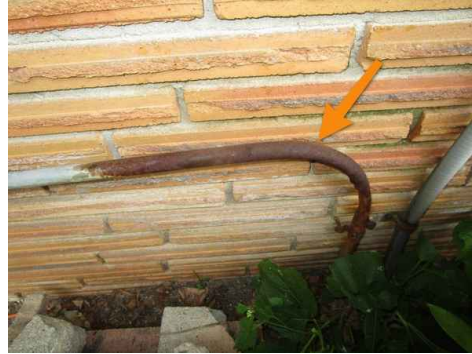
Rusted conduit with leaks/holes in conduit

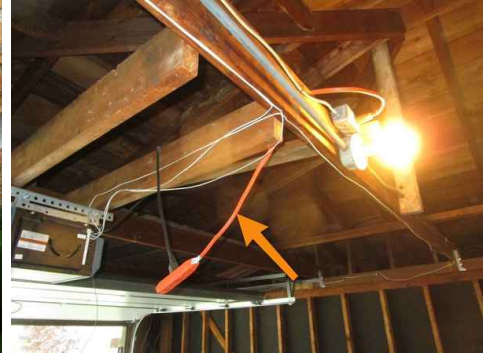
Extension cored wiring - garage

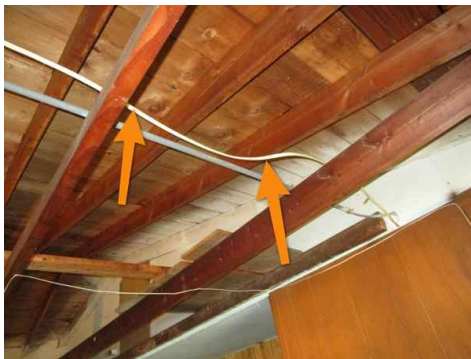
DIY wiring - garage
