MOUNTAINS TO SOUND HOME INSPECTION LLC

HOME INSPECTION REPORT

4615 153rd Ave Ct E
Sumner WA 98390

Jay Palmer
AUGUST 9, 2018

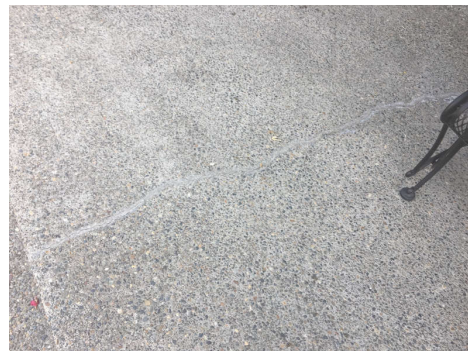
CRACKS IN WALKWAYS

There are a few cracks in the walkways around the residence that are mostly cosmetic. We suggest you view these yourself and repair as necessary.

Recommendation

Contact a qualified professional.

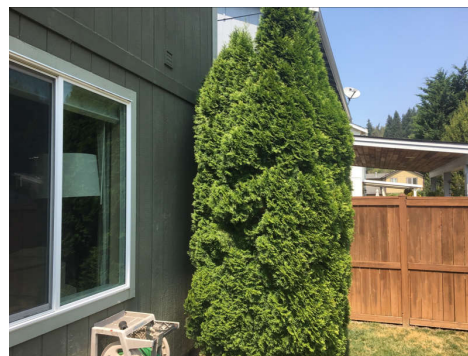
3.5.1 Exterior Siding Notes

VEGETATION IS ENCROACHING

Vegetation is encroaching on the structure, and should be kept a minimum of twelve inches away for the general welfare of the walls and foundation.

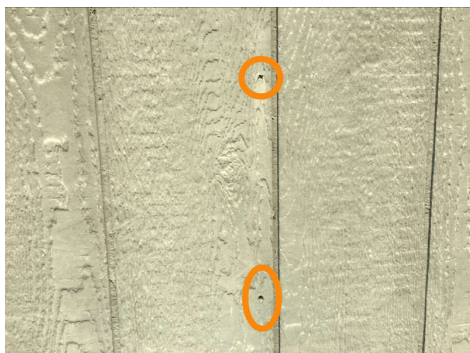
3.5.2 Exterior Siding Notes

COUNTER-SUNK NAILS

A number of holes or deflections through the surface of the siding material were not properly caulked and sealed. These were caused by driving nails deep into the siding material. This can cause accelerated deterioration of the siding from moisture. Caulking and painting of all nail heads, surface breaks and depressions that have broken through the siding surfaces is recommended.

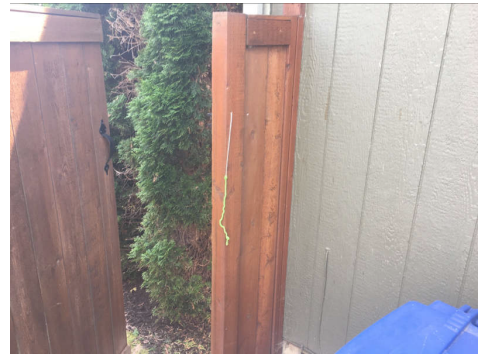
3.5.3 Exterior Siding Notes

FENCE ATTACHED TO HOUSE

Fence(s) were attached to or in contact with the building exterior. Such attachments can serve as a pathway for wood-destroying insects and can retain moisture against the exterior after it rains. We recommend repairs as necessary so there is at least a 2-inch gap between rails and building exteriors.

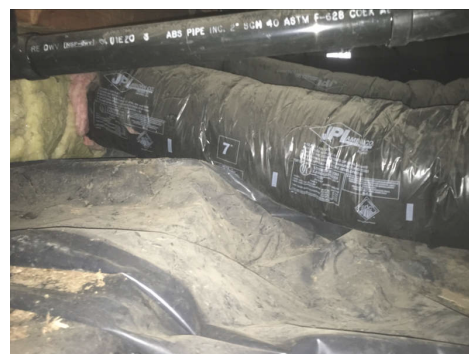
One or more of the heating ducts were in contact with the ground. We recommend A minimum of 4" of clearance be maintained.

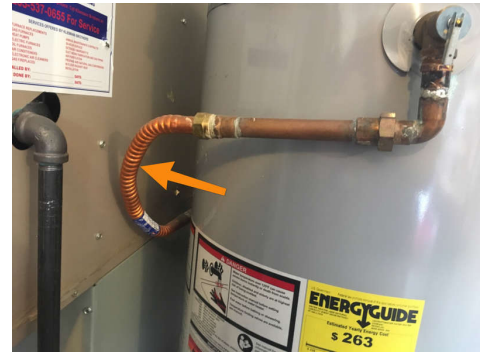
The discharge pipe from the relief valve includes a flexible line and should be replaced with a solid copper discharge pipe. This is because flexible lines can become kinked and possibly prevent the relief valve from working properly in the event it needs to release temperature or pressure and may cause a dangerous situation.

Recommendation

Contact a qualified plumbing contractor.

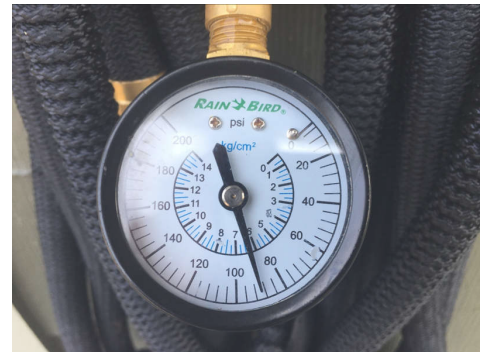
8.2.1 Main Water Shut-Off, Distribution & Supply

The water pressure inside the residence exceeds 80 psi and will stress components of the system. Appliances and components such as water heaters, dishwashers, washing machines and most water using appliances will function better and last longer under lower water pressure (usually 40-80 psi). You may want a licensed plumber to evaluate this and adjust the water pressure. This evaluation and service is recommended before the close of escrow.

Recommendation

Contact a qualified plumbing contractor.

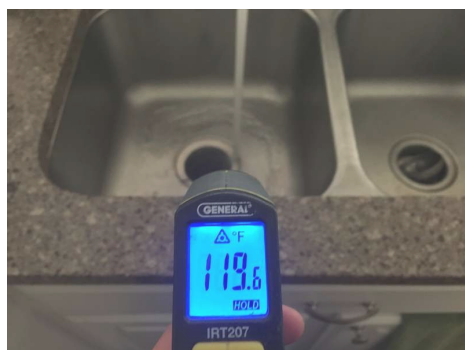
Sink and Faucet: Water temp

The Water temp at the Kitchen Faucet is Currently noted inbtge photo below. The U.S. Consumer Product Safety Commission (CPSC) urges all users to keep their water heater temps at 120 degrees Fahrenheit to prevent scalding and bacteria prevention reasons.

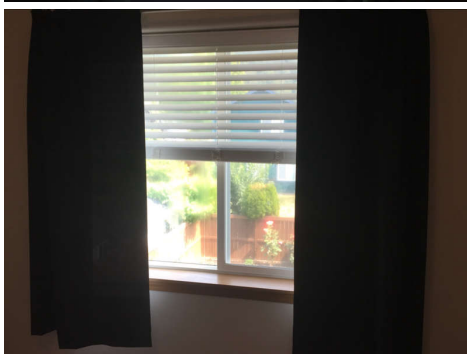
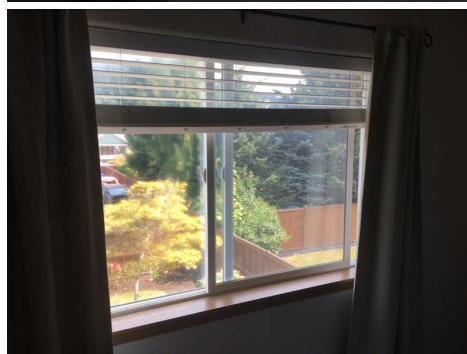
13.5.1 Windows

BROKEN SEALS

A window(s) has broken hermetic seals, and should be replaced. This is evident from fogging, or condensation forming between the panes of glass, that confirm that the seal has failed. If you are concerned we recommend that you have a professional check out all the windows within the residence.

Recommendation

Contact a qualified window repair/installation contractor.

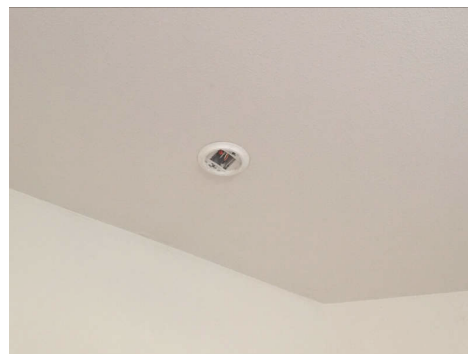
13.8.1 Smoke & CO Detectors Notes

THE SMOKE DETECTORS MISSING

The smoke detector is missing and should be installed as a fire safety feature.

Recommendation

Contact a qualified handyman.

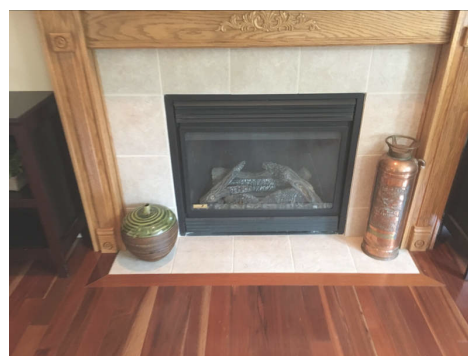
13.9.1 Fireplace Notes

The pilot lite was off on the fireplace and demonstration is recommended.

Recommendation

Contact a qualified handyman.

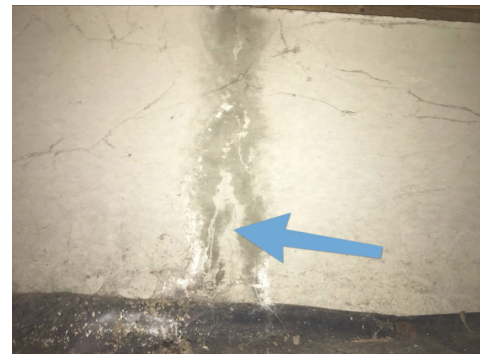
15.2.1 Foundation

SMALL CRACKS
