RESIDENTIAL INSPECTION

1234 Bee st
Honey Comb 75454

PROPERTY INSPECTION REPORT

Concerning: 1234 Bee st, Honey Comb 75454

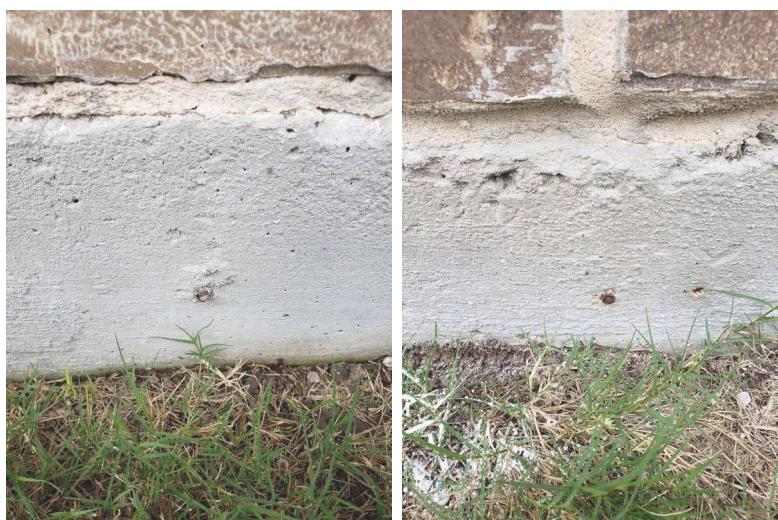
1: Exposed nails foundation

One or more areas showed exposed rusted nails. Exposed rusted nails will expand and crack the concrete Around it. Recommend contractor repair as needed.

Recommendation: Contact a qualified general contractor.

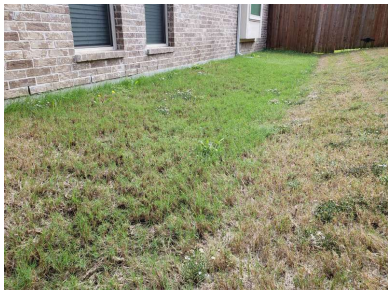
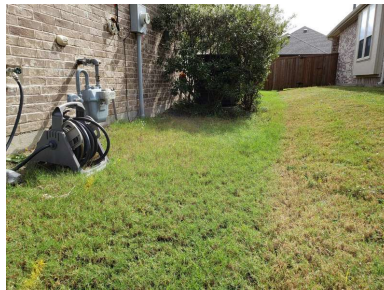
1: Slope

Slope not sufficient for proper drainage on West Side of the house.

Recommendation: Contact a qualified grading contractor.

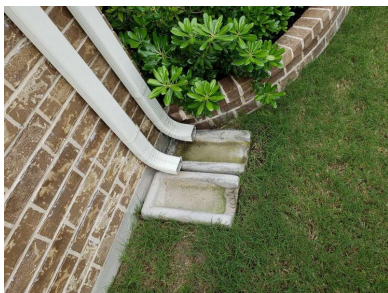
2: Splash Block

Splash block should be maintained in proper position to function as intended and keep water off foundation.

Recommendation: Recommended DIY Project

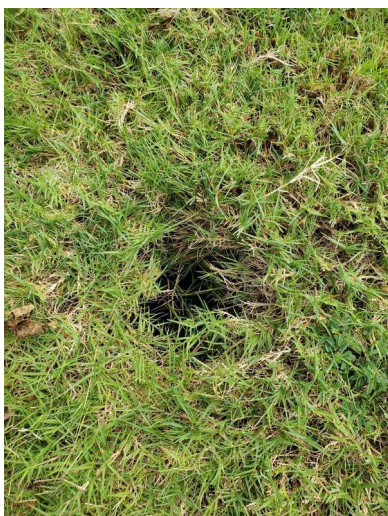
3: Sprinkler trip hazard

Sprinkler system poses as a trip Hazard recommend repairing.

Recommendation: Contact a qualified general contractor.

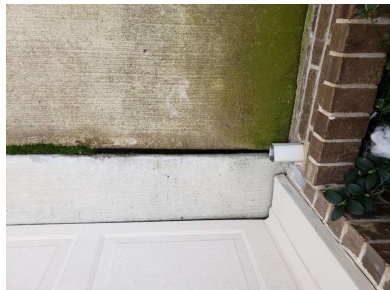
4: downspout drainage

Downspout should drain away from Foundation. Recommends repair and replace as needed.

Recommendation: Contact a qualified gutter contractor

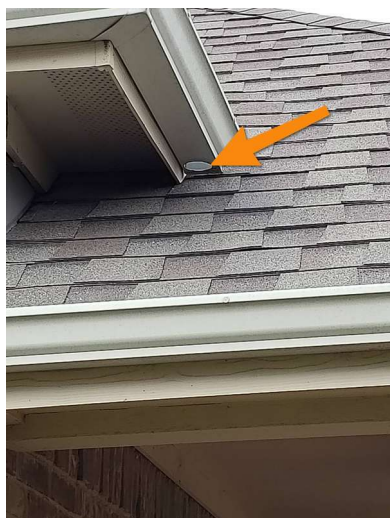
5: Missing Downspout

One or more areas are missing downspouts recommend repair and replace as needed.

Recommendation: Contact a qualified gutter contractor

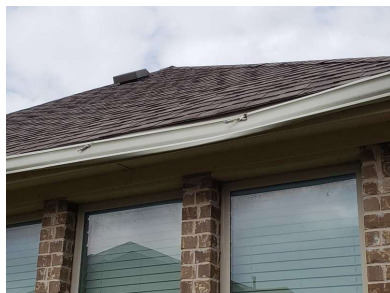
6: Damaged Gutter

One or more areas showed signs of damage gutters. Gutters help keep water away from Foundation and improves the drainage around the foundation. Recommend repair and replace as needed.

Recommendation: Contact a qualified gutter contractor

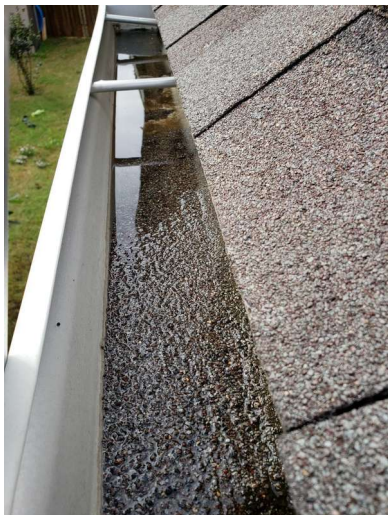
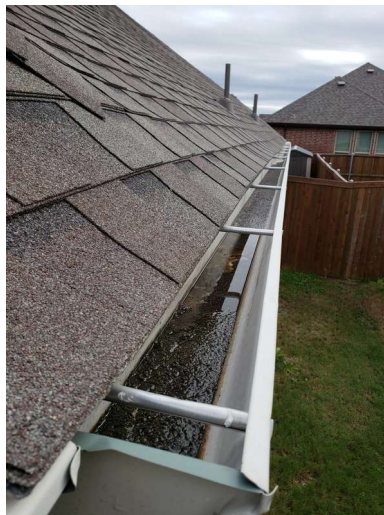
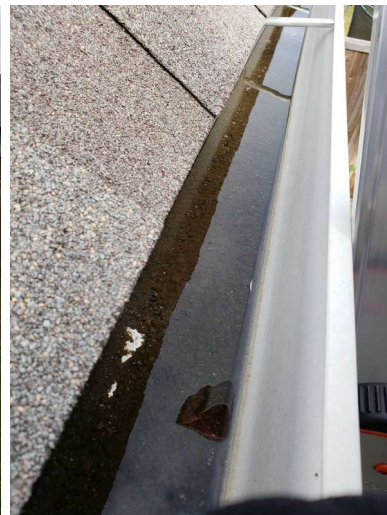
7: Gutter improperly sloped

One or more areas showed improperly sloped gutters away from downspout, build up of material in gutters was observed. recommend cleaning and Repair or replace as needed.

Recommendation: Contact a qualified gutter contractor

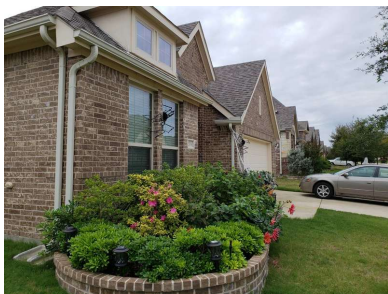
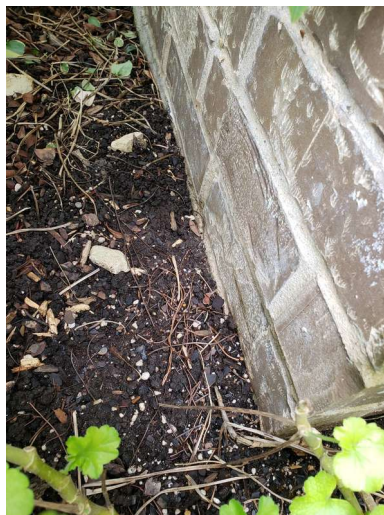
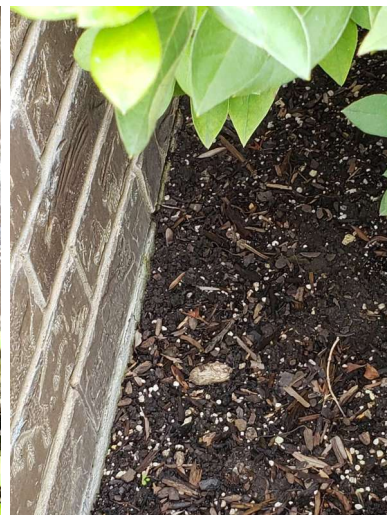
8: 2 inch gap for Brick veneer

There should be a 2 inch gap between the grading (soil) and the brick veneer finished siding. Providing this gap helps prevent water intrusion and insect intrusion to the house.

Recommendation: Contact a qualified landscaping contractor

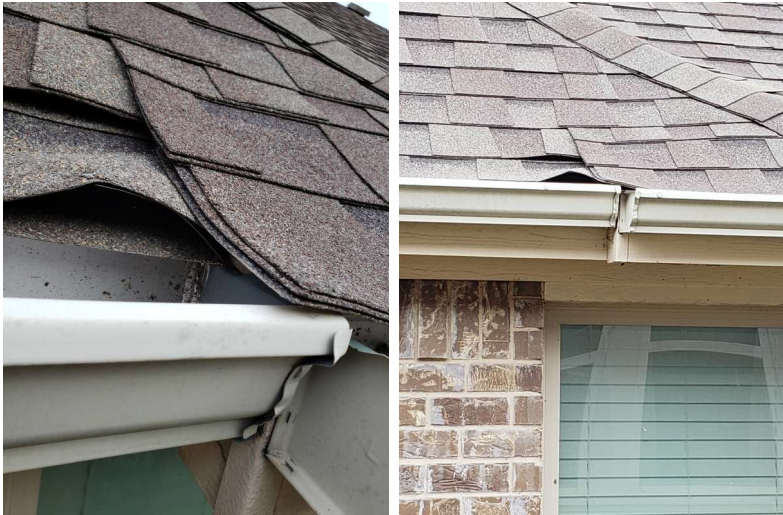
1: Shingles improperly laid

One or more areas showed damaged shingles recommend further evaluation by license professional.

Recommendation: Contact a qualified roofing professional.

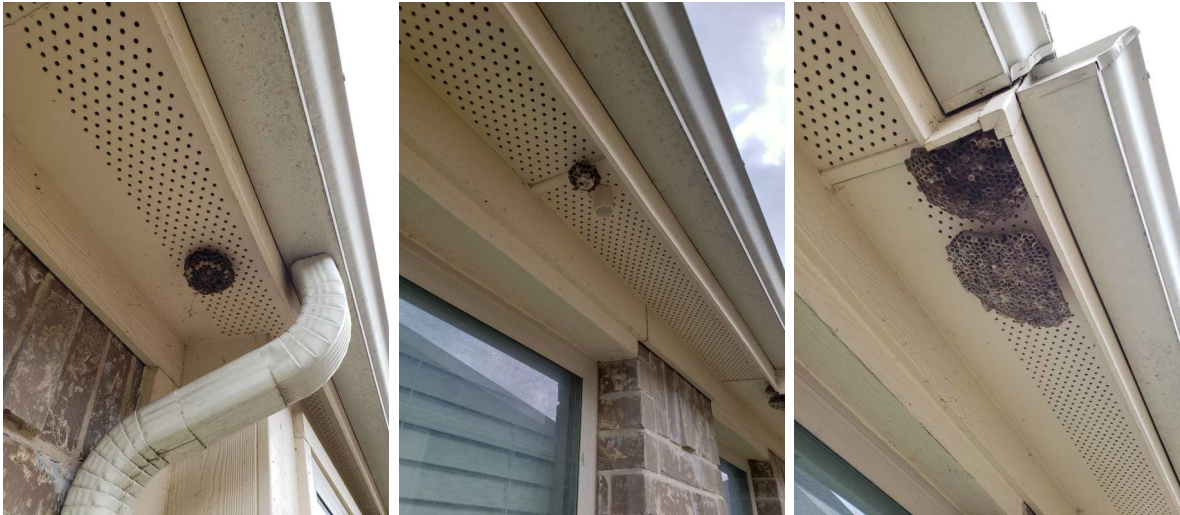
2: Insects

Organic organisms living on structure.

Recommendation: Contact a qualified pest control specialist.

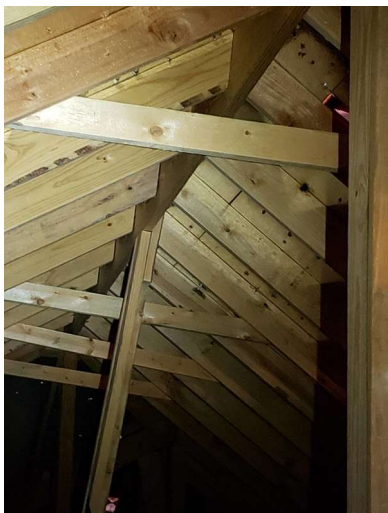
1: Missing Collar Tie

Collar tie's help support the structure of the roof from separating. One or more collar ties were missing at the time of inspection. Recommend further evaluation of the roof structure.

Recommendation: Contact a qualified roofing professional.

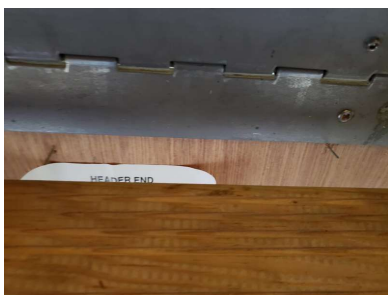
2: Exposed nails on attic door

Recommend removing nails so no one gets hurt.

Recommendation: Contact a qualified professional.

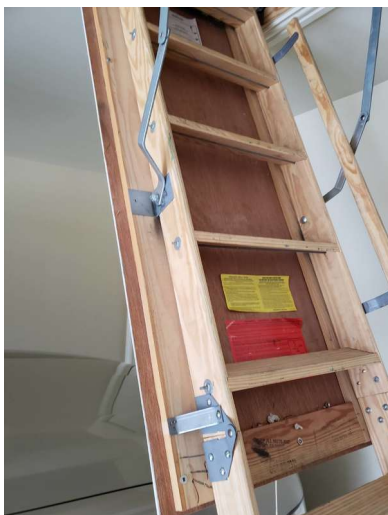
3: Attic access not fire rated

The attic access is not a fire-rated door which poses a fire risk to the home. Garage walls and door access need to be fire rated to protect the home from a fire in the garage. Recommend repair and replace as needed.

Recommendation: Contact a qualified general contractor.

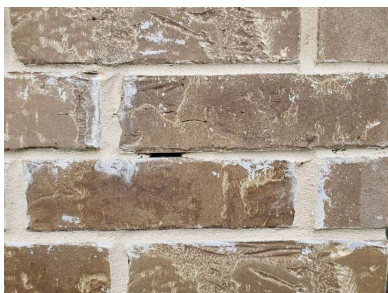
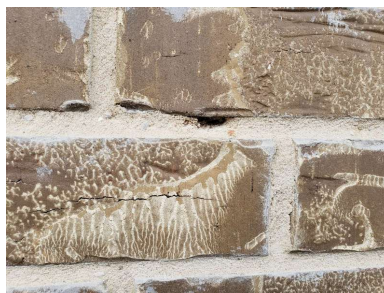
1: Mortar retouch

One or more areas on brick veneer wall have areas that need retouching of mortar.

Recommendation: Contact a qualified masonry professional.

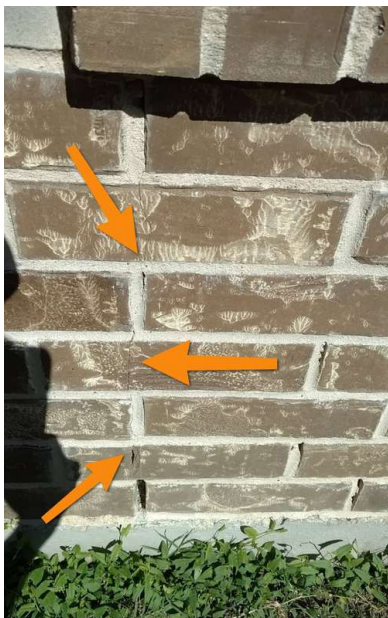
2: Minor crack recommend monitoring

South Exterior

Minor crack on brick veneer near window recommend monitoring for further development. Recommend further evaluation by structural engineer if the crack is active and gets bigger.

Recommendation: Recommend monitoring.

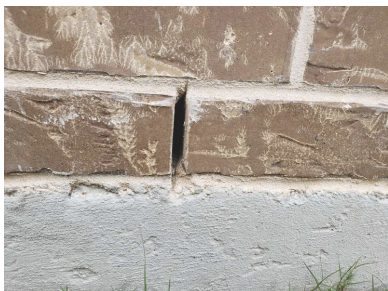
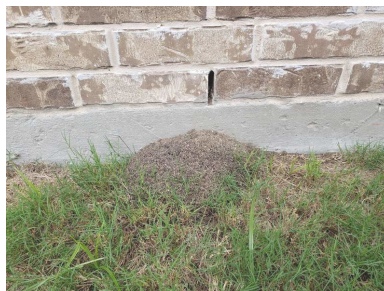
3: Weep holes

Brick veneer have a drainage system to allow water behind it to escape. These same holes if not properly maintained can allow water to build up behind the wall or insect intrusion. Recommend a contractor make proper repairs.

Recommendation: Contact a qualified masonry professional.

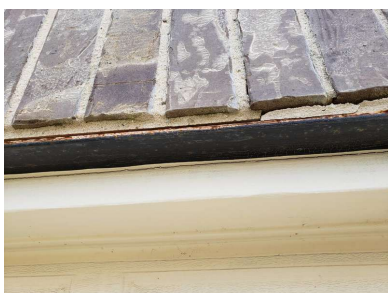
1: Garage door lintel

Lintel above garage door should be properly painted to prevent further rusting. Rusting of metal causes expansion which cracks material immediately surrounding it. Recommend repair and replace as needed.

Recommendation: Contact a qualified general contractor.

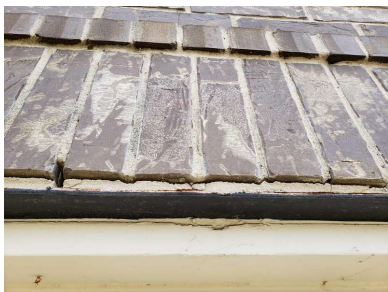
2: Garage door mortar damage

Mortar above the garage door has deteriorated recommend repair and replace as needed.

Recommendation: Contact a qualified general contractor.

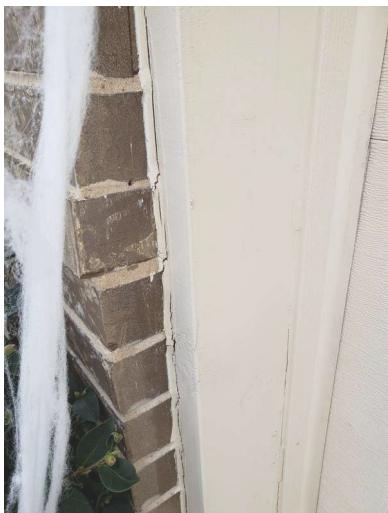
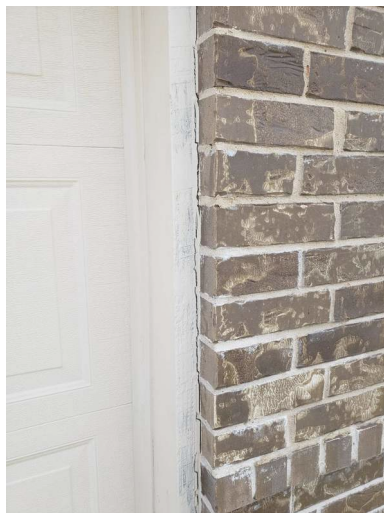
3: Caulking maintenance

Caulking around the house has deteriorated recommend annual maintenance to prevent water intrusion and rotting of structural components.

Recommendation: Contact a qualified general contractor.

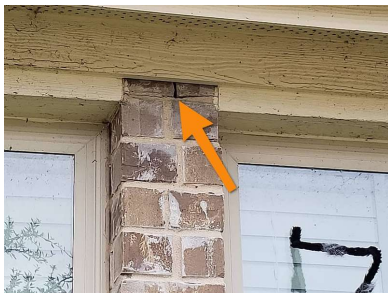
1: Framing damage

The framing of the window has caused damage to part of the house. Recommend a window professional to further evaluate the situation and repair as needed.

Recommendation: Contact a qualified window repair/installation contractor.

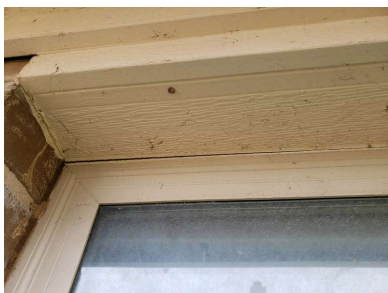
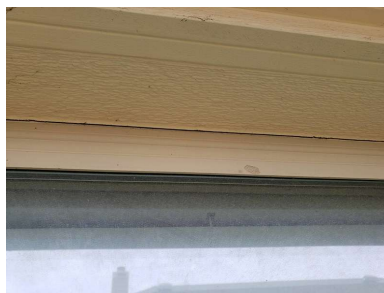
2: Caulking

One or more areas showed signs of deteriorated caulking. Recommend maintenance on an annually basis.

Recommendation: Contact a qualified general contractor.

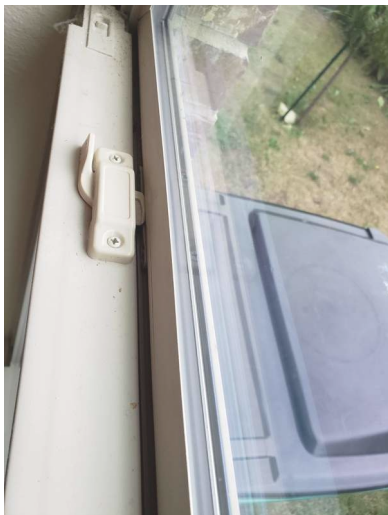
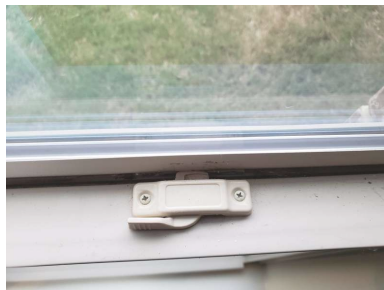
3: Window does not lock properly

One or more areas show that Windows did not properly lock. Recommend repairing and replace as needed.

Recommendation: Contact a qualified window repair/installation contractor.

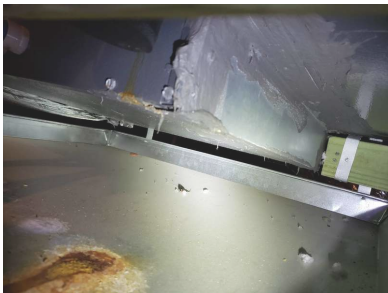
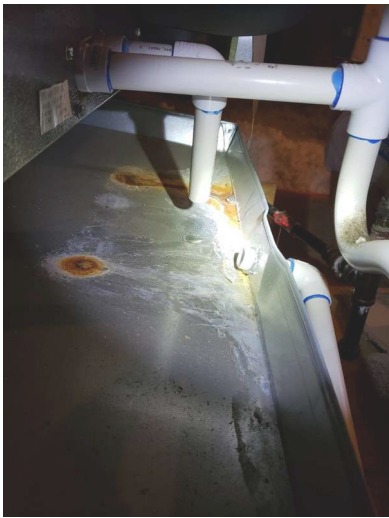
1: Condensate drain leak

Evidence of previous repair and leaking. Recommend further evaluation.

Recommendation: Contact a qualified heating and cooling contractor

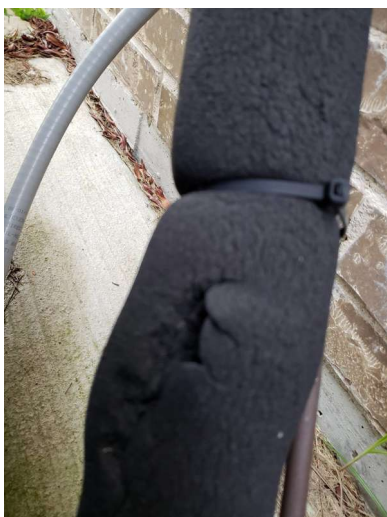
1: Insulation Missing or Damaged

Missing or damaged insulation on refrigerant line can cause energy loss and condensation.

Recommendation: Contact a qualified HVAC professional.

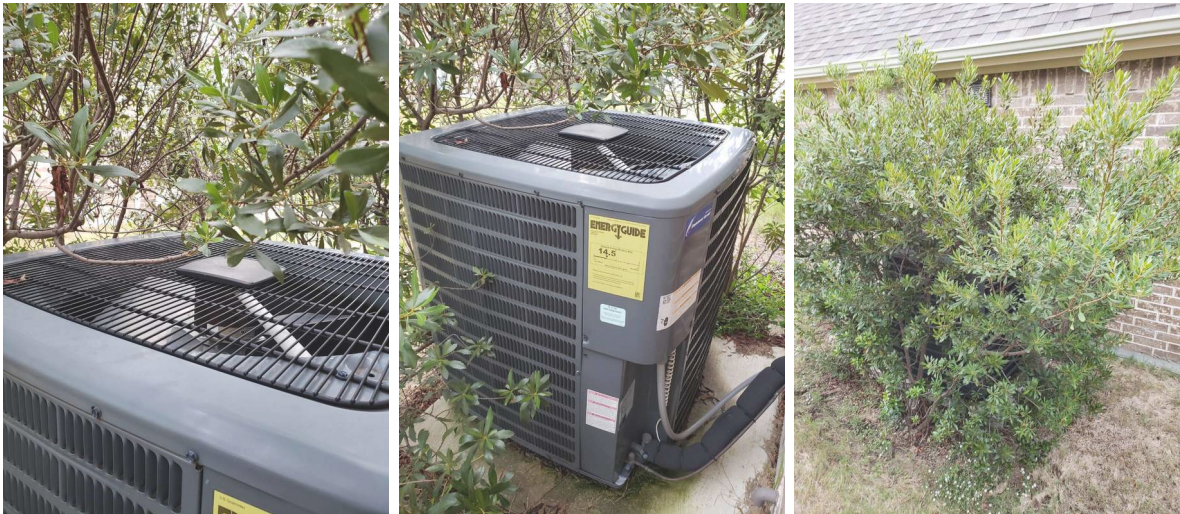
2: Clearance to vegetation

Recommend trimming back bushes for proper air flow and to maintain efficiency.

Make sure plants are at least 2-3 feet from the unit on all sides, and plan the landscaping so that the air conditioner is easily accessible for maintenance and repairs. If you have trees or other plants growing above the unit, trim regularly to keep a 5-foot clearance between them and the air conditioner.

Recommendation: Contact a qualified landscaping contractor

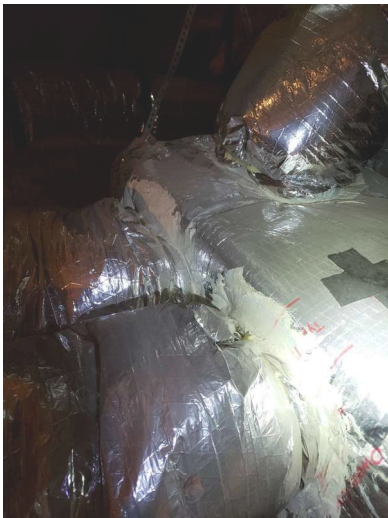
1: Air leak

Observed air leaking into attic space at the time of inspection

Recommendation: Contact a qualified heating and cooling contractor

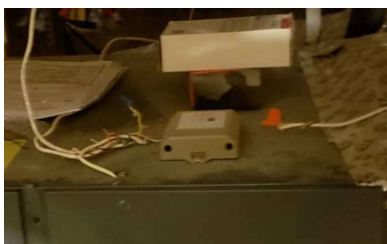
1: Exposed Ends & Splices

Attic on top of furnace

All wire connections & charged wires with exposed ends and splices should be covered in junction boxes for safety. Recommend a qualified electrician correct.

Recommendation: Contact a qualified electrical contractor.

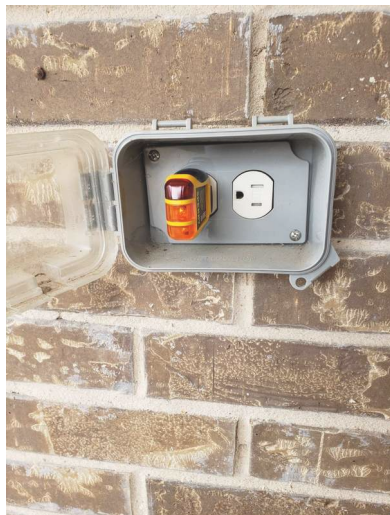
2: GFCI

Outdoors

GFCI receptacles are required in work areas and near sources of water. These receptacles help prevent electrocution by stopping power from these receptacles and all other ones down stream from it. Recommend adding GFCI receptacles to all required areas where not present.

Recommendation: Contact a qualified electrical contractor.

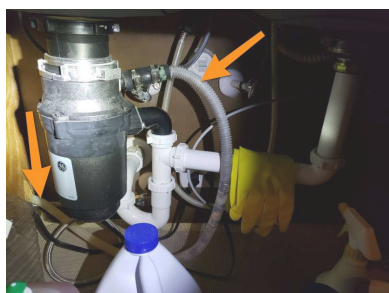
1: Improper installation

Backflow prevention device improperly installed recommend repair and replace as needed. Do not recommend using until cleaned and fixed. Operation with current configuration will result in dirty water flowing back into dishwasher.

Recommendation: Contact a qualified general contractor.

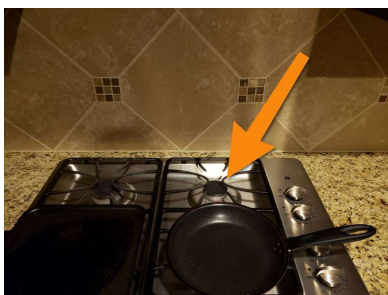
1: Burner Not Lighting

One or more heating elements did not heat up when turned on. Recommend qualified professional evaluate & repair.

Recommendation: Contact a qualified general contractor.

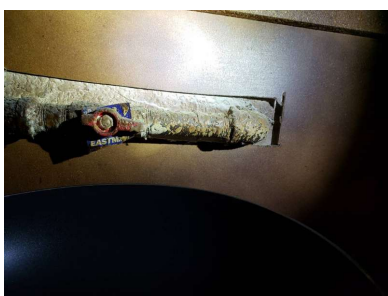
2: Dirty gas shut off valve

Gas shut off valve is dirty and corroding recommend cleaning and evaluating it's operation.

Recommendation: Contact a qualified general contractor.
