PRO SPEX RESIDENTIAL FOUNDATION/FRAMING INSPECTION REPORT COPY

15503 Sample Report Rd
LAUREL MD 20707

Boo Bah Loo
JULY 10, 2018

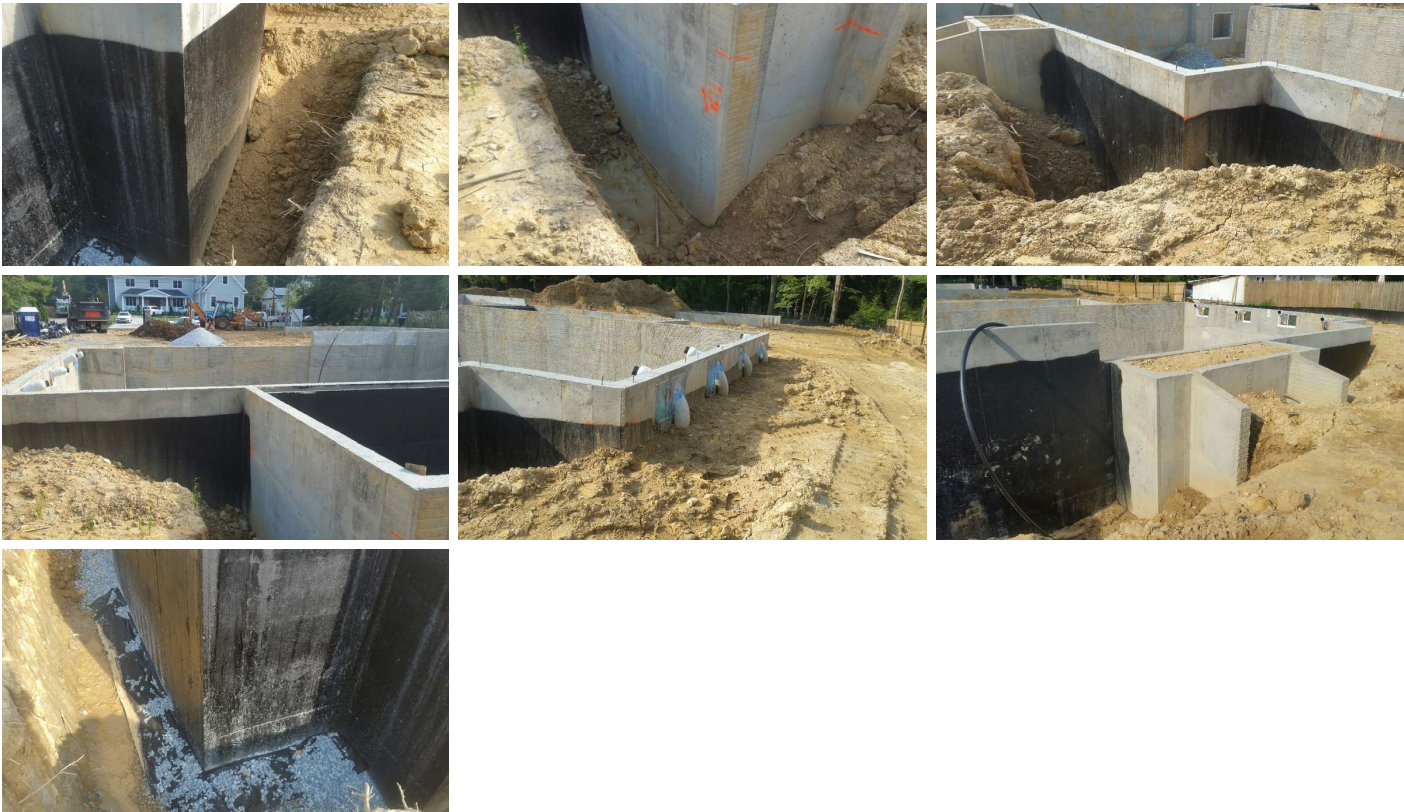
Sample Photos

Black Foundation coating with plastic vapor barrier has been installed on below grade walls and partially (75%) backfilled.

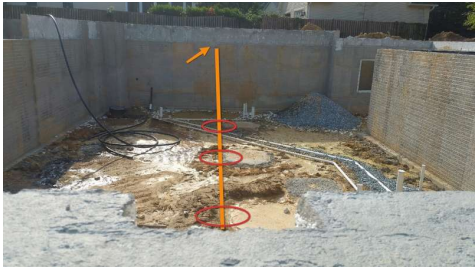
2.2.1 FOOTING & POST ALIGNMENT

FOOTING & POST ALIGNMENT

Being pocket intended the steel beam and footings for steel posts do not align.

Contact a qualified professional.

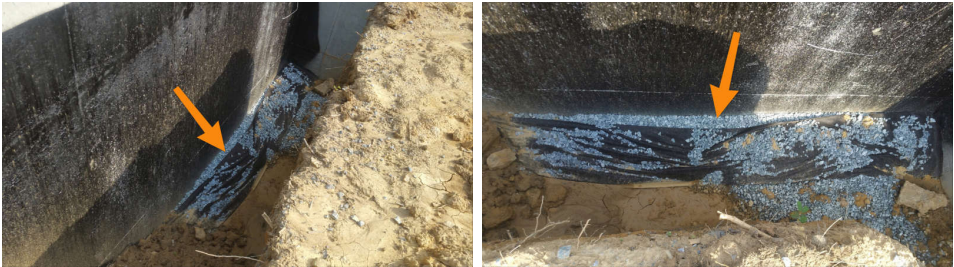
3.1.1 FOUNDATION DRAINAGE

FILTER FABRIC INSTALL

The filter fabric has shifted in a few areas, ensure it is properly in place before backfill. Filter fabric keeps soil from entering the drain pipes after backfill.

Contact a qualified professional.
