SAMPLE HOME INSPECTION REPORT

1234 New Construction Ct.
Hanover MD 21076

New Buyer
AUGUST 13, 2018

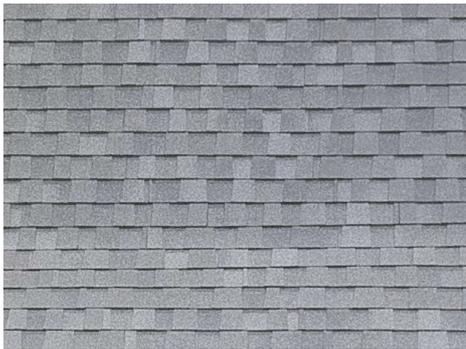
Roof Covering: Architectural Shingles

The roof was covered with laminated fiberglass asphalt shingles, also called "architectural" or dimensional shingles. Laminated shingles are composed of multiple layers of a fiberglass mat embedded in asphalt and covered with ceramic-coated mineral granules. Shingles with multiple layers bonded together are usually more durable than shingles composed of a single layer.

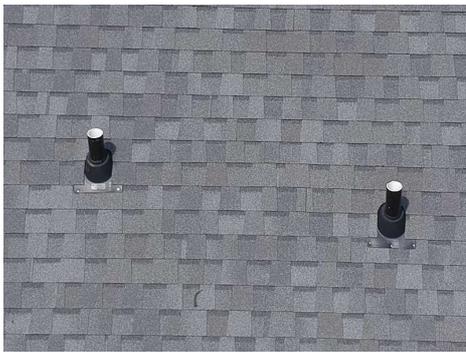
Flashing is a general term used to describe sheet metal fabricated into shapes and used to protect areas of the roof from moisture intrusion. Inspection typically includes inspection for condition and proper installation of flashing in the following locations: - roof penetrations such as vents, electrical masts, chimneys, mechanical equipment, patio cover attachment points, and around skylights; - junctions at which roofs meet walls; - roof edges; - areas at which roofs change slope; - areas at which roof-covering materials change; and - areas at which different roof planes meet (such as valleys). Flashing is often installed behind or underneath materials that conceal it from your inspector.

The photo shows examples of where roof flashing might be found under ideal conditions.

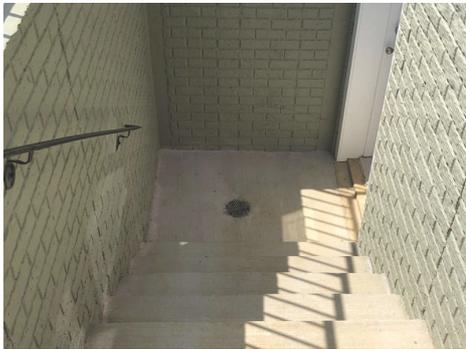
There is a drain at the bottom of the exterior stairs to the basement. This drain must be kept clear at all times. Your inspector cannot be certain this drain is functioning properly absent a rain storm.

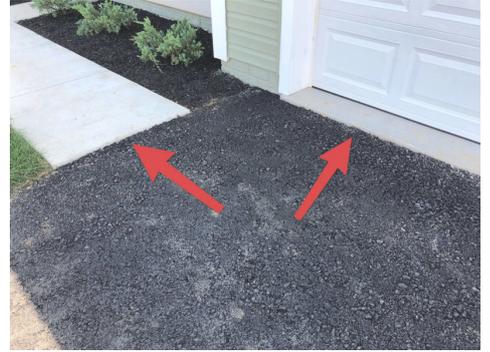
TEMPORARY TRIP HAZARD

The final layer of asphalt had not been applied at the time of inspection. Caution should be exercised as there will be trip hazards in the driveway until the asphalt is complete.

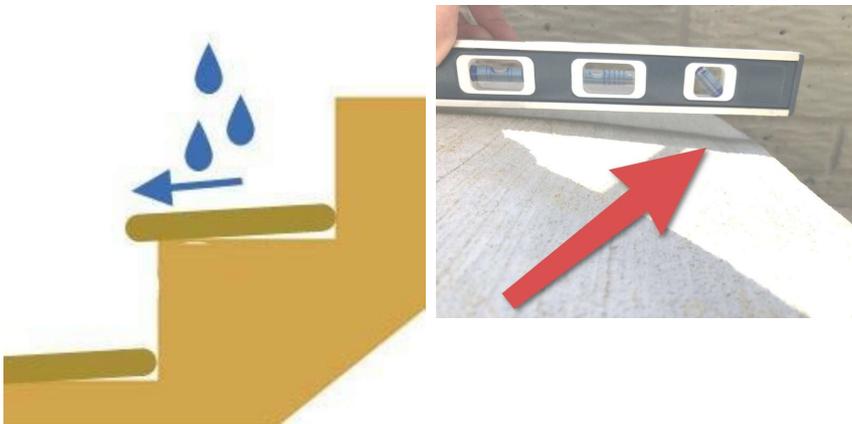
3.2.1 Steps / Porch / Deck

One or more stair treads are excessively sloped and may be a trip/fall hazard. Exterior stair treads should be sloped to prevent water from collecting but not more than a maximum of 1/4 inch per foot.

Slope should not exceed 1/4 inch per foot

Recommendation

Contact a qualified concrete contractor.

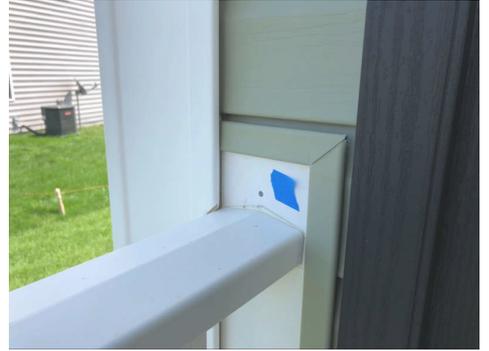
3.3.2 Siding / Trim / Flashing

Rear Basement Door

There are exposed nails in the exterior trim that should be filled or sealed to prevent corrosion.

Recommendation

Contact a qualified painting contractor.

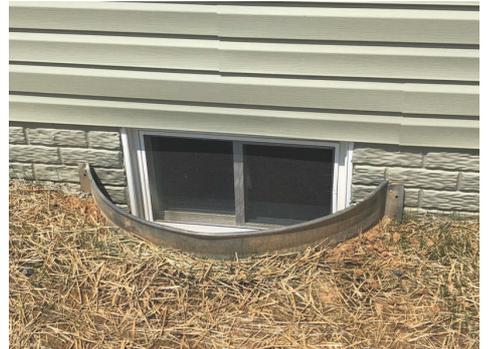
Window wells should be covered to keep water, children, and pests, such as foxes or skunks out of the window well. This is a common cause of wet basements.

Recommendation

Contact a qualified handyman.

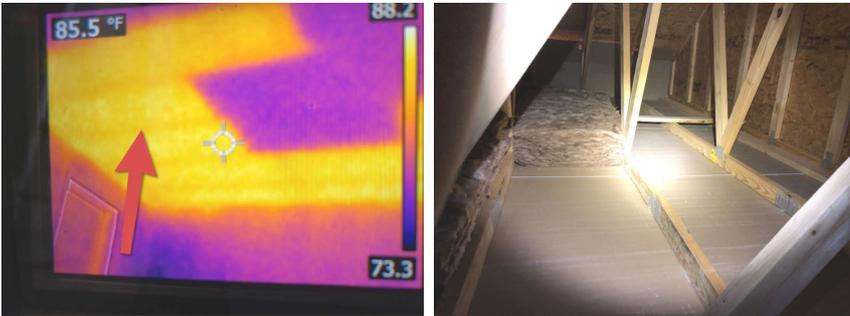
4.2.1 Insulation Condition

MISSING INSULATION IN ATTIC

Portions of the insulation was observed to be missing. This condition cause moisture problems and contribute to energy loss during the heating and cooling seasons if not corrected.

Yellow areas are hot due to missing insulation

Recommendation

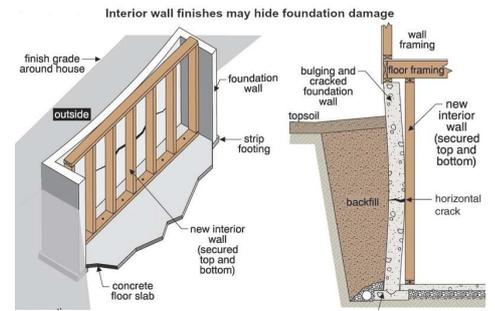
Foundation

FOUNDATION CONCEALED BY SOIL

Exterior portions of the foundation were partially or completely covered with soil. This prevented a thorough inspection of the foundation and may have concealed a defect. Any evidence or indications of a structural defect or failure of the foundation or footings will be noted in this report.

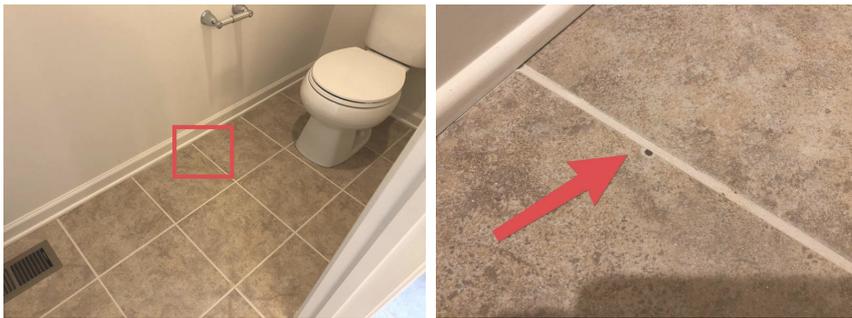
DAMAGED FLOOR TILES

There is a chipped floor tile in the master bathroom. This is a cosmetic defect that should not affect the durability of the tile.

Recommendation

Contact a qualified flooring contractor

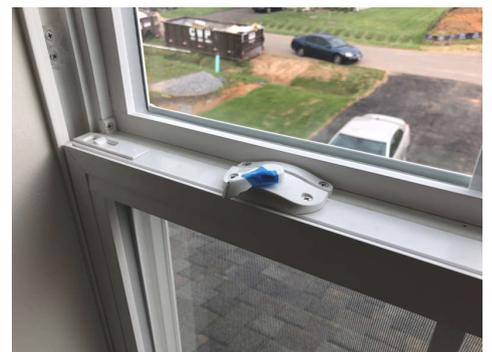
6.2.1 Windows / Doors / Closets

WINDOWS DIFFICULT TO LATCH

Recommendation

Contact a qualified window repair/installation contractor.

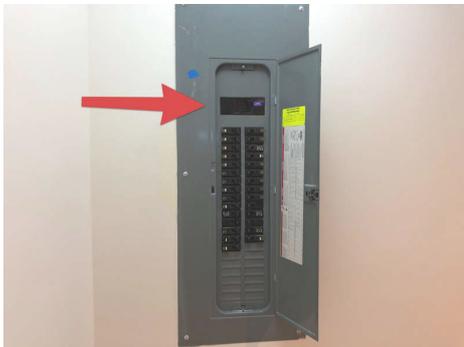
The main electrical shutoff (disconnect) is located in the basement. It is important to maintain easy access to the main service panel so that power can be turned off or back on in the event of an emergency. This is a very good place to keep a flashlight.

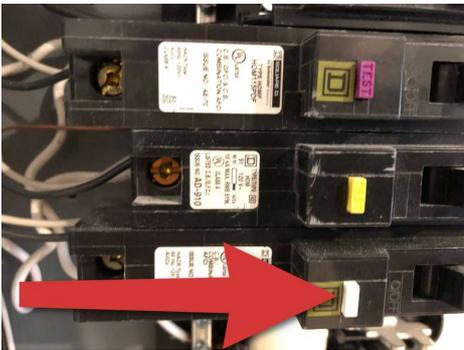
AFCI Breaker for protection from arcing

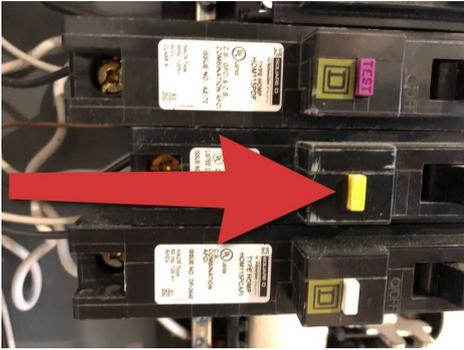
GFCI Breaker for wet locations

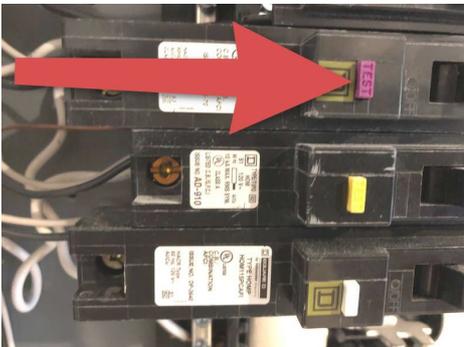
A combination AFCI & GFCI Breaker provides protection from arc-faults and ground-faults. You will need to reset the breaker to reactivate a protected outlet.

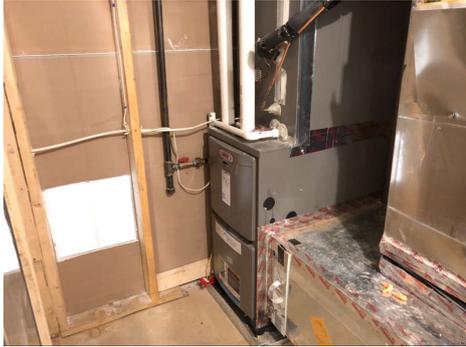
High-efficiency gas furnaces have AFUE ratings of 90% and greater. A solid-state control board controls the ignition. There is no continuous pilot light. There are two or sometimes three heat exchangers installed inside a high-efficiency gas furnace. Condensate is produced when heat is extracted from the flue gases. The temperature of the flue gases is low enough to use a PVC pipe as the vent exhaust pipe. There is no need to vent the exhaust gases up a chimney stack.

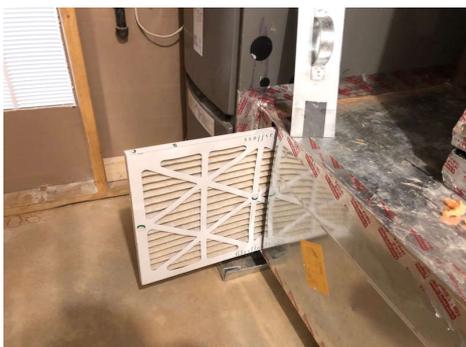
Furnace Air Filters should be checked monthly and replaced as needed. Failure to change the filter when needed may result in the following problems:

- Reduced blower life due to dirt build-up on vanes, which increasing operating costs.
- Reduced effectiveness of air filtration resulting in deterioration of indoor air quality.
- Increased resistance resulting in the filter being sucked into the blower. **This condition can be a potential fire hazard.**
- Frost build-up on air-conditioner evaporator coils, resulting in reduced cooling efficiency and possible damage.
- Reduced air flow through the home.
- Dirty filter cause **dirty refrigerant coils which are the #1 cause of major repairs.**

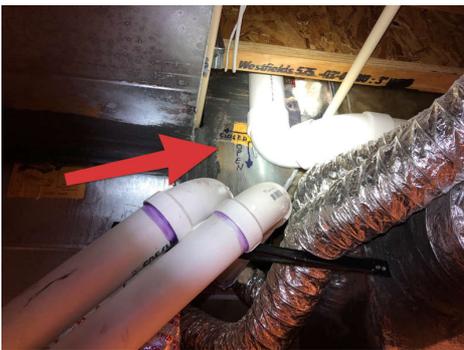
The supply duct near the furnace has a damper installed. This allows some control of the air flow to certain parts of the home. It may allow you to control how much conditioned air moves to the upper level or lower level. Determining this is beyond the scope of a general home inspection. A typical strategy is to direct more of the air upstairs during the cooling season as the lower level will usually be cooler or to direct more air to the downstairs in the heating season as warm air rises. You will need to experiment some to determine if the damper is useful to you at all.

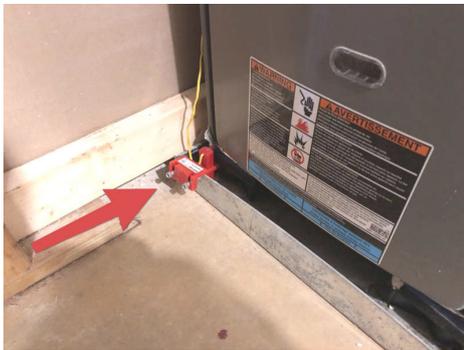
Condensate disposal: Drip Pan With Float Switch

This heating and cooling system had a drip pan installed with a float switch to prevent flooding.

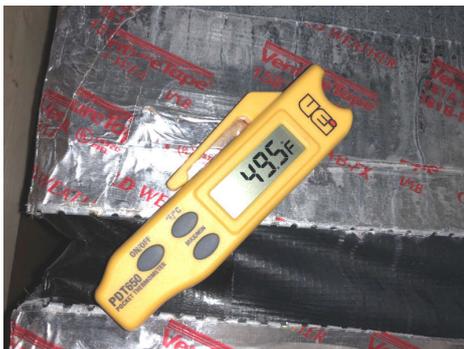
Cooling System: System Cooling Adequately

The air is being cooled adequately. The temperature was checked at the air handler.

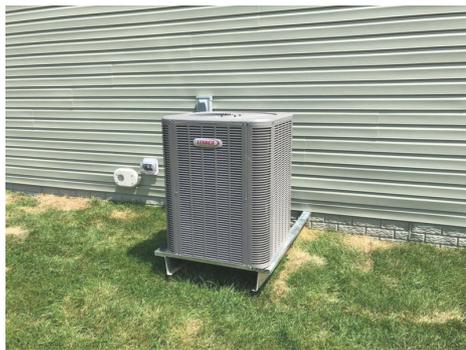
The air conditioning system is a split system in which the cabinet housing the compressor, cooling fan and condensing coils was located physically apart from the evaporator coils. As is typical with split systems, the compressor/condenser cabinet was located at the home's exterior so that the heat collected inside the home could be released to the outside air.

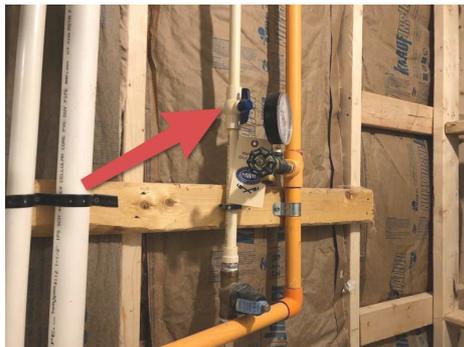
Shuts off plumbing only

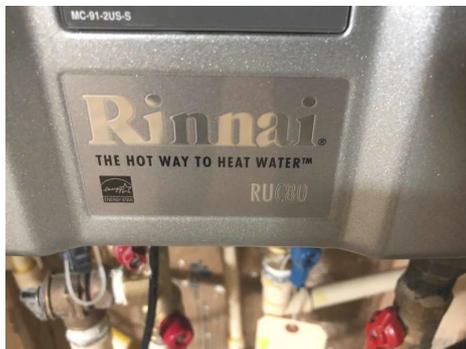
Tankless water heaters save energy by avoiding the stand-by losses associated with conventional water heaters which must constantly maintain water in a tank at a minimum temperature.

Due to calcium build-up on components, tankless water heaters may require service annually. Failure to service the water heater in a timely manner typically results in a reduced hot water flow rate.

Illustration is an example only

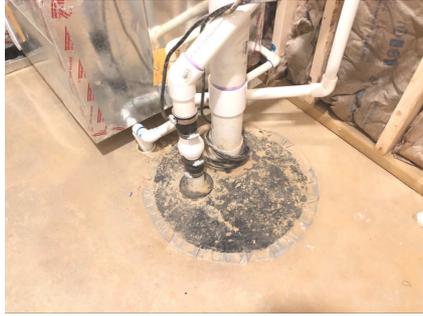
The lid to the pit or "crock" containing the sump pump is part of the radon reduction system and is sealed. Your inspector did not break the seal and could not inspect the sump pump. Any indication of failure will be noted in this report.

Example of radon reduction system in sump pump lid

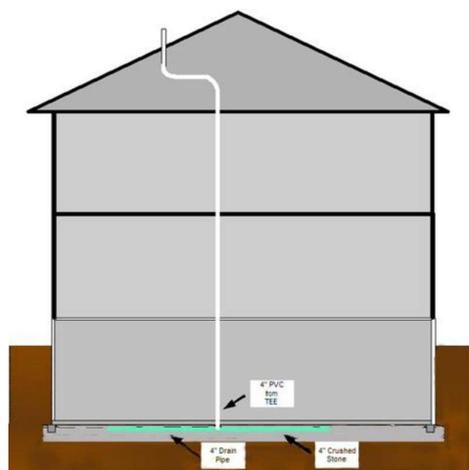
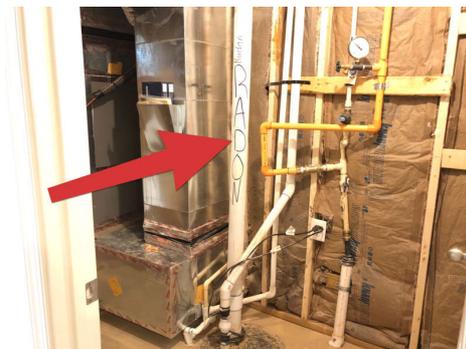
Passive Shunt Installed

A passive radon shunt allow radon gas to escape through a pipe to the outside atmosphere. If properly installed this may be an effective means of radon reduction. Testing is the only way to know if it is in fact effective at reducing radon gas levels in the home.
