## HOME INSPECTION REPORT

1312 7th Ave SE  
Olympia WA 98501

MARCH 13, 2019

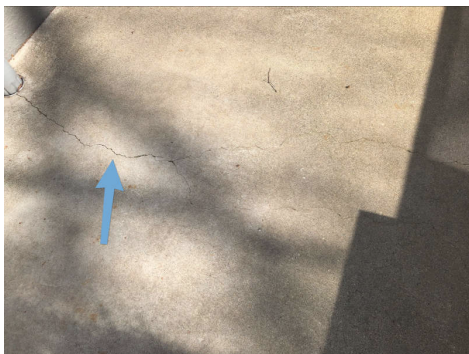
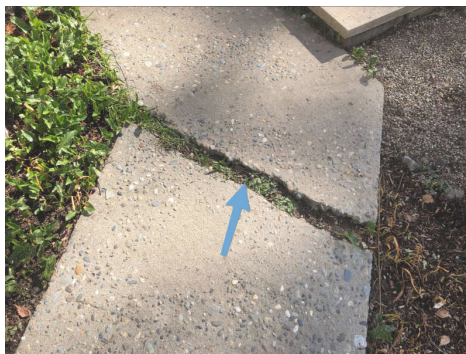
**CRACKS IN WALKWAYS****FRONT**

There are a few cracks in the walkways around the residence that are mostly cosmetic. We suggest you view these yourself and repair as necessary.

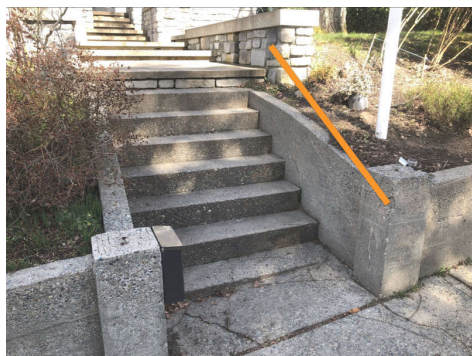
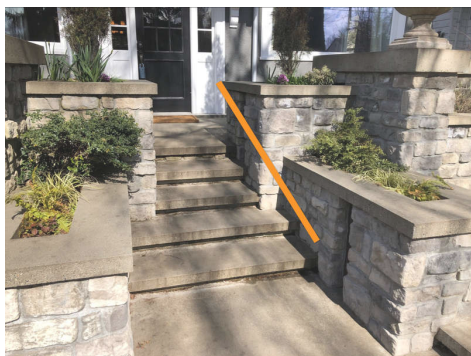
**MISSING RAIL****FRONT**

The stairs are missing graspable rails. These are recommended on stairs where three or more risers are present. We recommend rail be installed.

Contact a qualified professional.

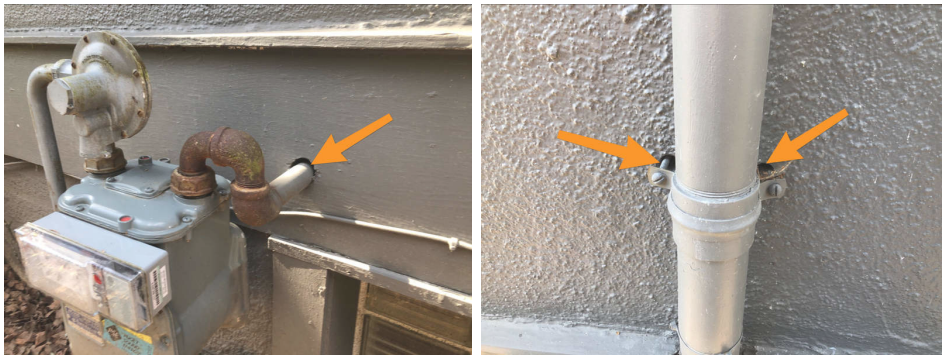
Gaps and/or holes were observed on one or more sides in the siding around plumbing, gas, cable, wiring and/or other penetrations. We advise that all the holes and the gaps be caulked and/or sealed to prevent moisture and/or pest intrusion.

Contact a qualified professional.

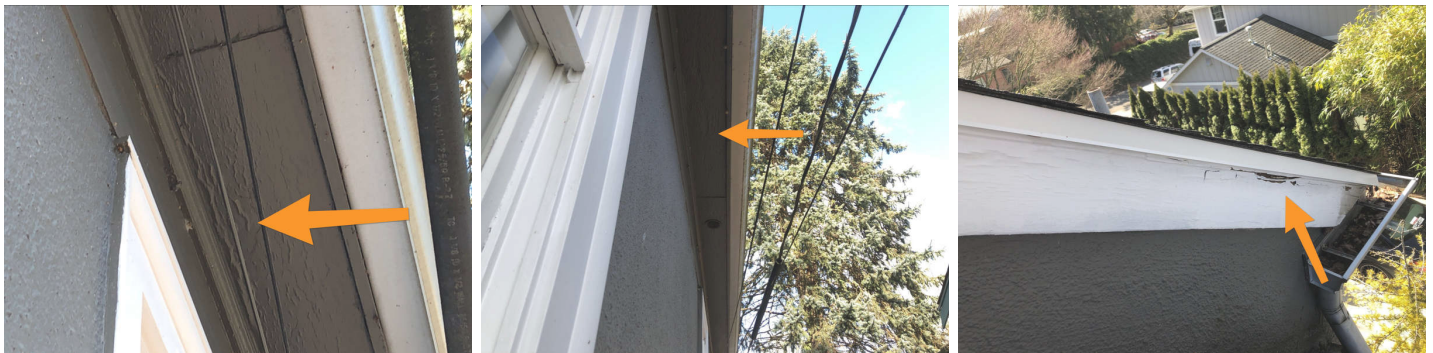
**SECTIONS OF FASCIA OR WOOD TRIM ARE WEATHERED**

Sections of the fascia board or wood trim around the residence are slightly weathered, and should be serviced as necessary to prevent further deterioration. Service such as scraping, repainting and sealing.

Contact a qualified handyman.

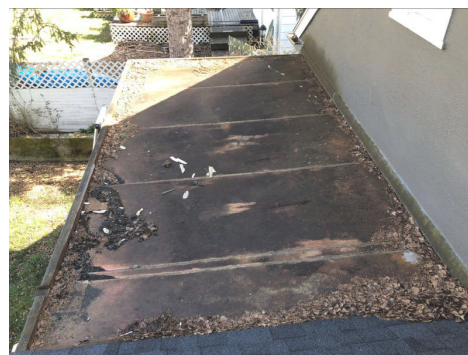
Parts of the roof needs to be cleaned of moss and/or debris. This can restrict drainage and lead to moisture intrusion and moisture damage if not corrected.

Contact a qualified professional.

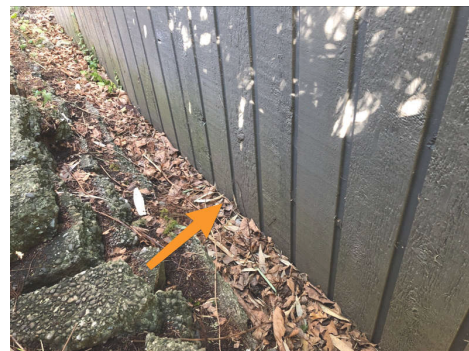
**EARTH TO WOOD CONTACT**

The siding was in contact with or nearly contacting soil or mulch or concrete. This is a condition conducive to deterioration and wood destroying organism infestation. We recommend removing soil a six-inch space between any siding material and soil where possible and repairs to any damaged or deteriorated siding.

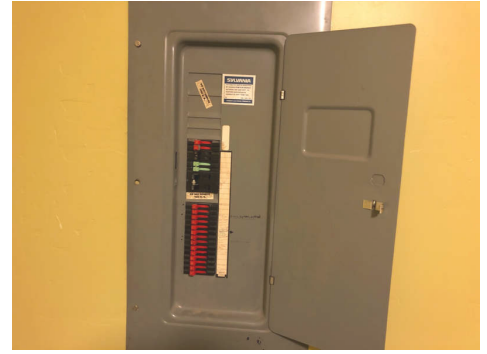
The panel was manufactured by Zinsco/Sylvania and has been alleged to be defective. However, in the interests of safety, the backs of the breakers should be properly evaluated and serviced as necessary by a electrician to ensure that there is no scorching or evidence of overheating. This service is recommended at least before the close of escrow and preferably within the inspection period. Ultimately, our recommendation is to replace this panel with a modern panel.

Contact a qualified electrical contractor.

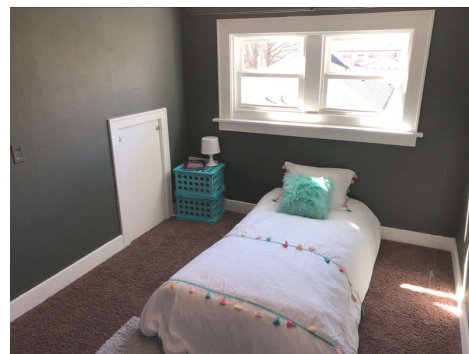
**HEAT SOURCE MISSING FROM ROOM**

A permanent heat Source was missing from one or more rooms. We recommended having fixed heaters installed.

Contact a qualified professional.

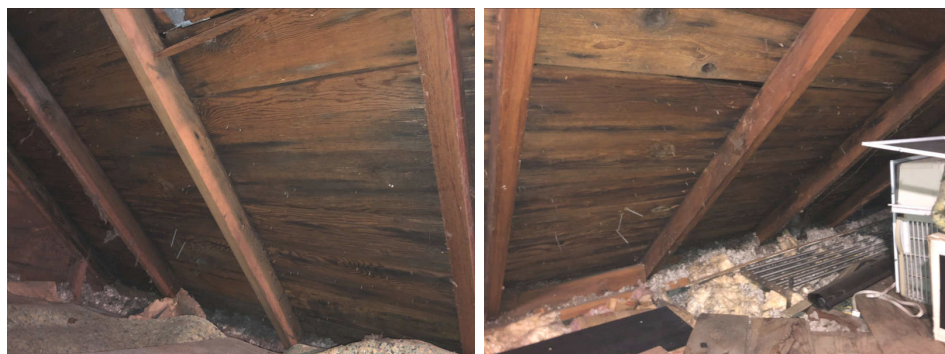
#### DECK STAINING

Discoloration and dark staining was observed on the roof sheathing. This is often caused by poor ventilation and is commonly considered a microbial growth. Recommend improving ventilation and cleaning.

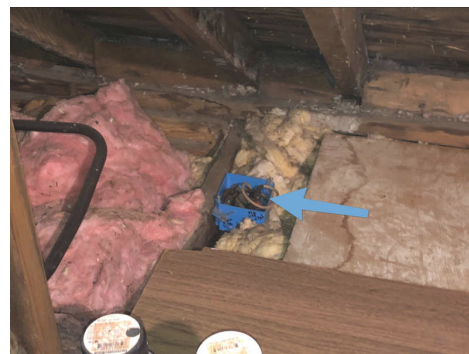
#### COVER PLATE MISSING OR DAMAGED

It cover plate is missing or damaged. Recommend repair.
