## RESIDENTIAL REPORT

1234 Main Street

Sample Home Inspection

OCTOBER 8, 2018

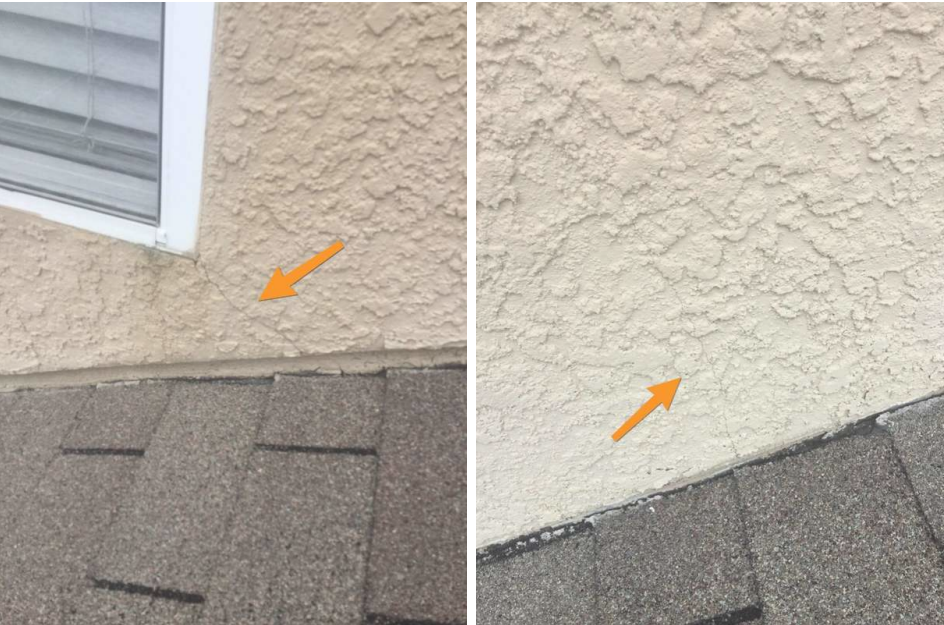
2.1.1 Siding, Flashing & Trim

#### CRACKING - MINOR

Minor cracking observed in one or more places. This is commonly a result of temperature changes, and typical as homes with stucco age. Recommend monitoring.

Recommendation  
Recommended DIY Project

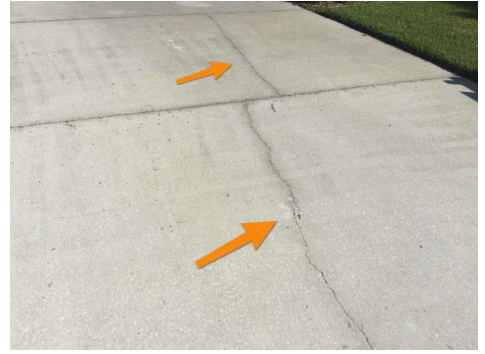
2.3.1 Walkways, Patios & Driveways

#### DRIVEWAY CRACKING - MINOR

Normal settling & cracking observed. Recommend monitor and/or patch/seal.

Recommendation  
Contact a qualified driveway contractor.

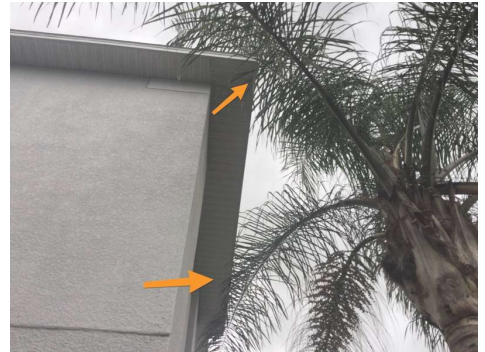
### 2.6.1 Vegetation, Grading, Drainage & Retaining Walls

## TREE OVERHANG

Trees observed overhanging the roof. This can cause damage to the roof and prevent proper drainage. Recommend a qualified tree service trim to allow for proper drainage.

Contact a qualified tree service company.

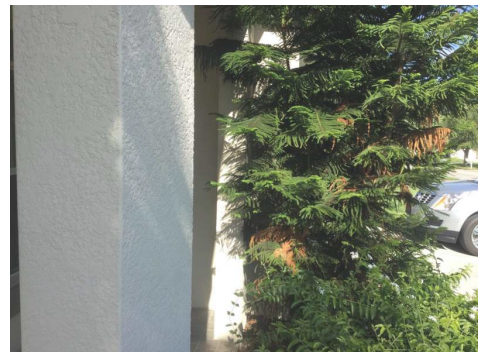
### 2.6.2 Vegetation, Grading, Drainage & Retaining Walls

## VEGETATION TOO CLOSE TO STRUCTURE

Found vegetation in contact with exterior walls which can damage exterior siding. Recommend trimming plants away from the walls.

Contact a qualified landscaping contractor

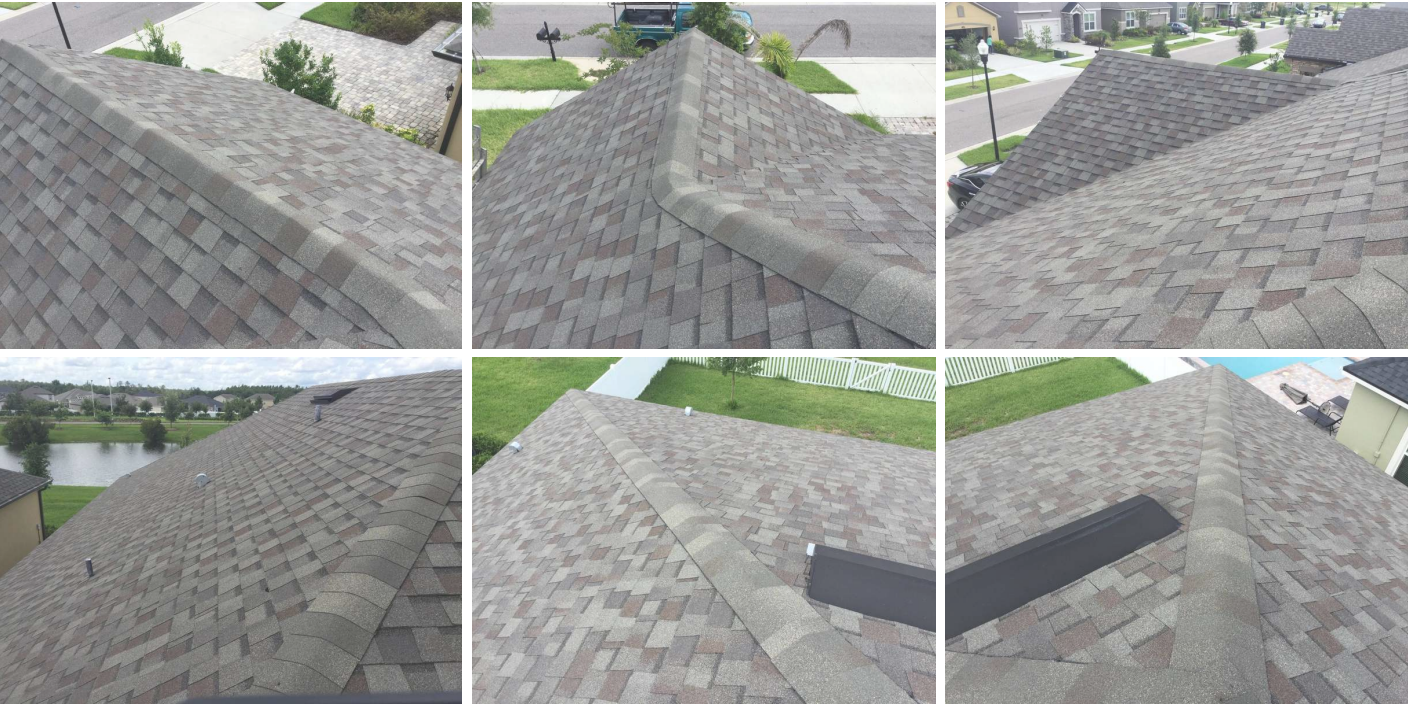
3.1.1 Coverings

SHINGLES MISSING

Observed areas that appeared to be missing sufficient coverings. Recommend qualified roofing contractor evaluate & repair.

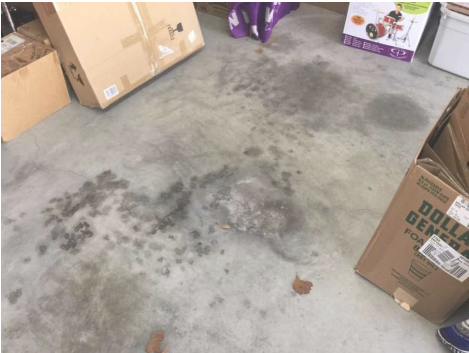
5.2.1 Floor

### STAINING

Garage floor shows visible staining from oil/grease. Recommend scrubbing with a degreaser or cleaning solution.

Recommended DIY Project

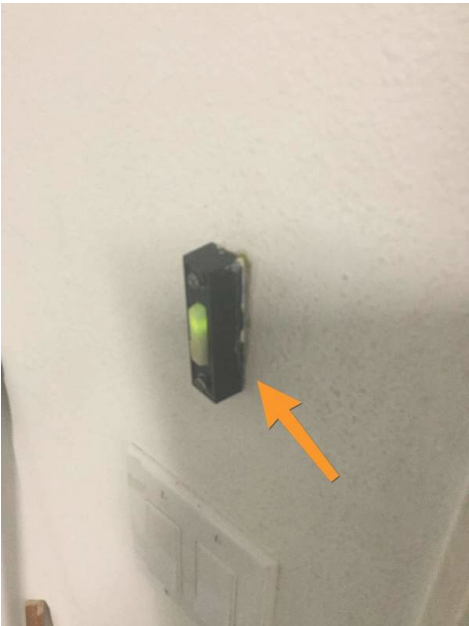
5.5.1 Garage Door Opener

### LOOSE WALL SWITCH

Secure as needed.

Contact a handyman or DIY project

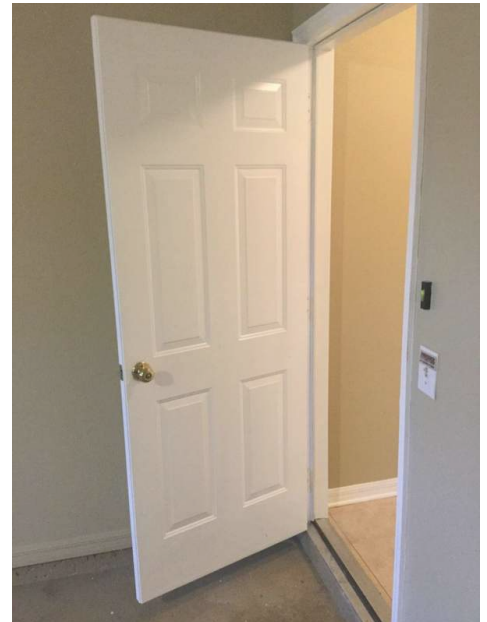
5.6.1 Occupant Door (From garage to inside of home)

### NOT SELF-CLOSING

Door from garage to home should have self-closing hinges to help prevent spread of a fire to living space. Recommend a qualified contractor install self-closing hinges.

Contact a qualified door repair/installation contractor.

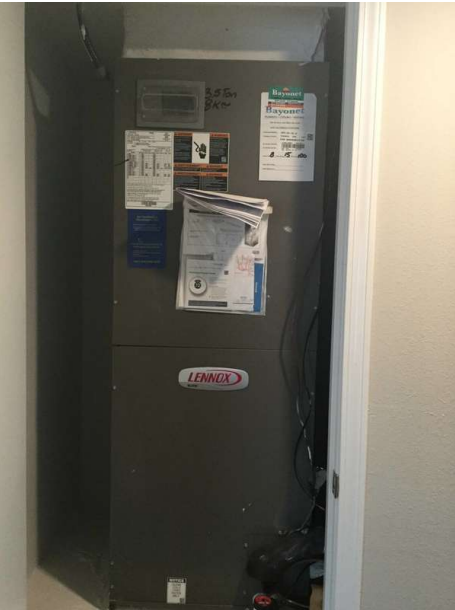
<b>Heating Equipment: Brand</b> Lennox	<b>Heating Equipment: Energy Source</b> Electric	<b>Heating Equipment: Heat Type</b> Forced Air

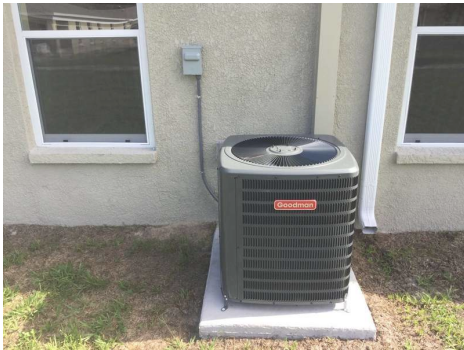
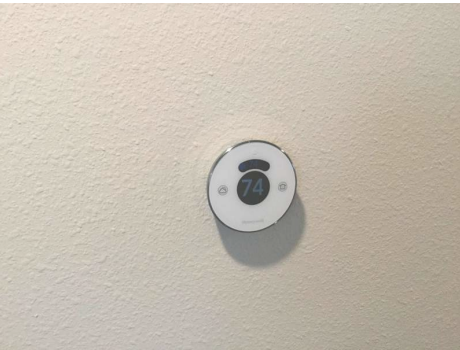
<b>Heating Equipment: Location</b> Hall	<b>Heating Equipment: Manufacture Date</b> 2012	<b>Cooling Equipment: Configuration</b> Central	
<b>Cooling Equipment: Energy Source/Type</b> Electric	<b>Cooling Equipment: Location</b> Exterior East	<b>Cooling Equipment: Manufacture Date</b> 2012	
<b>Distribution Systems: Ductwork</b> Insulated			
<b>Cooling Equipment: Brand</b> Lennox

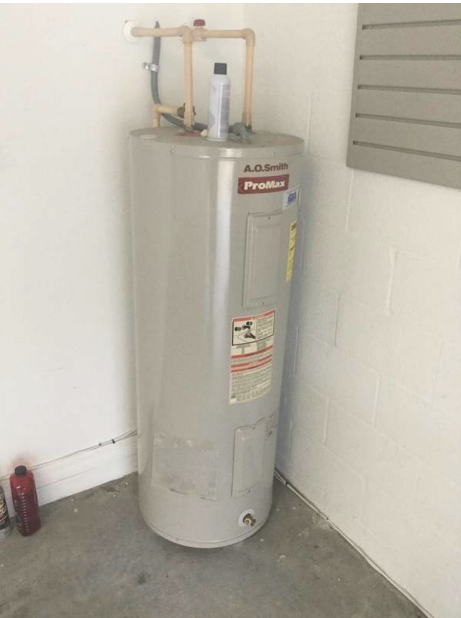
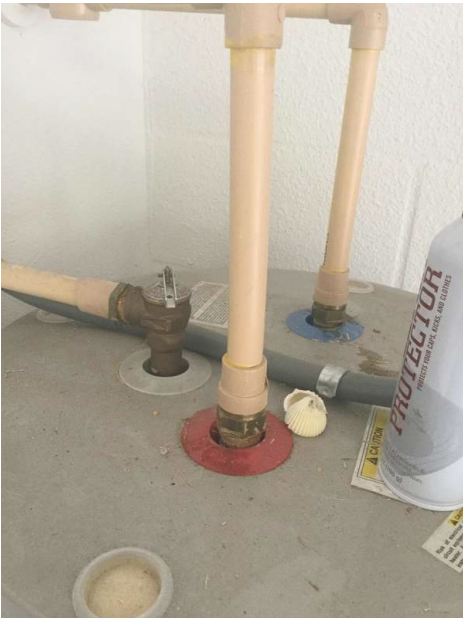
I recommend flushing & servicing your water heater tank annually for optimal performance. Water temperature should be set to at least 120 degrees F to kill microbes and no higher than 130 degrees F to prevent scalding.

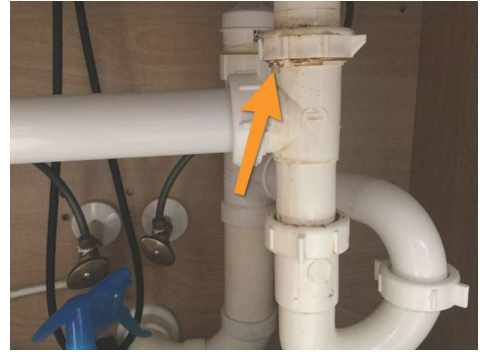
## 7.2.1 Drain, Waste, &amp; Vent Systems

**LEAKING PIPE**

A drain, waste and/or vent pipe showed signs of a leak. Recommend a qualified plumber evaluate and repair.

Contact a qualified plumbing contractor.

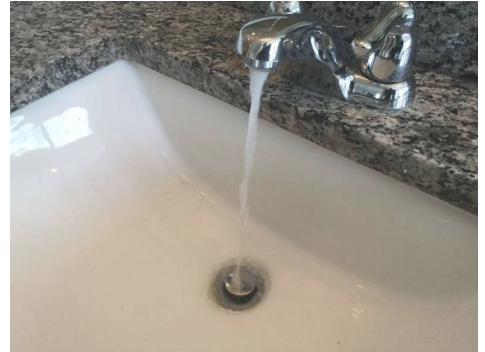
## 7.3.1 Water Supply, Distribution Systems &amp; Fixtures

Master Bath

**LOW FLOW AT FIXTURE**

Low water flow observed at one or more fixtures. Recommend evaluation and repair by a qualified professional

Contact a qualified plumbing contractor.

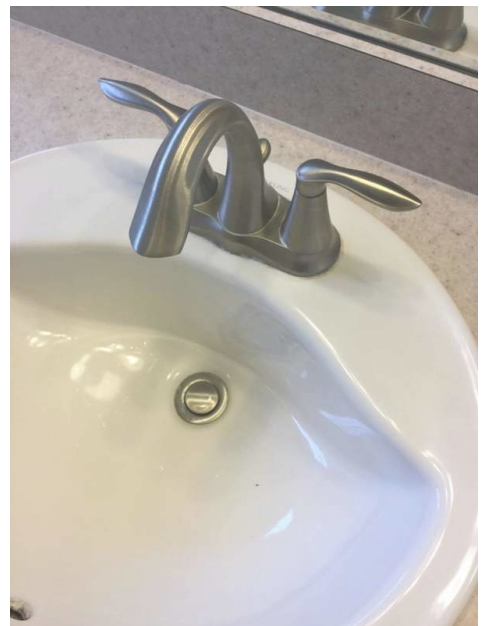
## 7.3.2 Water Supply, Distribution Systems &amp; Fixtures

Hall Bathroom

**SINK DRAIN DOES NOT OPERATE USING NORMAL CONTROLS**

Recommend evaluation and repair by a qualified individual.

Contact a handyman or DIY project

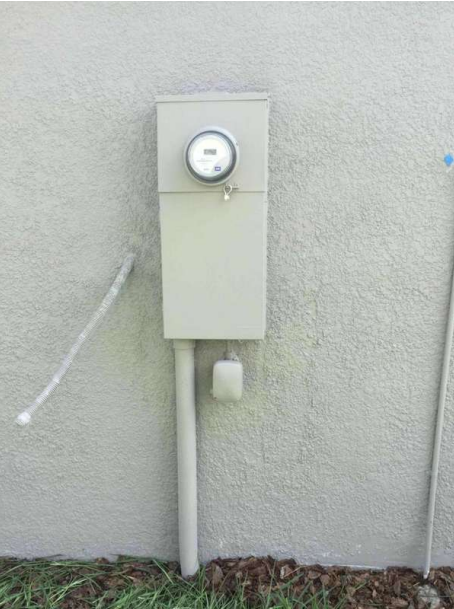
**Service Entrance Conductors:**  
**Electrical Service Conductors**  
Below Ground

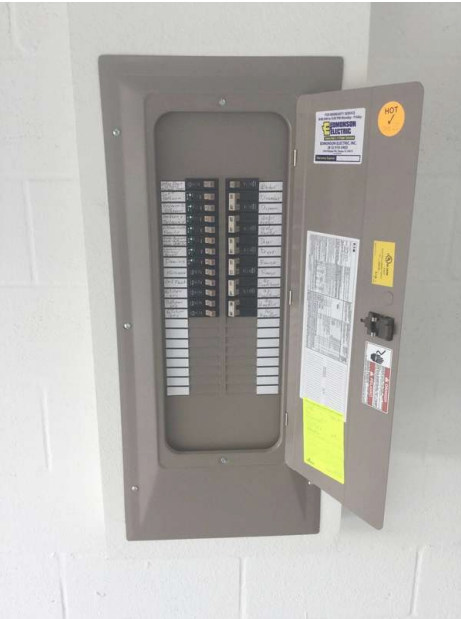
**Main & Subpanels, Service & Grounding, Main Overcurrent Device: Electric Panel Location(s)**  
Garage

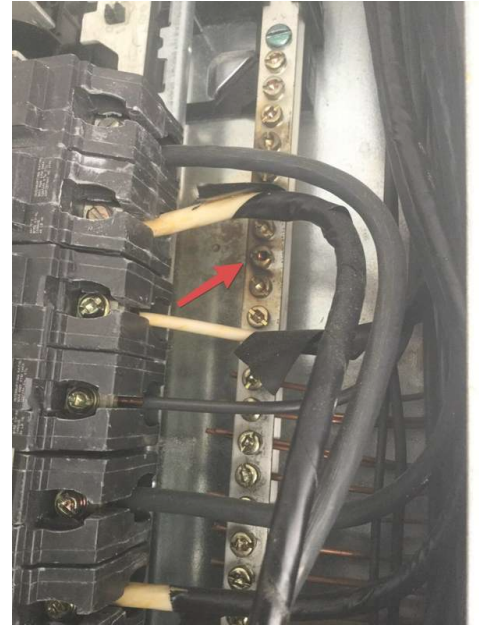
8.2.1 Main & Subpanels, Service & Grounding,  
Main Overcurrent Device

### BURNT AREA

Burnt area indicating possible past arc fault. Recommend evaluation by a licensed electrician.

Contact a qualified electrical contractor.

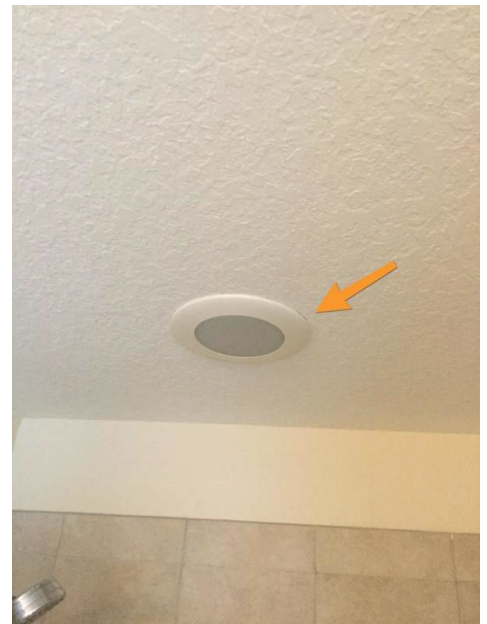
8.4.1 Lighting Fixtures, Switches & Receptacles

### LIGHT INOPERABLE

One or more lights are not operating. New light bulb possibly needed.

Contact a qualified electrical contractor.

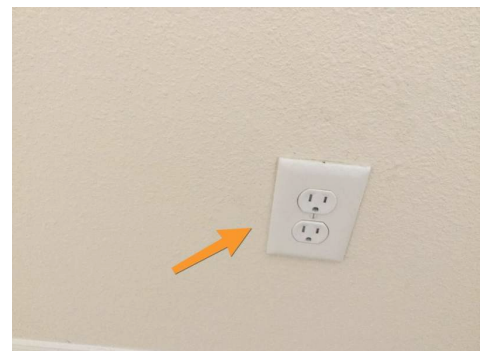
8.4.2 Lighting Fixtures, Switches & Receptacles

### LOOSE ELECTRICAL OUTLET

Outlet moves excessively when plugging or unplugging a device which could result in a shock hazard. Recommend repair by a qualified professional.

Contact a qualified professional.

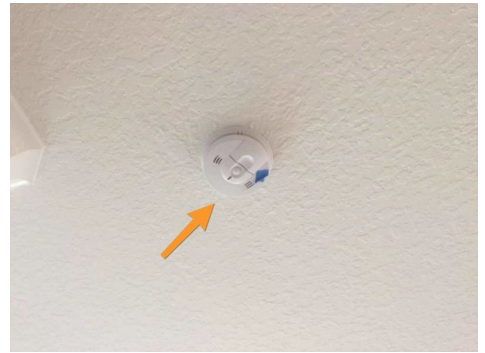
## 8.6.1 Smoke Detectors

**LOW BATTERY**

Smoke detector failed to respond when tested. Recommend battery be replaced.

Recommended DIY Project

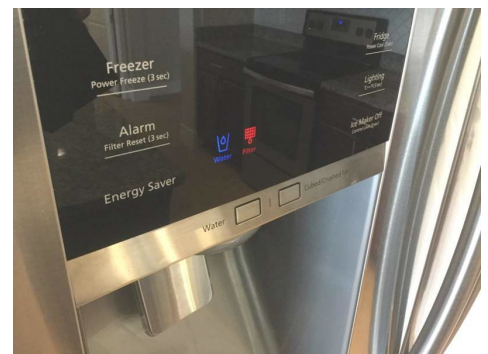
## 9.2.1 Refrigerator

**FILTER STATUS REQUIRES CHANGE**

Refrigerator water filter indicator shows filter needs replacement.

Recommended DIY Project

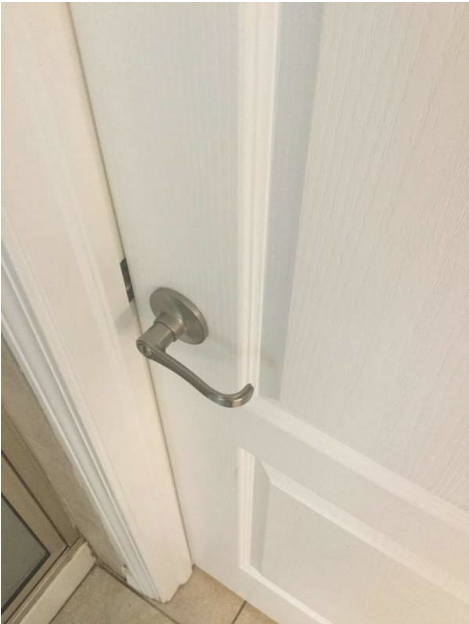
10.1.1 Doors

### DOOR DOESN'T LATCH

Door doesn't latch properly. Recommend handyman repair latch and/or strike plate.

Contact a qualified handyman.

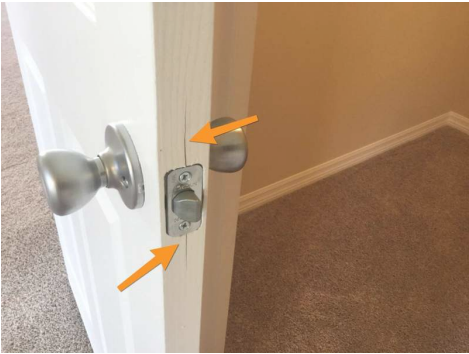
10.1.2 Doors

### DAMAGE

One or more interior doors were damaged. Recommend repair or replacement by a qualified professional.

Contact a qualified professional.

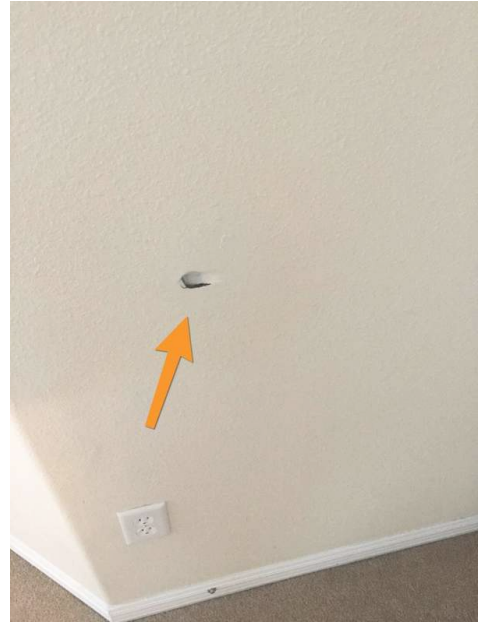
10.4.1 Walls

### DOORKNOB HOLE

Wall had damage from doorknob. Recommend a qualified handyman or drywall contractor repair.

Contact a qualified drywall contractor.

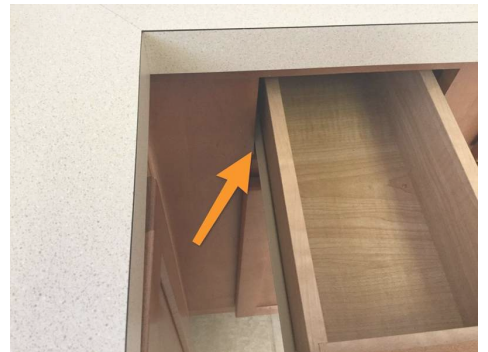
#### 10.7.1 Countertops & Cabinets

### DRAWER(S) DAMAGED OR STICKING

One or more cabinet drawers was not functioning properly or visibly damaged at the time of inspection. Recommend repair by a qualified professional.

Drawer slide is not attached.

Contact a qualified cabinet contractor.
